## Bat Emergence and Re-Entry Surveys (BERS)

38 Yardley Road, Hedge End, Southampton, SO30 0HQ

Enlarged dormers on to both north and south elevations.

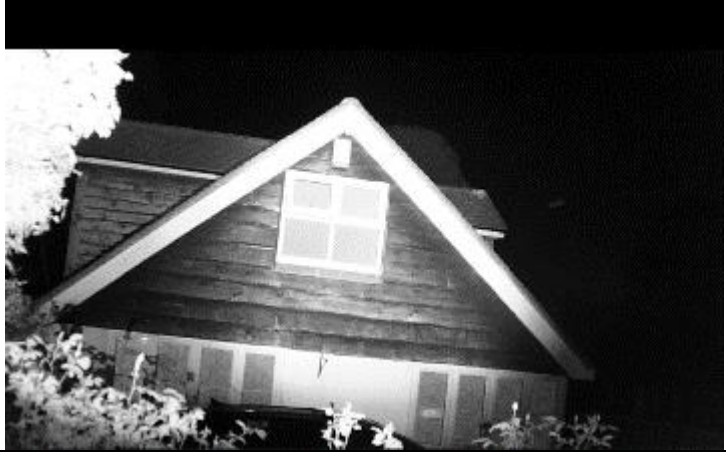
| <i>Surveyor 1</i> | <b>No emergencies observed.</b> A common pipistrelle bat (CP) was observed foraging at the south elevation/in the rear garden-where?) at 20:54. No further activity was recorded during the survey. | N/A |
| <i>IR position</i> | The footage reflected the view of surveyor 1. | |

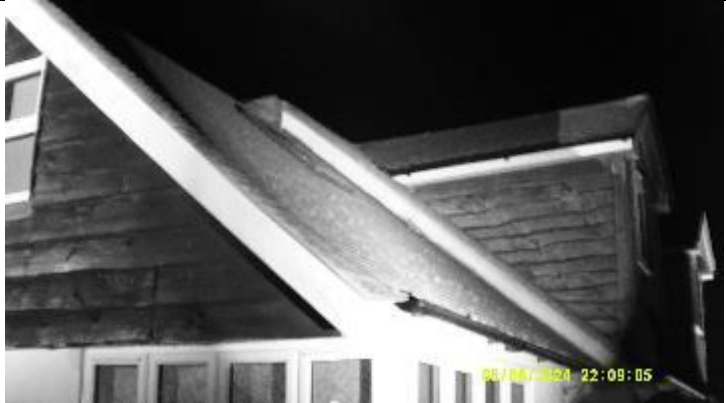
| <i>Surveyor 2</i> | <b>No emergencies observed.</b> The first activity recorded was a pass by a serotine bat at 21:11. The bat was heard not seen. A common pipistrelle was observed foraging in the neighbour's garden at 21:13. (brief or constant foraging activity from 21:13 to when?) Three further passes by common pipistrelles were recorded between 21:22 and 21:51. The bats were heard not seen? | N/A |
| <i>IR position</i> | The footage reflected the view of surveyor 2. | |

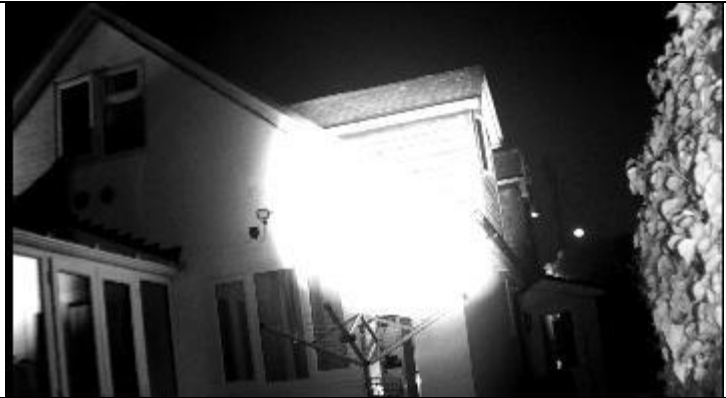
| <i>Surveyor 3</i> | <b>No emergences observed.</b> The first activity recorded was a direct pass by a common pipistrelle bat at 20:52. The bat was heard not seen. At 21:08 a common pipistrelle was observed foraging between the back and front gardens. Foraging activity continued for approx. 10minutes? At 21:11 a common pipistrelle was observed/recorded foraging along the hedgerow before continuing in a westerly direction, offsite. The last activity recorded was a pass by a common pipistrelle at 21:42. The bat was heard not seen. | N/A |
| <i>IR position</i> | The footage reflected the view of surveyor 3. | |

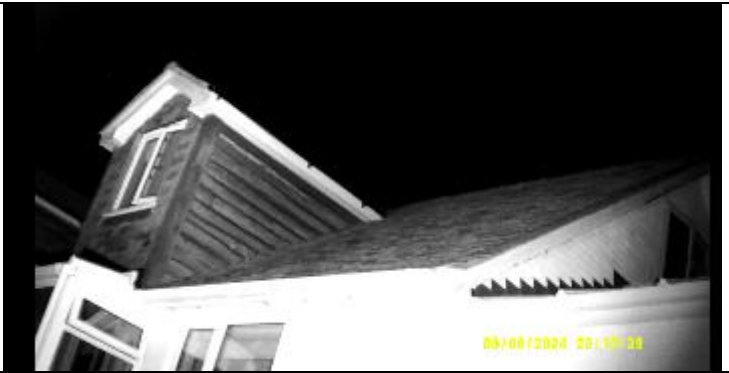
| <i>Surveyor 4</i> | <b>No emergences observed.</b> The first activity recorded was a direct pass by a common pipistrelle bat at 20:59. The bat arrived from the east and continued off site in a westerly direction. The last bat detected was a soprano pipistrelle, heard but not seen, at 21:55. Occasional passes by common pipistrelle were recorded, including one with social calling at 21:48. No further activity was observed. | N/A |

| <i>IR position</i> | The footage reflected the view of surveyor 4. | An infrared (IR) photograph of a building at night. The image shows the upper portion of a structure with a gabled roof and a chimney. The building is illuminated by a bright light source, likely a night vision or IR camera, creating a high-contrast scene. A timestamp in the bottom right corner reads "09/08/2024 22:10:19". |

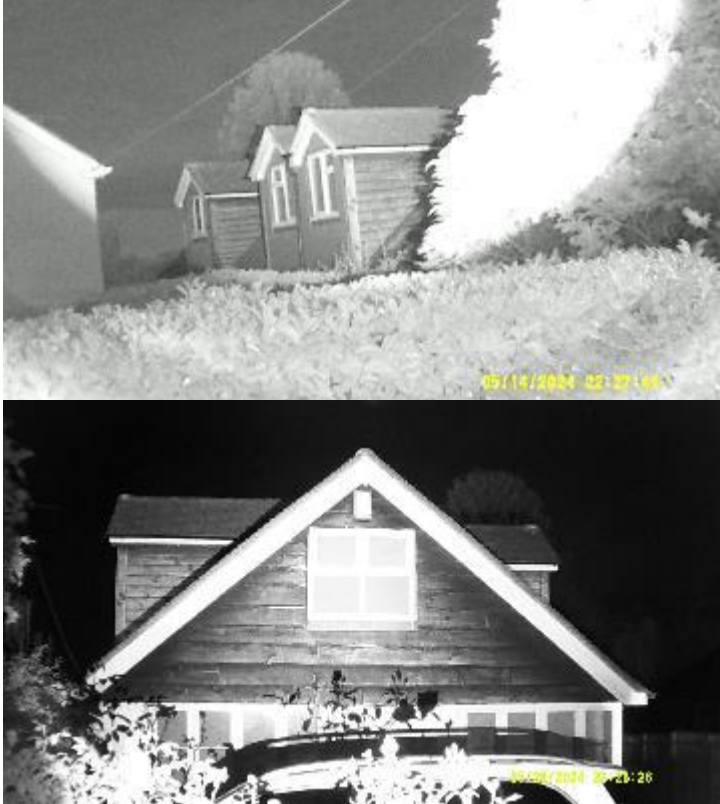
| <i>Surveyor 1</i> | | <b>No emergences observed.</b> The first activity observed was a commuting pass by a noctule bat at 21:25. The bat passed northwest over the building. A common pipistrelle bat was seen at 21:31 heading southeast over the building. A common pipistrelle was heard but not seen at 21:37. The final bat of the survey was a common pipistrelle observed passing south and then north across the gardens at 22:02. | | | | N/A | |

| <i>IR position</i> | The footage reflected the view of surveyor 1. | |

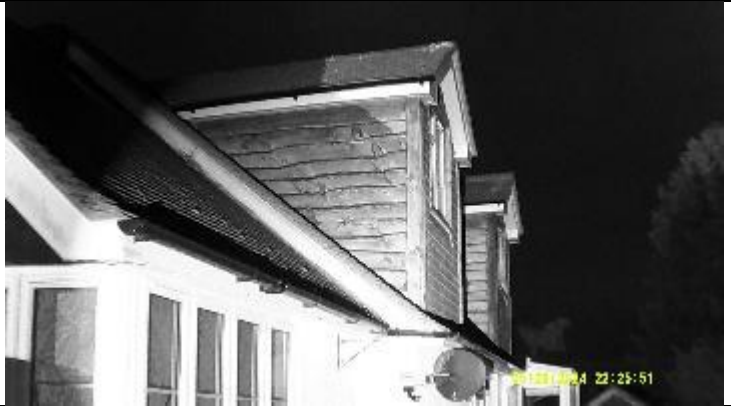
| <i>Surveyor 2</i> | <b>No emergences observed.</b> The first activity recorded was a commuting pass by a noctule bat at 21:26. The bat passed south to north at height above B1. Second species recorded was common pipistrelle at 21:31, commuting west over the building between the two dormers. A common pipistrelle foraged over the driveway and commuted offsite at 21:32, two individuals were recorded commuting south along the western aspect of the house and finally a common pipistrelle commuted across the driveway. The last bat recorded was at 22:04 and was seen not heard. | N/A |

| <i>IR position</i> | The footage reflected the view of surveyor 2. | |

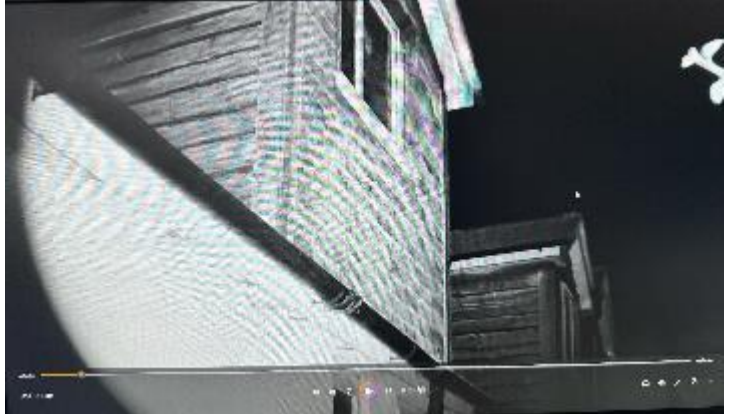
| <i>Surveyor 3</i> | <b>No emergences observed.</b> First bat was noctule, heard not seen at 21.30/32. A Common pipistrelle was also HNS at 21.54. A direct pass by a brown long-eared bat was observed at 21:59. The last bat recorded was a common pipistrelle foraging at the rear of the property before continuing north over the roof of B1. | N/A |
| <i>IR position</i> | The footage reflected the view of surveyor 3. | |

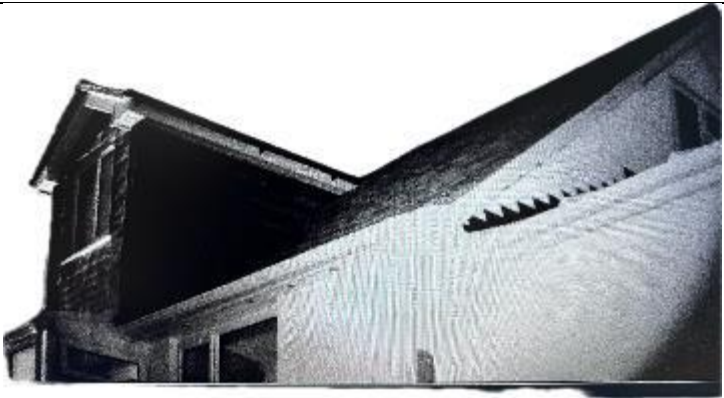
| <i>Surveyor 4</i> | <b>No emergences observed.</b> First bat 21.25 was a noctule seen commuting over the building northwest. A common pipistrelle was heard not seen at 21.31 21.38. At 21.43 a common pipistrelle commuting north to south at the side of building. A common pipistrelle was also heard not seen at 21:59. The last bat was a common pipistrelle, heard not seen at 22:04. | N/A |

| <i>IR position</i> | The footage reflected the view of surveyor 4. | |
