## BAT ROOST ASSESSMENT

11 OAKMOUNT AVENUE, CHANDLER'S FORD, EASTLEIGH, SO53 3AB

FINAL REPORT

June 2024

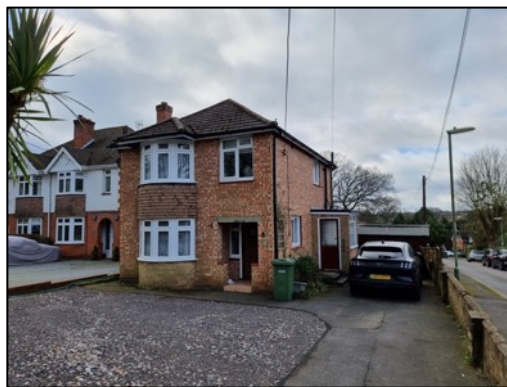
The building comprises a two-storey brick-built house which rises to a pitched and hipped design roof clad with concrete interlocking roof, ridge and hip tiles (Figure 1). The house is oriented north to south. The eaves extend beyond their wall plates and are enclosed with uPVC fascia and under boards with adjoining guttering. A total of three single-storey flat roofed extensions protrude from the house. One from the western elevation and two from the southern elevation (Figures 2 and 3). The windows and doors are set in uPVC frames which are tight fitting to the surrounding brickwork.

**Figure 1** – northern elevation of the house

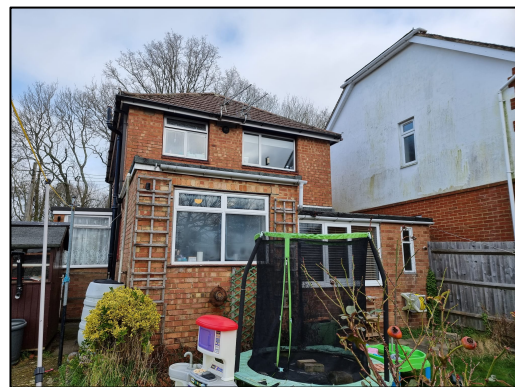
**Figure 2** – southern elevation with two extensions

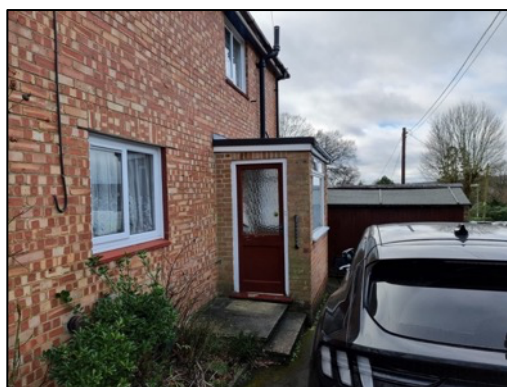
**Figure 3** – western elevation with single extension

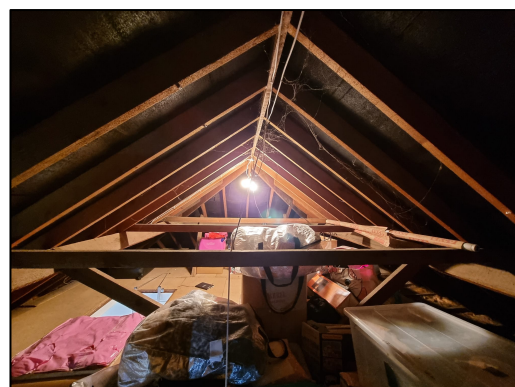
Internally, the house supports a single roof void. The roof is lined with heavy-duty bitumen lining and fibreglass insulation is present on the floor which is boarded (Figure 4). The space is used for storage and is frequently disturbed with light cobwebbing present along the ridge beam.

**Figure 4** – interior roof void of the house

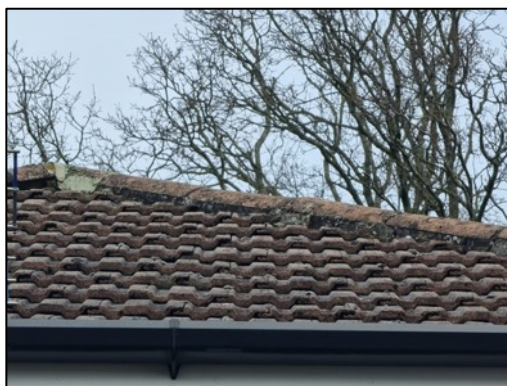
| <b>Suitability</b> | <b>Evidence</b> |
|---|---|
| <b>Exterior</b><br><br>The following suitable access/egress and roosting features were recorded externally during the survey:<br><br><ul style="list-style-type: none"> <li>- Gaps under the interlocking roof tiles (Figures 5 and 6).</li> <li>- Missing mortar under the ridge/hip tiles has created crevices.</li> </ul> | No evidence of roosting activity was recorded externally during the survey. |

**Figure 5 – lifted roof tiles on western roof face**

The preliminary roost assessment confirmed that the property supports moderate roost suitability i.e. a structure which could be used by bats but is not likely to support a roost of high conservation status (e.g. maternity roost). This assessment was based on the nature of the identified roost features on the building including the gaps under the roof and ridge tiles.

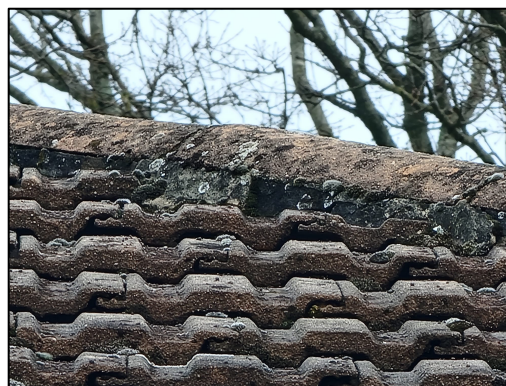
**Figure 6 – lifted roof tiles**

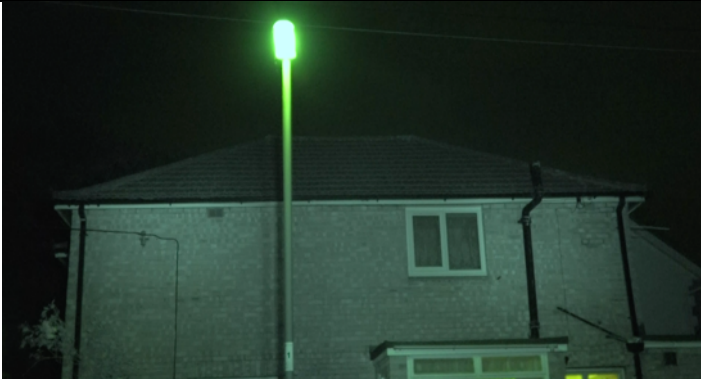
During the course of the emergence survey carried out on the 15<sup>th</sup> May 2024, no bats were recorded emerging from the survey area. The first recorded bat comprised a common pipistrelle *Pipistrellus pipistrellus* bat which was recorded in the distance at 21:21. A single common pipistrelle was recorded foraging in the distance again at 21:23, 21:35, 21:36, 21:45, 22:07 and 22:11. No further activity was recorded during the course of the survey.

During the course of the emergence survey carried out on the 7<sup>th</sup> June 2024, no bats were recorded emerging from the survey area. The first recorded bat comprised a common pipistrelle bat which was recorded foraging in the distance at 22:24. A single common pipistrelle was recorded foraging in the distance again at 22:35. No further activity was recorded during the course of the survey.

| Survey Date | 15th May 2024 | 7th June 2024 |
|---|---|---|
| Western Elevation | | |

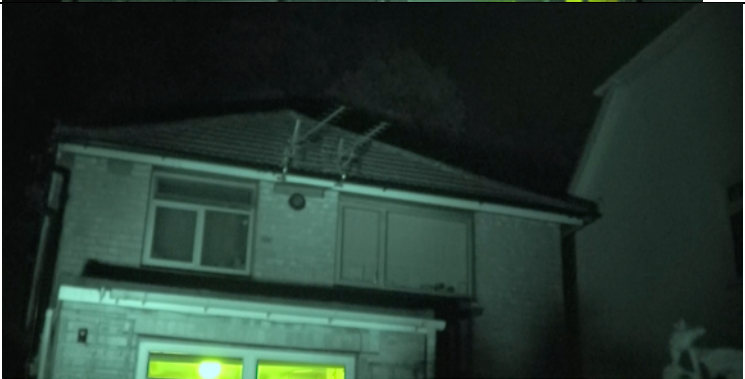
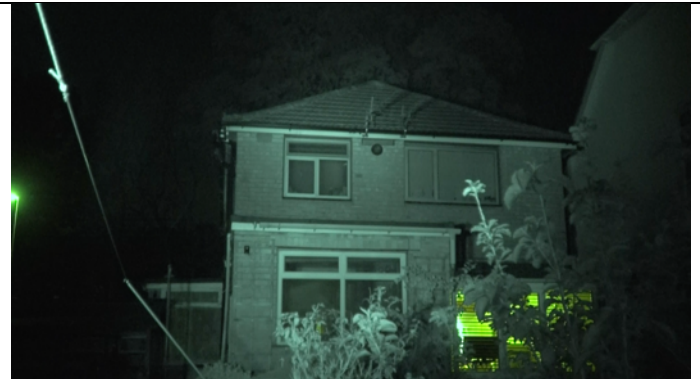
| Survey Date | 15th May 2024 | 7th June 2024 |
|---|---|---|
| Southern Elevation | | |
