## Preliminary Ecological Appraisal and Preliminary Roost Assessment

57 Church Road Bishopstoke Hampshire SO50 6DN

13<sup>th</sup> February 2024

Two, two-bedroom maisonettes. Including the internal reconfiguration of the existing building, installation of two dormer windows, solar panels and a two-storey extension of the southern elevation to match the existing roof pitch.

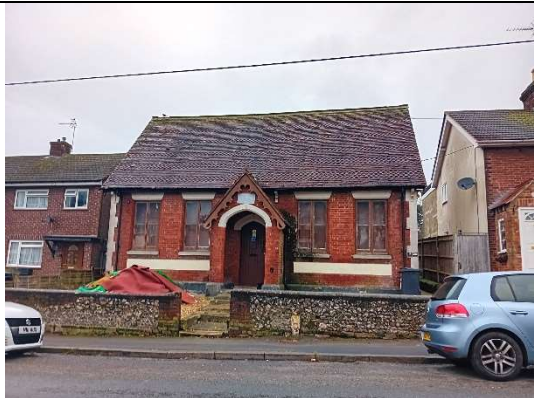
| | B1 - overview | B1 is a red brick detached single-storey dwelling. The porch on the northern elevation is made from the same bricks with concrete features around the top of the door. The roof is hipped and made of clay tiles with gaps between tiles being identified as well as missing tiles. | |

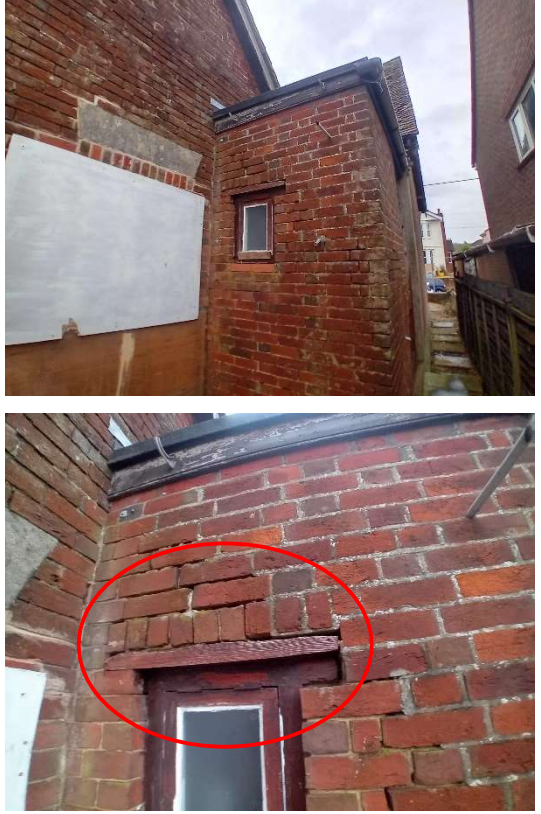
| | B1 – north elevation | Brick brickwork was in moderate condition gaps in the brickwork suitable for crevice-dwelling species. There are also large gaps in the eaves and soffit of the roof creating access for roosting bats at the gable end. | |

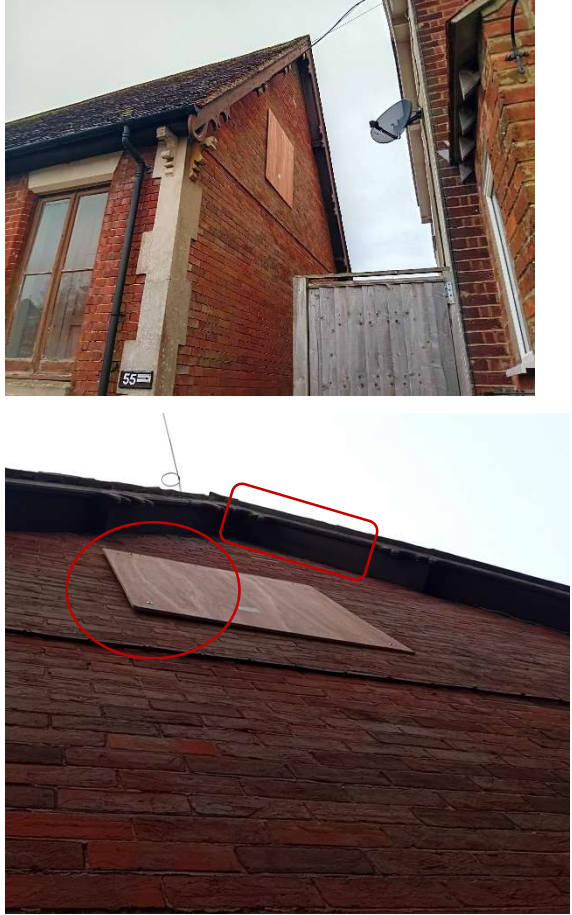
| | B1 – south elevation | <p>The brickwork is in good condition with no gaps in the brickwork. There are visible gaps in the eaves and soffit creating potential roosting features. The wooden gable under the gable end is lifted at the bottom corner making the internal loft space accessible.</p> | |

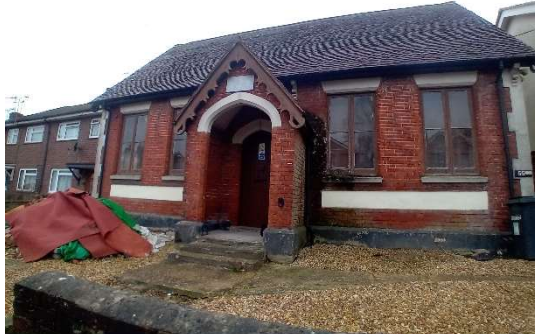
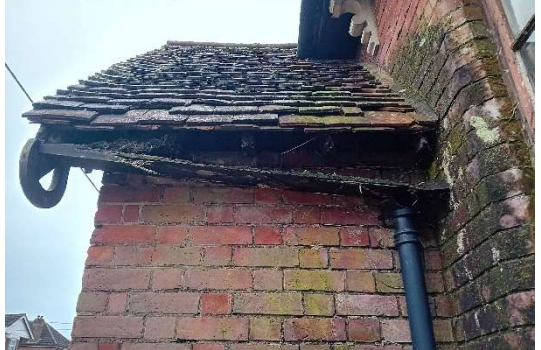
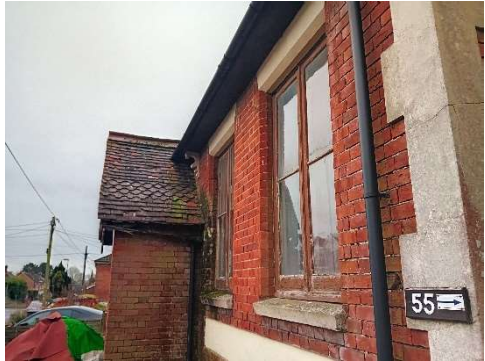
| | B1 – east elevation | <p>The soffit of the porch is broken with an old swifts nest being found inside. This creates a suitable roosting feature for bats and a nesting feature of nesting birds. There are also gaps in the tiles on the porch as well as missing tiles.</p> <p>The brickwork is in moderate condition with gaps being present along the eastern elevation, particularly around the eaves and windows.</p> | |

| <b>Birds</b> | |
|---|---|
| <i>Summary of Survey Findings</i> | An old bird's nest was observed within the broken soffit box of the front porch. |

| <b>Birds</b> | |
|---|---|
| <i>Recommendations</i> | Modification to the building should be undertaken outside the period 1st March to 31st August. If this timeframe cannot be avoided, a close inspection of the building should be undertaken immediately, by qualified ecologist, prior to the commencement of work. All active nests will need to be retained until the young have fledged. |

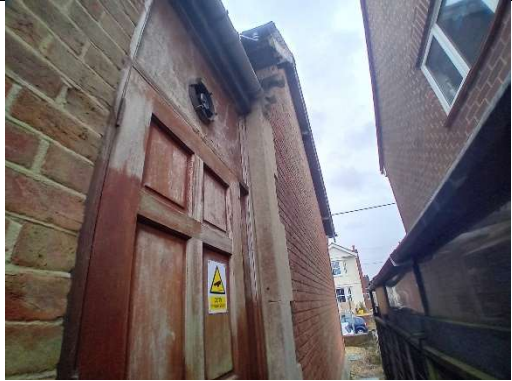
| | B1 – west elevations | <p>The brickwork on the western elevation is in good condition with very few gaps. Small gaps in the eaves were visible as this creates light spills during the internal access. These features are suitable for roosting bats.</p> | |

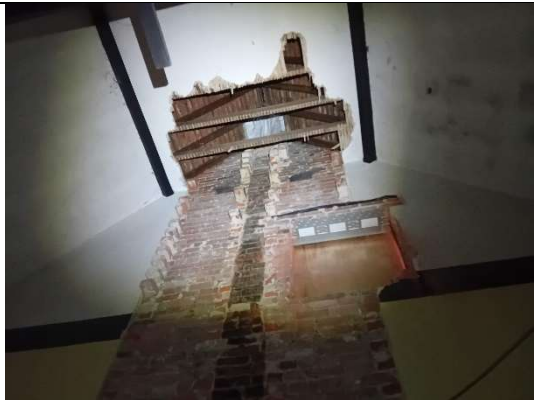
| | B1 – interior | <p>The roof void was not accessible but the was visible due to holes in the boarding. This showed the roof was not lined. Brickwork is exposed and is a moderate condition with gaps that are suitable for crevice-dwelling species. No bat droppings or evidence of roosting bats was found in the areas that were accessible.</p> | |

| Recommendations | Three bat emergence and re-entry surveys are required during the active bat season (optimal May to August, suboptimal September) to characterise the roosts present. Infra-red cameras should be used as an aid. Surveys should be a minimum of two weeks apart. Three surveyors are required to provide full coverage of the building | | |

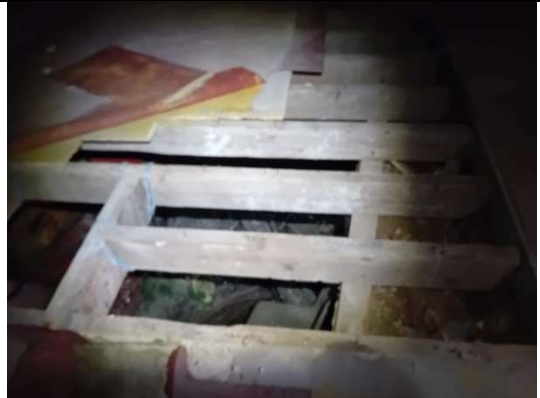
| | B1 – interior (cellar) | <p>The floorboards that would form a void of the cellar roof have been removed due to poor condition. The cellar floor was wet from flooding. The cellar is sub-optimal for roosting or hibernating bats as the cellar is open, causing fluctuation in humidity, light and temperature and is prone to flooding.</p> <p>The cellar does not have any suitable gaps for crevice dwellers and the absence of floorboards make this unsuitable for void dwellers. No evidence of bats was present in the cellar.</p> | |

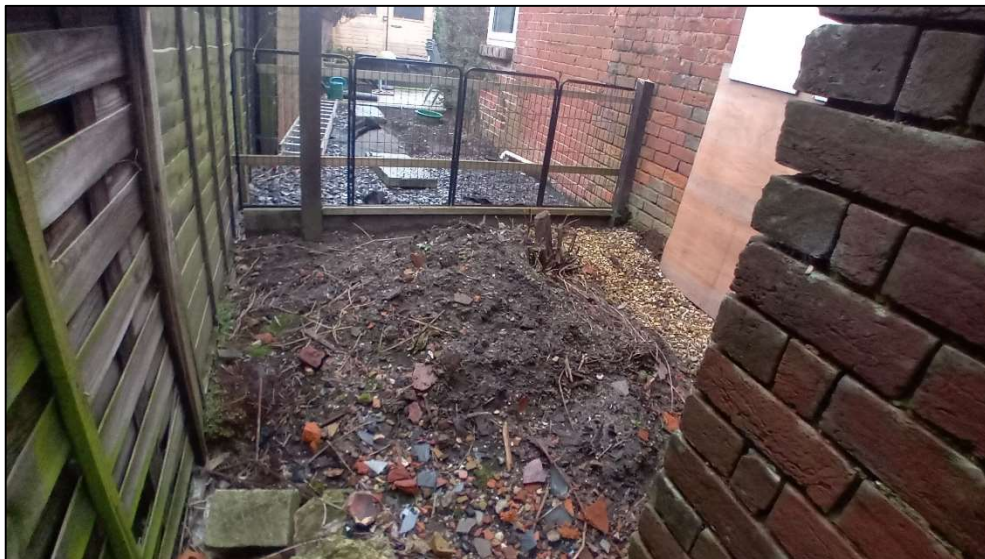
Photo 1: Rear garden of bare ground

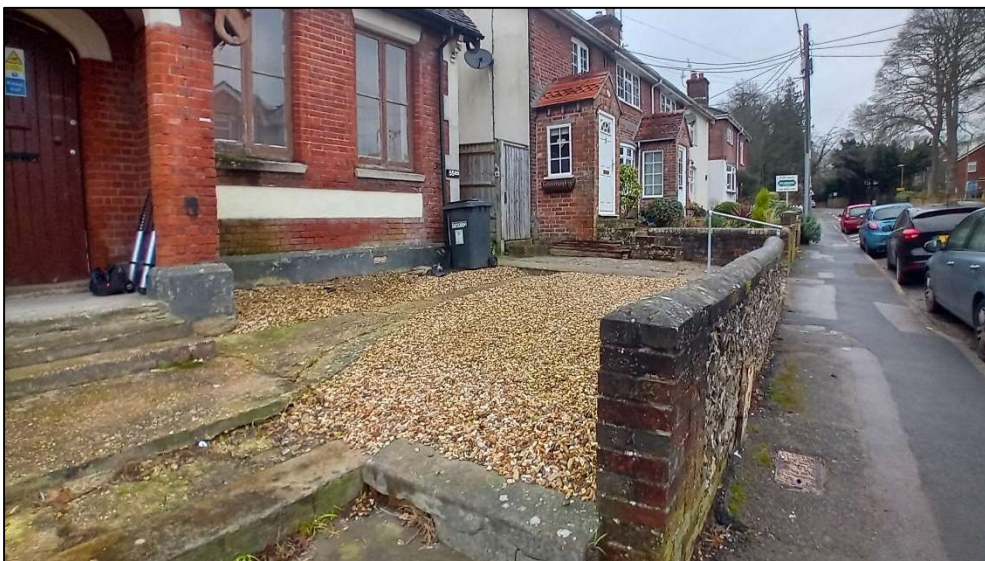
Photo 2: Front of B1, showing artificial;  
unsealed surface
