**Greywell, Station Hill,  
Bursledon,  
SO31 8AA**

Preliminary Ecological Appraisal

Report Number: 0726

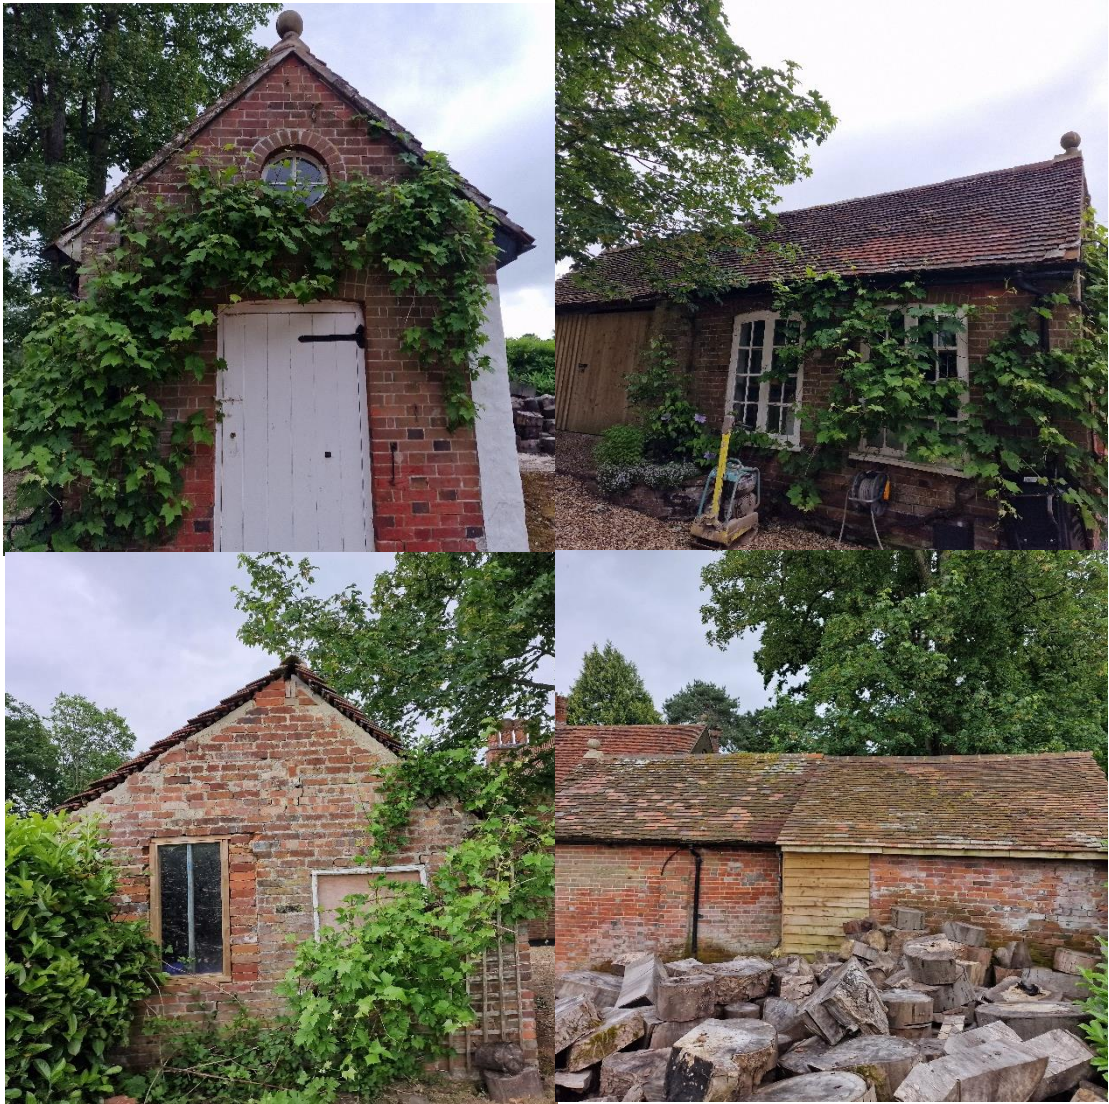
- 4.5 The outbuilding has many lifted/missing tiles and gaps in brickwork or mortar that could provide access and roosting features for bats (Photo 1). Internally (Photo 2), the building is divided in two. The eastern half is used as a shed and the roof is boarded. No signs of bats were noted during the survey, though due to the internal construction it is unlikely that evidence would be visible. The western half of the building is used to store garden equipment. The roof has no lining below the clay tiles and so opportunities for crevice dwelling species is limited. No signs of bats were noted in this half of the building either. This building is deemed to have medium suitability for roosting bats and will require two emergence surveys to determine presence/absence.

**Photo 1:** The four aspects of the outbuilding showing lifted tiles and gaps along the roof line

- 5.1 Two emergence surveys for the outbuilding and one for the single roof between May and August/September are required to confirm absence of roosting bats. If bats are seen roosting during those surveys a third survey may be necessary to categorise the roost.
- 5.2 An aerial inspection of the tree earmarked for removal by an ecologist to confirm the absence of roosting bats is necessary.
- 5.3 A mitigation licence will need to be attained if bats are found to be roosting in the cottage.
- 5.4 An ecologist will oversee removal of tiles on the roof.
- 5.5 One integrated bat box will be included in the new garage and one bat box will be added to the existing building. More mitigation may be necessary depending on the results of the emergence surveys.

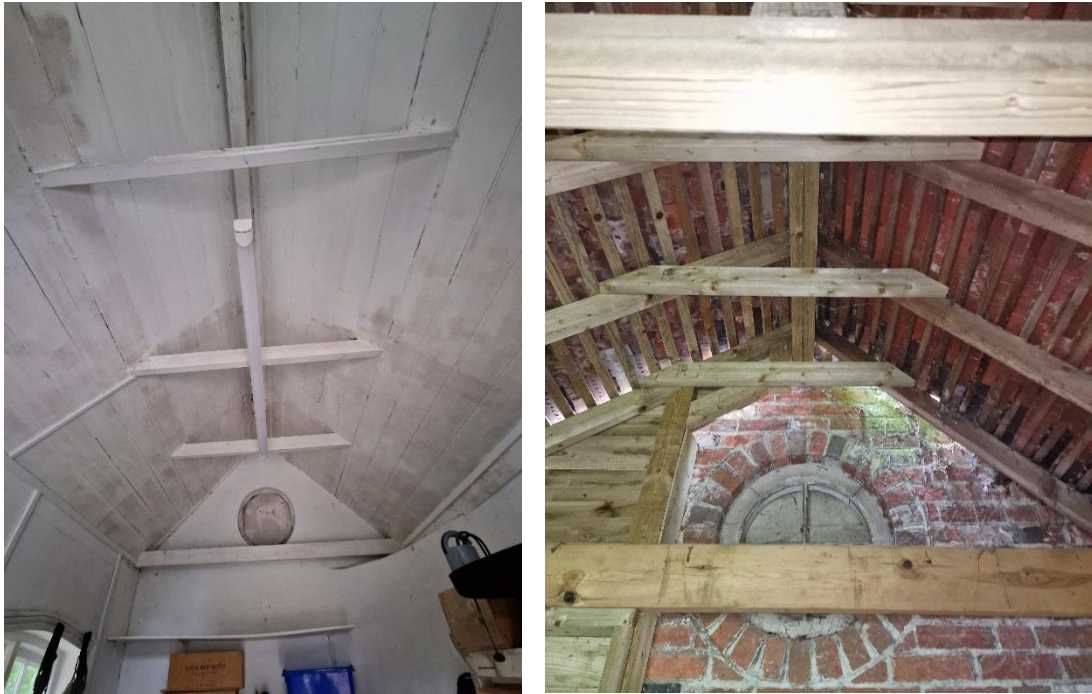
**Photo 2:** Internal views of the roof of each half of the outbuilding

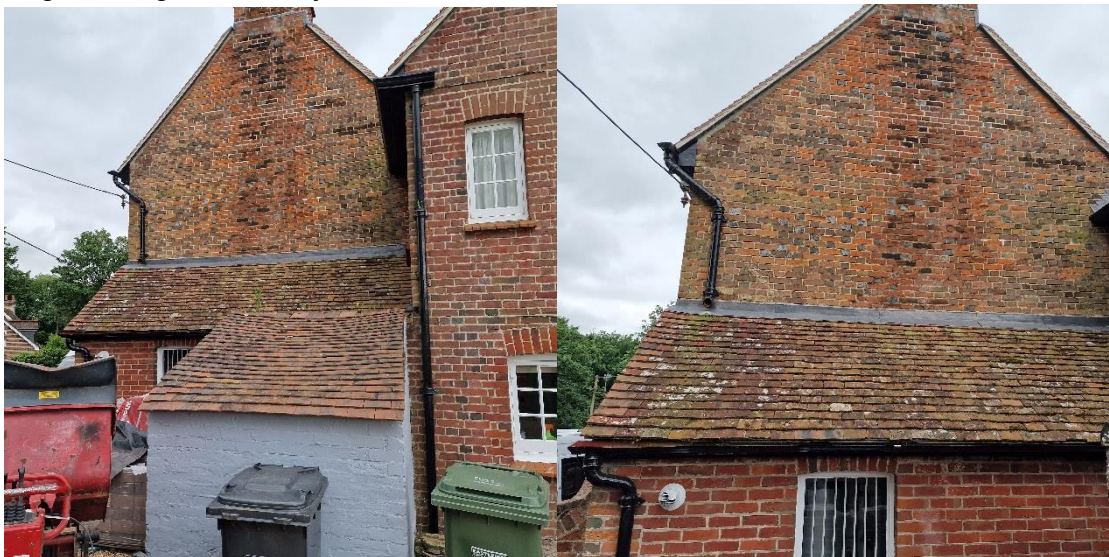
- 4.6 The small area of roof on the main dwelling effected by the proposals (Photo 3) also has several lifted tiles that provide roosting opportunities to crevice dwelling species. There is also a small void that is inaccessible so there could be signs of bats that are not visible and overlooked. Due to the limited height and other available roosting opportunities adjacent, this area has low suitability for roosting bats and will require a single emergence survey to confirm absence.

**Photo 3:** Two views of the small single-story roof, showing lifted tiles and small gaps

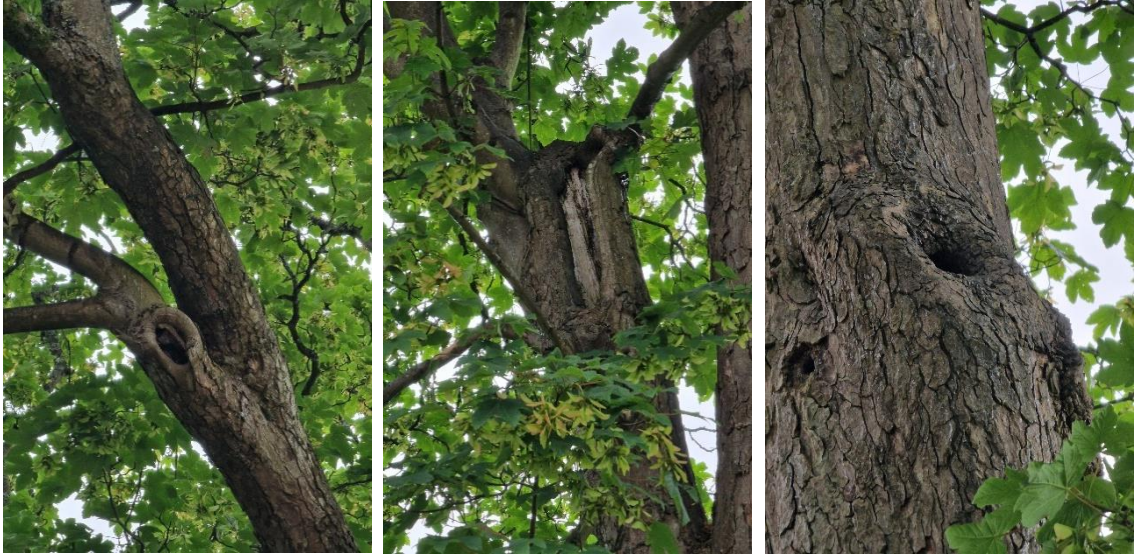
- 4.7 Just to the south of the outbuilding is a mature sycamore, set to be removed as part of the proposals. During the visit, this tree was inspected, and several potential roosting features were noted, including Woodpecker, wounds and pruning scars. The tree will require an arial survey to determine the suitability and use of these features for bats.

*Photo 2: A collection of pictures of PRF's on the Sycamore planned for removal*

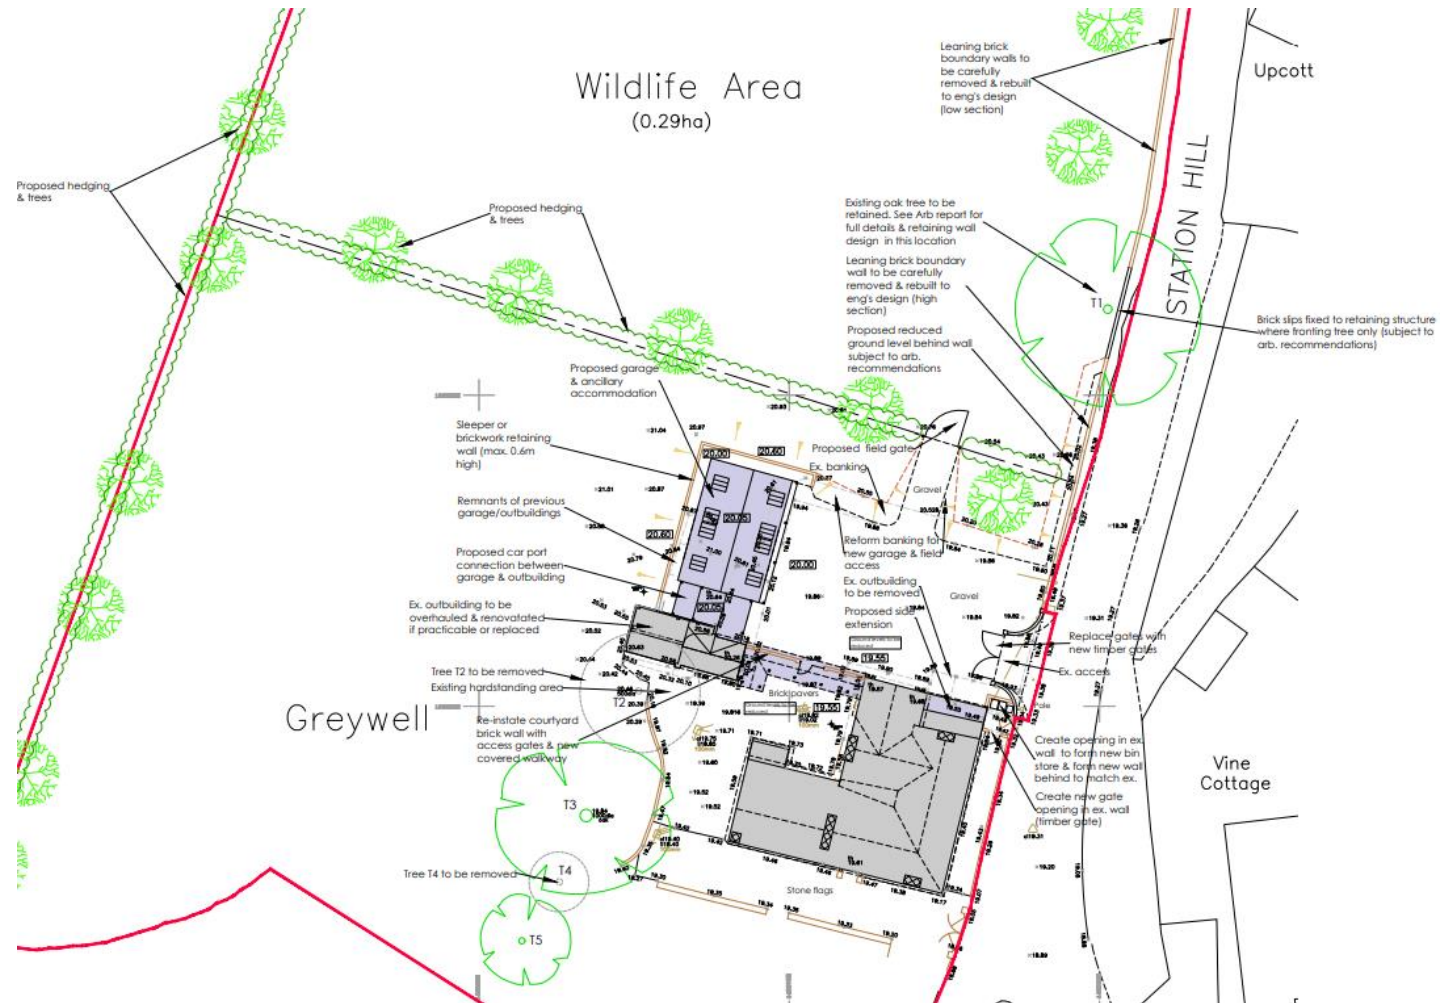
## Appendix C: Proposals

The amendments to the approved planning application L/24/97193 include alterations to the small single-story roof on the north of the main dwelling and the roof of the existing outbuilding.
