## Preliminary Ecological Appraisal

Swinley, Pylands Lane, Bursledon, Southampton, Hampshire, SO31 1BH

This report is prepared to inform a planning application with the Eastleigh Borough Council. The proposal is described as:

The re-roofing and refurbishment of the existing dwelling, including an extension to the western elevation.

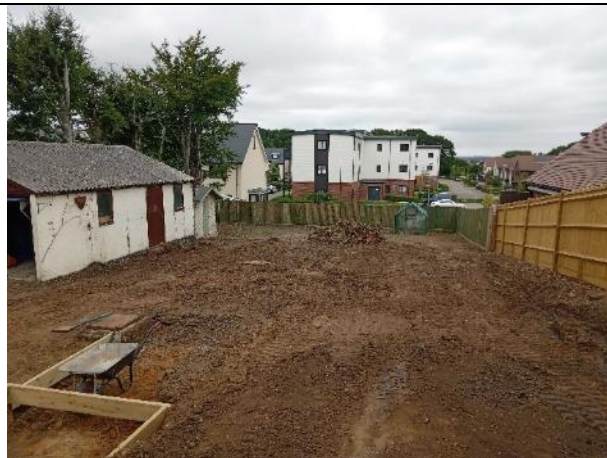
The site was being cleared at the time of the survey and predominantly comprised bare ground with some small areas of ornamental planting (**Fig 2 & 3**). Satellite imagery shows that an area of lawn, ornamental planting, approximately four trees, and a gravel driveway have been lost during site clearance. A refuse pile comprising logs, fencing, and vegetation is present to the north of the site (**Fig 4**). Some early colonising species have started to colonise the bare ground to the northmost part of the site, with seedlings of Common Ivy (*Hedera helix*), Bramble (*Rubus fruticosus*), Dandelion (*Taraxacum officinale*), Field Bindweed (*Convolvulus arvensis*) and Creeping Buttercup (*Ranunculus repens*) present.

**Figure 2.** View of bare ground to the north of the site.

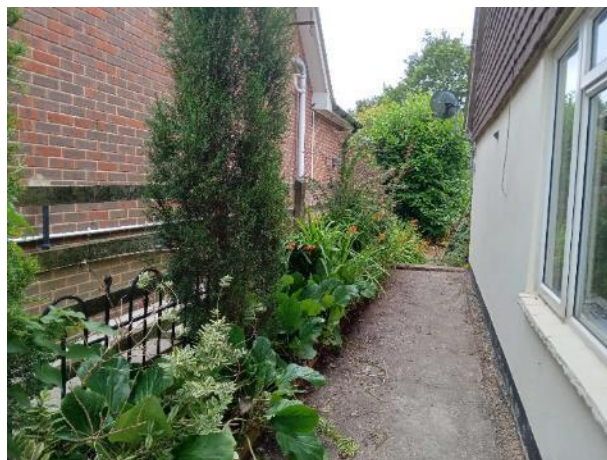
**Figure 3.** Ornamental planting along the eastern boundary of the site.

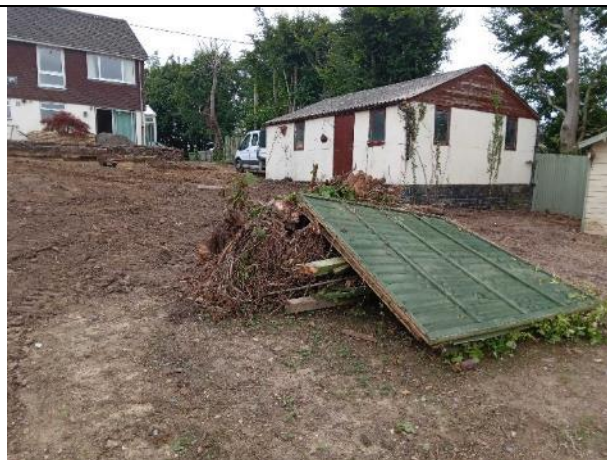
**Figure 4.** View of the refuse pile located to the north of the site.

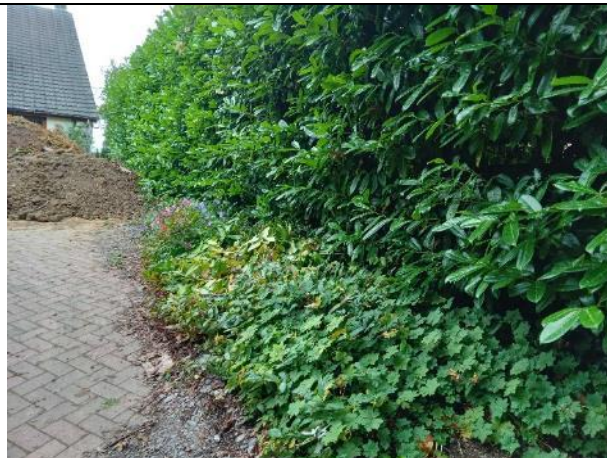
A well-managed ornamental hedgerow is present along the eastern boundary (**Fig 5**). The species within the hedgerow comprise **dominant** Cherry Laurel (*Prunus laurocerasus*), **occasional** Holly (*Ilex aquifolium*), and Common Ivy (*Hedera helix*). There is a small strip of herbaceous species including Geranium (*Pelargonium spp.*), Creeping Buttercup (*Ranunculus repen*), and Common Silverweed (*Argentina anserina*) to the west of the hedgerow, and a boundary fence to the east. A mound of soil from the site clearance is encroaching onto the hedgerow and as such many of the herbaceous species have been covered.

**Figure 5.** View of the ornamental hedgerow along the eastern boundary of the site.

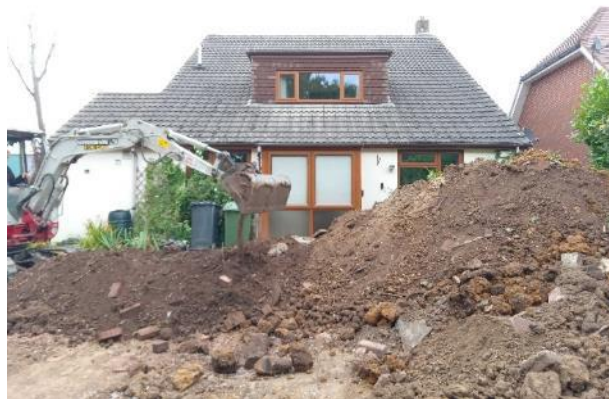
There is a block paving driveway to the south of the site that appears to have been partially removed (**Fig 6**). A mound of soil from the site clearance covered much of the driveway making it difficult to distinguish where the driveway ends. There is also an area of hardstanding to the rear of the dwelling with some ornamental planting (**Fig 7**). A gravel pile was present on the patio area at the time of visit.

**Figure 6.** View of block paving driveway under a mound of soil.

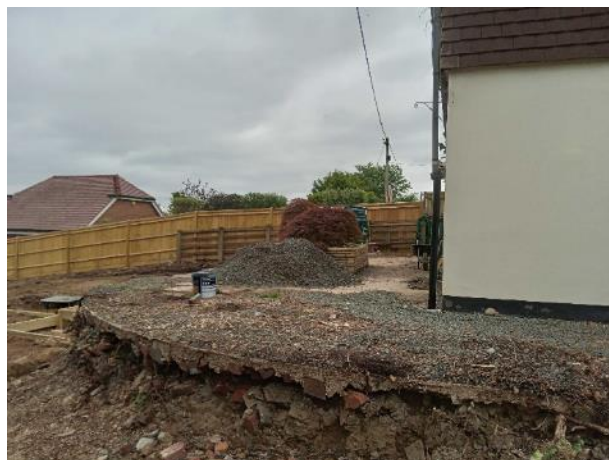
**Figure 7.** View of hardstanding to the rear of the dwelling.

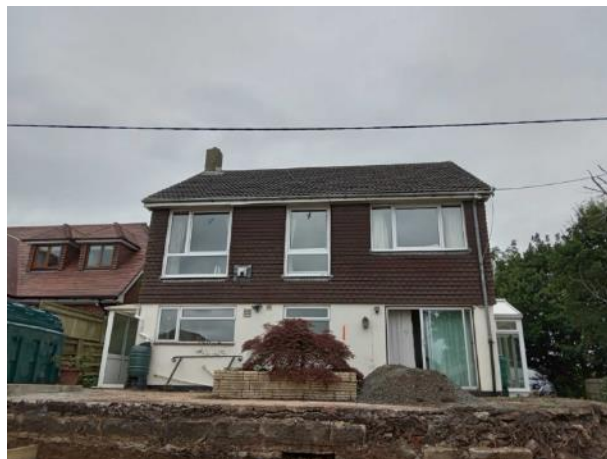
B1 is a detached, two-story residential dwelling featuring external rendering and clay hanging tiles, with a roof constructed of clay tiles and two gable ends. The dwelling also has a chimney stack on the eastern gable end and a dormer window on the southern elevation. There is a single loft void lined with bitumen felt, with fiberglass insulation present on the floor and partial boarding. A potential roosting feature (PRF) map can be found in Appendix 3.

**Figure 8.** View of the northern aspect of B1.

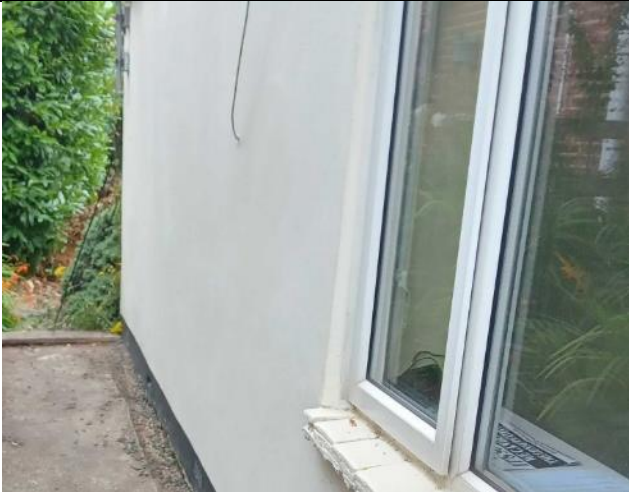
| Feature | Materials | Condition/Description | Suitability/Access/Evidence of Bats |
|---|---|---|---|
| Walls | Rendering | All good condition. | N/A |

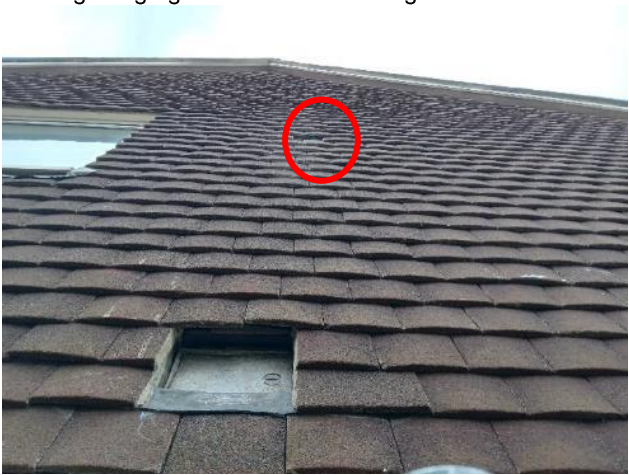
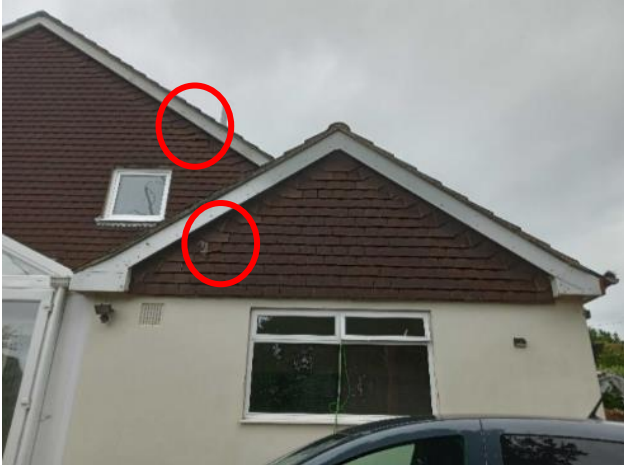
| | Hanging tiles | Clay hanging tiles | <p>The hanging tiles are present on both gable ends and are generally in poor condition with gaps under many of the tiles. There are slipped and missing hanging tiles on the western gable end and slipped and missing hanging tiles on the eastern gable end.</p> | <p>Slipped, missing and broken hanging tiles and gaps under the hanging tiles could provide roosting opportunities for crevice dwelling bats</p> |

| | | | <p>Hanging tiles are also present on the second storey of the northern elevation and are in generally moderate condition with some gaps present under the hanging tiles.</p> | |

| <p><u>Recommendations</u></p> | <p><u>Foraging and Commuting Bats</u><br/> No further surveys are required.</p> <p><u>Roosting Bats (B1)</u><br/> Three bat emergence and re-entry surveys are required during the active bat season (optimal May to August, suboptimal September) to assess the extent of bat activity, roost types, and whether maternity or hibernation roosts are present. At least two of the surveys should be completed during the optimal survey period mid-May to August inclusive.</p> | | | | |

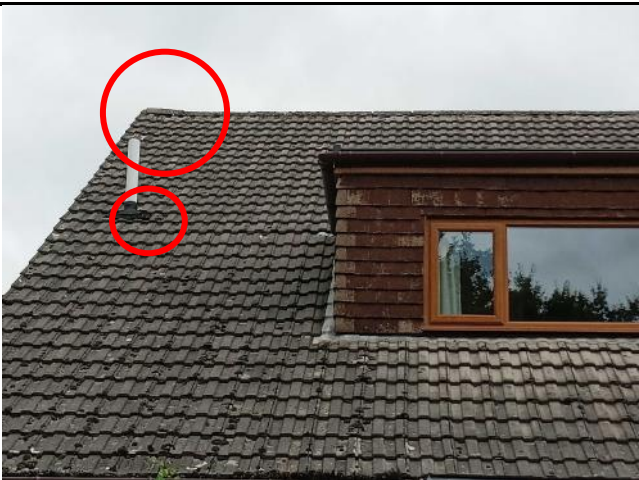
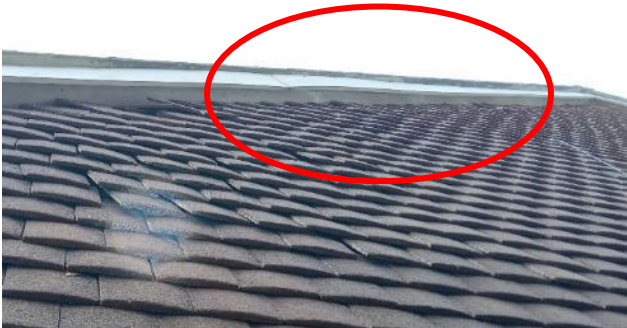
| | Roof | Clay tiles | The clay tiles on the northern and southern aspects of the roof are tight fitting and in generally good condition apart from a gap under the ridge tile on the western side. There is also a gap under the led flashing around the boiler flue. | Small gaps under the ridge tile and under led flashing could present roosting opportunities for individual crevice dwelling bats. |

| | Soffits and Fascia | Timber | <p>The soffits and fascias are in generally moderate condition with some light warping of fascia wood on the eastern gable end. There is also a gap present between the fascia and roof tiles on the southwest corner.</p> | |

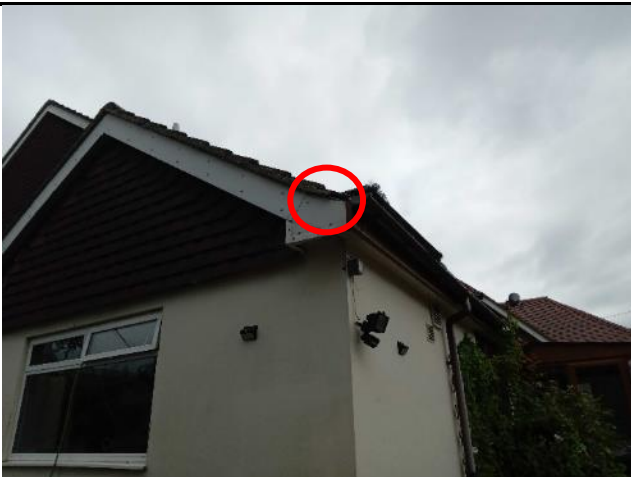
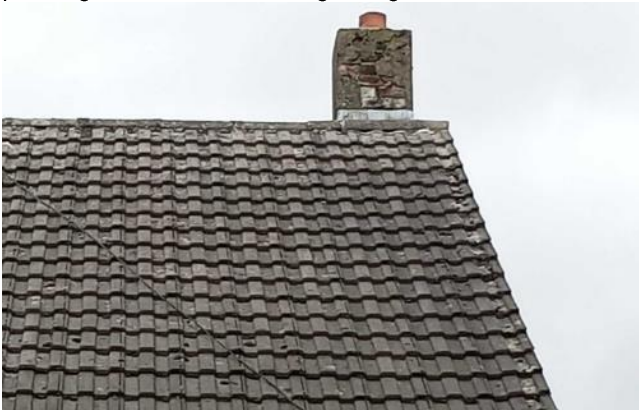
| | Chimney | Brick build with rendering and led flashing | <p>The rendering is in poor condition with multiple cracks and sections removed revealing the brickwork underneath. There are gaps in the pointing however, the flashing is in good condition.</p> | Gaps in the pointing and cracks in the rendering may provide roosting opportunities for individual crevice dwelling bats. |

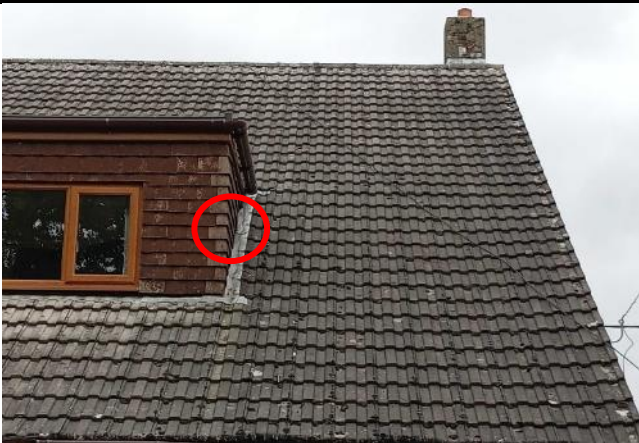
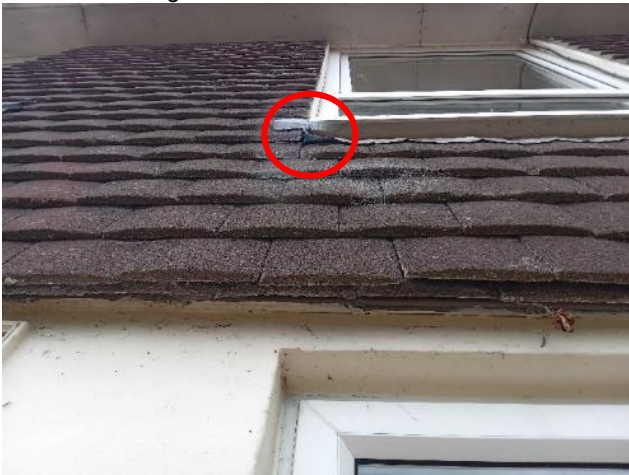
| | Dormer Window | | <p>There are several gaps under the hanging and hip tiles on the dormer window. Otherwise, the flashing and window are tightly sealed.</p> | Gaps under the hanging tiles could provide roosting opportunities for crevice dwelling bats |

| | Windows/Door Frames and Lintels | PVC windows and doors | Windows and doors are tightly sealed except from a gap under the window flashing on the northern elevation.<br> | Gaps under the flashing could provide roosting opportunities for crevice dwelling bats |

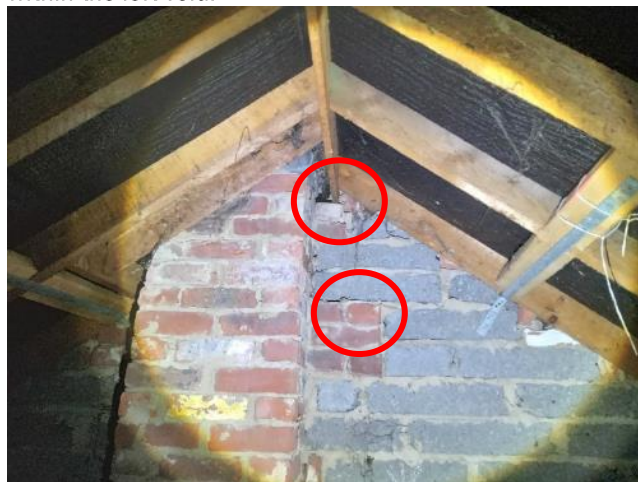
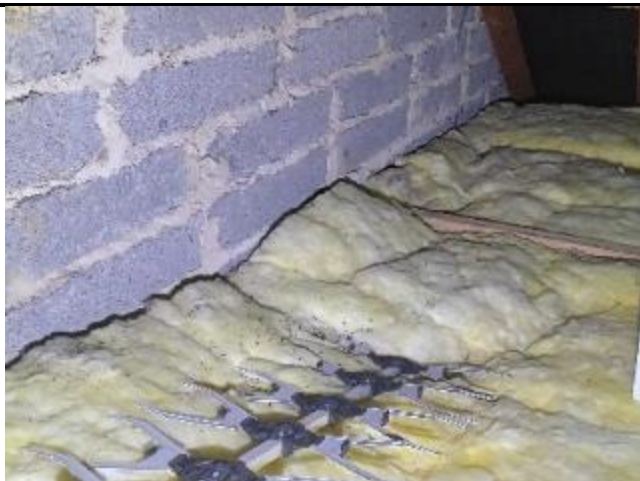
There were several gaps in the brickwork along with two clusters of 10-15 bat droppings present at the gable ends. The droppings were 5 – 8mm in size and had a fine to medium texture indicative of Common pipistrelles. The majority of the droppings appeared to be fresh, and six were retained for DNA analysis. The results of DNA testing have confirmed the presence of Common pipistrelle (*Pipistrellus pipistrellus*) within the loft void.

| | <p><u>Habitat Value</u><br/> B1 provides <b>high value</b> for roosting bats due to the presence of multiple potential roosting features and direct access into the loft void. As Common pipistrelle bat droppings were found inside the loft void at both gable ends, B1 is a <b>confirmed roost</b>.</p> <p>B2 is considered to be of <b>negligible value</b> for roosting bats and will be retained under the proposed development.</p> | | | | |

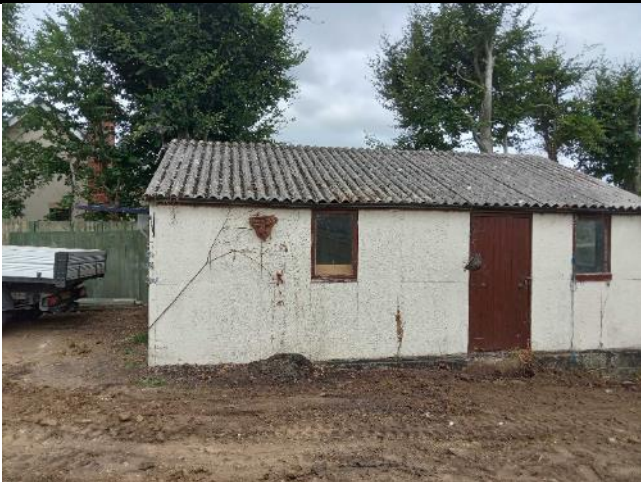
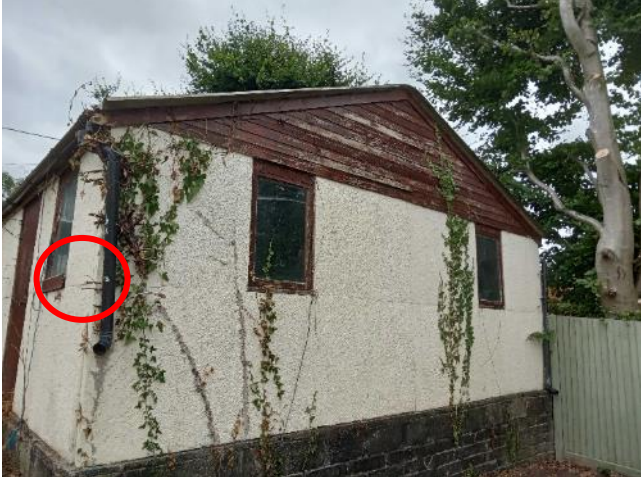
| | Cladding | Timber | The timber cladding is in poor condition with much of the woodwork rotten and several gaps providing direct access into the garage. | N/A |
| | Windows/Doors | Timber window frames and metal garage doors | The timber windows are in poor condition with much of the woodwork rotten and gaps around window ledge on the eastern aspect. Garage doors are not tightly sealed. | Gaps under the window ledge may provide roosting opportunities for individual crevice dwelling bat. |

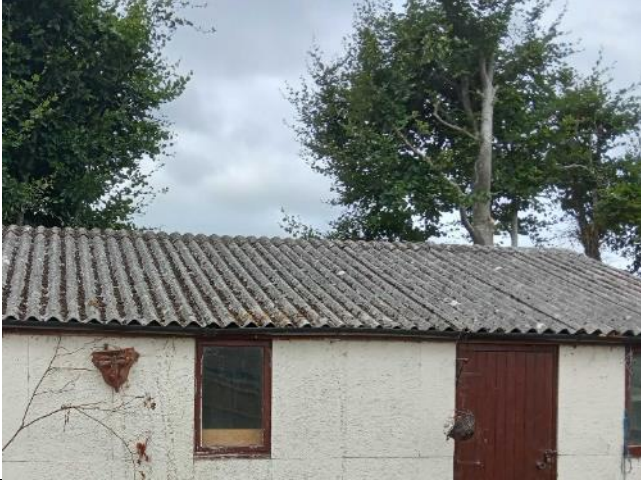
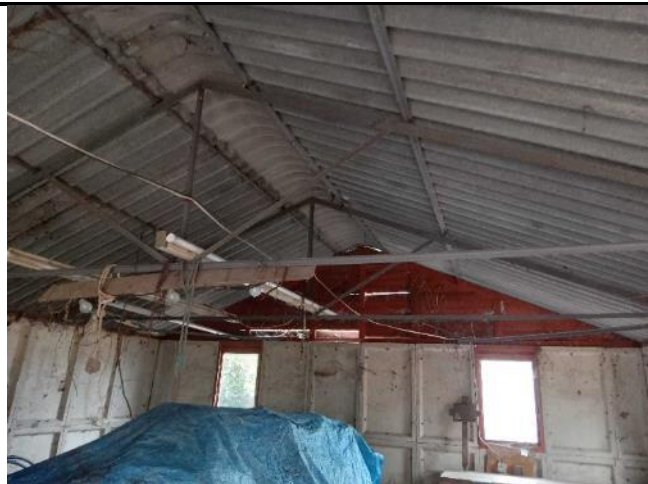
| | Roof | Corrugated metal | <p>The roof is in generally poor condition with moss, lichens and debris present. No roosting features are present</p> | N/A |
| | Internal | Prefabricated concrete sheets and metal beams | <p>The roof is not lined, and no insulation is present making the inside of the garage cool. There are several gaps under the corrugated metal roofing that allow direct access outside. No evidence of bats was found.</p> | N/A |
