**38 NICHOL ROAD, CHANDLERS FORD**

**BAT SURVEY REPORT**

**SEPTEMBER 2024**

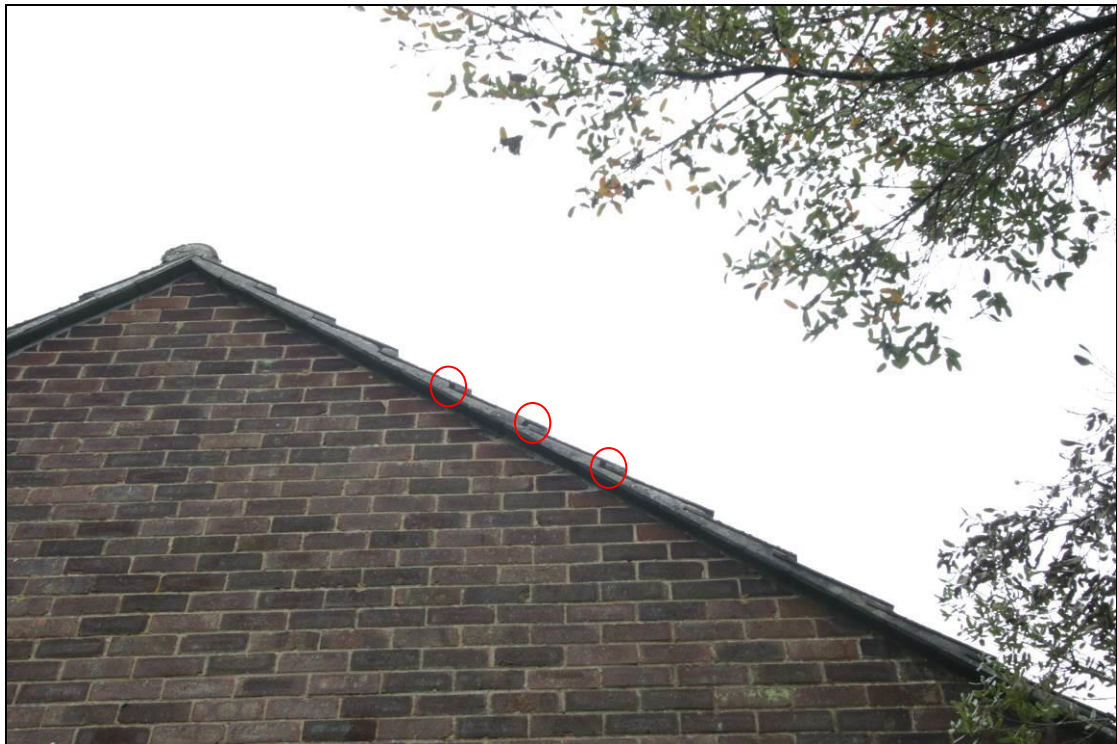
**Photo 1: Small gaps present in apex of building**

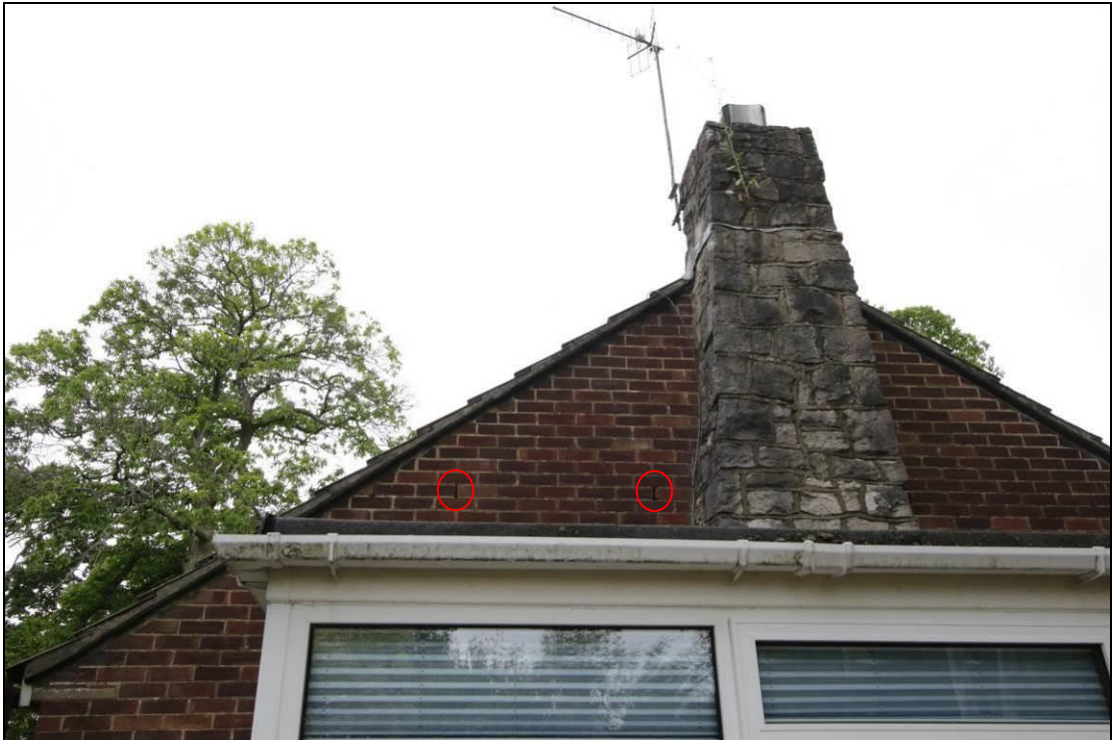
***Photo 2: Small air gaps in apex wall***

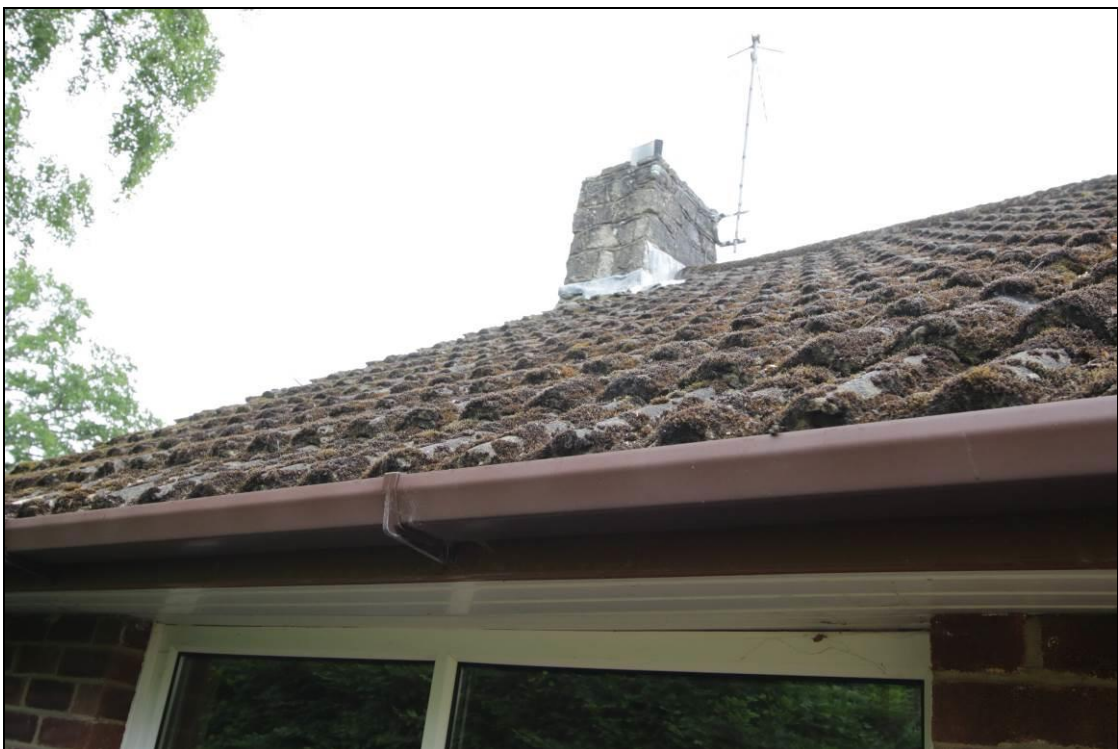
***Photo 3: Interlocking roof tiles, ridge tiles and soffits are generally well sealed with few gaps***

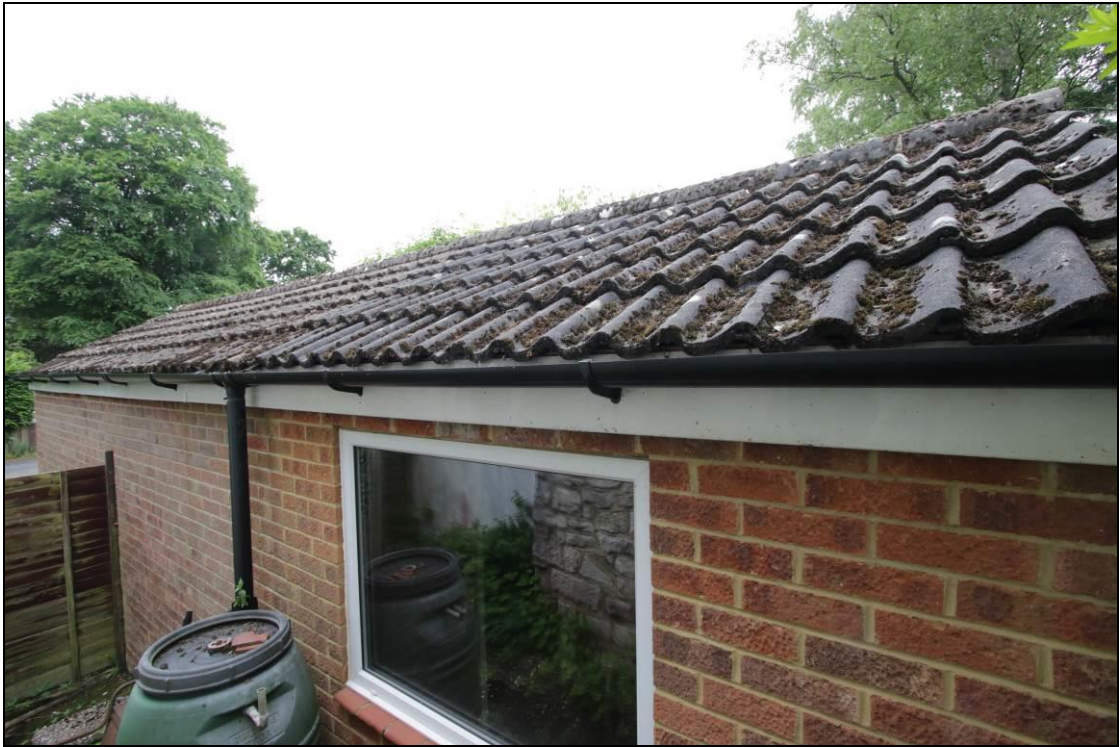
***Photo 4: Single storey garage with interlocking roof tiles, ridge and soffits also mostly well sealed***

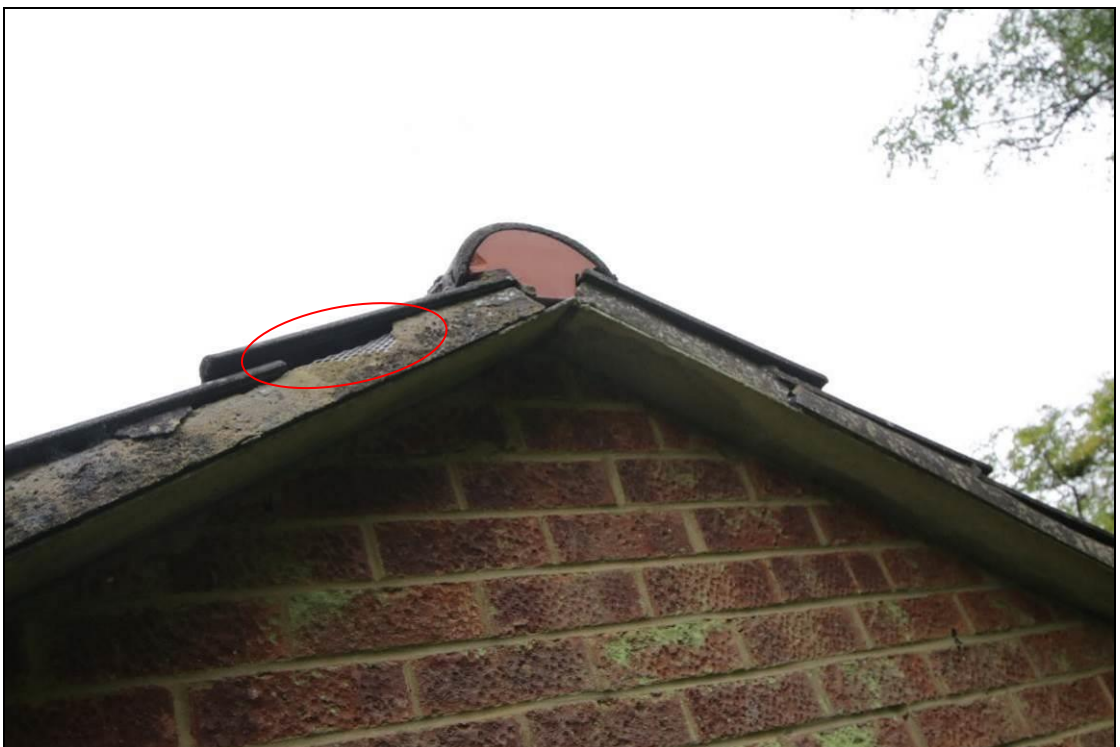
***Photo 5: Gap in northern apex of garage may access a small roof cavity***

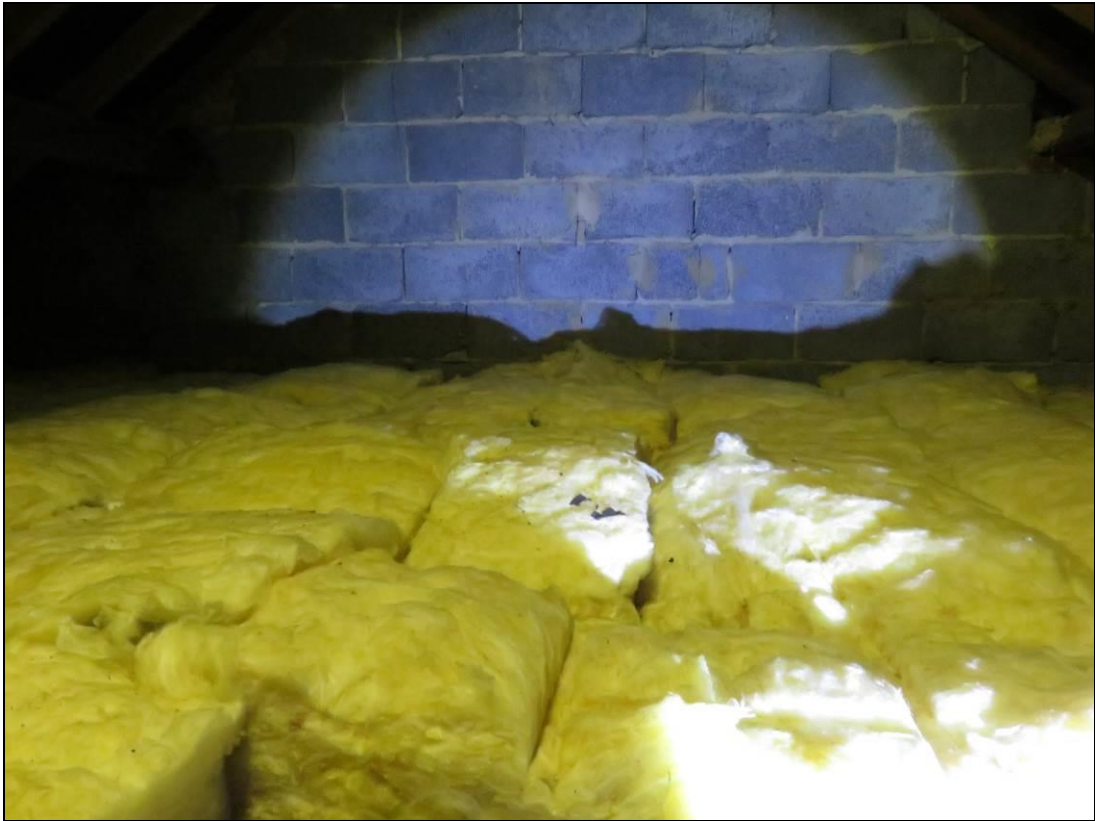
**Photo 6: Loft Void from Internal Inspection – no evidence noted**

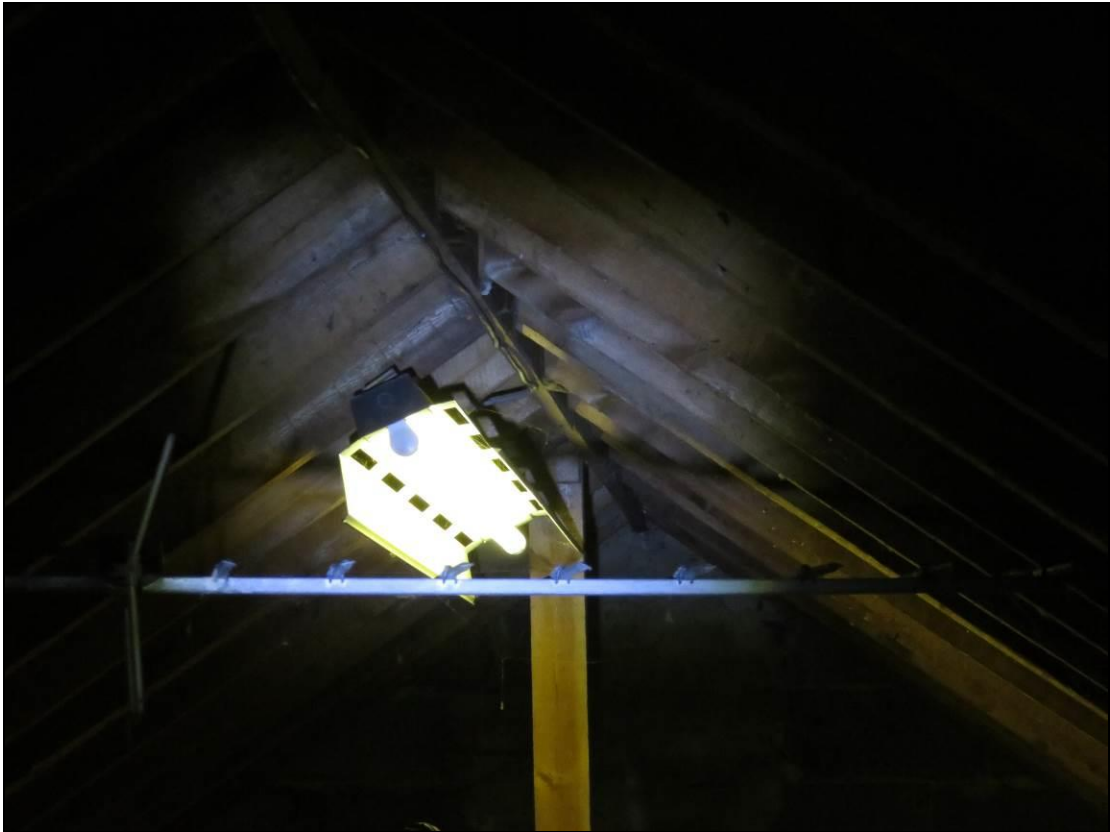
***Photo 8: Loft Void from Internal Inspection – no evidence of bats recorded , upper loft void with cobwebs indicated no recent use***

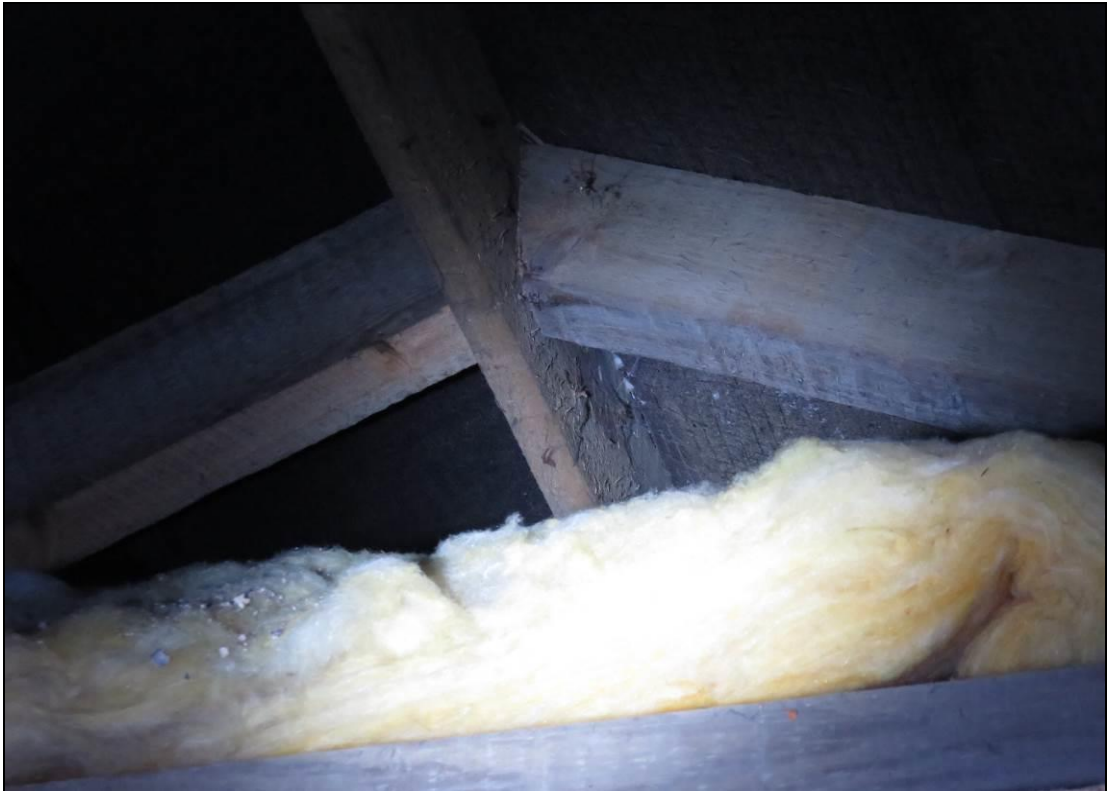
**Photo 10: Loft Void of garage from Internal Inspection – no evidence of bats recorded , upper loft void with cobwebs indicated no recent use**

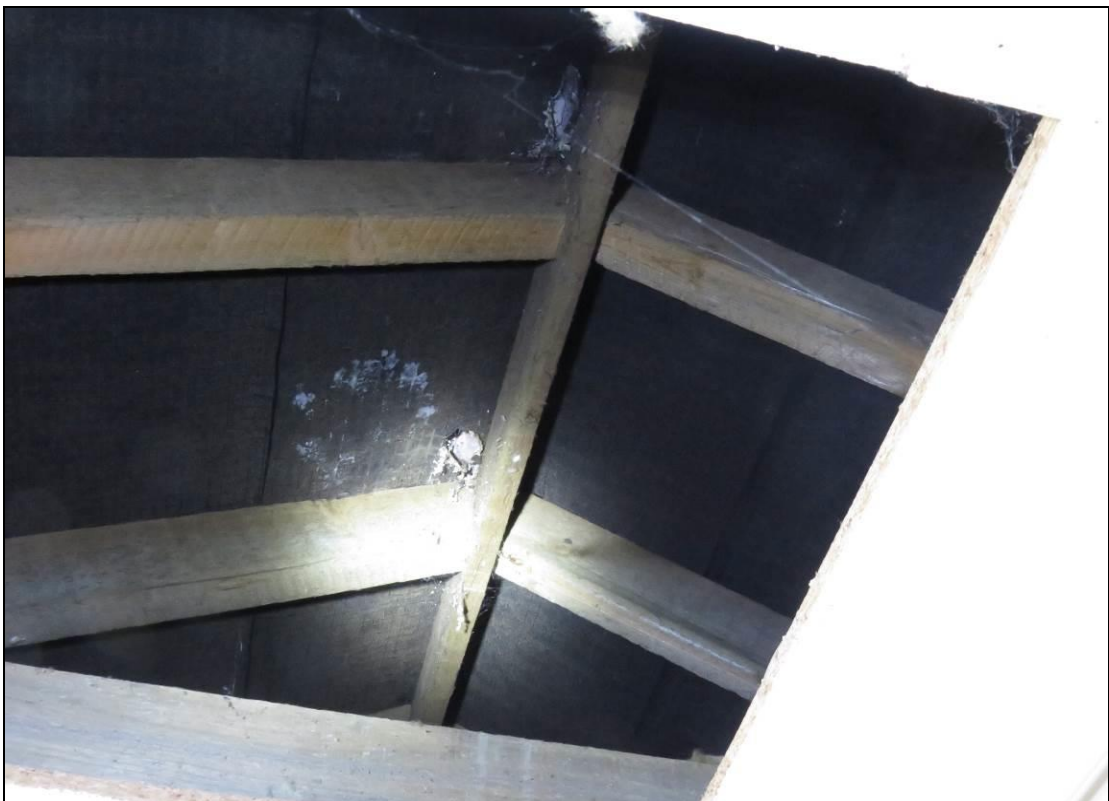
**Photo 11: Loft Void of garage from Internal Inspection – no evidence of bats recorded , upper loft void with cobwebs indicated no recent use**

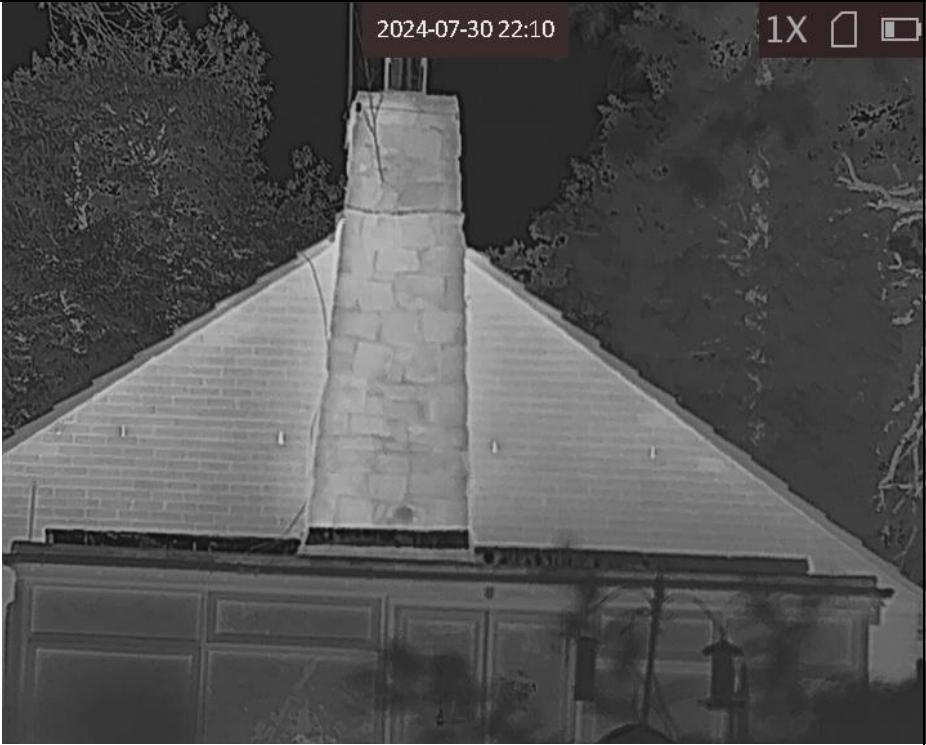
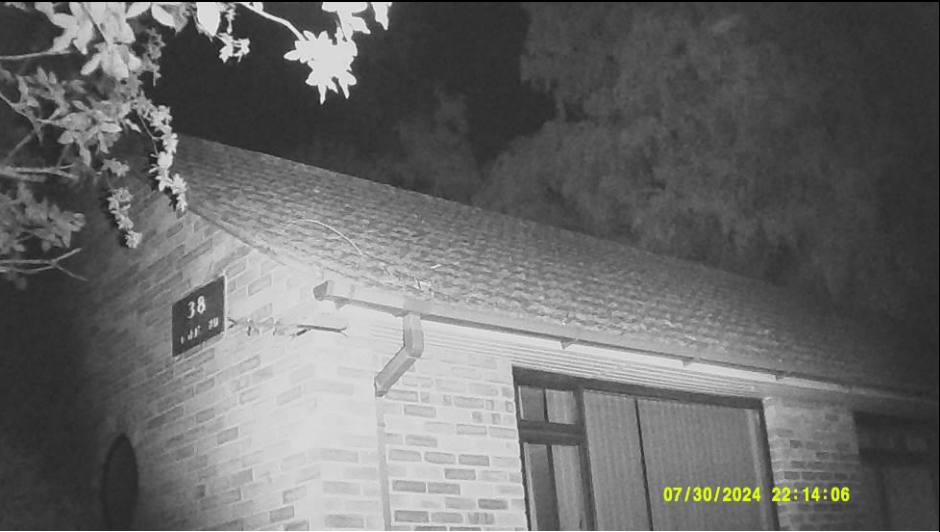
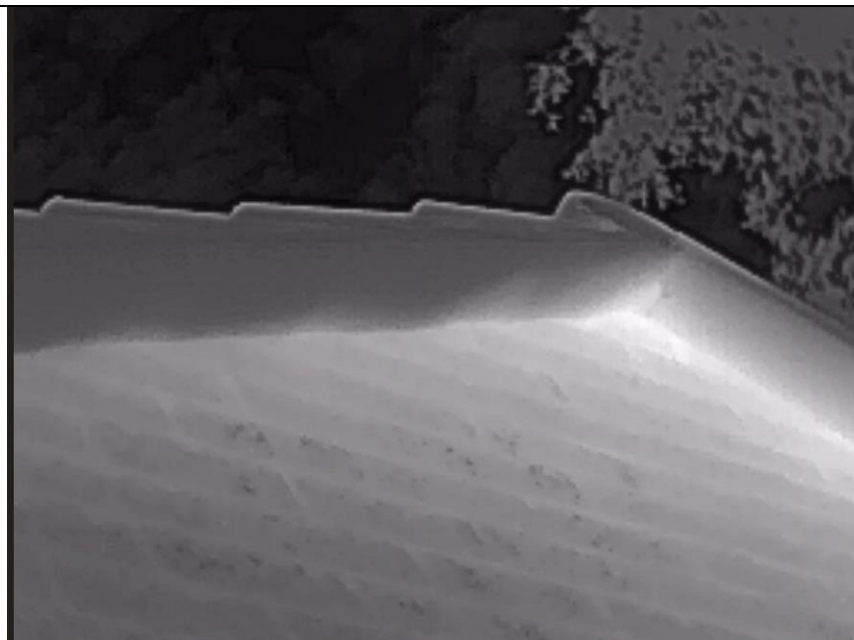
Technical Appendix 1

NVA Screengrabs from Emergence Survey

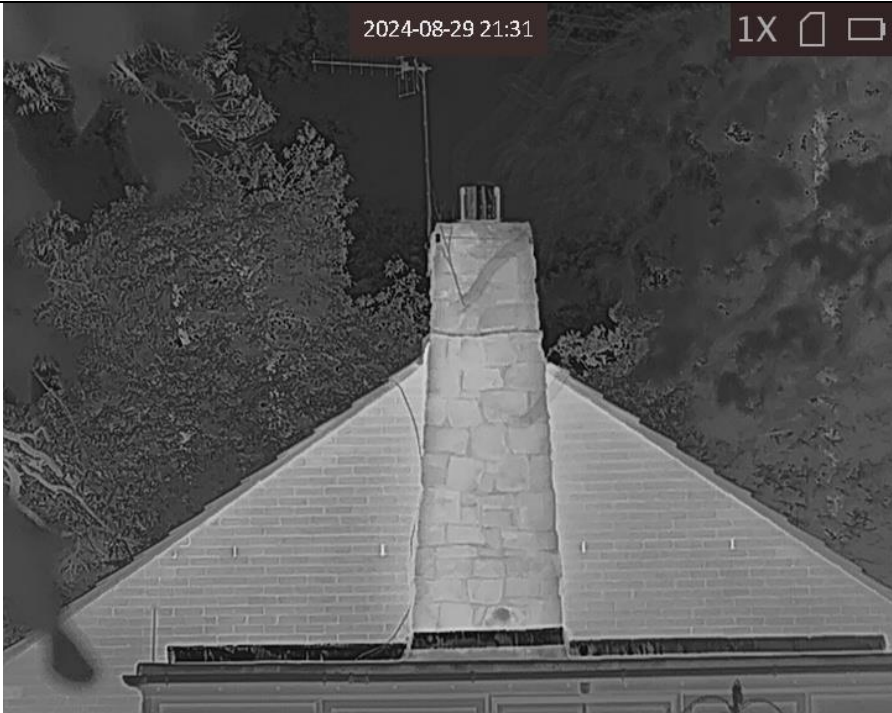
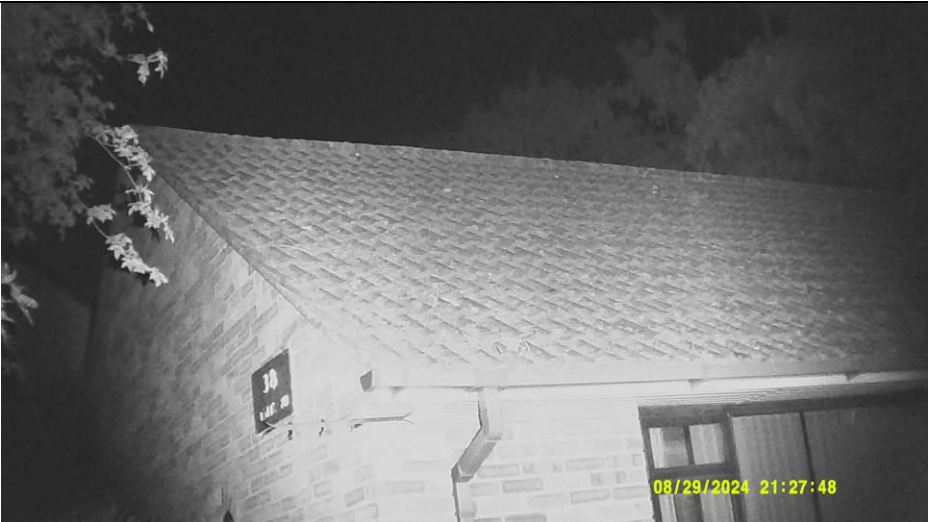
Garage PRF

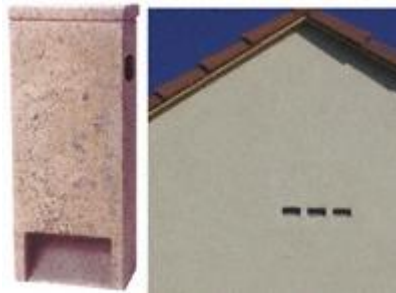
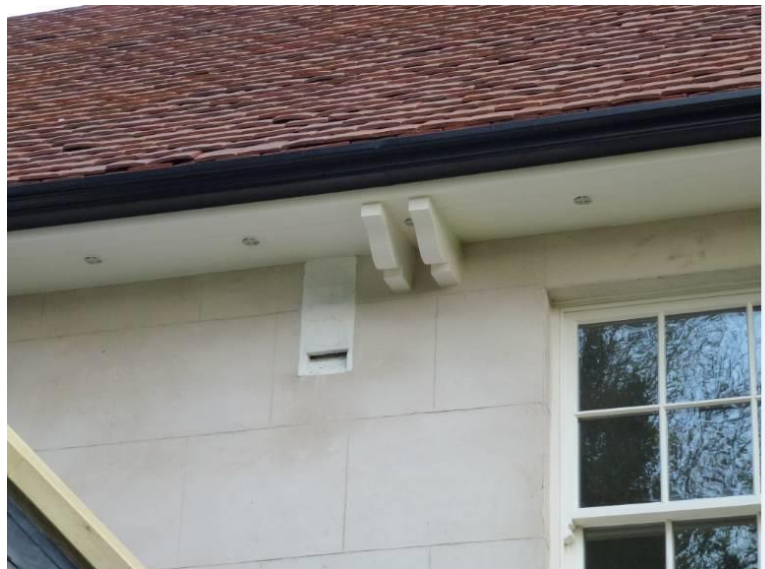
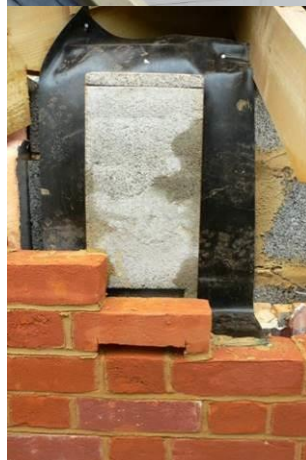
**Schwegler Bat Roost Unit  
2FR**

This Tube system meets the characteristic behavioural requirements of the types of bats that inhabit buildings. Made with Schwegler wood-concrete, the design maintains excellent climatic conditions inside the roost unit allowing the animals to either hang onto the wooden rear or onto the wood-concrete front. The box, once installed is maintenance free and self cleaning.

The roost unit can be installed within any external walls (brick, block or panelling) either flush or beneath the wall surface (with suitable entrance ramp extension)

Dimensions: height 47.5 x width 20 x depth 12.5 cm,  
Entrance: width 15 x height 2 cm, Weight: ca. 9,8 kg

Within Brick, can also be placed within cavity with only entrance visible

- 3.4.5 New bat roosting features will be incorporated into the new building design, and this could include bat bricks and bat tiles, with suitable mitigation options provided in **Technical Appendix 2**. A total of two features are recommended and locations are provided in **Figure 4** below.

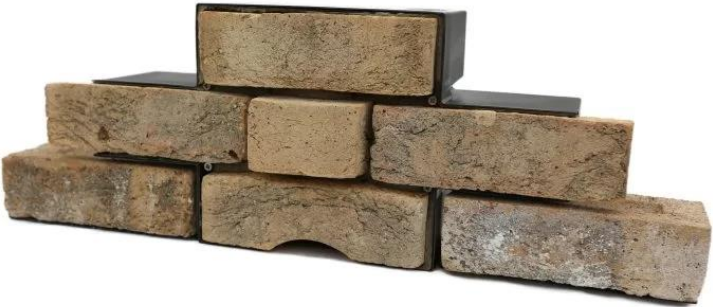
| <p><b>Birdbrickhouses:</b></p> <p>Bat boxes (also referred to as bat tubes) can be supplied in brick fronted, half bond and quarter bond brickwork or alternatively with a stainless steel mesh fitted to the front. The mesh is designed for optimum adhesion in render and stonework applications. A basic version can be fitted directly behind weatherboarding or into studwork.</p> <p>See:<br/><a href="https://www.birdbrickhouses.co.uk/products/bat-brick-houses/">https://www.birdbrickhouses.co.uk/products/bat-brick-houses/</a></p> | |
