**Wessex Tyres**

**PLANNING SUBMISSION**

This planning application is for a replacement roof to the main building at Wessex Tyres, retrospective approval for a wheel tracking unit and reception pod.

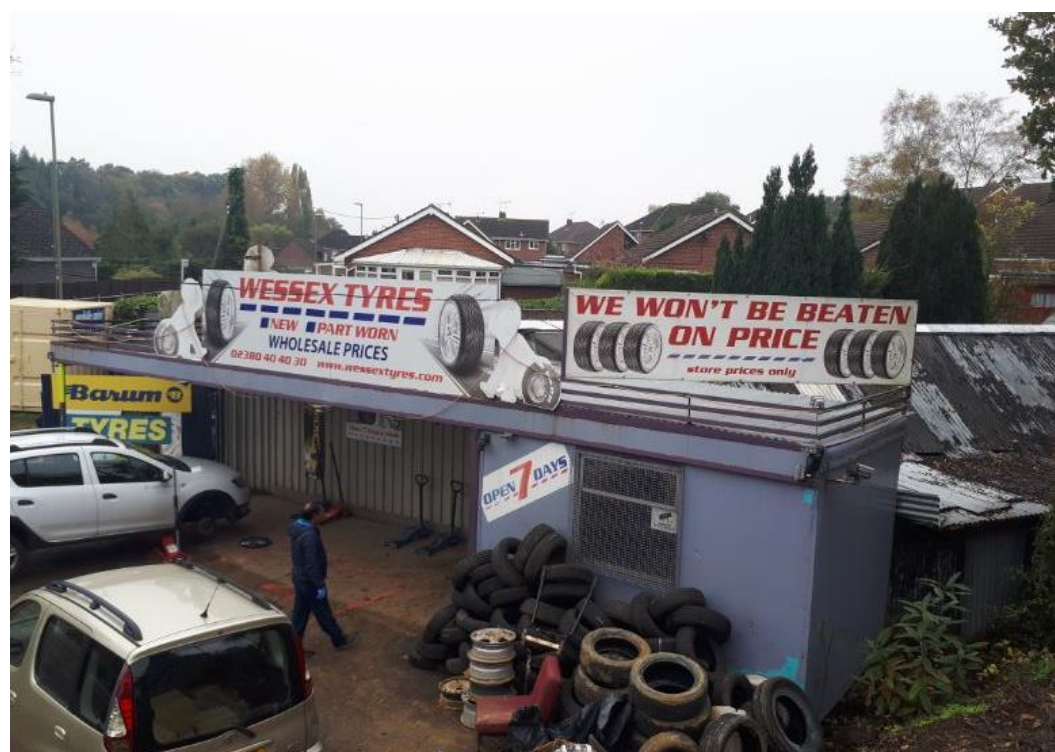
Figure 2 – Main Workshop Building (viewed from Providence Hill)

The existing workshop comprises a portal frame structure mounted to a low brick wall, with corrugated cladding and roof. This structure is in a poor state of repair and flooding has caused further internal damage

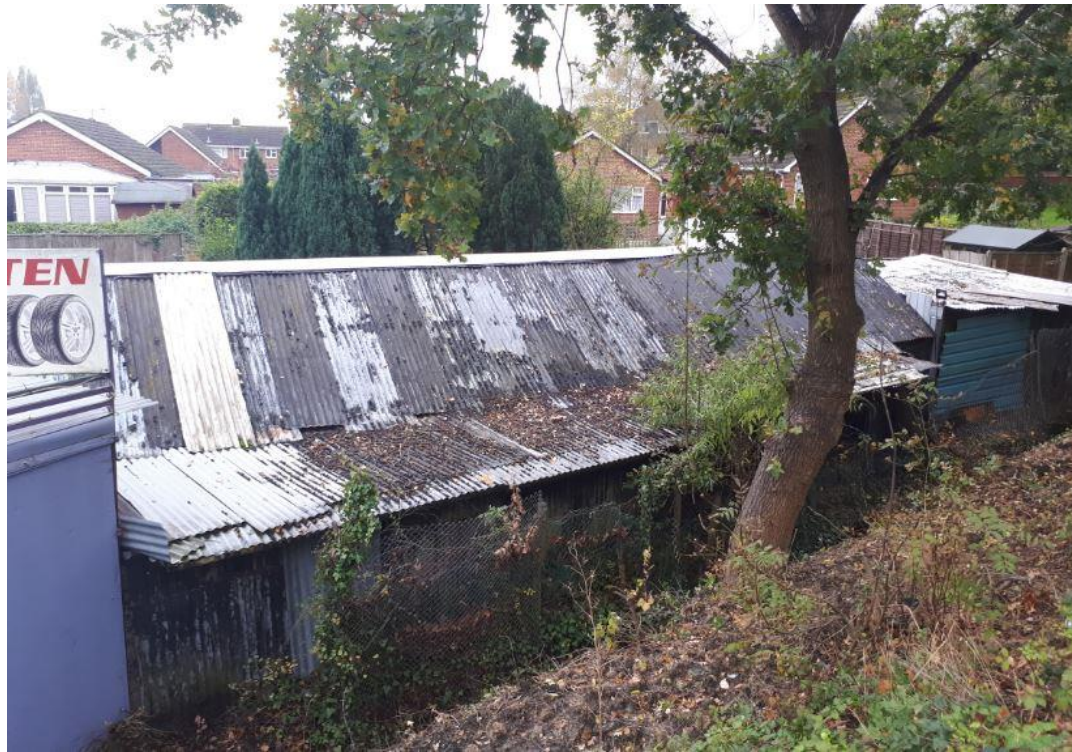
Figure 3 – Earthen bank to Eastern Boundary of Application Site

The site sits approximately 1-2m lower than the adjacent road to Providence Hill which is buttressed by an earthen bank immediately to the eastern boundary of the site (see figure 3). High panel fencing surrounds the existing storage area on top of a low retaining wall to the boundary with No.7 Forge Close.

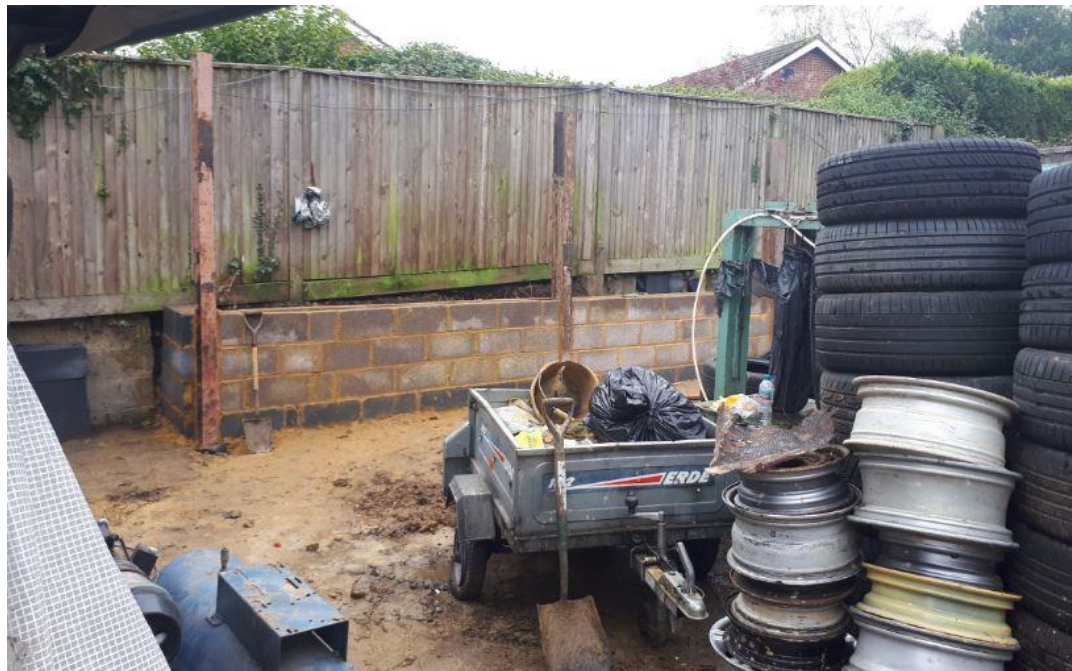
Figure 4 – Boundary with No.7 Forge Close indicating ground level change (photo taken prior to the erection of the Wheel Tracking Unit)

The site is an established centre for the fitting and repairing of vehicle tyres. Neighbouring properties are residential in character and are located at an elevation of approximately 0.7-0.9m above the application site (see figure 4). The nearest residential property, No.7 Forge Close, is located approximately 11m distant from the site boundary.

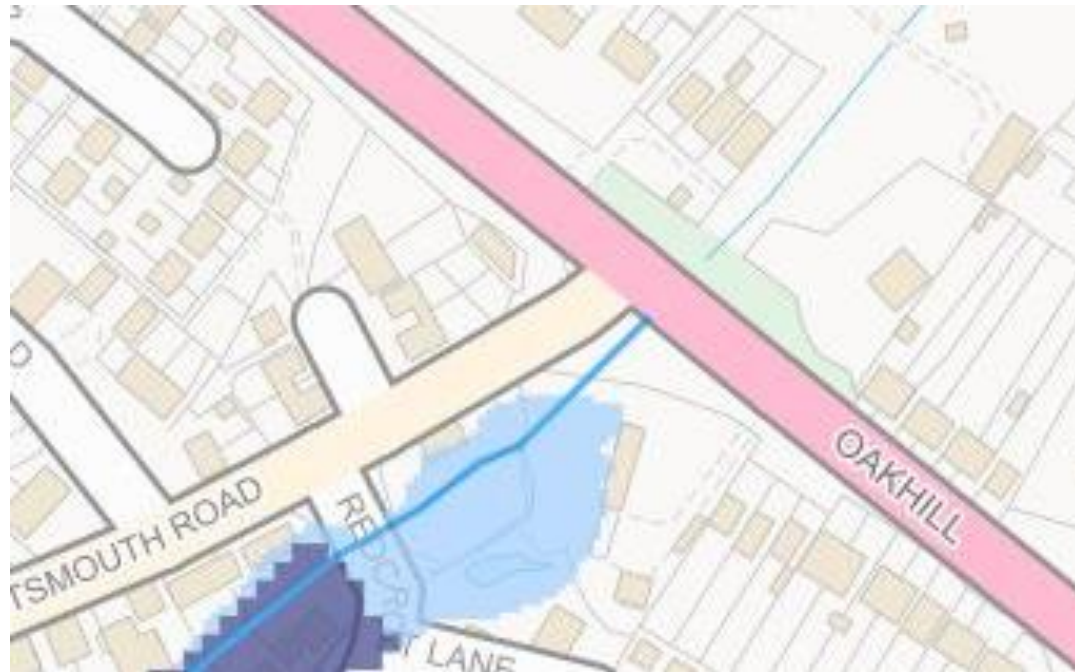
Figure 5 – Flood Risk Map (extract)

The Environment Agency flood risk maps were reviewed (see figure 5) and it was identified that the site does not lie within any Flood Zones and therefore no further flood risk assessment work has been undertaken

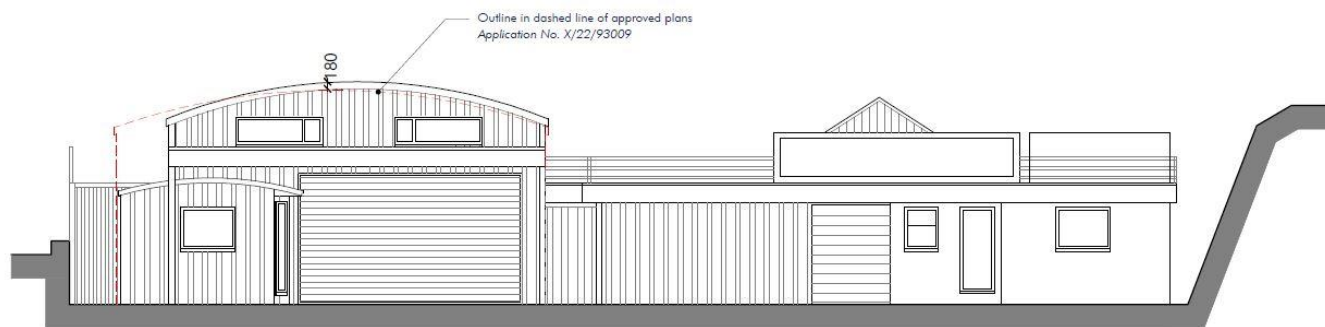
Figure 7 - Front Elevational Changes showing Approved Elevations (bottom two images), the as-built/consented scheme, and the new application (top image)

The mono-pitch roof form will remain at broadly the existing eaves level and rise to a height approximately 0.35m higher than the approved ridge. This will not be noticeable from Providence Hill due the landform arrangement, and it will appear that the roof rises to meet the sloped bank. This will provide a rationalised workshop space, with suitable working head heights, which the ante-rooms in their current state are unable to provide
