Preliminary Roost Assessment (PRA) bat survey:

**35 Gordon Road,**

**Chandlers Ford,**

**SO53 5AN**

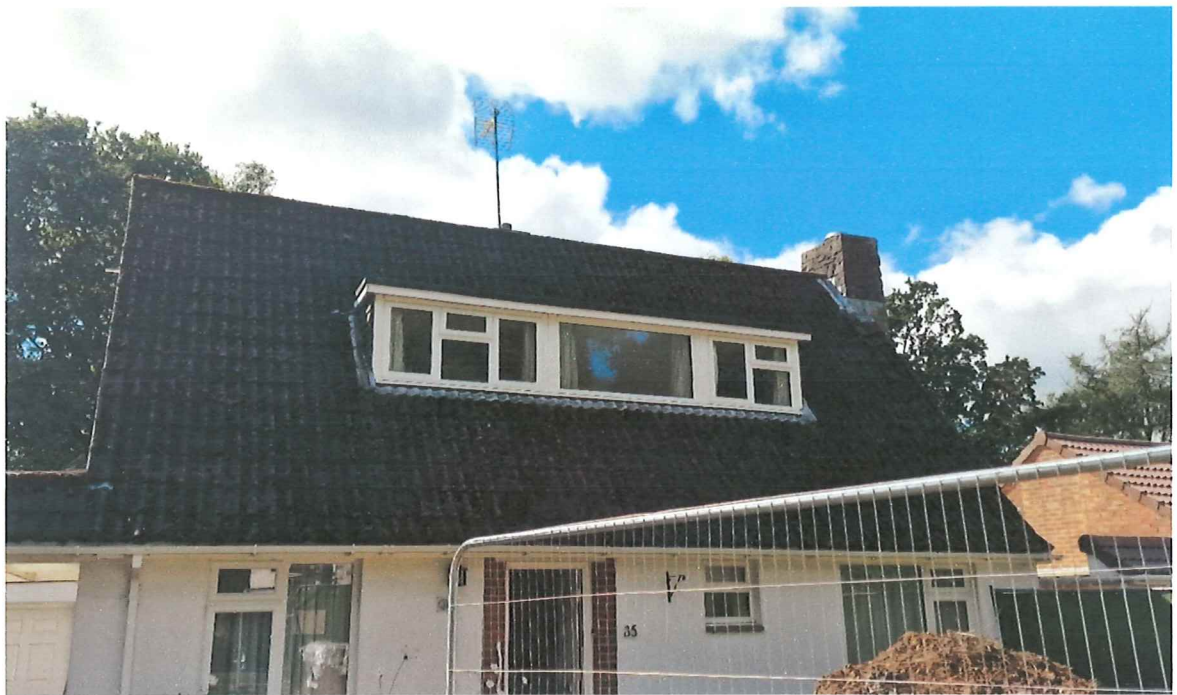
**Picture 1:** The front elevation.

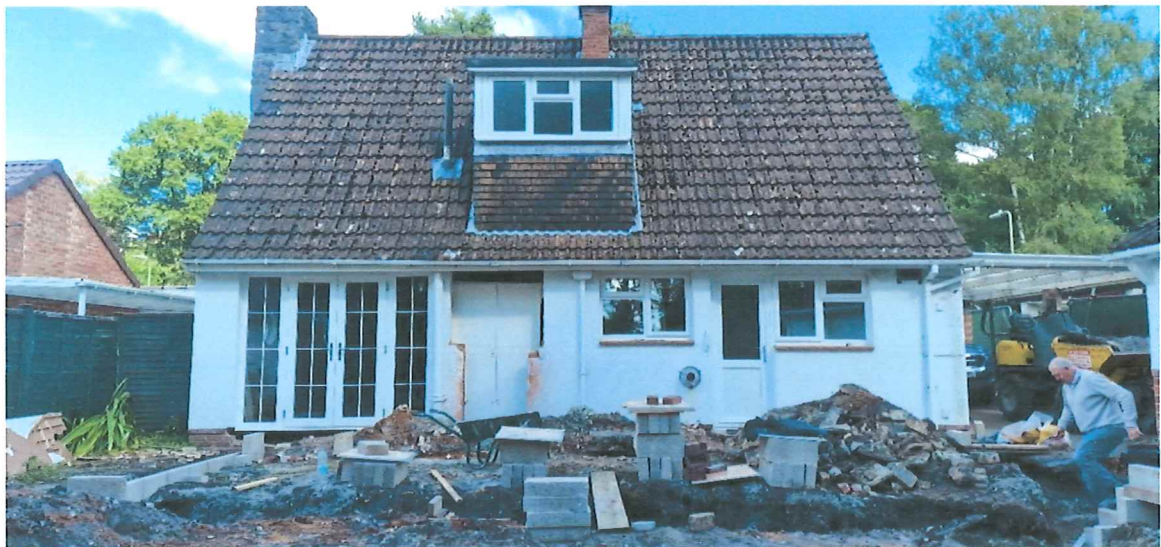
elevation this has a felt roof which is in good order, the cheeks are covered in hanging tiles, there are gaps around the corner tiles that would allow ingress.

**Picture 2:** Showing the rear elevation.

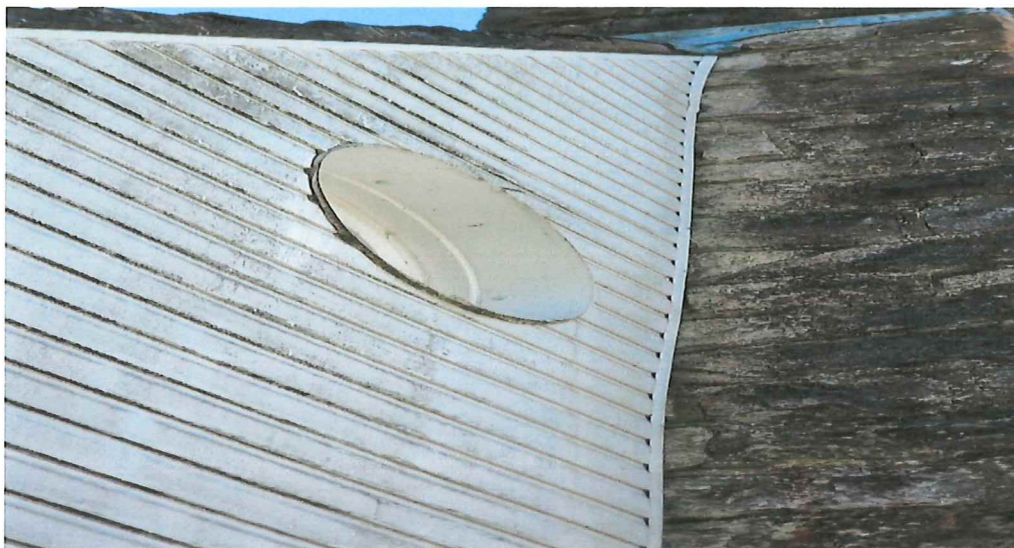
- 2.6 The tile verges are in good order with no missing pugging and no obvious gaps or holes that would allow ingress into the building.
- 2.7 The building has an exterior chimney, the chimney and the lead flashing around the top has a number of gaps that could allow ingress into the building.

- 2.8 The gable walls are covered with UPVC cladding which has gaps around the edges and at the apexes that could allow ingress into the building.
- 2.9 At the front there is a double width dormer window, which has a felt flat roof which is in good order, the dormer cheeks are covered in tight fitting hanging tiles with no obvious gaps or holes. There is a single width dormer on the rear

**Picture 3:** Showing the gaps around the UPVC cladding and the lead flashing.

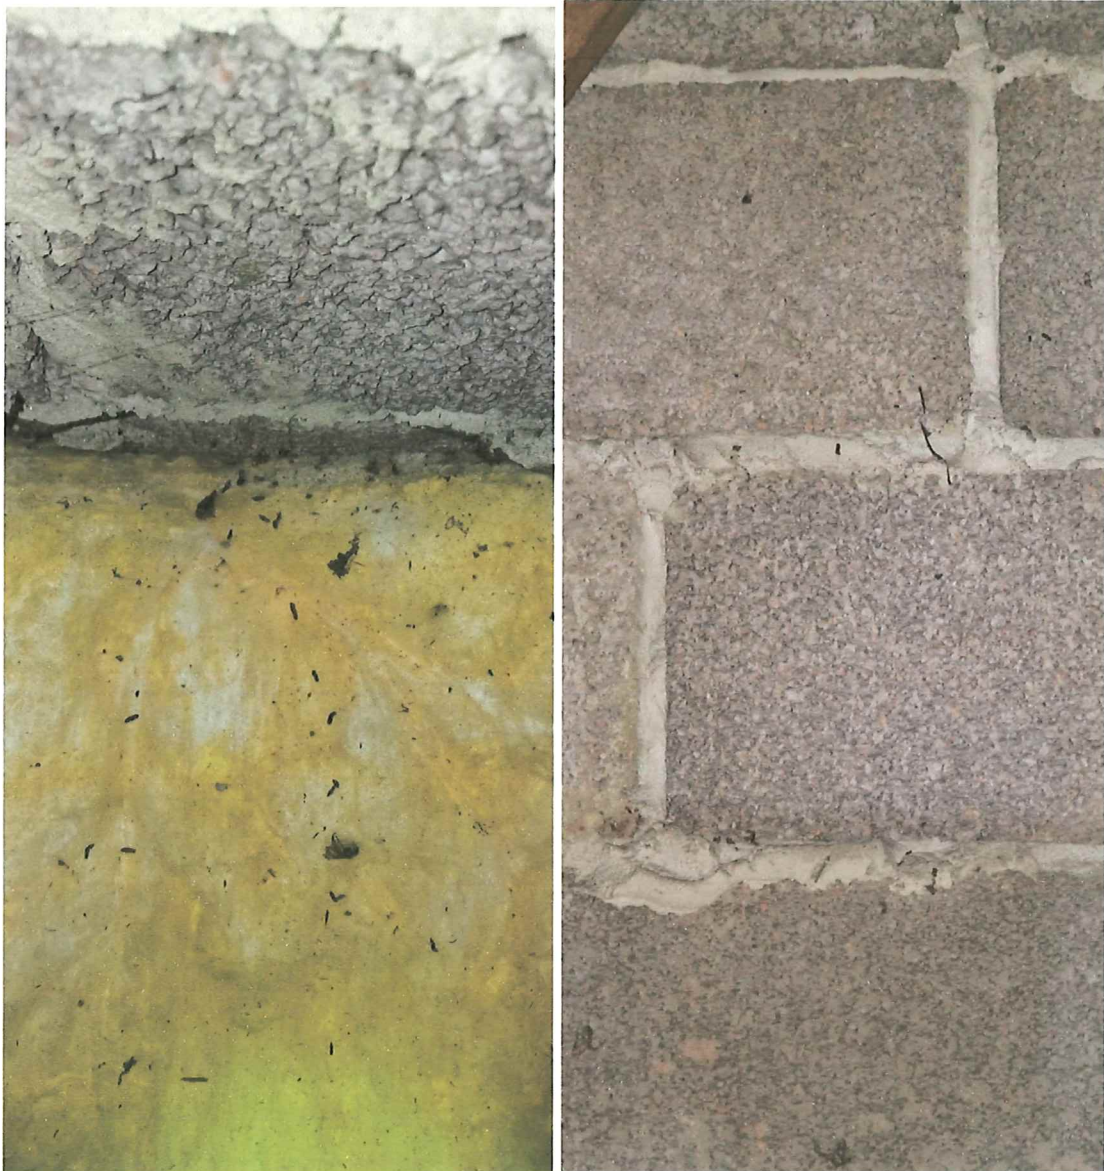
- 2.15 There are bat droppings against the eastern gable wall and on the insulation below, there are a few droppings within the roof space beyond this area. DNA has shown them to be from Common Pipistrelle bats. (figure 1 & 2)

**Picture 4:** Showing the bat droppings at the eastern gable.

- 3.4 It is recommended that **3 bat activity surveys are undertaken** to ascertain the type and size of roost within the building as set down in the Bat Conservations 'Bats Surveys for Professional Ecologists: Good Practice Guidelines'.

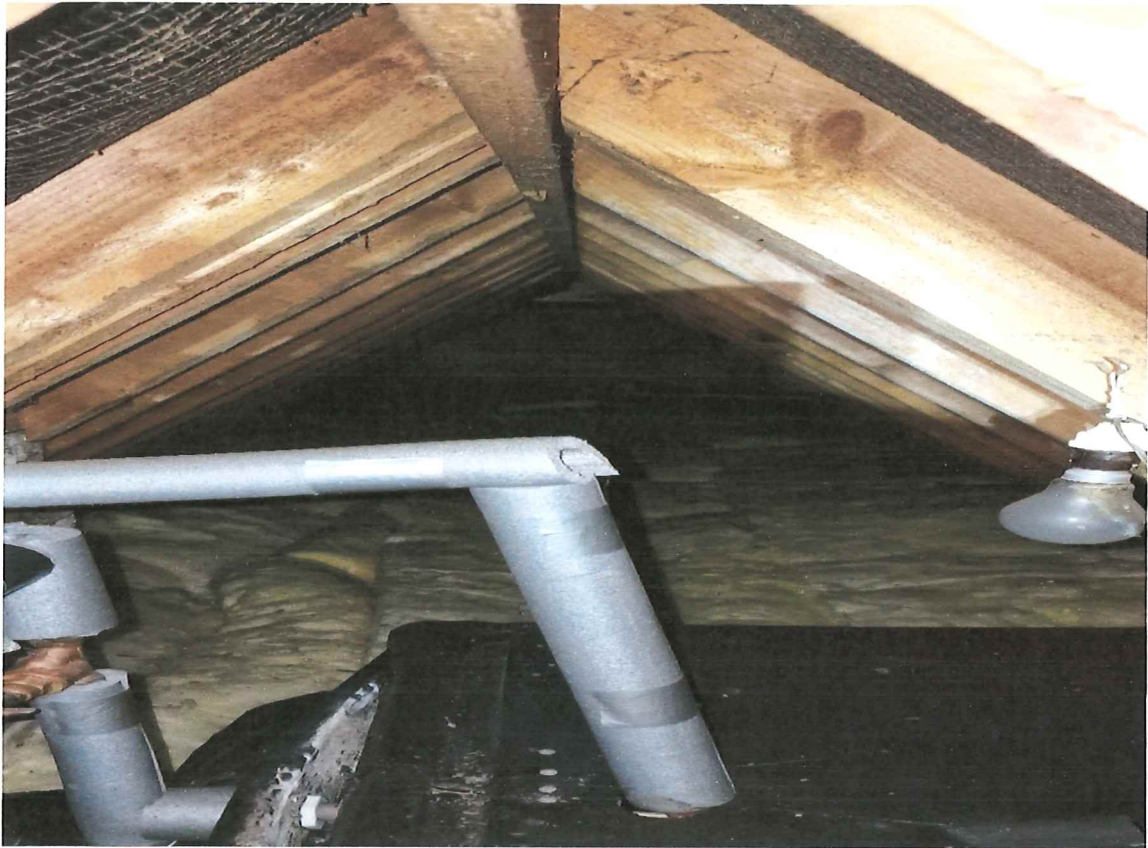
- 2.11 The roof space covers the middle of the roof void as there are rooms built into the roof, there are eave areas as well.
- 2.12 The roof void above the rooms has insulation on the floor and is about 1.2m to the ridge access was moderate throughout as the water tank is difficult to get past and there are no crawl boards.

- 2.13 The tiles are backed with F1 bitumen felt, there are no obvious gaps or holes in the felt.
- 2.14 There is no light coming in from the eaves or anywhere else as the insulation is tucked right into the eaves.

**Picture 5:** Showing the internal structure of the building and the thick layer of insulation.
