**Protected Species Walkover  
and  
Bat Assessment**

**Bursledon Hall**

**Blundell Lane  
Bursledon  
Southampton  
SO31 1AA**

**24-048  
July 2024**

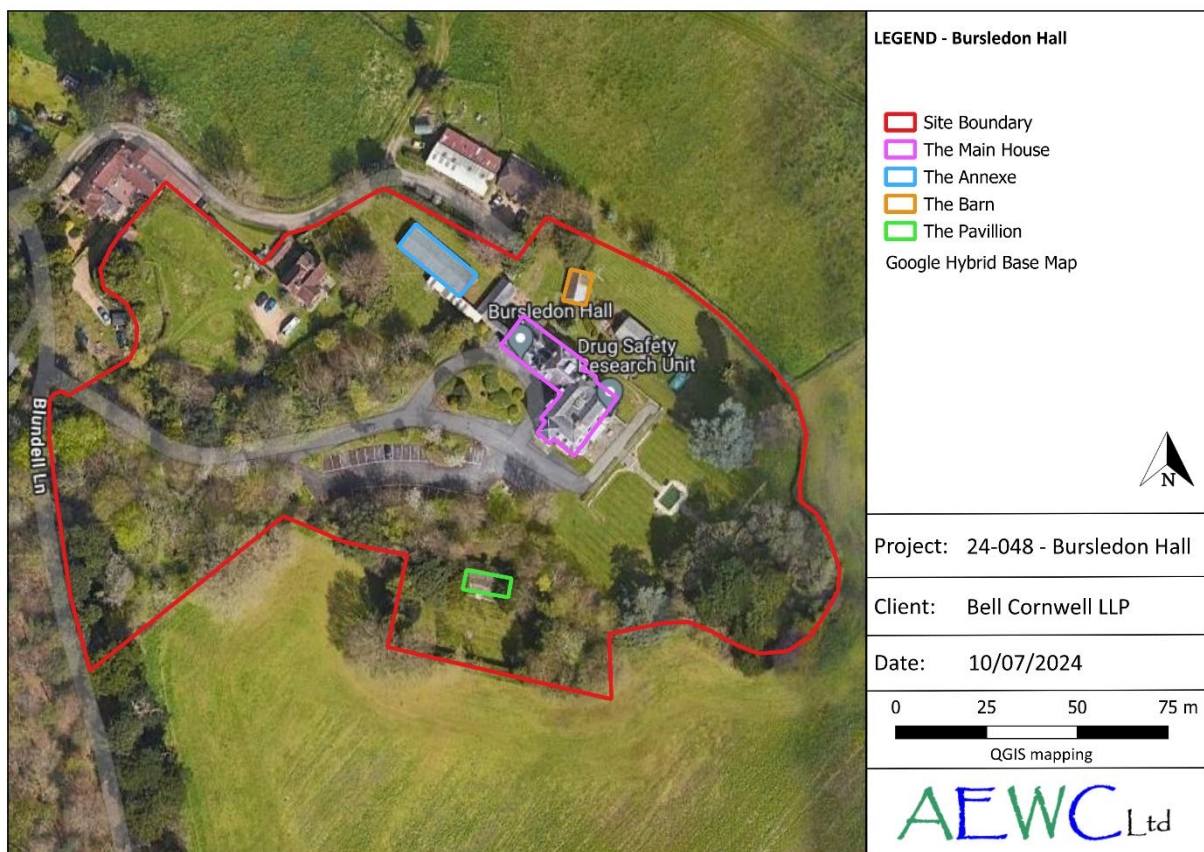
- 2.2 The site is approximately 2.05ha and comprises a series of buildings surrounded by hardstanding, mown grass lawn, ornamental shrubs, and scattered trees. There is a small ornamental pond in the garden in the southeast and longer sward grassland in the northwest. There are woodland blocks in the southeast and southwest of the site, and a belt of woodland adjacent to the driveway near the site centre. On some of the site boundaries are hedgerows. See Figure 2.

**FIGURE 2: AERIAL VIEW OF THE SITE SHOWING THE SITE BOUNDARY AND BUILDINGS SUBJECT TO SURVEY**

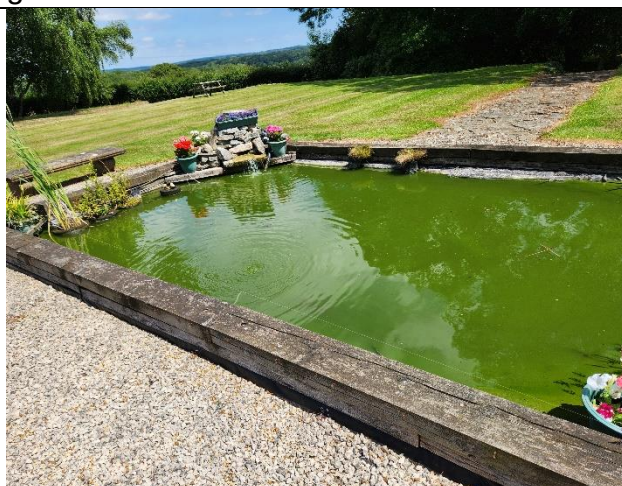
- 5.19 Within the formal garden in the southeast of the site is a small ornamental pond. This has sheer sides created by stacked timber boards, the water was found to be stagnant, and no aquatic vegetation was present, with potted plants at the water edge only.
- 5.20 There are a small number of individual mature trees scattered around the site within the lawn areas.
- 5.21 There are native hedgerows along the northeastern boundaries, composed of hawthorn (*Crataegus monogyna*), field maple (*Acer campestre*), and holly (*Ilex aquifolium*), with occasional hornbeam (*Carpinus betulus*), pedunculate oak, ash (*Fraxinus excelsior*), and hawthorn trees. On the southern boundary, to the south of the Pavilion, is an ornamental garden privet (*Ligustrum ovalifolium*) hedge. A line of holm oak (*Quercus ilex*) trees connects this hedge to the woodland in the southwest of the site.

**Photograph 9:** The onsite pond (pond 1).

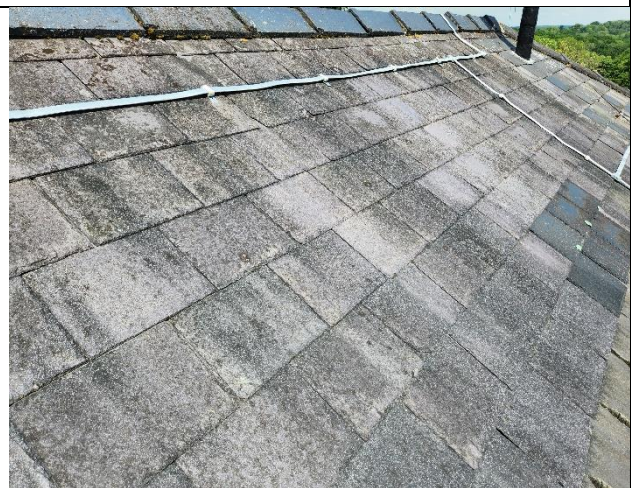
- 5.40 The external brick walls are in excellent condition and no cracks or other crevice features were identified.
- 5.41 The roofs are mostly in very good condition, with tightly fitting slate tiles. A small number of potential crevice roosting features were identified associated with the roof, including slipped or broken slate tiles, lifted lead flashing, and mortar gaps under ridge tiles. These could be utilised by crevice-dwelling species of bat.

**Photograph 14:** Tightly fitting slate tiles across most of the roof.

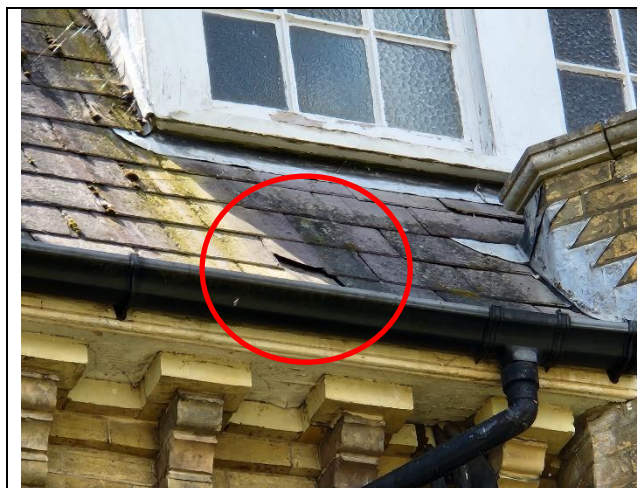
**Photograph 15:** Broken roof tile on the Main House creating a crevice space.

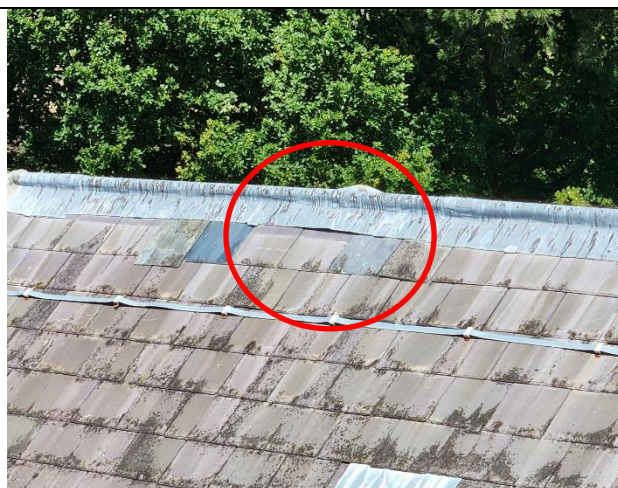
**Photograph 16:** Lifted lead flashing on the Main House creating a crevice space.

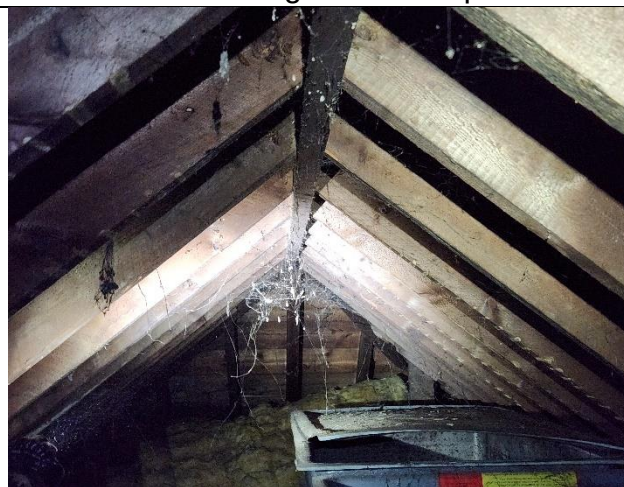
- 5.44 The loft voids were cobwebbed at the rafters, indicating an absence of recent bat activity here. No evidence of bats, such as droppings, was found.

**Photograph 17:** Cobwebbed roof void within the Main House.

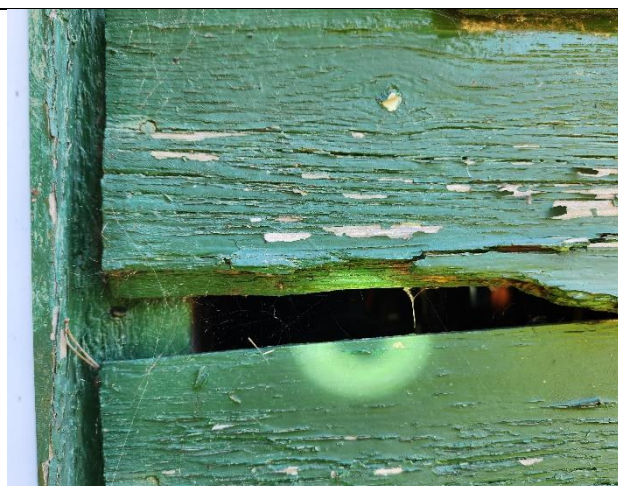
5.54 There are potential routes of access into the building for bats through gaps above the double doors on the western elevation and through small holes in the walls where there has been damage and degradation. The eaves appeared well sealed.

**Photograph 26:** Gap into the Barn through a damaged wall.

- 7.4 All areas with potential for bats will be soft-stripped under direct supervision of the licensed ecologist.
- 7.5 Stripping must only be conducted when the air temperature is sufficiently high (at least 8°C) and in the absence of strong wind and rain, so as to not risk harming bats which may be found.

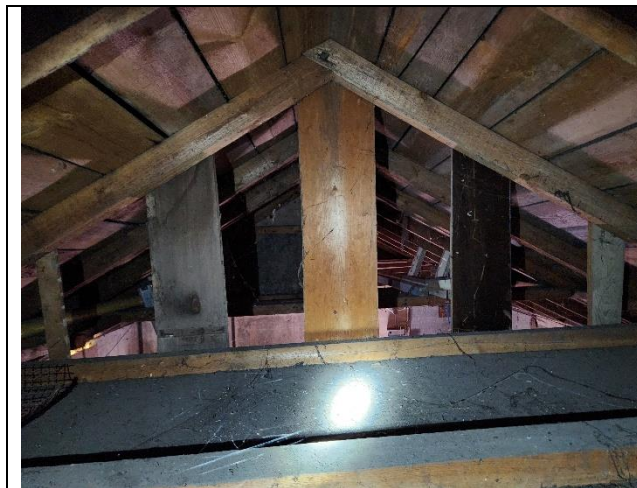
5.55 Internally there is a small, partially enclosed roof void in the northern end of the building, with the remainder being open to the rafters. The roof is lined with timber sarking, which is in good condition and tightly fitting.

**Photograph 27:** The partially enclosed loft void at the northern end of the Barn.

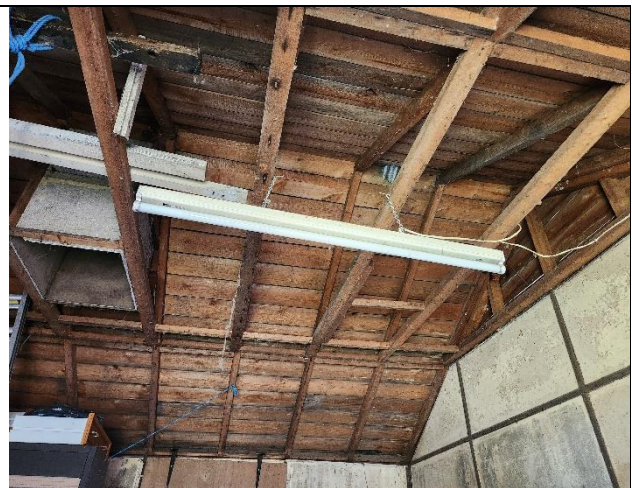
5.57 The rafters were cobwebbed, indicating an absence of recent bat activity, and no evidence of bats was found. The building has high interior light levels during the day due to the presence of windows on the eastern elevation, and this includes within the small loft void section since this is open-ended into the remainder of the building. The high light levels would reduce the likelihood of void-dwelling species of bat using this space for day roosting.

**Photograph 28:** The southern end of the Barn, open to the rafters.

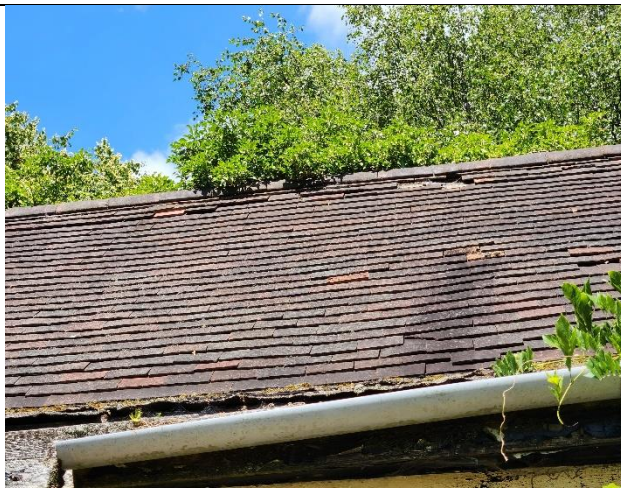
- 5.60 The exterior walls are in good condition and no crevice features were identified here.
- 5.61 There are several lifted, slipped, and missing clay roof tiles which would provide access inside the building. It is unlikely that these would provide crevice roosting opportunities since the roof is unlined, and therefore the overlap between tiles would provide the only crevice space and this is very shallow. No gaps were seen beneath the ridge tiles, which appeared well sealed. Most of the northern, eastern, and western roof pitches are covered by moss and climbing vegetation, blocking access to most of the tile gaps, however the southern roof pitch provides open access.

**Photograph 31:** Gaps in the southern roof pitch.
