# Site Investigation Report

148175.3.TSI

Auger were commissioned by Sedgwick International UK to undertake a site investigation within the area of concern (AOC) at the property.

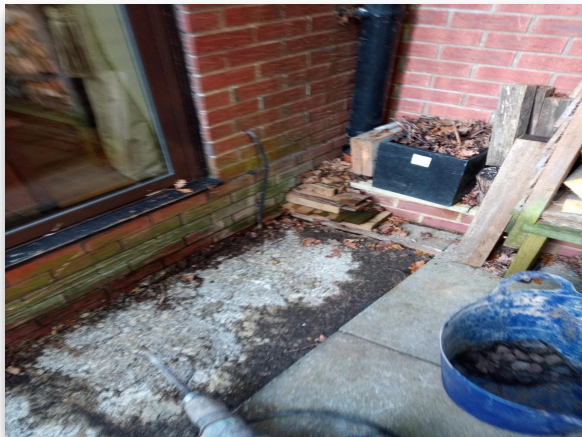
Fig 1.1: Trial Hole 1 Location

Within TH1 we revealed the footing and augered to the required depth (3m) in the proposed location. We took soil and root samples. These measurements are shown in Trial Hole Log 1 below. Due to the SVP being located in the corner between the extension and main property we have been unable to expose both footings.
