# Site Investigation Report

148175.1.USI

| Brief | Auger were commissioned by to undertake a site investigation and CCTV inspection of the underground drainage within the area of concern (AOC) at the property. |

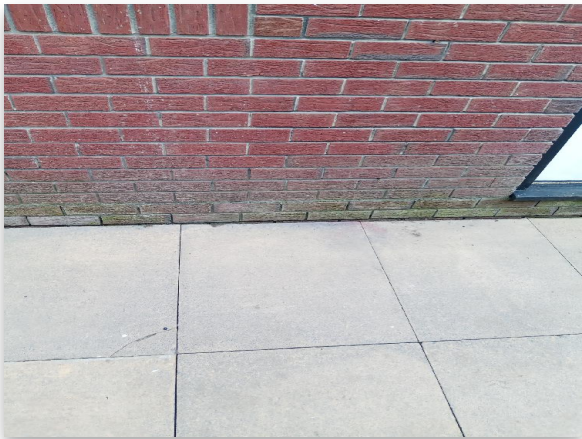
| Trial Hole Findings | <p>Within TH1 we revealed the footing and augered to the required depth (3m) in the proposed location. We took soil samples. We were unable to collect root samples from TH1 because no roots were present during the trial hole, hence no samples were retrieved. These measurements are shown in Trial Hole Log 1 below. The base of the footing was determined by probing to a depth below 1.0m and therefore the exact profiles/depth cannot be guaranteed.</p> <p>TH2 was moved following a conversation with the customer who built and lay the foundations for the extension. The customer informed us that the footings were 2m deep and because of this we decided to move the TH and excavate a BH at the rear of the property; reaching the required depth and collecting soil and root samples. Measurements of BH2 are shown in Trial Hole Log 2 below.</p> |

| Fig 1.1: Trial Hole 1 Location | Fig 1.2: Trial Hole 1 Footing |
