**DESK STUDY REPORT**  
**for the development at**  
**LAND SOUTH OF MORTIMERS LANE,**  
**FAIR OAK, HAMPSHIRE**  
**SO50 7HN**  
**on behalf of**  
**BLOOR HOMES SOUTHERN**

| <b>Report:</b> | <b>DESK STUDY REPORT</b> |
| <b>Site:</b> | <b>LAND SOUTH OF MORTIMERS LANE, FAIR OAK, HAMPSHIRE, SO50 7HN</b> |
| <b>Reference:</b> | <b>GE21215/DSRv1.1/NOV24</b> |

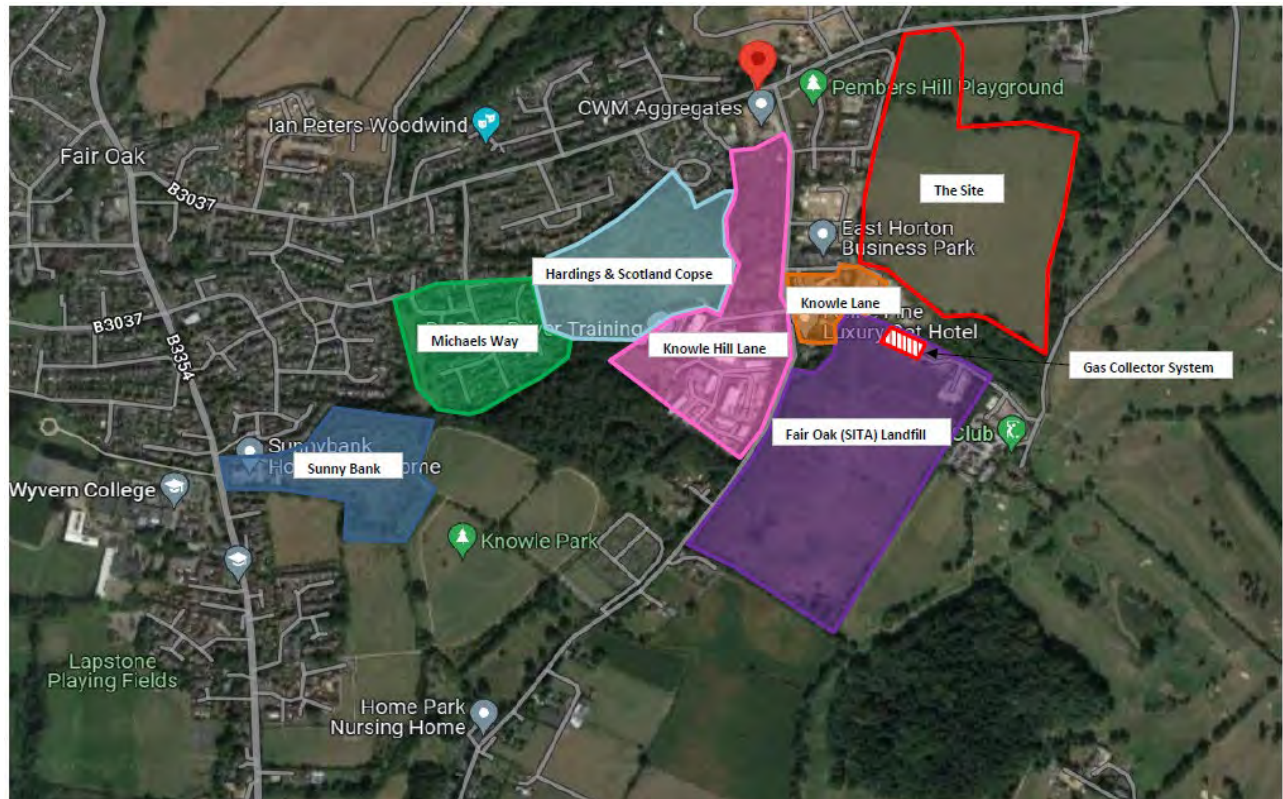
**Plan 1 – Approximate locations of historical and authorised landfill sites in proximity to the site boundary**

Fair Oak Landfill is a closed landfill site with active gas and leachate management systems in place. Knowle Lane has been partially redeveloped with a data recovery centre and other commercial uses. Knowle Hill Lane has also been partially redeveloped with an industrial estate located in the south of the landfill area. Hardings and Scotland Copse is generally undeveloped and comprises public open space and woodland.

Below is a plan (Plan 1) which shows the approximate location of these identified landfill sites in relation to the subject site, based on a review of the Environment Agency and Local Authority records provided as part of the Landmark dataset. The plan also includes the former landfill sites Michaels Way and Sunny Bank Landfills although these sites are in excess of 500m from the site they are located within the same underlying permeable geology of the Whitecliff Sand. No liabilities are taken for any inaccuracies in respect to these boundaries where plotted in relation to the subject site:
