**LAND EAST OF CHICKENHALL LANE, EASTLEIGH, SO50 6AF**

**GROUND CONDITION ASSESSMENT**

**OCTOBER 2024**

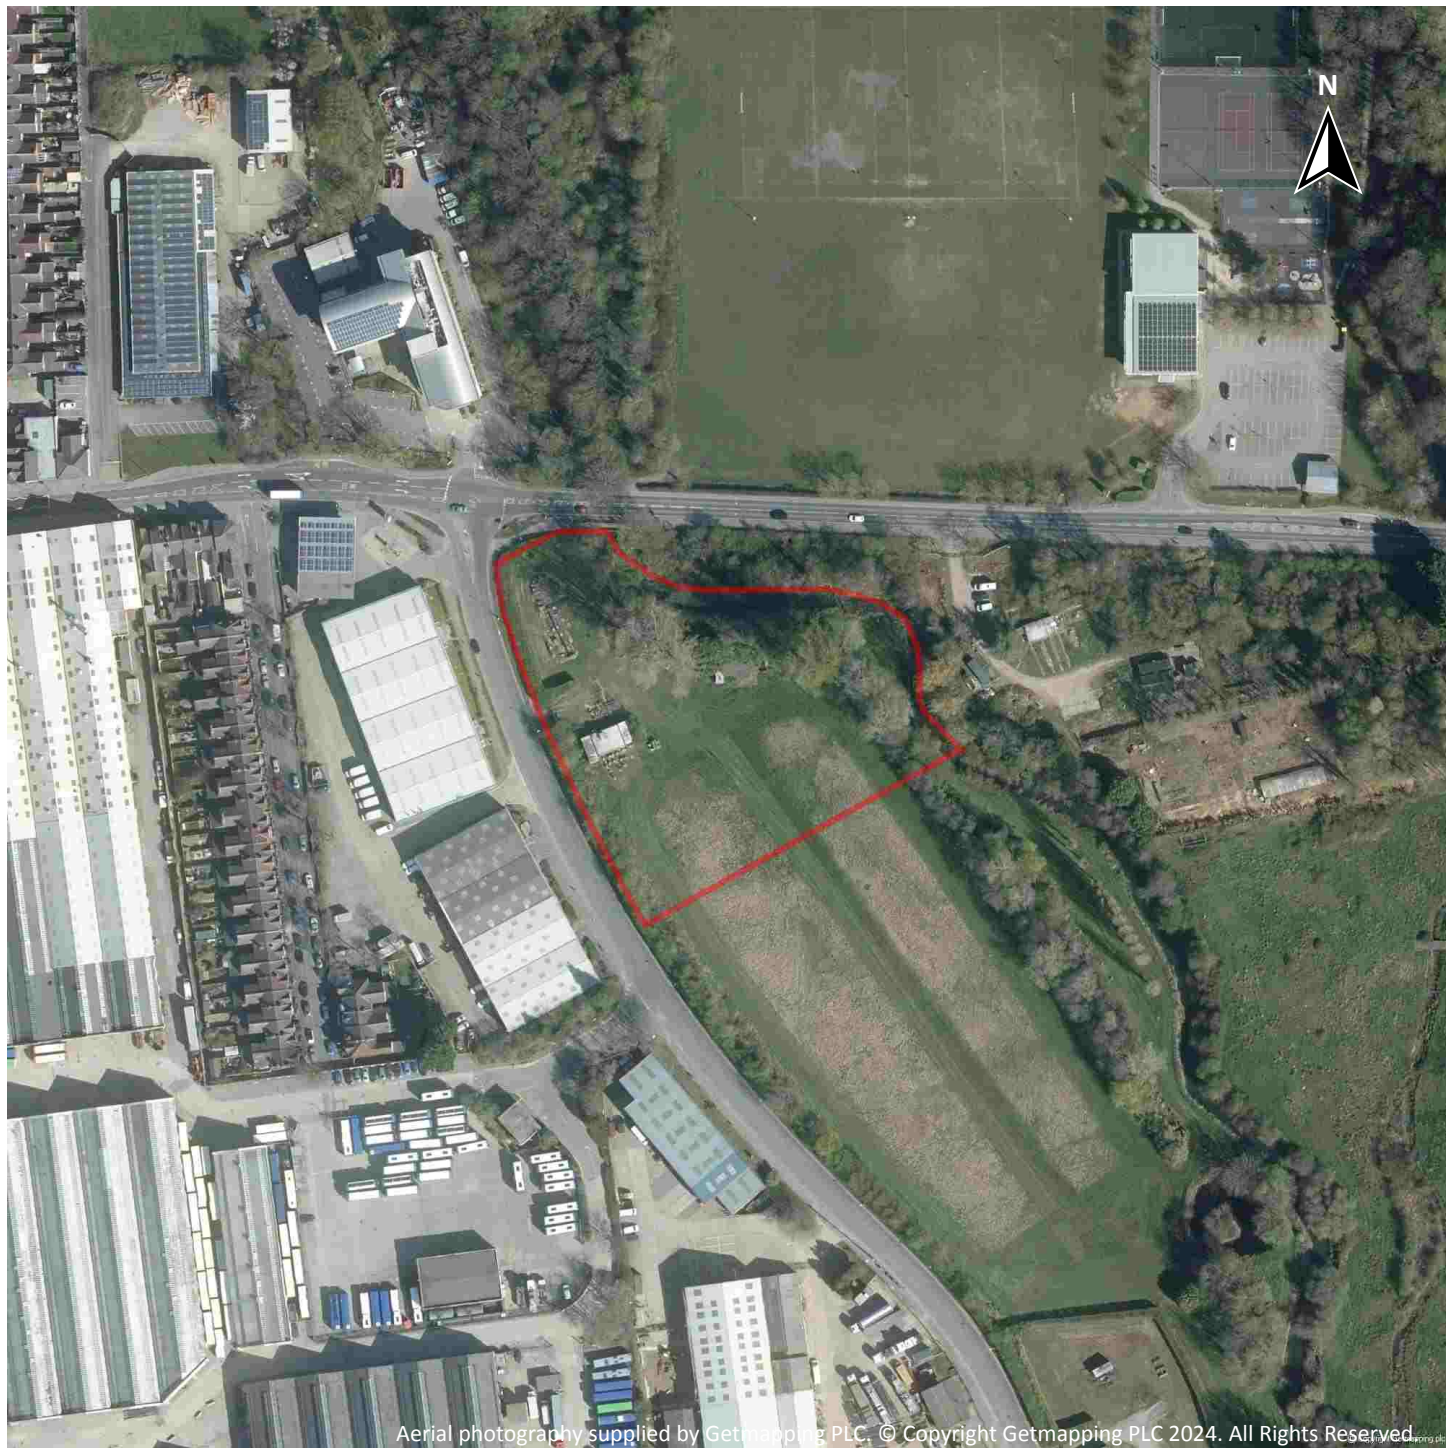
## Recent aerial photograph

Capture Date: 05/04/2020

| Site History | Historical map extracts from 1868 to 2024 indicate that the study site has remained mainly undeveloped, with the exception of the small scaled storage/garage buildings now present on-site (not shown on any historical maps). Early maps also indicate that there used to be a crossing point (over the River Itchen) and associated track crossing the site but by 1909 the crossing had already been moved and Bishopstoke Rd and bridge over the River had been developed to the north of the site. A small creek or tributary arm is noted to extend from the east into the southwest corner of the site. Aerial images also show that the northern portion of the site has been used in recent years as storage for materials (unknown) and stockpiled soil. No evidence of stockpiling is noted on the historical aerial imagery in the centre or south of the site. |

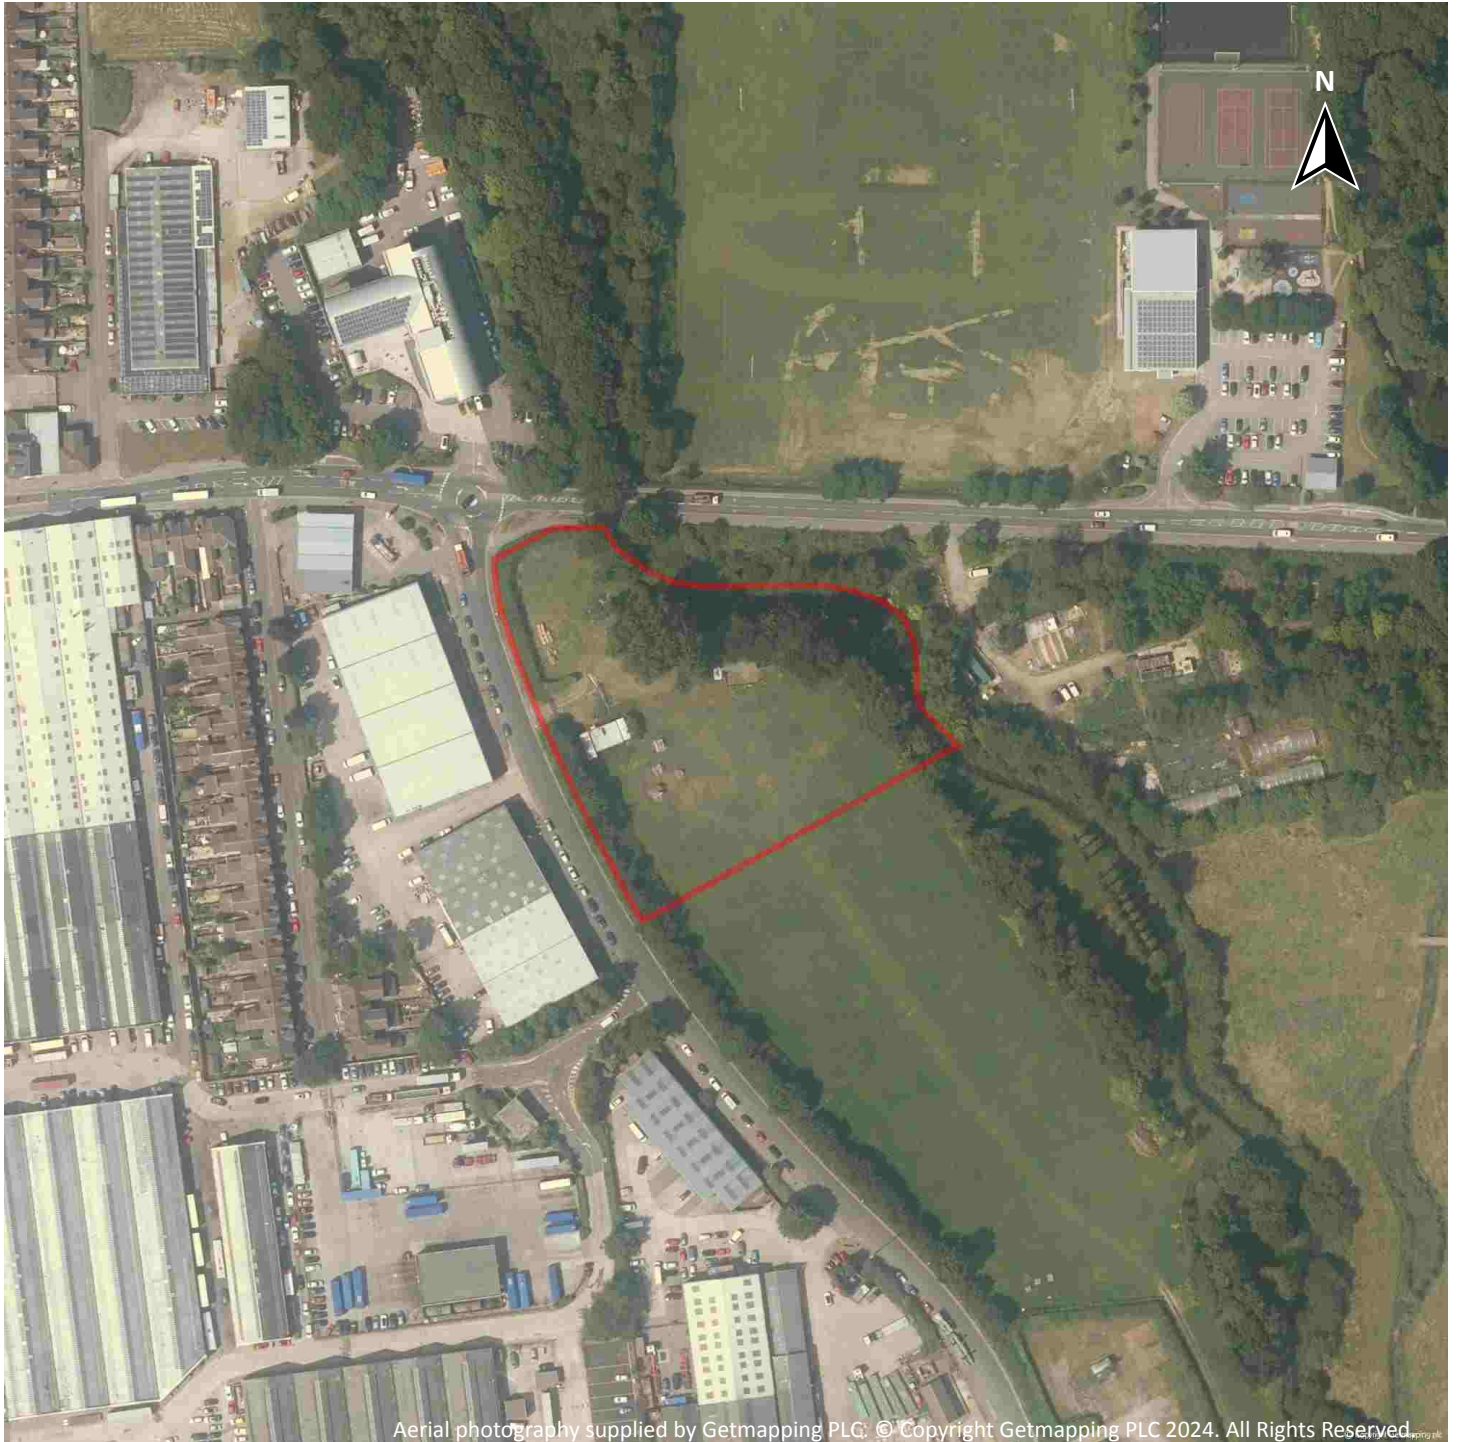
## Recent site history - 2017 aerial photograph

Capture Date: 21/06/2017

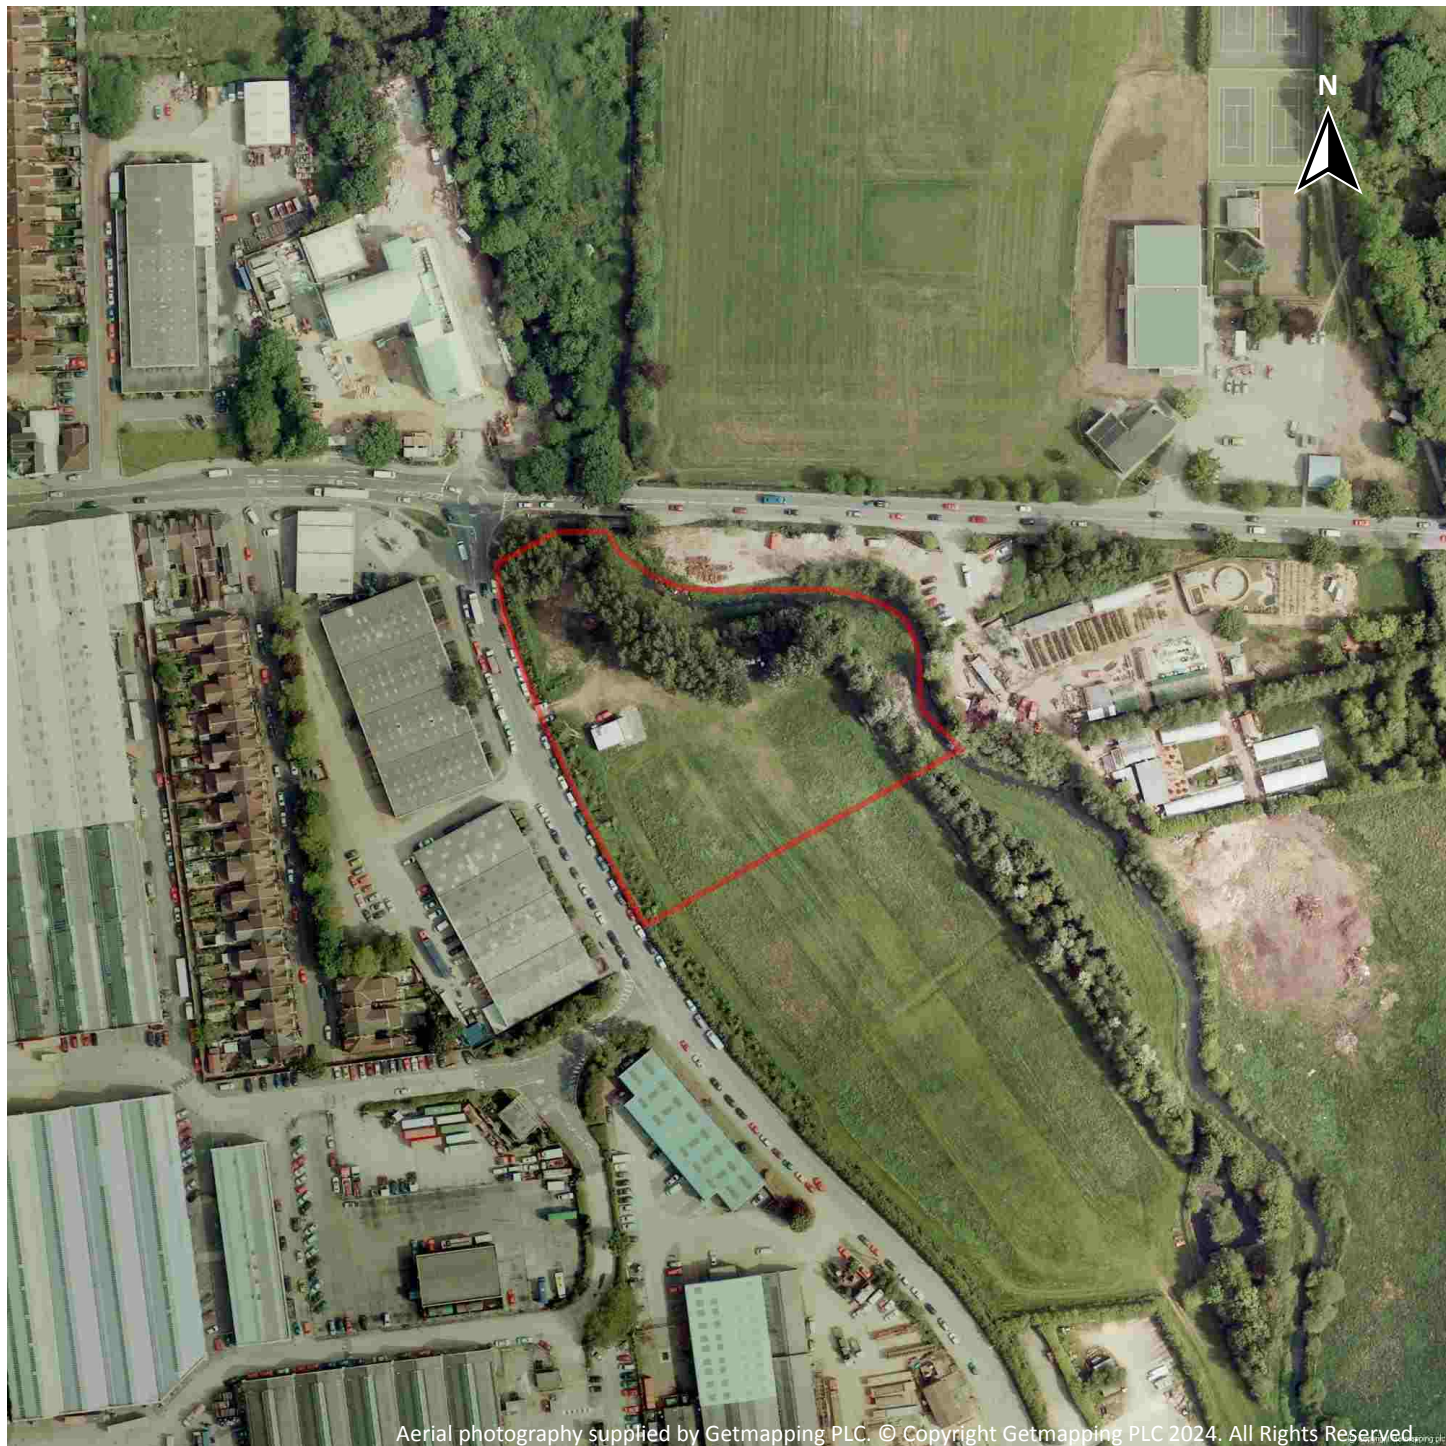
## Recent site history - 2005 aerial photograph

Capture Date: 27/05/2005

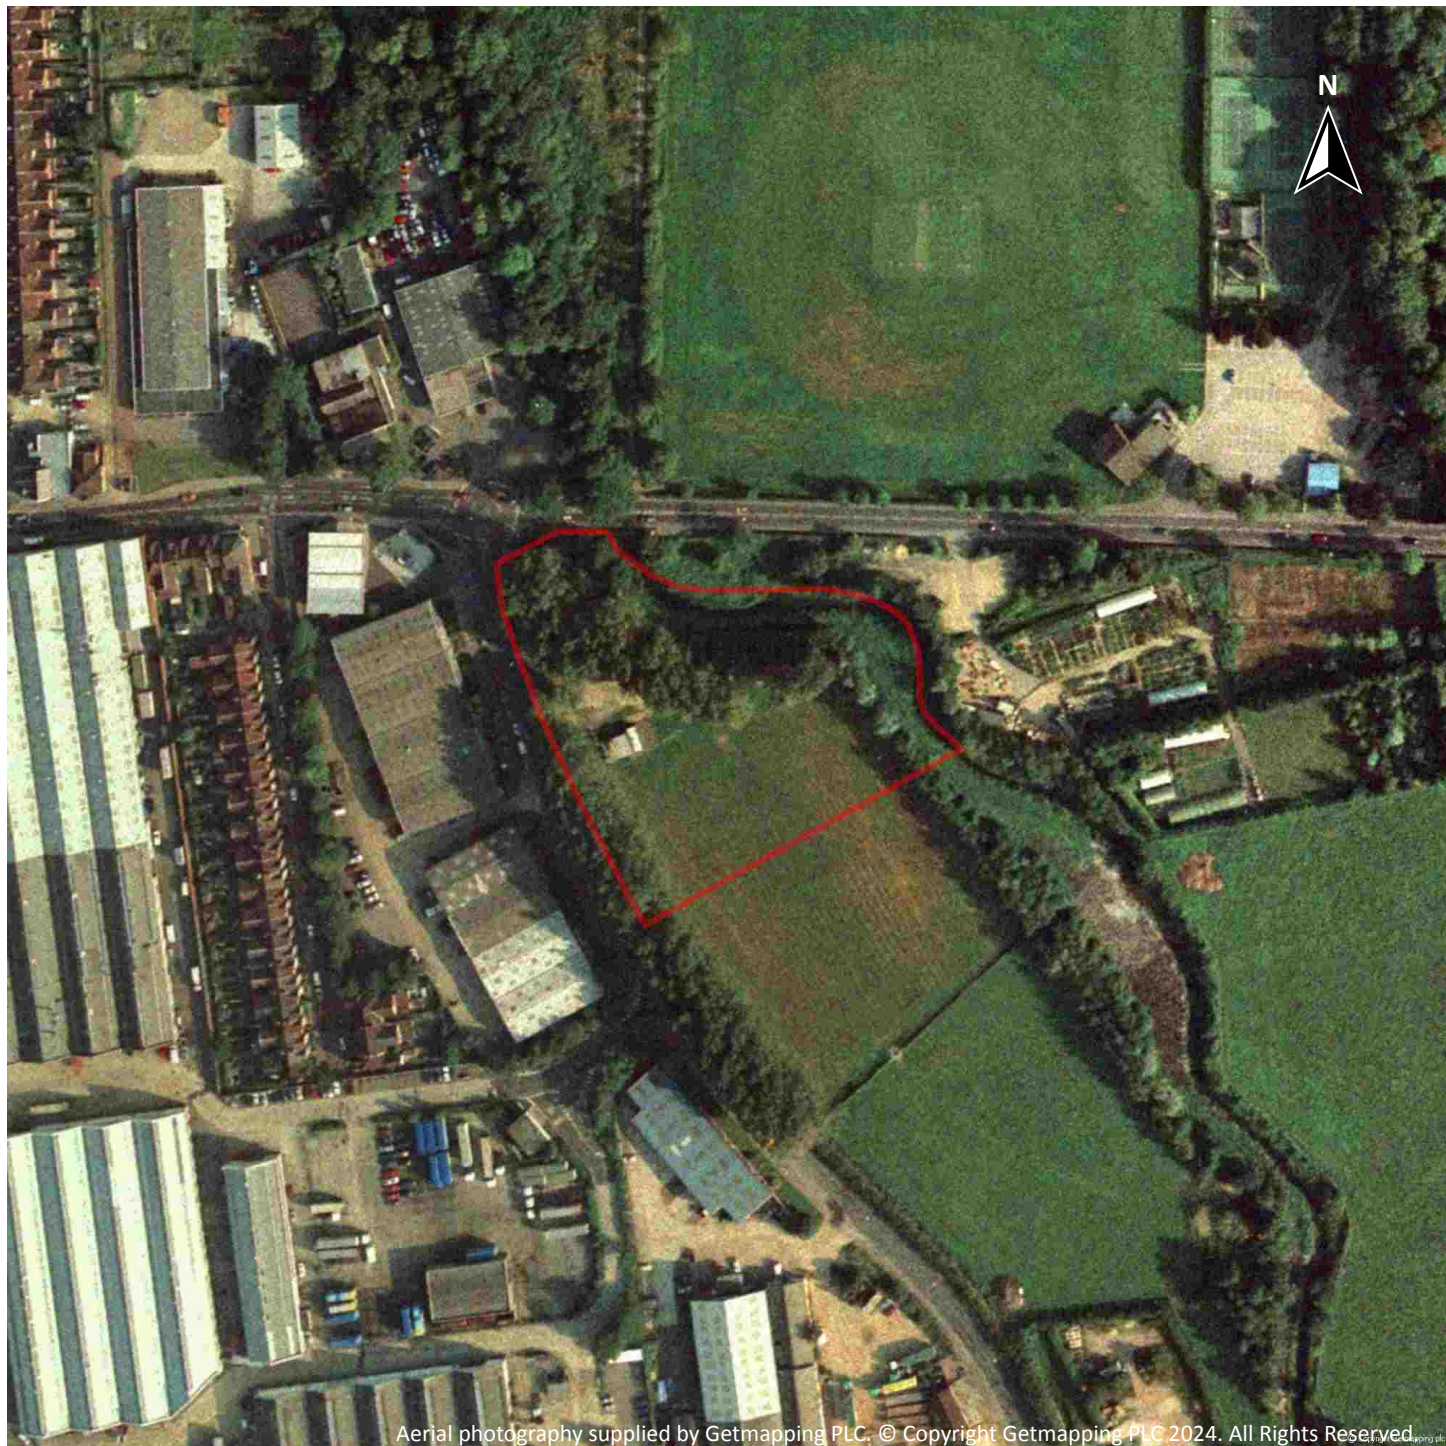
## Recent site history - 1999 aerial photograph

Capture Date: 30/04/1999

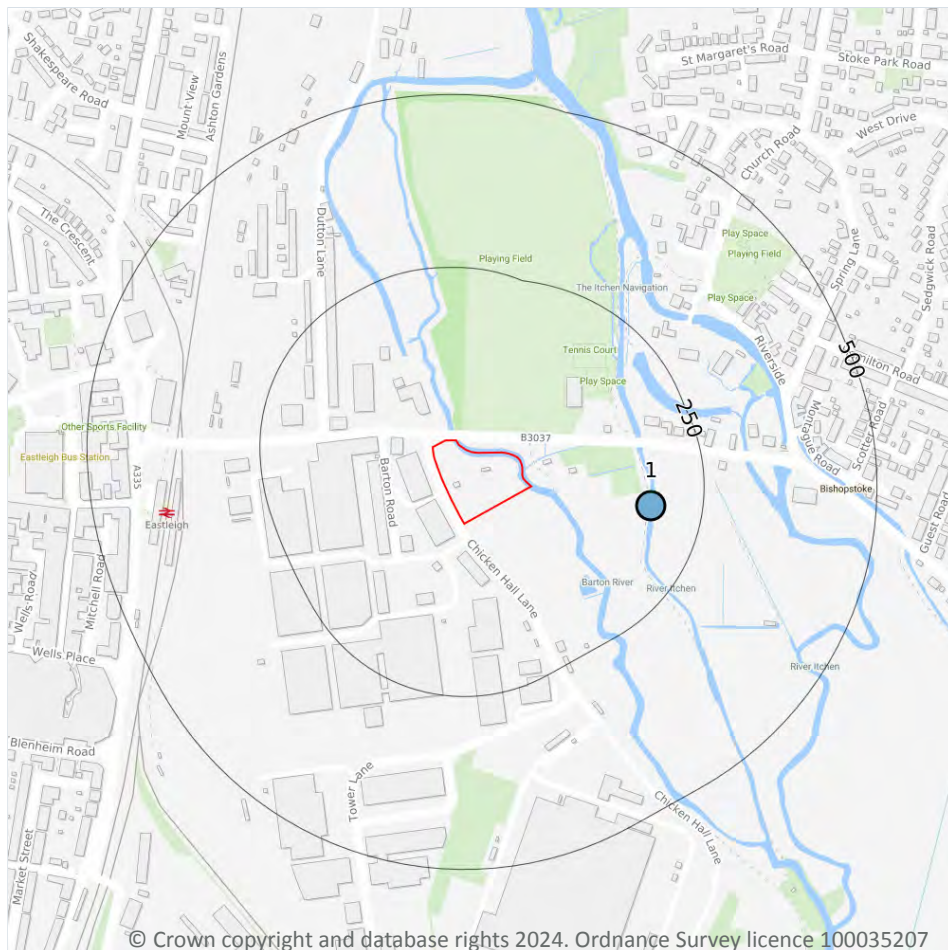
## Abstractions and Source Protection Zones

- Site Outline
- Search buffers in metres (m)
- Source Protection Zone 1  
Inner catchment
- Source Protection Zone 2  
Outer catchment
- Source Protection Zone 3  
Total catchment
- Source Protection Zone 4  
Zone of Special Interest
- Source Protection Zone 1c  
Inner catchment - confined aquifer
- Source Protection Zone 2c  
Outer catchment - confined aquifer
- Source Protection Zone 3c  
Total catchment - confined aquifer
- Drinking water abstraction licences  
Polygon features
- Drinking water abstraction licences  
Linear features
- Groundwater abstraction licence (point)
- Groundwater abstraction licence (area)
- Groundwater abstraction licence (linear)
- Surface Water Abstractions (point)
- Surface Water Abstractions (area)
- Surface Water Abstractions (linear)

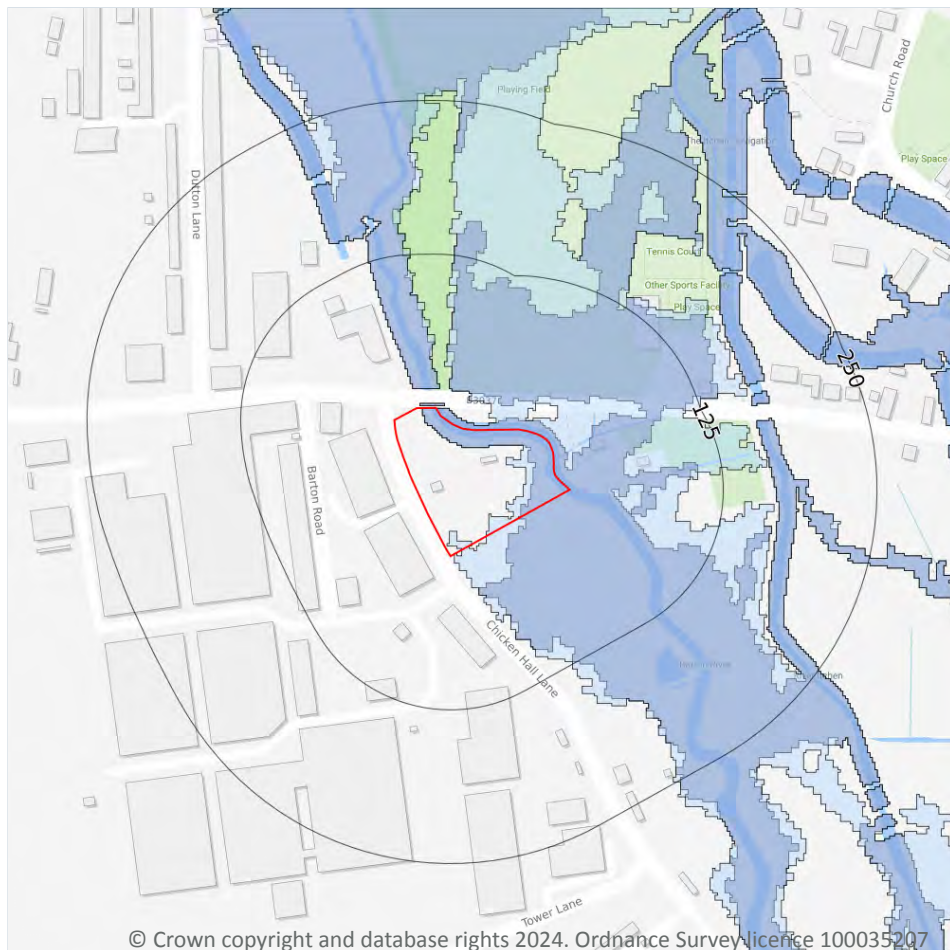
## River and coastal flooding - Flood Zones

- Site Outline
- Search buffers in metres (m)
- Flood zone 2
- Flood zone 3

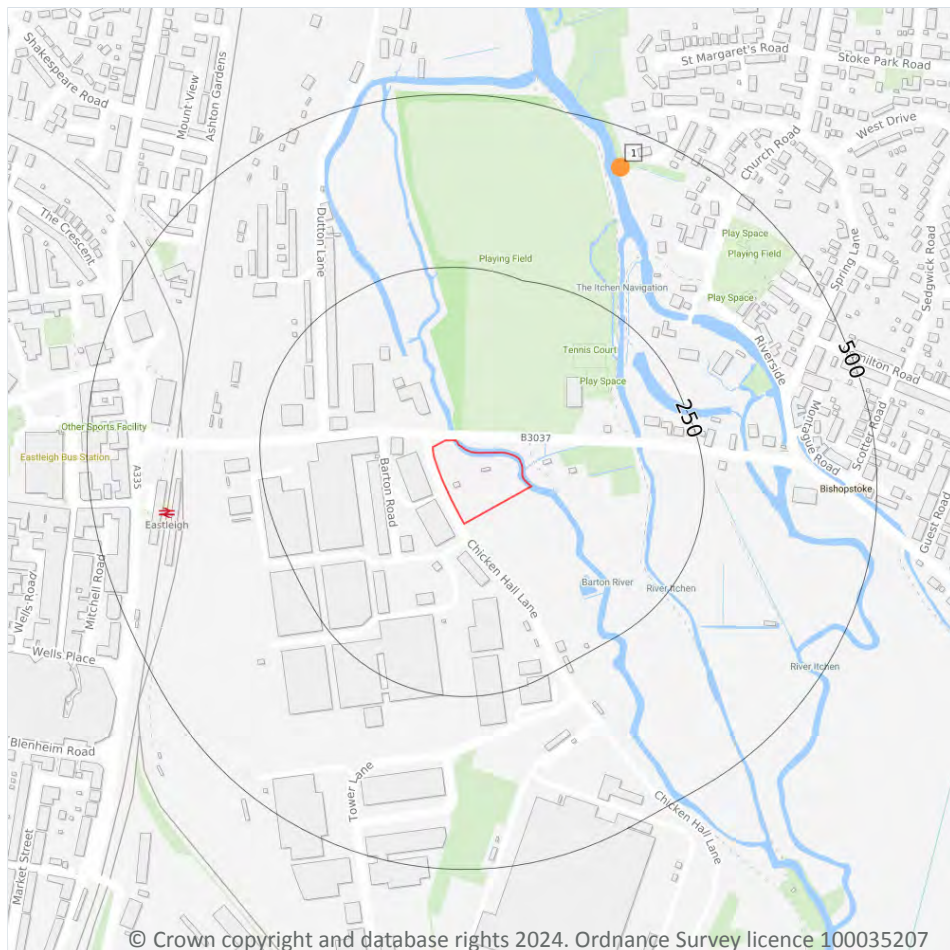
## 19 Ground cavities and sinkholes

- Site Outline
- Search buffers in metres (m)
- Natural cavities (Area)
- Natural cavities (Point)
- Mining cavities
- Reported recent incidents
- Historical incidents
- BGS karst database (Point)
- BGS karst database (Line)
- BGS karst database (Area)
