2 Western Road, West End, SO30 3EL  
**Preliminary Roost Assessment**

EC2174

Linkert Homes

July 2024

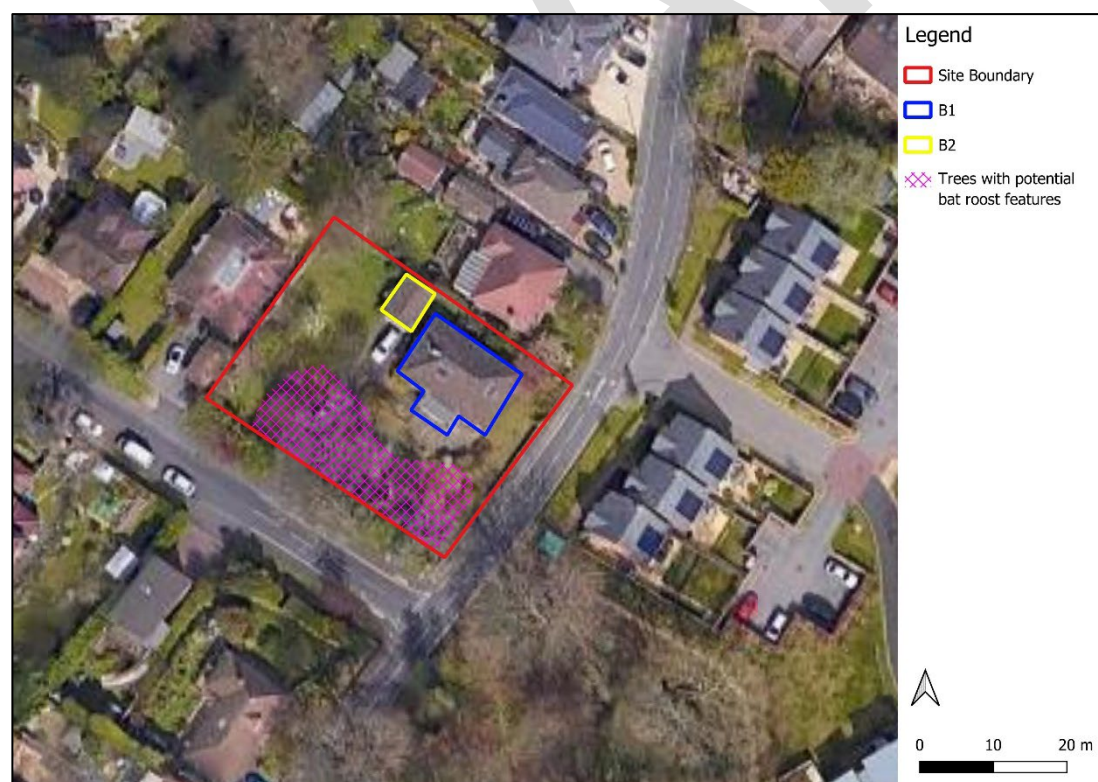
Figure 2. Location of application site - near view showing location of B1, B2 and trees with bat potential. QGIS 2024.

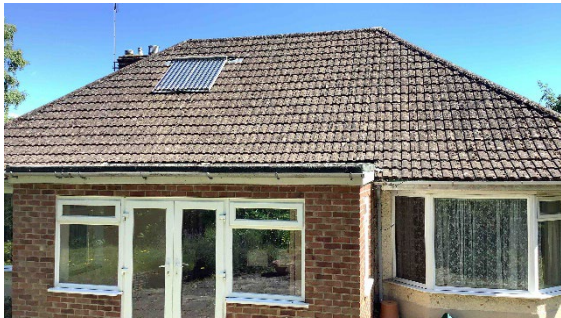
B1 was a residential detached bungalow constructed from a combination of rendered and unrendered brick, with painted wooden soffit and fascia, plastic fascia, plastic guttering, and metal window and door frames (App. B Photo 1-3). The roof of B1 is pitched and covered with clay roof tiles, solar panels and has a brick chimney with lead flashing. A small flat asphalt section of the roof was noted on the south aspect of B1.

**Photograph 1.** B1 south aspect

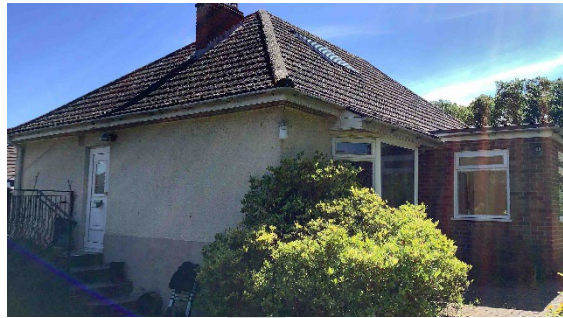
**Photograph 2.** B1 west aspect

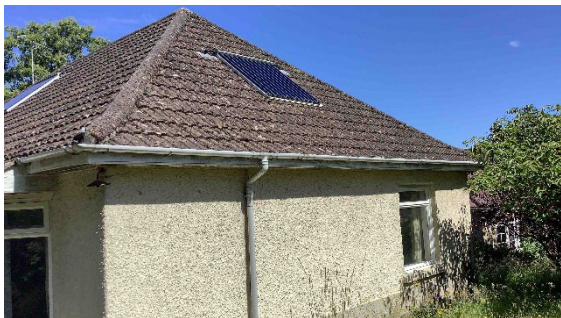
**Photograph 3.** B1 east aspect

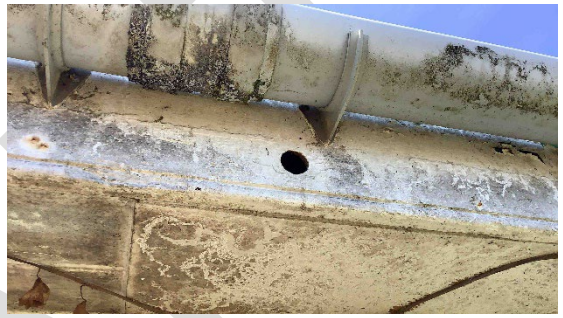
Potential roosting features (PRF) for bats were present on B1 as gaps under roof tiles and gaps and holes in the external soffit and fascia (App. B Photo 4-7). Two bat droppings were identified below a PRF of a hole in the soffit on the southern aspect of B1 (App. B Photo 8). The gaps under roof tiles have potential to allow bat access into the internal roof void. Access to the internal space to confirm the presence of an internal roof void was not possible, a precautionary view is that a roof void is likely to be present and has potential to support a number of bats.

**Photograph 4.** B1 - hole in fascia north aspect

If the proposed works will result in any disturbance to the structures on site, then further survey is required. Further survey of B1 and B2 would be required to determine the presence or likely absence of bats due to the high and low potential for adverse impacts on bats as a result of any works. Further survey would consist of three (for B1) and one (for B2) dusk emergence surveys which must be conducted May through September, with only one visit in September.

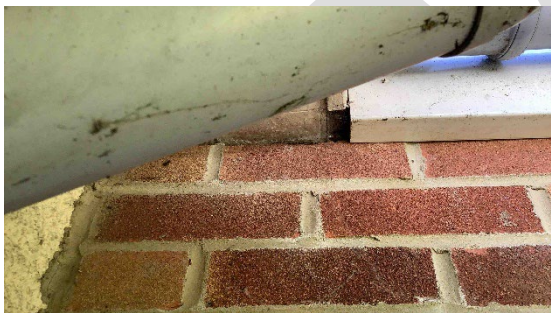
**Photograph 5.** B1 - fascia gap west aspect

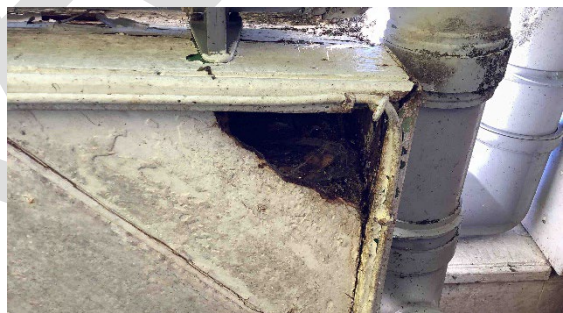
**Photograph 6.** B1 – soffit hole south aspect

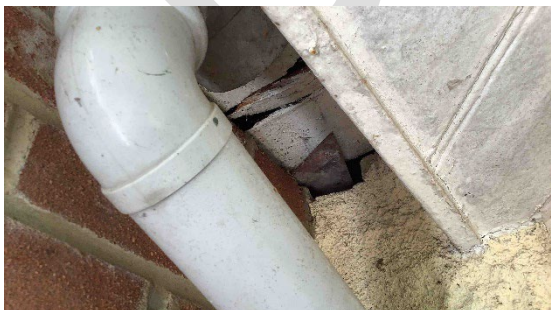
It is concluded that B1 has high potential to support roosting bats as bat roosting features are present, evidence of bat habitation was identified, there is good surrounding foraging habitat, and any internal roof space has the precautionary potential to support a number of bats.

**Photograph 7.** B1 – south aspect soffit hole  
(bat droppings below)

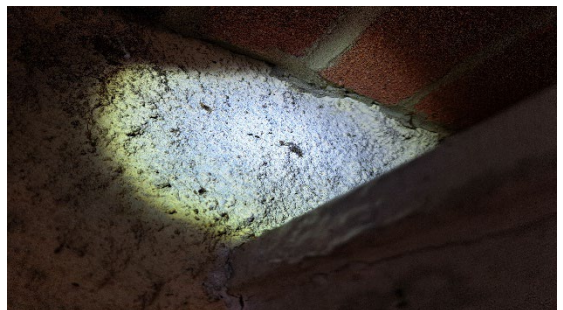
The buildings surveyed was concluded to have high (B1) and low (B2) potential to support roosting bats, with bat droppings identified beneath a PRF in the soffit of the southern aspect of B1.

**Photograph 8.** B1 – Bat droppings below soffit  
hole in photo 7.

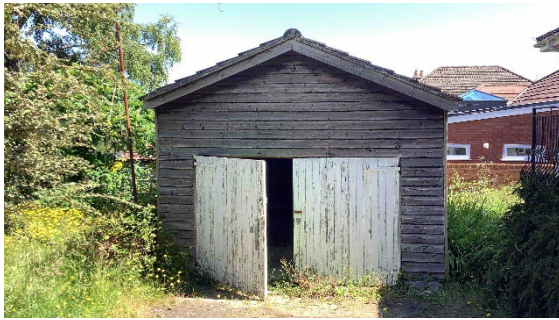
B2 was a garage associated with the main building, constructed from wooden panels, with plastic window frames on the east aspect, a wooden soffit and pitched roof covered with clay tiles (App. B Photo 9-11). The internal space of B2 is one open room with exposed wooden framing (App. B Photo 12).

**Photograph 9.** B2 south aspect

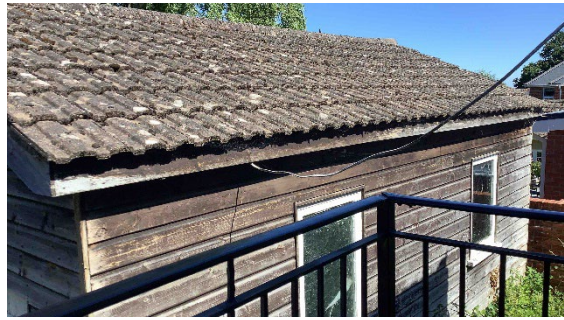
**Photograph 10.** B2 east aspect

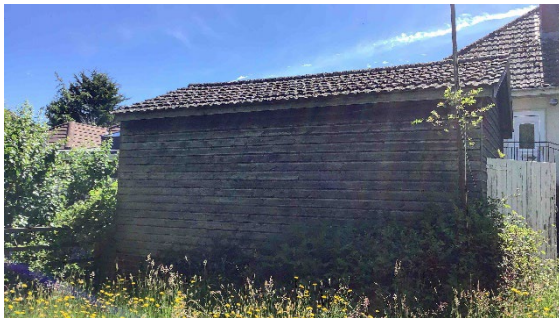
**Photograph 11.** B2 west aspect

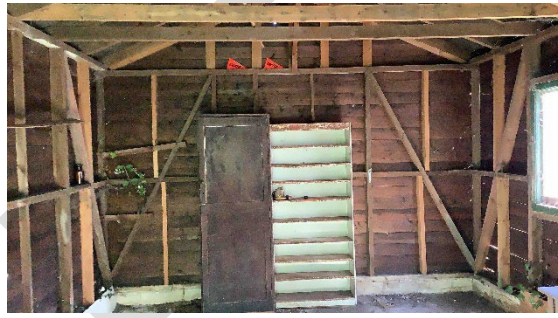
PRF's were only present underneath gaps in the roof tiles and between the roof lining and roof tiles, as the internal space of B2 was well lit from the windows on the eastern aspect. Interior holes in the roof lining were identified to allow access from roof into interior (App. B Photo 13). The northern aspect of B2 could not be inspected as it adjoined to the fence line of a neighbouring property.

**Photograph 12.** B2 internal space

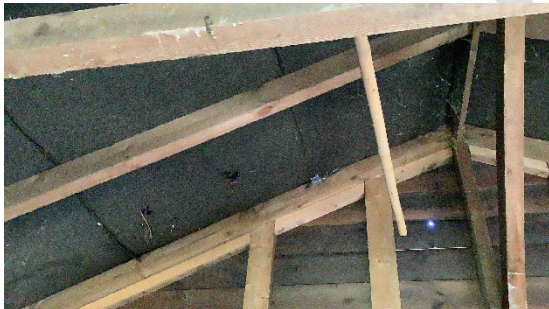
No evidence of bat habitation was found in the external or internal features. It is concluded that B2 has low potential to support roosting bats with a limited number of small spaces PRF's identified that could only support a small number of bats.

**Photograph 13.** Holes in roof lining of B2

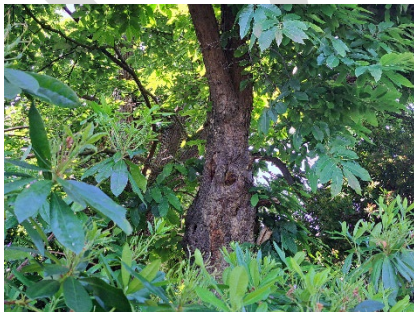
PRF's were identified within the trees onsite within the vegetated gardens of B1. PRF's of knotholes were identified within the semi-mature sweet chestnuts (*Castanea sativa*) onsite on the southern boundary (App. B Photo 14-16).

**Photograph 15.** Potential roost feature  
knothole in tree onsite.

The trees present onsite on the southern border have potential to support roosting bats through features such as knotholes and may provide bat commuting routes to the adjacent Telegraph Wood. The trees onsite should be retained and protected where possible. If the trees are to be impacted by the development, including any management works to facilitate the development, such as crown lifting for access, then individual tree assessments for potential roost features would be required with the potential for further survey needed.
