Sheet 1 —  
1 to 200 @ A0

**BALANCING POND 2**

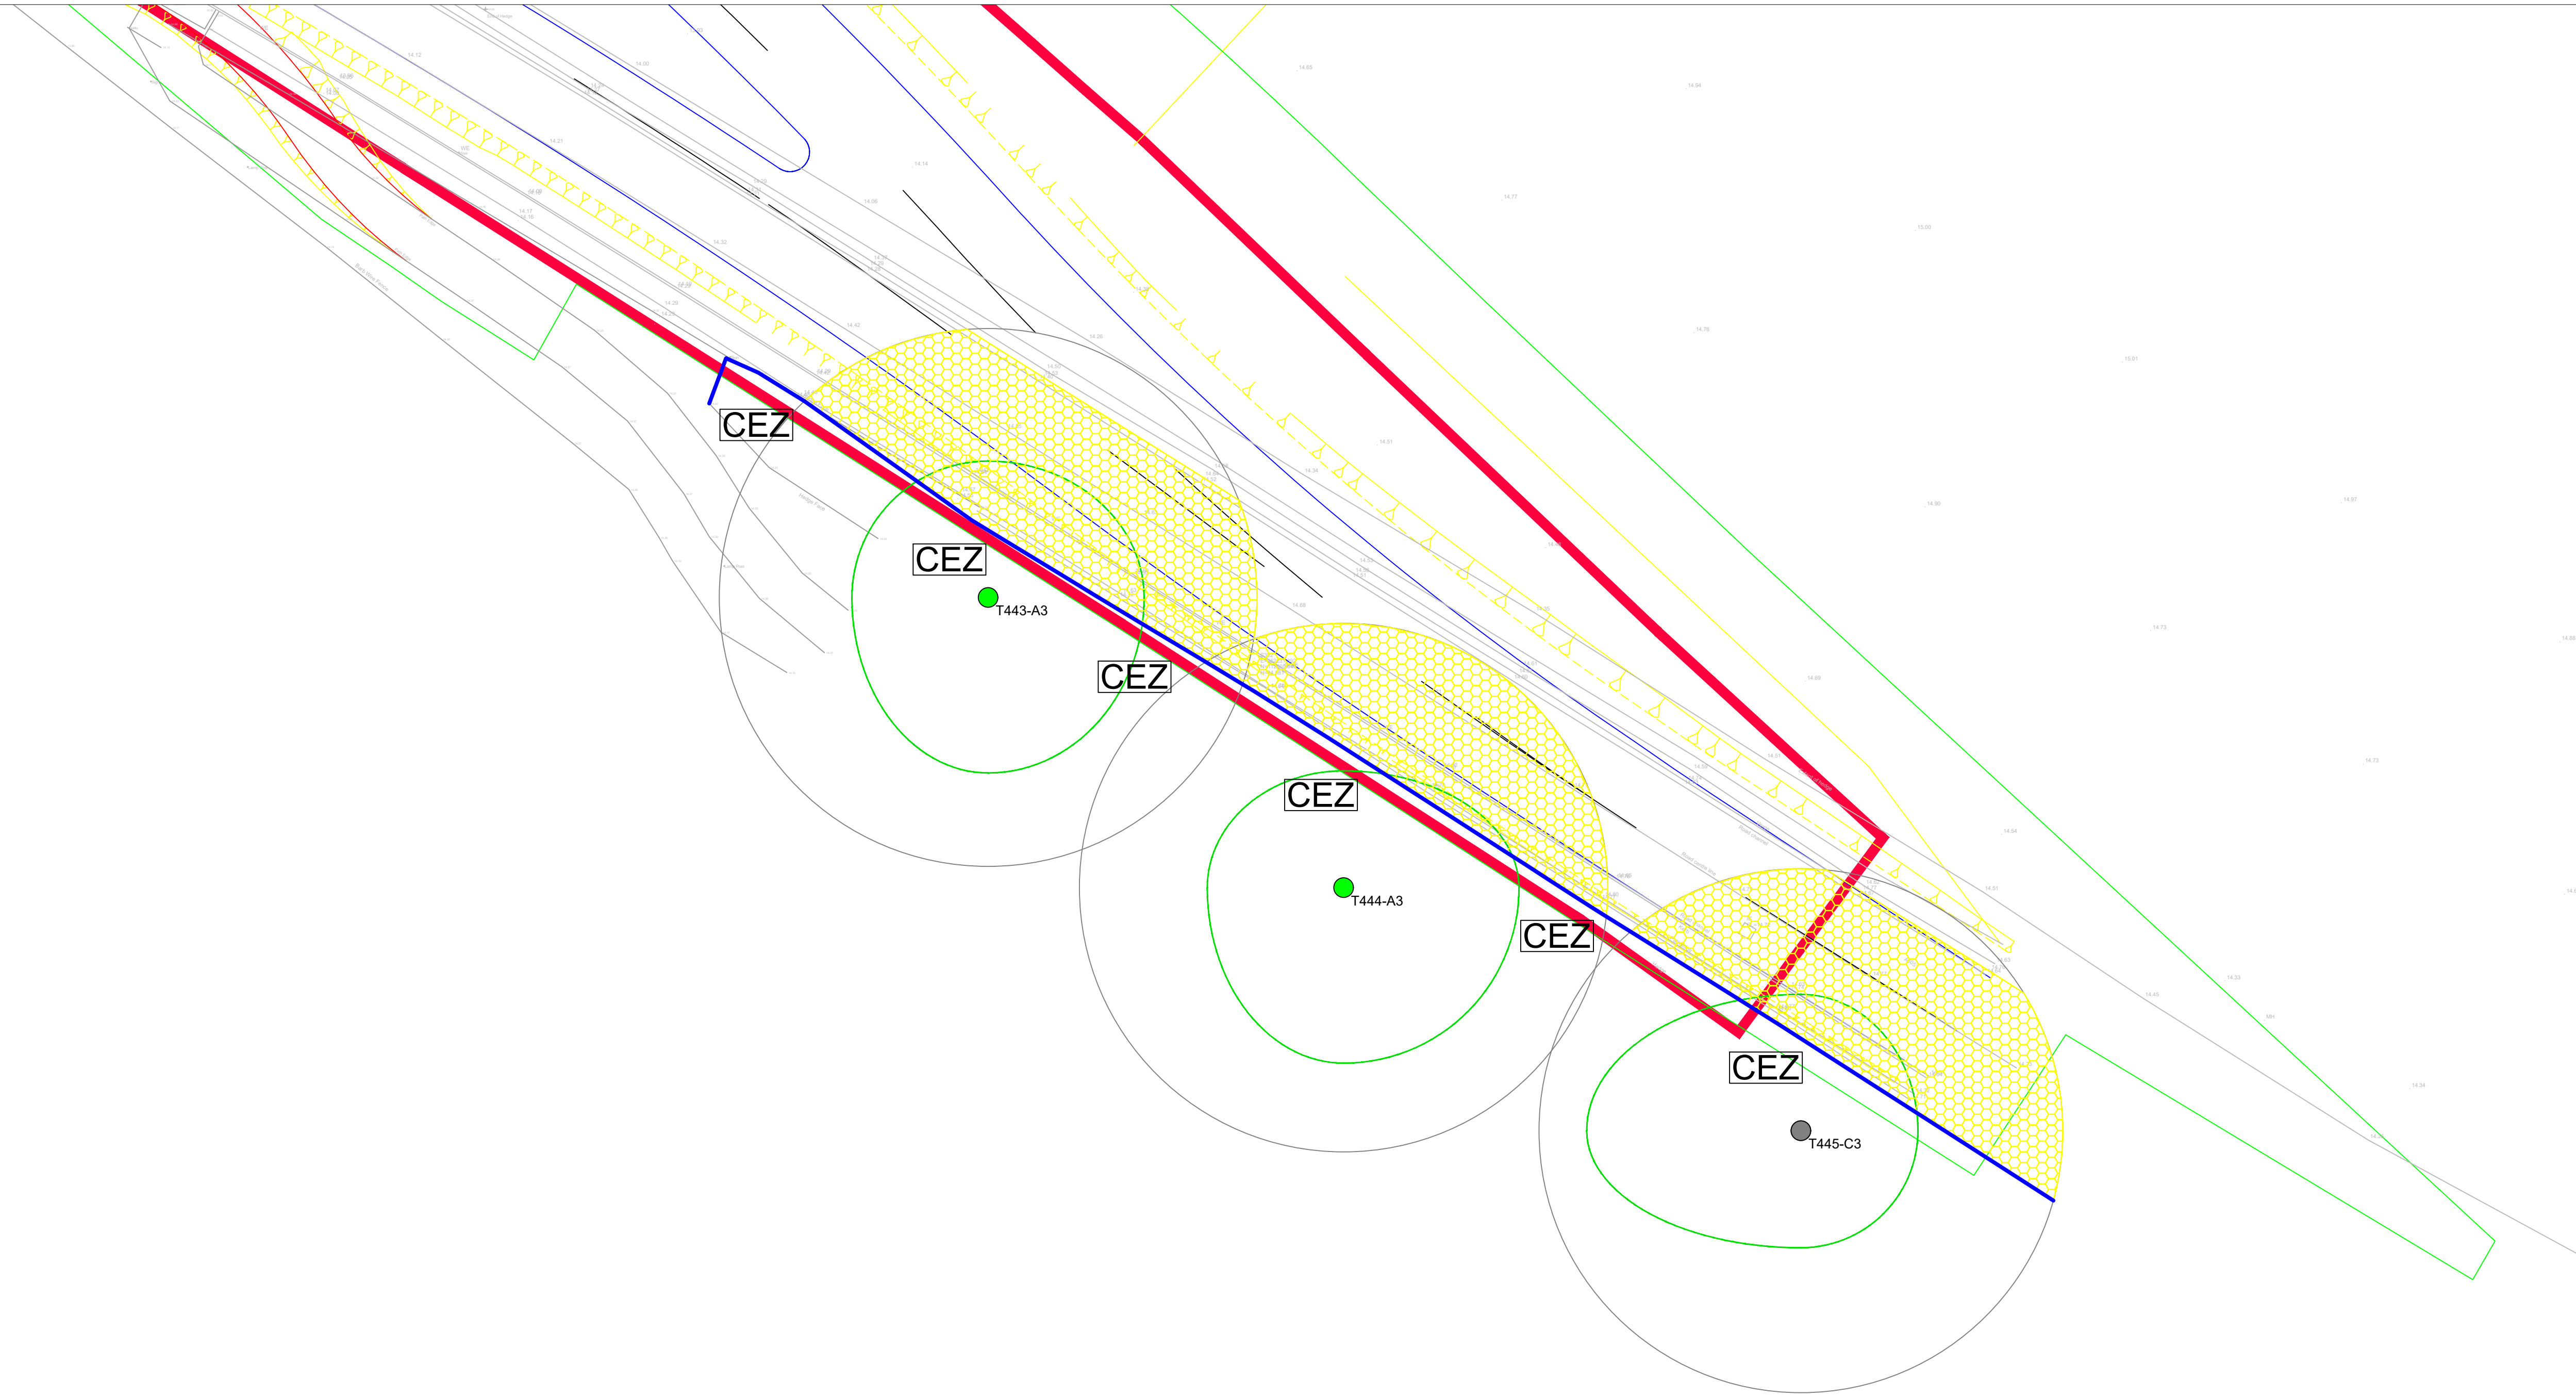
Thicket comprised the understorey to the individually surveyed trees and was made up predominantly of Elm and Willow with occasional Hawthorn and Privet.  
The Elm present would inevitably be lost to Dutch Elm Disease and was evidenced by already fallen stems, the Willow would eventually collapse to the ground, thereby none of this thicket was of particular individual merit although collectively it did contribute to the verdant highway screen.
