# Technical Note

**Site:** Boorley Green Phase B5

**Ref:** GE18071

**Client:** Linden Homes

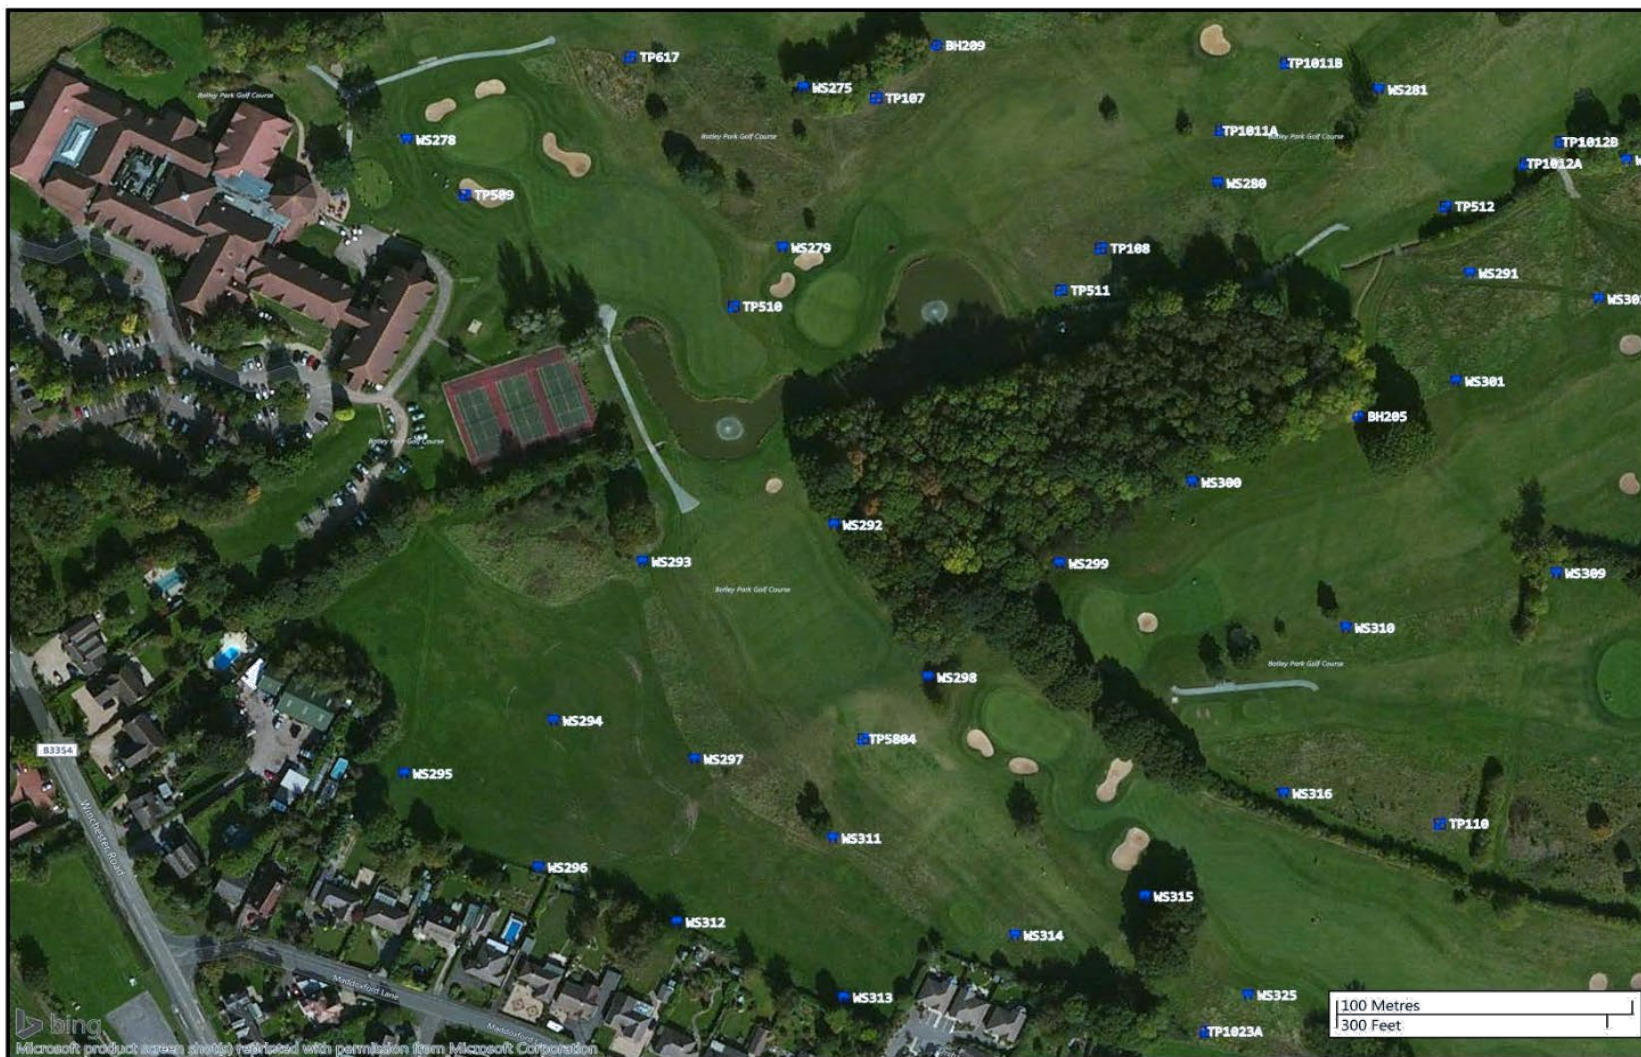
A review of pre-existing ground investigation records was undertaken to clarify the encountered ground conditions during the site's former use as a golf course. The relevant exploratory hole logs for positions within the B5 development parcel (WS292-294, WS297-WS298 and TP5084) and two deeper boreholes (BH205 and BH209) near to parcel B5 are enclosed together with a plan as Figure 1 showing the location of these exploratory holes.

The ground conditions encountered within or in close proximity to parcel B5 comprised Topsoil 0.3-0.7m thick overlying firm to stiff becoming stiff, or stiff silty clay. The clay strata would have been considered suitable, in general, for conventional foundations with foundation depth likely to be governed by tree influence. Based on the results of laboratory testing, a high volume change potential would be applicable for foundation design, thereby requiring a minimum founding depth of 1.0m bgl (Linden standard minimum foundation construction depth is typically 1.2m so deeper than the minimum for volume change potential). Heave protection and deepening to account for tree influence would be applicable.

| <b>Project:</b> | Boorley Green - Parcel B5 | | | <b>Title</b> | Previous Ground Investigation Plan | |

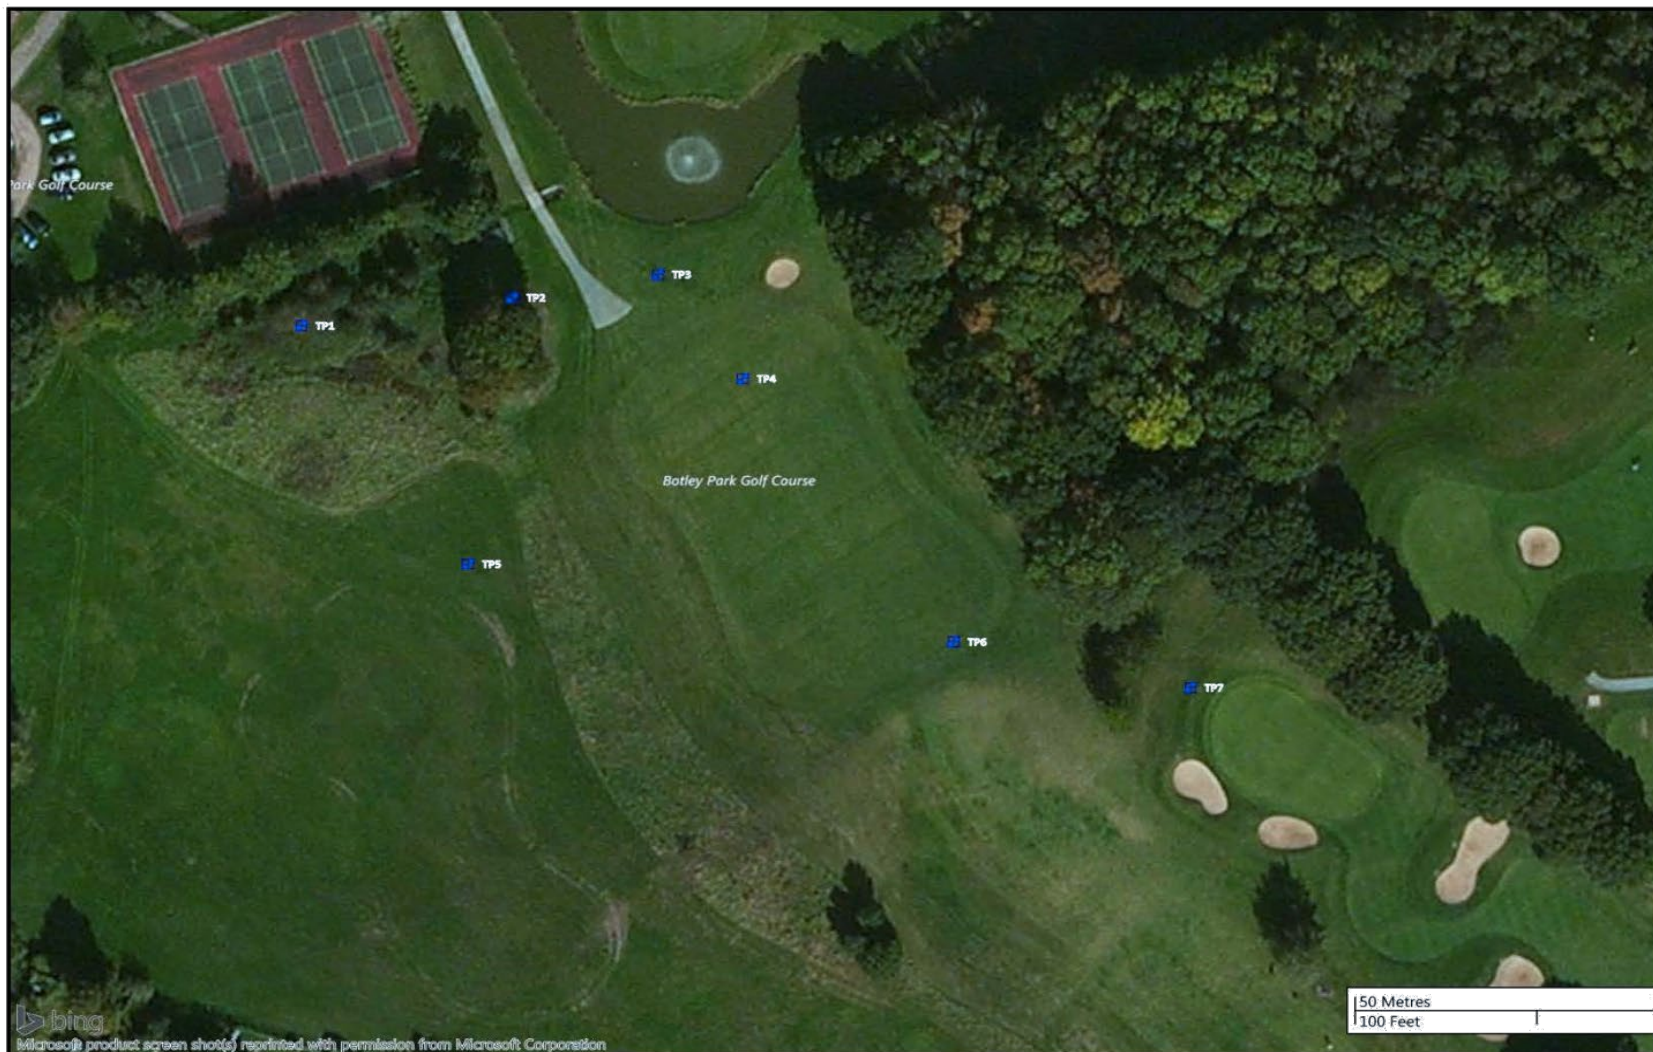
ground levels provided by the Client's on-site Contractor. Trial pit positions are presented on Figure 2 (overlain on pre-development aerial photography) and Figure 2 (overlain on development layout plan).

| <b>Project:</b> | Boorley Green - Parcel B5 | | | <b>Title</b> | Trial Pit locations on predevelopment aerial photograph | | |

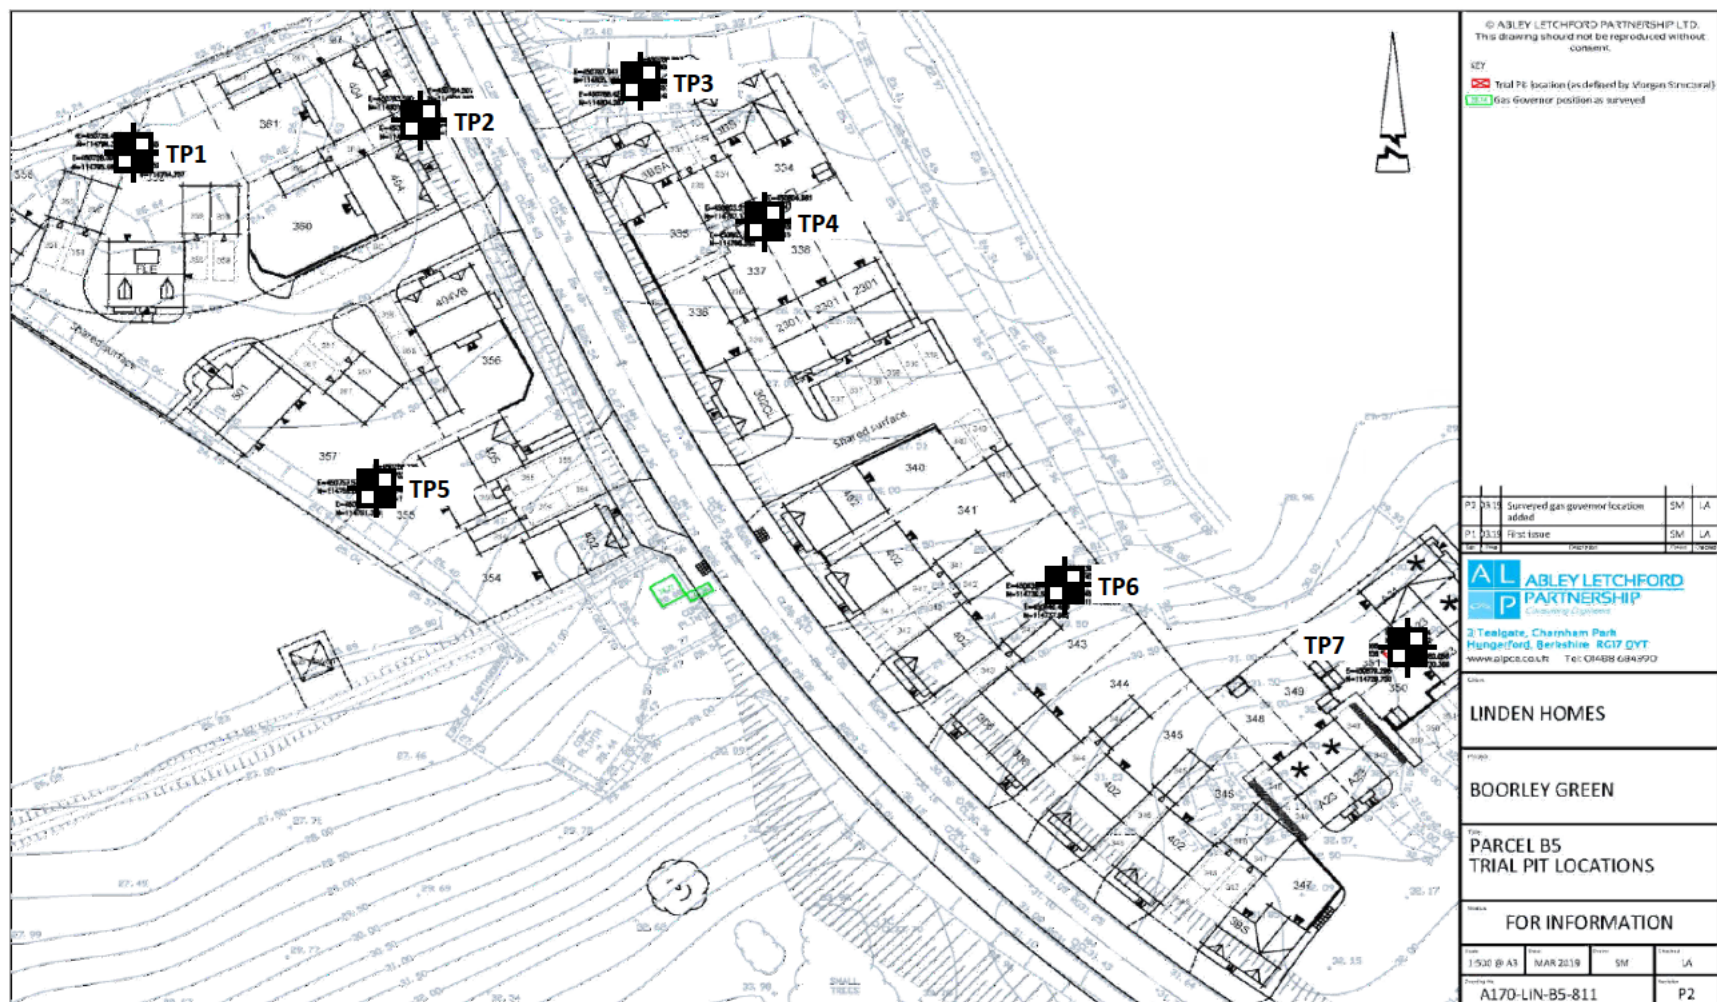
| <b>Project:</b> | Boorley Green - Parcel B5 | | | <b>Title</b> | Trial Pit locations on proposed layout | | |

In addition to the water ingress via land drain in TP6, groundwater ingress was also observed in TP7 at 2.0m bgl as a seepage and running sand. Groundwater was also encountered during drilling of WS293 during the previous investigation, with groundwater ingress at 2.0m bgl. WS293 was located approximately mid-point between the locations of TP1, TP2 and TP5 (approximately Plot 356 based on the development layout plan provided).

In the portion of the site where trial pits TP6 and TP7 were located (approximately Plots 340-352), it is considered that conventional foundations would be suitable and could be constructed to terminate in undisturbed, natural stiff clay soils at depths of c. 1.5m bgl.

In the portion of the site downslope of the stockpiles, i.e. Plots 334-339 and 354-361, covered by trial pits TP1 and TP3-TP5, it is considered that the depth of Made Ground encountered, presence of lower strength clay soils and tree influence at TP1 (and likely for TP2) would require conventional foundations to extend to depths in excess of 2.5m bgl. Whilst technical approval for deep strip foundations could be dependent on which Building Control organisation is engaged for this site, it is considered that there could be constructability issues such as overdig and side collapse in the clay Made Ground, coupled with possible increased foundation width, generation of excessive spoil volumes and a substantial increase in concrete costs due to increase in volume of concrete required.

In conclusion, it is considered that conventional foundations may be suitable for the portion of the site around and upslope of the stockpiles (approximately Plots 340-352), subject to clarification for Plots 340-342 following stockpile removal. A piled foundation solution is recommended for the remainder of the site, i.e. Plots 334-339 and 354-361).
