## **Netley Chapel Tower – Structural Repairs and Conservation Design and Heritage Statement**

**Royal Victoria Country Park  
February 2025**

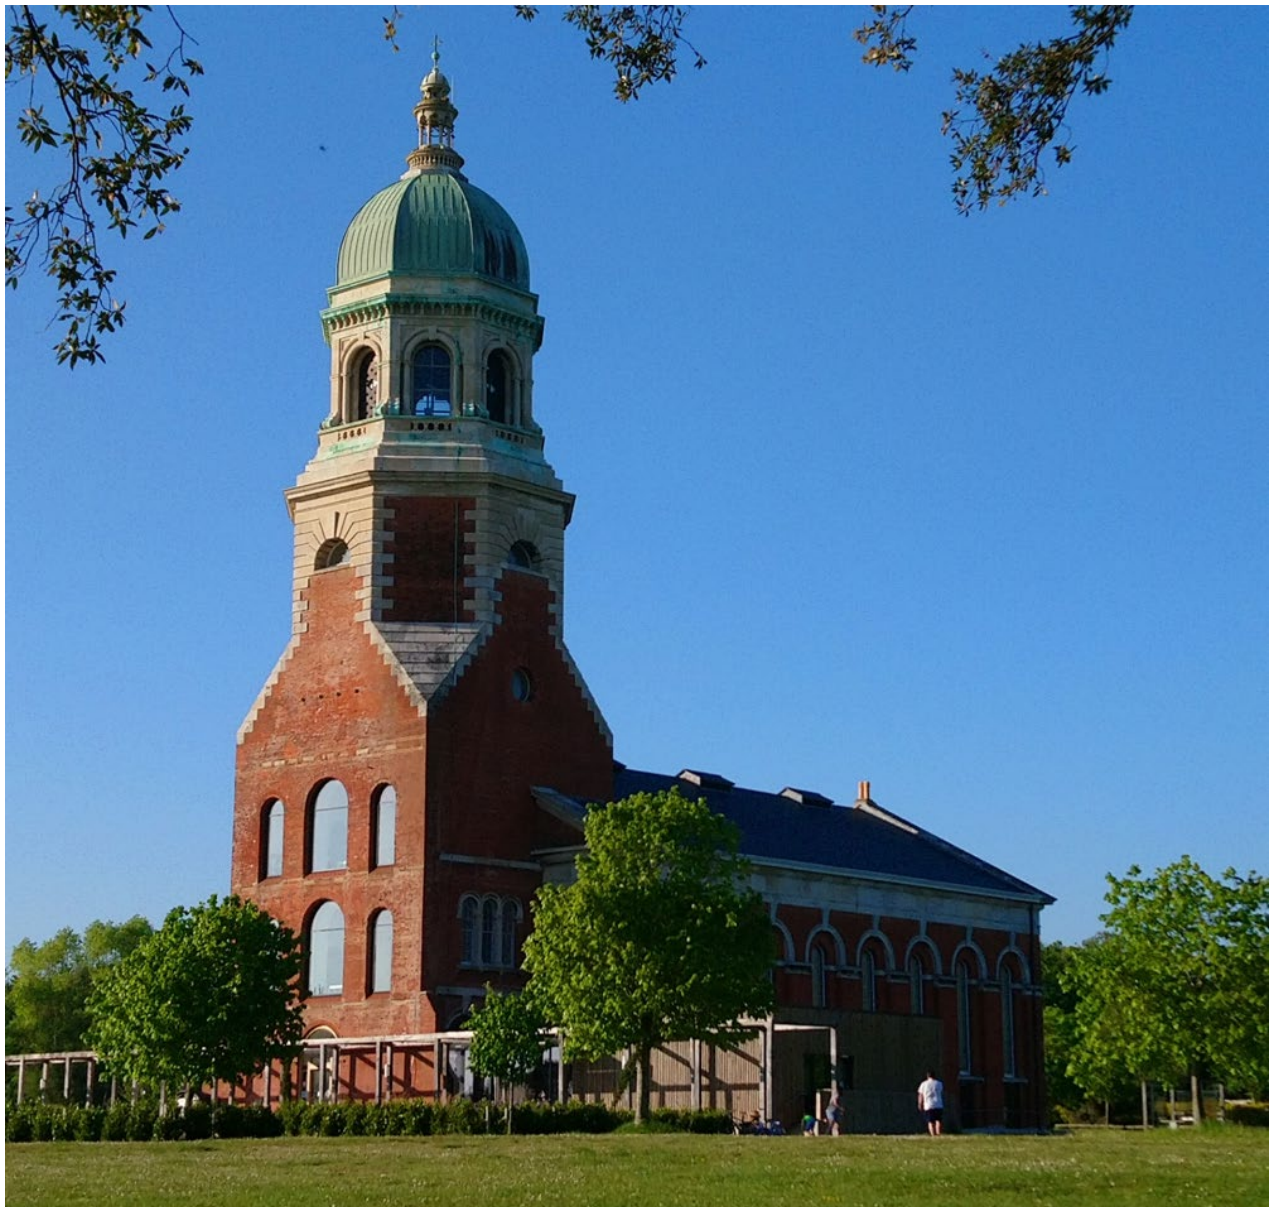
**Figure 2 - The Chapel tower and the recently added café and pergola.**

The tower is massive, the square base rising above roof height; the ornamental upper treatment starts with broaches, above which the tower becomes octagonal. Above a cornice, the Portland stone structure has stepped back walling, which then supports a pavilion of open arches, within an architectural framework of keystone, architraves, pilasters and entablature on brackets, surmounted by a copper clad dome, Portland stone lantern, and cupola.

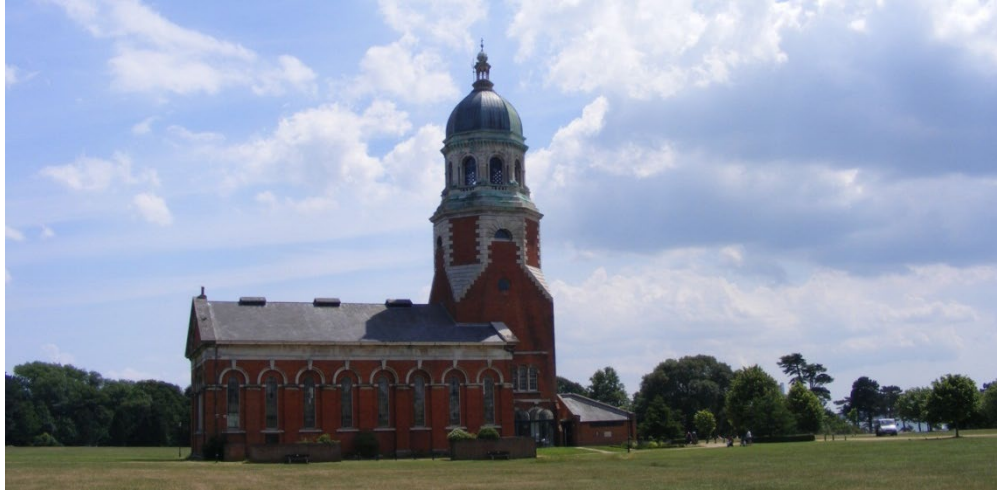
Figure 4 - The North West Elevation of the Chapel showing the former toilet block.

In the 1980's the Chapel was converted into a Heritage Centre, for which a number of alterations and additions were made, including a new brick building on the front elevation to provide toilet facilities. As part of these works an exhibition was installed around the perimeter of the main chapel hall. In 2007 a significant amount of structural and repair work was undertaken to the tower by Hampshire County Council. Then in 2018 replacement of the toilets to the side to increase the prominence of the tower.

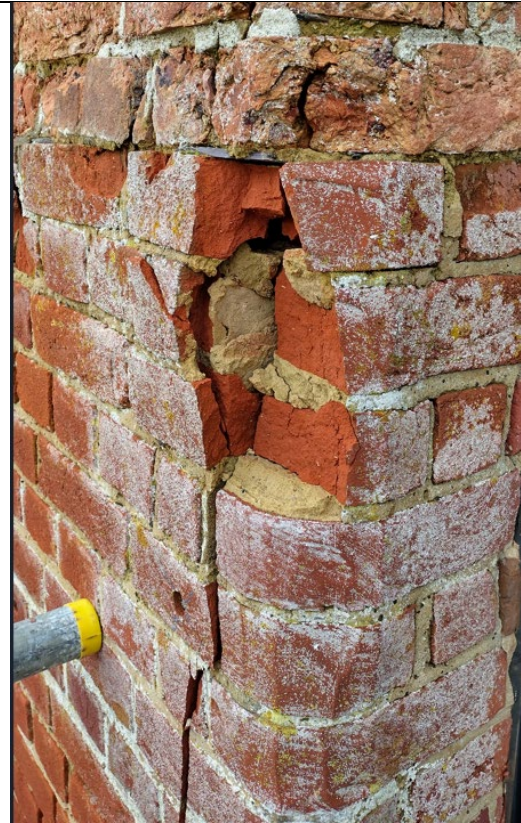
Fig 17, Significant crack at window reveal

More recently, in 2022 a piece of brick fell from the first-floor window reveal onto the footpath leading to the main entrance. When comparing images from 2020, this was a new crack, and other known cracks were showing signs of further deterioration. In some instances, cracks on the external façade, aligned with cracks and plaster damage internally. In general, the cracks are on the south-west and south-east elevations.

*Cracked bricks, and those that have begun to crumble shall be removed and replaced with suitable reclaimed or new bricks. Care must be taken not to use bricks that are too strong, as this will adversely affect the wall. Where the brickwork has become weaker and cracked by the moisture ingress it is proposed to enhance the brickwork stress and damaged brickwork integrity by installation of a proprietary stainless steel 'Cintec' anchor system. Whilst this would be an intrusive process and could uncover and disturb further flaws within the wall, the system is proven to offer a concealed mass brickwork enhancement.*

- Bore holes through external walls to establish the core construction.
- Masonry reinforcement using Cintec anchors. To achieve an invisible repair, this would require removal of individual face bricks and in some case, removal of a section of plaster. The masonry is then cored drilled, and a steel bar enclosed in a mesh fabric sleeve is inserted into the hole which is injected with grout under low pressure. The outer face brick is then replaced.

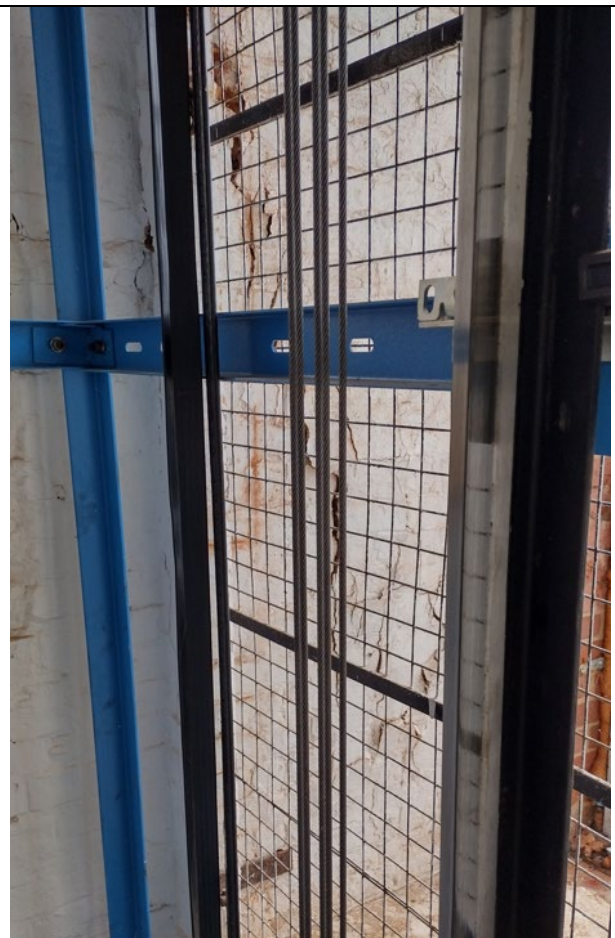
Fig 19, Lift shaft significant cracks within window reveal.

*For this reason, it is also worth remembering that the distressed brickwork facing south-west, was not intended to be exposed to the weather. It was originally the internal wall along the corridor, the arch windows would have been for the lift shaft and a change in direction of the corridor.*

*With the Cintec installation it is envisaged that only the outer depth of brick, where damaged, would be replaced. The internal cracks would be lime grouted under light pressure to fill to some extent and restore an element of integrity and more important to re-provide moisture permeability.*

- Internal masonry crack repairs and strengthening.
- Removal of internal finishes, plaster and decorations, to improve breathability of the masonry structure and to mitigate the ongoing deterioration of these finishes internally caused by trapped moisture. (including finishes to the lift shaft inner walls).

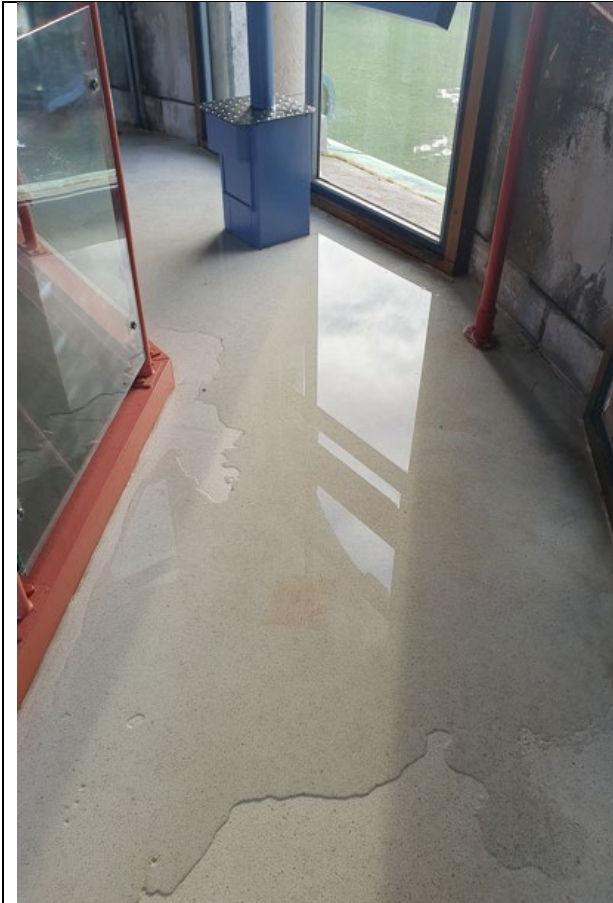
Fig 20 Upper floor windows leaking

The existing belfry windows are of a relatively modern intervention and provide weather protection to the belfry openings. They are thought to have been installed during the 1985 refurbishment. They are in poor condition and leak significantly. The replacement windows will be similar, but more effective. One arch window-pane will become a louvre to promote high-level ventilation of the tower and aid drying out. Alternate windows have an external iron lattice as part of the original belfry, and these will be retained.

5. Replacement of aluminium windows at belfry level, incorporating louvres

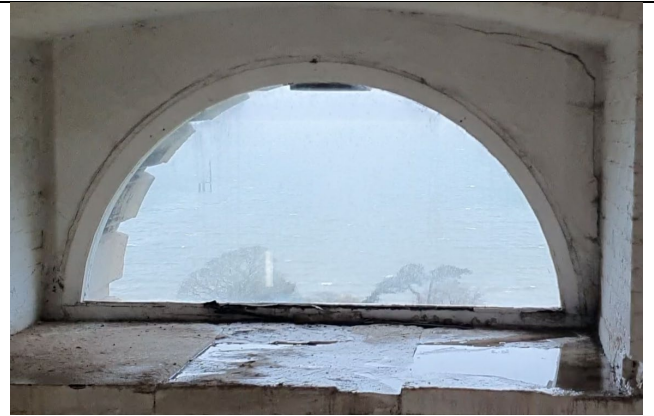
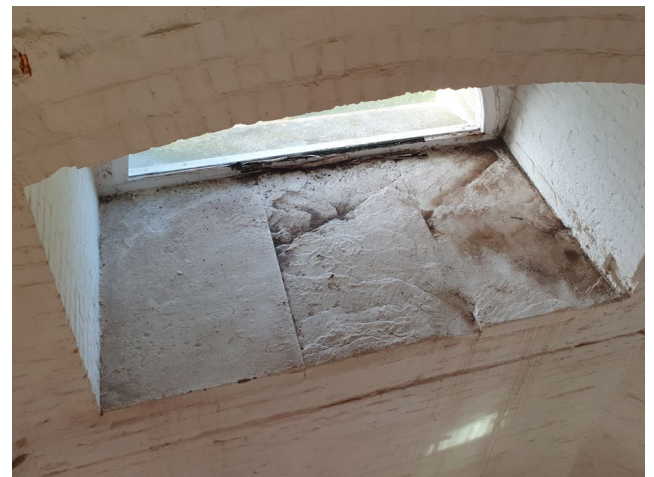
Fig 21 Staircase level windows leaking

The stairwell windows are painted timber again thought to have been installed during the 1985 refurbishment. They are in poor condition and leak significantly, due to being exposed to the elements at high level. Being approximately 18m – 25m above ground level, future maintenance is very difficult. Therefore, aluminium frames are proposed as a product that will provide greatest longevity with minimum maintenance. One arch window-pane will become a louvre to promote ventilation of the tower and aid drying out.

6. Replacement of decayed timber windows incorporating louvres
