## **36 Missenden Acres**

### **Preliminary Roost Assessment**

**36 Missenden Acres**  
**Ecology 8804**  
**Version 01**

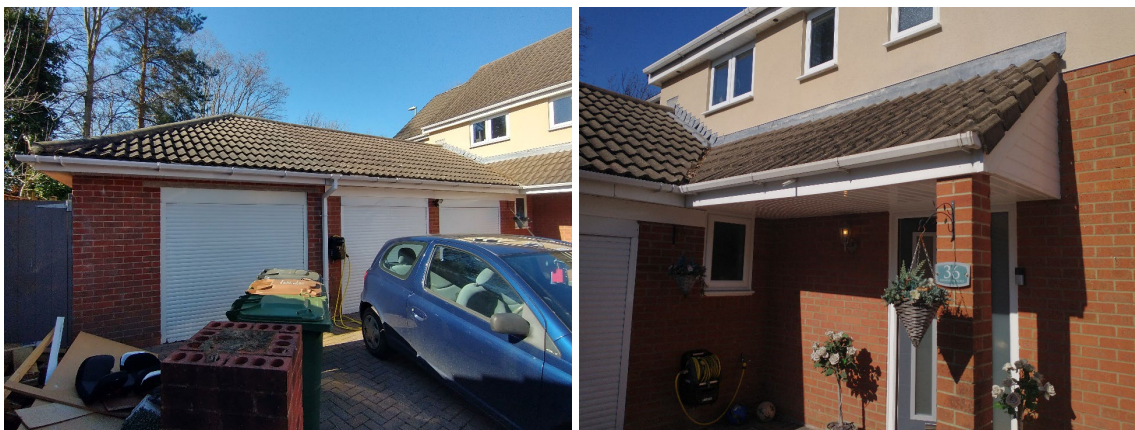
**Figures 1 and 2:** Garage and porch section, respectively.

- 4.5 The garage is a single-storey section of the residential dwelling (**Figure 1**) which has been converted into two rooms. The garage comprises brick elevations, a pitched roof of clay roof and ridge tiles. uPVC garage doors are present on the northern elevation, uPVC soffit boxes and guttering are present around the eaves of the garage. A small porch is present on the eastern elevation of the dwelling (**Figure 2**) and has the same composition as the garage with uPVC soffits and a uPVC cladding section on the northern elevation.

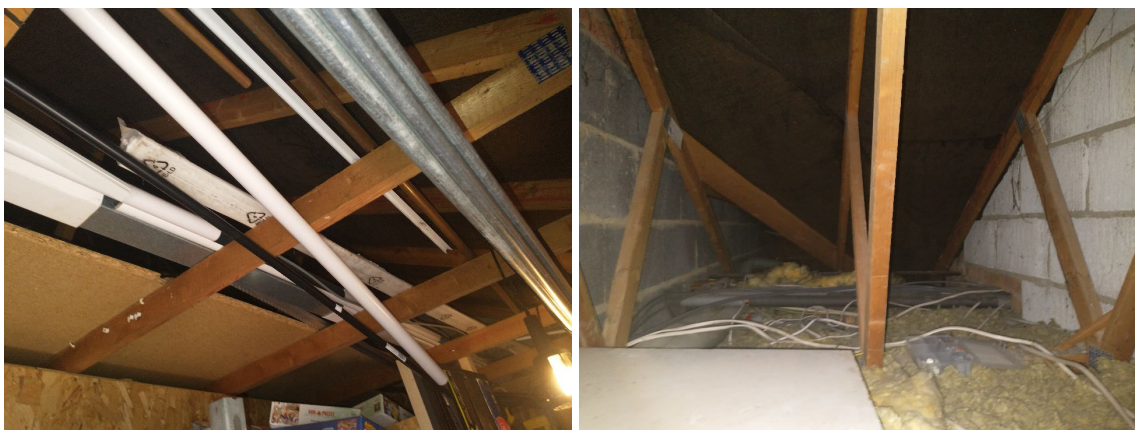
**Figures 3 and 4:** Open section of void over garage and smaller roof void, respectively.

- 4.6 The interior of the garage has been converted into a living space, with two roof voids present. The main roof void is present above the majority of the garage and is open from the northern section of the garage (**Figure 3**). Access was not possible due to the section of the void being used for storage. Internal lighting is present in this section and the garage is regularly used which will likely cause high levels of disturbance to the roof void.
- 4.7 A second, smaller roof void is present above the western section of the garage (**Figure 4**). The void is approximately one metre high, five metres wide and one metre long. A small section of void, less than 0.5 metres high and 0.5 metres wide extends over the porch.

- 4.8 The roof voids are lined with bitumen roofing felt with a typical timber truss design. The floors are partially boarded and have insulation present. The small roof void is well sealed with no visible access points into the void. No evidence of bats was recorded in the voids.

- 4.9 No evidence of bats was recorded during the survey. The garage building is in good condition and relatively newly built, there are no external potential roost features and no access/egress points across the garage section of the building. Whilst access into the void was not possible, the lack of access points present on the exterior of the building indicates that no bats will be able to access the void. Due to the lack of access points and exterior potential roost features, it is considered that the building has no potential for roosting bats and no further action is required.
- 4.10 The development may result in increased lighting, the trees to the south of the site are likely used by foraging and commuting bats, mitigation measures are provided in **Section 5.0**.

- 5.1 The garage has been assessed as having no potential for roosting bats and no further surveys are required. There is potential for the south of the site to be used by the local bat population for foraging and commuting.
