2. SITE DESCRIPTION

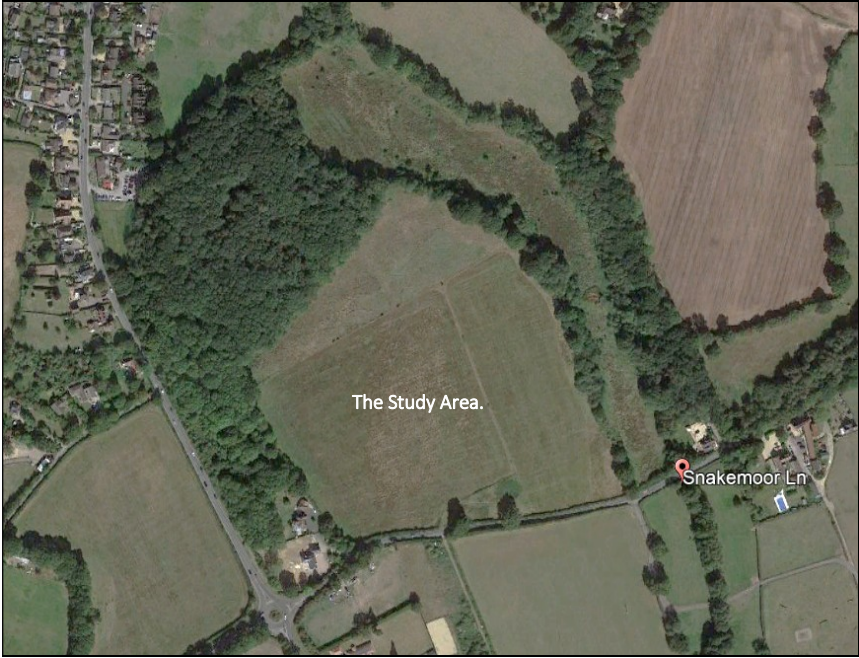
| | Comments | References |
|---|---|---|
| 2.1 Site Size & Extent | <p>The Site lies just beyond the south-eastern margins of Horton Heath, 9km north-east of Southampton City Centre and is centered on Grid Coordinates: Easting 449897, Northing 116374. The nearest Post Code is SO32 2BW.</p> <p>The investigation was carried out within an approximate pentagonal area with maximum dimensions of 320m by 300m. The aerial image (dated 2020) in Figure 5 below, shows the location of the field that comprises the study area.</p> <div data-bbox="411 521 1273 1176"></div> | <div data-bbox="1362 1104 1525 1128">Google Earth, 2025</div> |
