## STROUDWOOD FARMHOUSE, WINCHESTER ROAD, LOWER UPHAM, HAMPSHIRE SO32 1HH

### A Heritage Statement

## **A Heritage Statement to support an application for Listed Building Consent**

**RHC Project No. 2025-34**

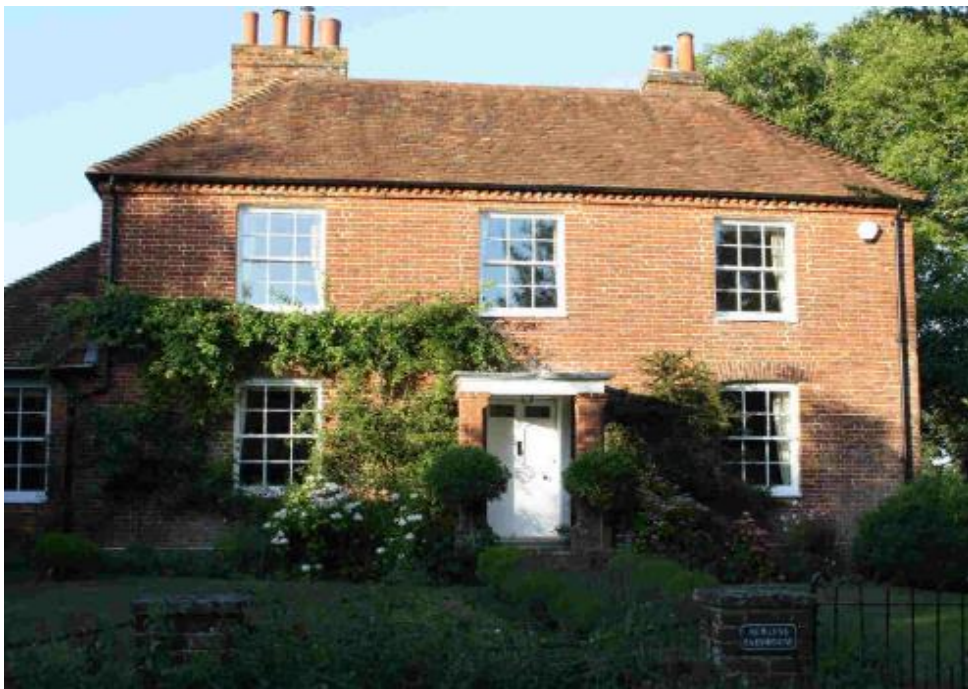
**Fig. 4: The south, front elevation of Stroudwood Farmhouse.**

- 4.2 Stroudwood Farmhouse is of three bays and two storeys, with a double-span hipped roof of plain clay tiles (Figs. 4 and 5). The front, south elevation is formal and symmetrical, with a central panelled front door. This was previously set within a modern porch supported in square pillars, but this has now been replaced by a more substantial enclosed porch, of timber-framed and glazed construction. The front doorway is flanked by six-over-six sash windows of historic pattern which are set within square-headed openings, with flat arches of rubbed red brick (Figs. 4 and 5). At the first floor are three six-over-six sashes, which conform to the ground-floor openings, albeit without the rubbed-brick arches. Construction is of red brick throughout, laid in Flemish bond, with a dentil eaves cornice. Brickwork includes some use of blue headers.

‘C18, C19. 2 storey house, with double roof above; earlier front, later rear. Symmetrical facade of 3 windows. Red tile roof, hipped, with brick dentil eaves. Flemish bond brickwork, red with a mixture of blue headers; red rubbed flat arches to ground floor openings. Recent sash windows, in style. Panelled door without architrave, and a modern unobtrusive porch on square pillars’.

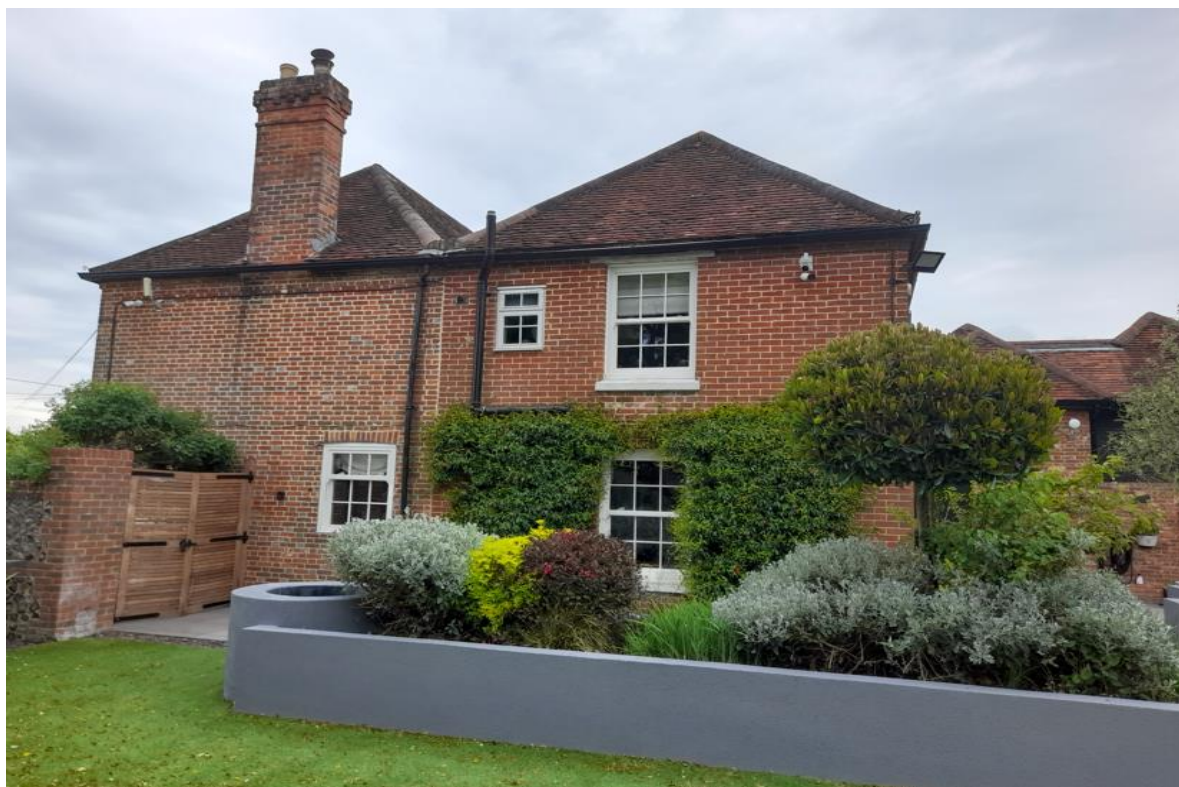
- 4.3 The roof is of double-span form, with a central valley-gutter, and contrasting brickwork on the east elevation reveals that construction was of two phases, with the simple original house of c. 1790, enlarged in the early nineteenth century by the addition of a rear extension of comparable ground-plan (Fig. 6). The additional range was of a closely conformable style and construction, which effectively doubled the depth of the house. The original house was presumably of single-room depth, back to front. The east elevation of the original phase has a single sash window within a segmental-headed opening at the ground floor, while the adjoining elevation of the later addition has single, six-over-six sashes, with stone cills, at both ground and first-floor levels (Fig. 6). The left-hand side of this elevation has a tall brick stack, with a brick band and cornice at the top. The north elevation is comparatively plain, with modern French doors to the left and a ground-floor casement window to the right. The first floor has a single casement to the right, and there is a brick stack at the eaves on this side, which displays a distinct degree of lean and may be rebuilt as part of the proposed scheme of repairs (Fig. 7).

**Fig. 6:** View, looking south-west of the east elevation of Stroudwood Farmhouse, with double-span hipped roof and two distinct phases of brickwork construction.

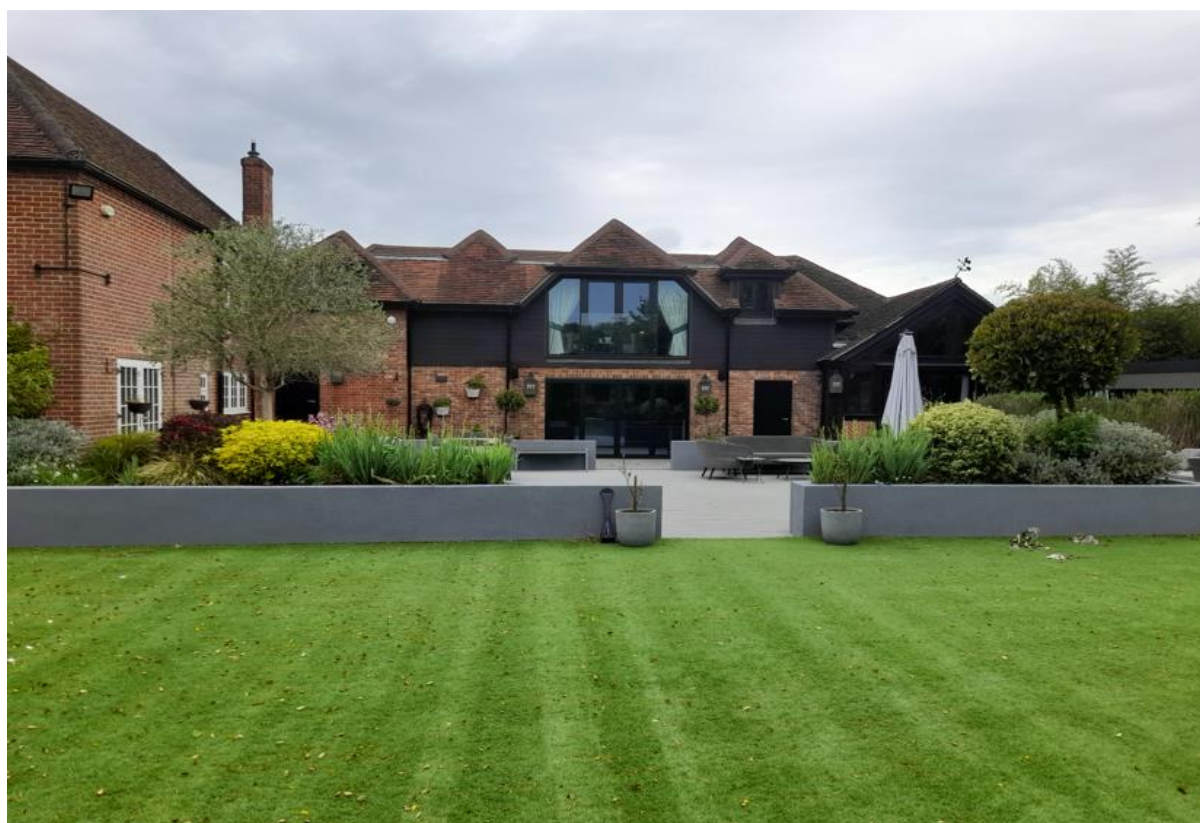
**Fig 7:** View looking east, of the north elevation of Stroudwood Farmhouse and surrounding garden and adjoining converted barn.

- 4.4 The Farmhouse is attached to a range of buildings at its north-western corner which has been converted to modern residential accommodation, and which appears to have originally been an agricultural building, presumably a barn (Fig. 7). This comprises part of a courtyard arrangement of buildings, now also converted, which originally comprised part of the historic farmstead associated with the house (Figs. 3 and 11). A group of modern farm buildings is located immediately to the north of this. On its eastern side, Stroudwood Farmhouse is surrounded by extensive gardens, with a wide paved patio to the rear of the house (Fig. 7). On its southern, front side, the farmhouse is surrounded by gardens and an extensive gravelled area and driveway which is accessed off the B2177 road. The Farmhouse is largely screened from the roadway by boundary vegetation.

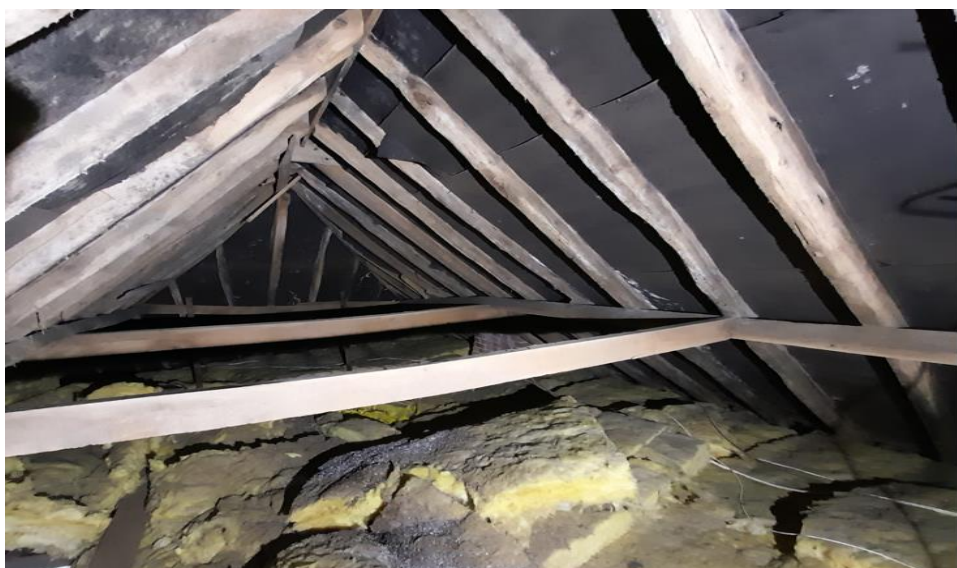
- 4.5 The timber-framed roof of Stroudwood Farmhouse appears to be largely original, and embodies vernacular methods of construction (Figs. 8 and 12). The timber roof structure is unusual, and its notably inferior mode of construction is surprising in view of the evident status of the Farmhouse. Common rafters are largely of hand-cut oak, but are of thin and irregular scantling, averaging 50mm by 80mm in cross-section. These are set at irregular centres, ranging from 330mm and 400mm, with a roof-pitch of 42°. Ceiling joists are of similarly irregular dimensions and centring. There are no roof-trusses as such, with purlins propped directly off ceiling joists, thus providing inadequate support to rafters (Fig. 17). There are no heavy struts to provide horizontal support to purlins. At the hipped ends of the roof, smaller-section joists are notched, and have minimal end-bearing capacity (Fig. 18). A number of thin tie-beams between purlins appear to be of relatively modern, machine-cut timber (Figs. 8 and 12). The roof-space accommodates a colony of long-eared bats.

**Fig. 8: View, looking west within the roof-space, with details of timber-framed construction.**

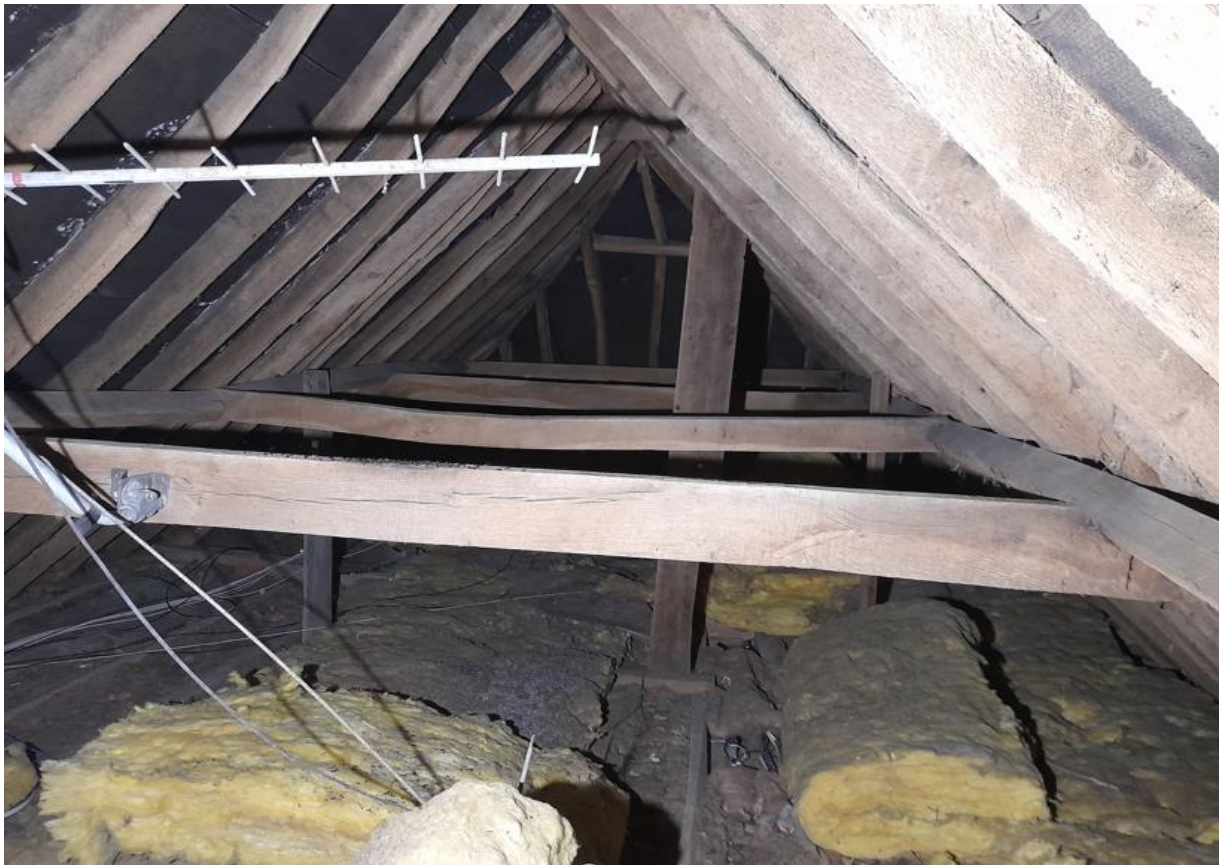
- 5.1 The external walls of the Farmhouse support a hipped roof which is constructed of cut timber common rafters which are supported by timber purlins. (Figs. 8, 12 and 20). Recent refurbishment of the roof has included the installation of impermeable bitumen felt sheeting below clay tiles. Existing oak rafters measure approximately 50mm by 80mm, and are set at centres of between 330mm and 400mm, with a roof pitch of 42°. Ceiling joists are of variable size, measuring 50mm by 40mm at 500mm centres at each end, and 55mm by 80mm at 300mm centres within the centre of the roof-space. At the supports, the 40mm-deep joists are notched 20mm and have 20mm end-bearing (Fig. 18).

**Fig. 12: View looking east within the affected roof-space, with detail of timber construction.**

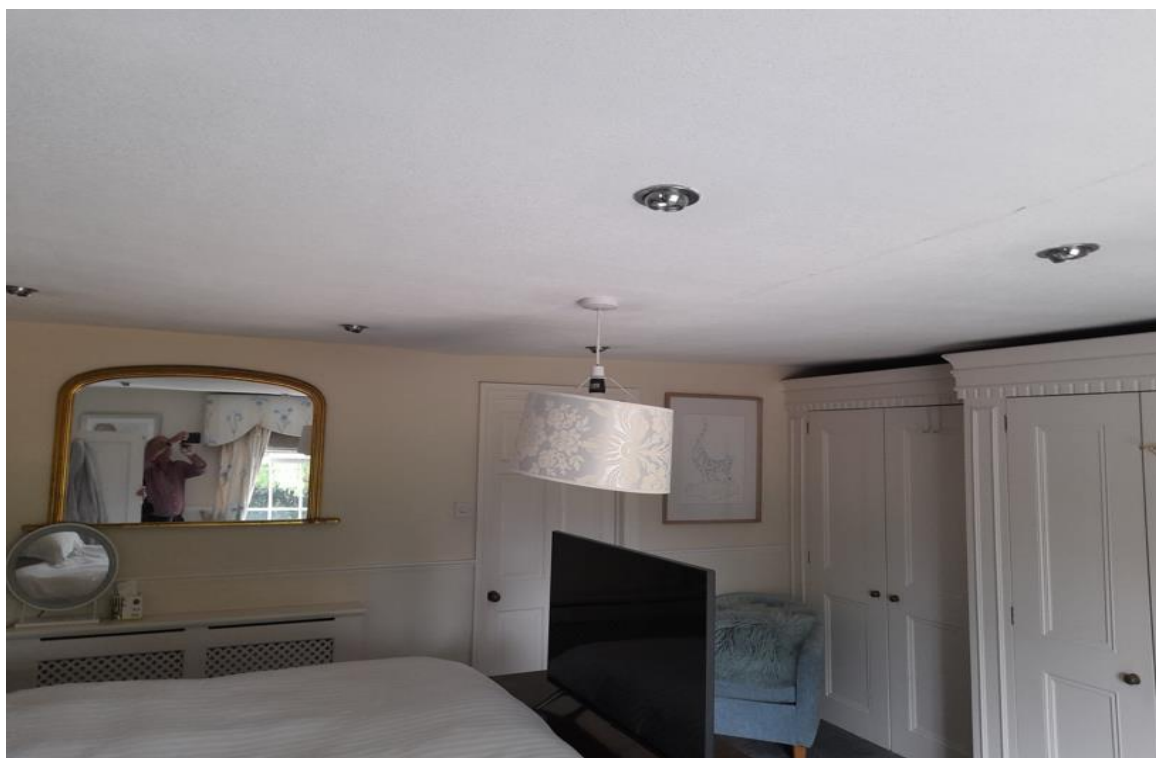
- 5.2 At the first floor, ceilings exhibit evidence of sagging, with linear cracks appearing in plastered wall surfaces (Figs. 13 and 14). These problems are reported to have worsened in recent months, with the centre of an affected bedroom ceiling now approximately 110mm lower than the ceiling of the

**Fig. 13: Ceiling deflection in the western front bedroom of Stroudwood Farmhouse.**

- Temporary Acrow props with bearing plates should be installed beneath affected ceiling joists, to provide immediate support and prevent further deflection. This would mitigate the risk of structural failure while repairs are carried out. The use of external scaffolding will enable the safe removal of tiles, battens, and impermeable felt, and the installation of new materials.

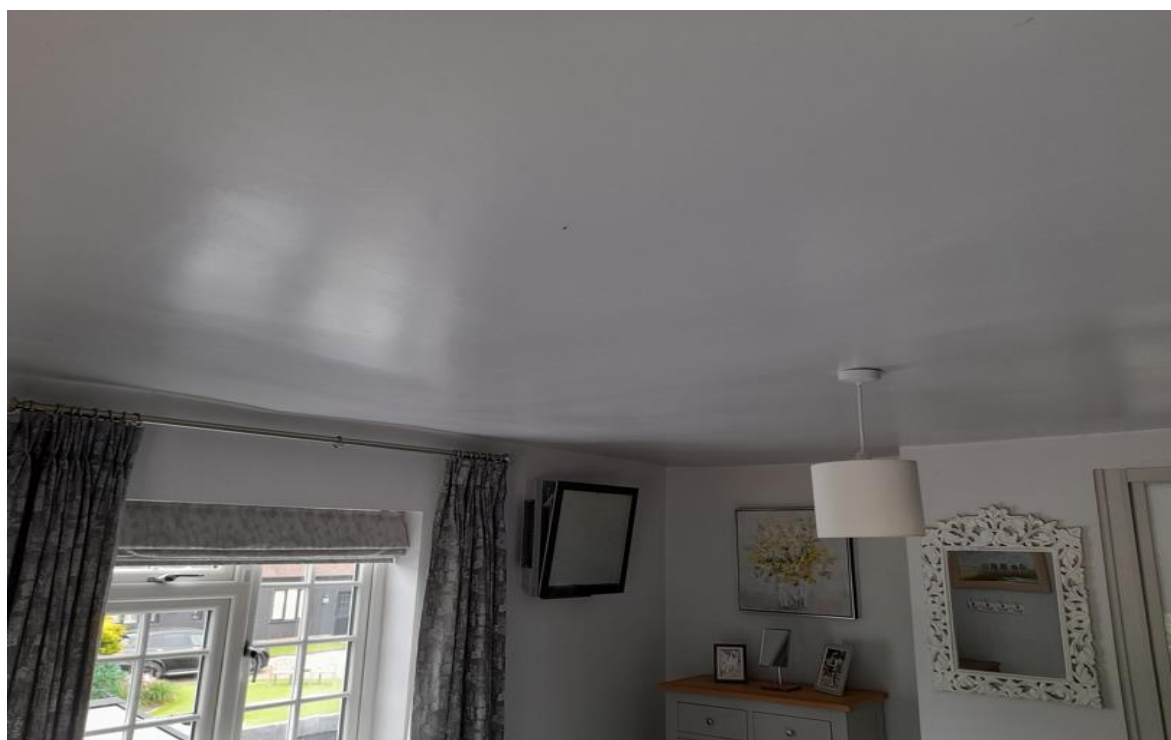
adjoining hallway (Figure 4). Of the two first-floor rooms inspected, the ceiling of the eastern front bedroom appears to be the worst affected (Fig. 14).

**Fig. 14: Ceiling deflection in the eastern front bedroom of Stroudwood Farmhouse.**

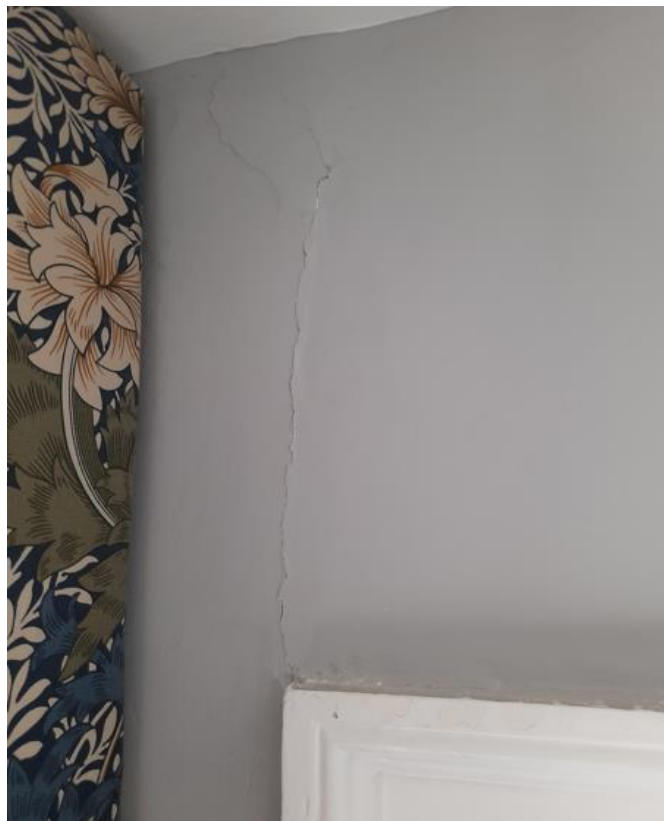
- 5.3 Recent cracking of surface plasterwork was observed in a number of first-floor rooms, most particularly in the landing, above the door to the western front bedroom (Fig. 15). Much of this problem has become evident only recently, and suggests possible structural instability in load-bearing walls. In addition, some affected doorframes now exhibit signs of distortion.

**Fig. 15: Cracking in surface plasterwork on the first-floor landing.**

5.8 This notching of joists further weakens them, reducing load-bearing capacity and resulting in excessive cracks and deflection. In the absence of true roof-trusses, the purlins lack sufficient vertical support. In several locations, these are propped directly onto ceiling joists, without intermediate struts or braces, resulting in point-loading and further stress to the joists (Figs 17 and 20). As the joists do not span the same direction as the rafters, the roof is splaying and spreading horizontally. This arrangement is unusual, and resulting stress on structural walls may explain the increasingly apparent vertical cracking above the doorways on the first floor (Fig. 15).

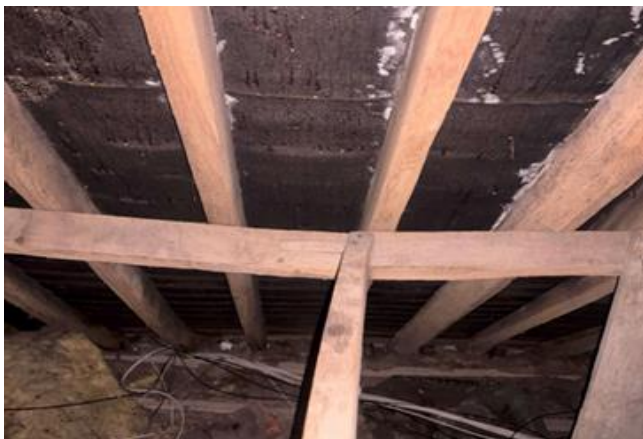
- 5.4 There are numerous indications of dampness affecting roof-space timbers, with condensation visible on a number of surfaces. Green and white mould growth was observed on rafters and bituminous felt surfaces. A number of timber elements were flaky or soft to the touch, suggesting the possible effects of wet rot. (Figs. 16, 17, 21B and 21C).

- 5.5 Serious structural deficiencies were observed in roof timbers, with a number of timber joints having separated, or widened (Fig. 19). Purlins were deflecting at the hips, with some rafters inadequately secured with single nails (Fig. 16). Woodworm infestation was also apparent, although this may be partly historical. Some purlins are propped off ceiling joists, rather than load-bearing beams or walls, and provide inadequate support to rafters (Figs. 17 and 20). There are no bracing struts to provide horizontal support to the purlins. The roof framework is considered to be of notably inferior construction.

**Fig. 16: A deflecting purlin joint.**

- Additional load-bearing beams should be installed, to support purlins and redistribute roof loads away from ceiling joists. Steel-plate reinforcements will limit deflection and any weakness at splice locations. Lateral restraint to the rafters at eaves-level should prevent roof-splay. The existing joists are inappropriately sized for the bearing and span and will require reinforcing with new joists.

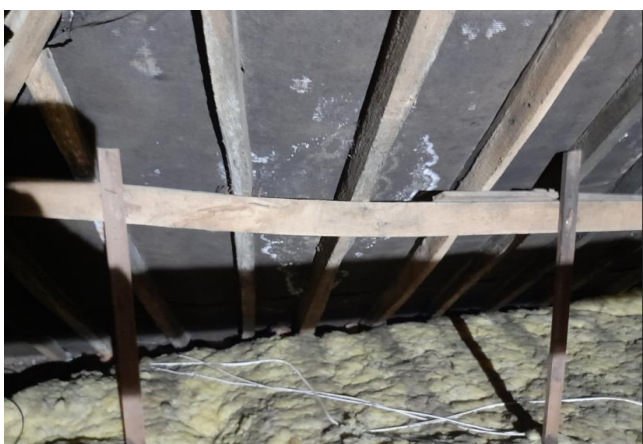
**Fig. 17: A purlin supported off ceiling joists.**

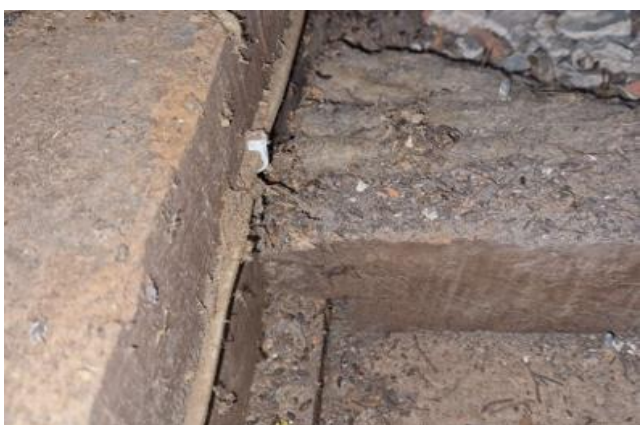
**Fig. 18: A notched ceiling joist and end-bearing.**

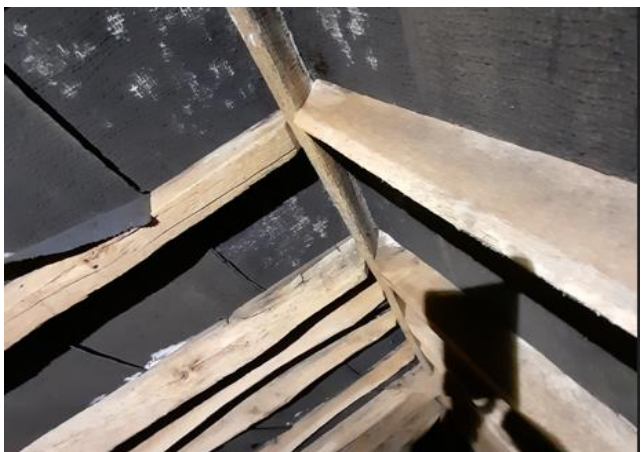
**Fig. 19: Widening joints between rafters and ridge-beam.**

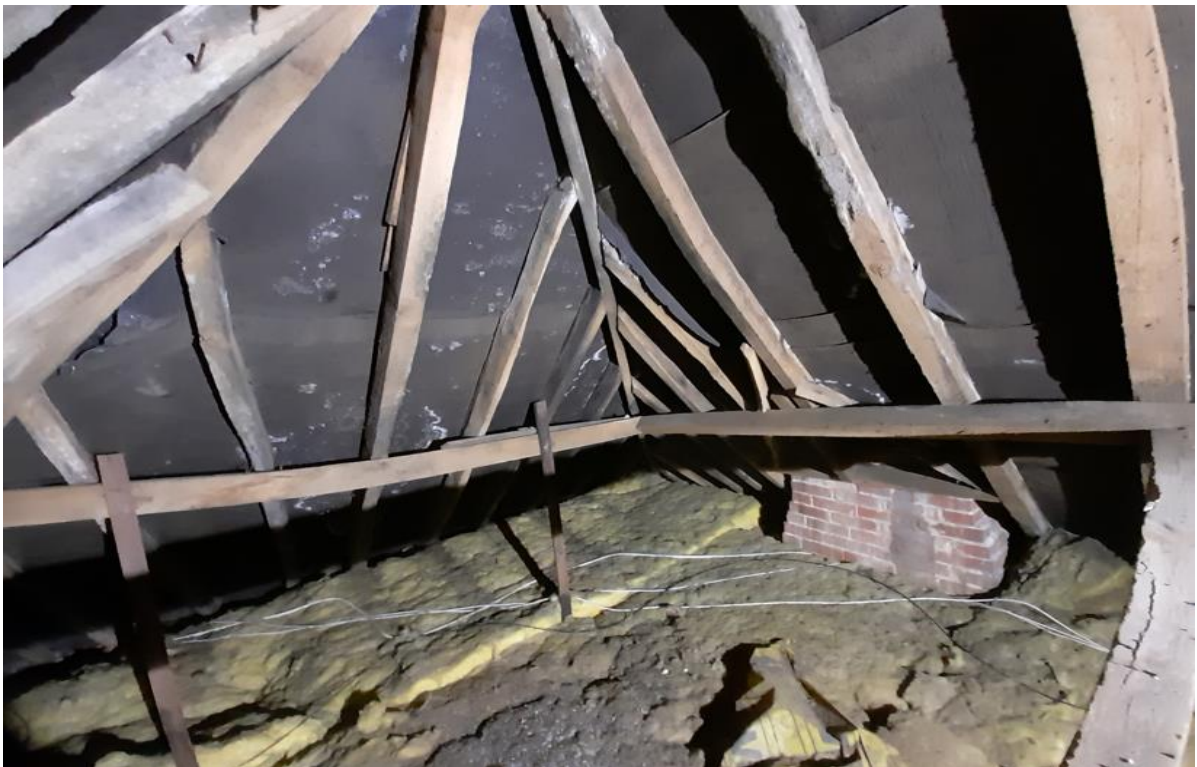
5.7 2. The existing roof structure has no provision for soffit ventilation, which has contributed to the problem of dampness, with no airflow to regulate humidity levels. Timber elements have consequently deteriorated, with visible signs of wet rot and mould growth (Figs. 21, A-D). The poor construction has been based on the principle of purlins supported by ceiling joists, rather than by load-bearing walls or beams (Figs. 17 and 20). In view of the load imposed by a tile roof, this arrangement is deficient, and clearly inadequate for the load imposed. This appears to be particularly the case at the hipped ends of the roof where smaller-section joists (50mm by 40mm) are notched, and have minimal end-bearing capacity (Figure 20).

Fig. 20: Timbers at the eastern hipped end of the roof, with purlins supported on inadequate joists.

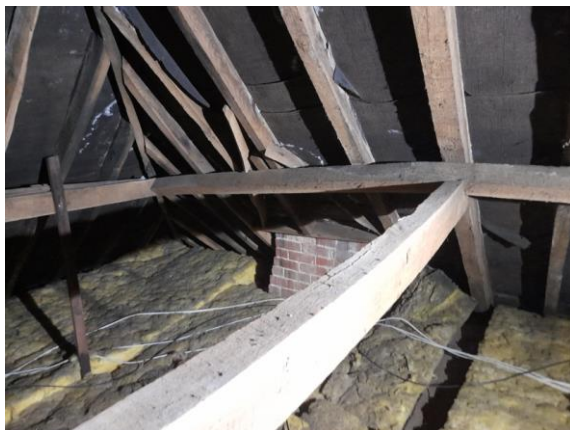
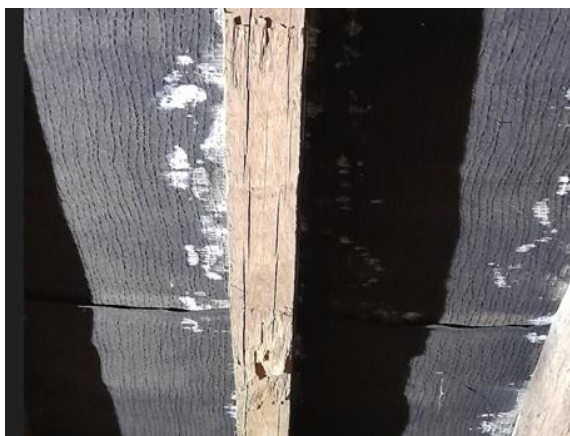
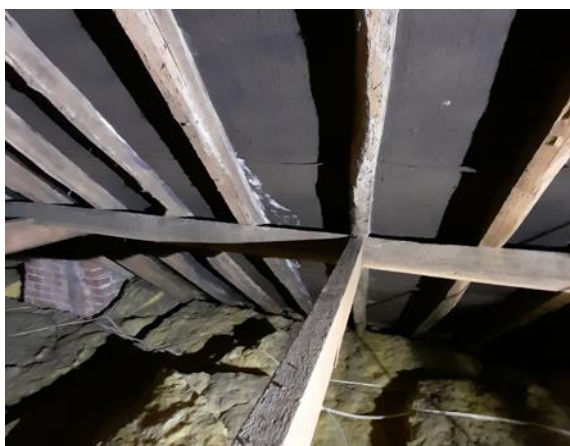
**Fig. 21 A-D: Details of timber roof construction and evidence of decay.**

- Detailed condition assessment of individual timber elements will enable the identification of those elements requiring replacement. Severely decayed or defective rafters, purlins and joists should be replaced with appropriately graded timber, to match existing historic fabric.
