Preliminary Roost Assessment (PRA) & Bat Activity Surveys (BAS)

**89 Kingsway Road,**

Survey and report by: Vesper Conservation & Ecology Limited

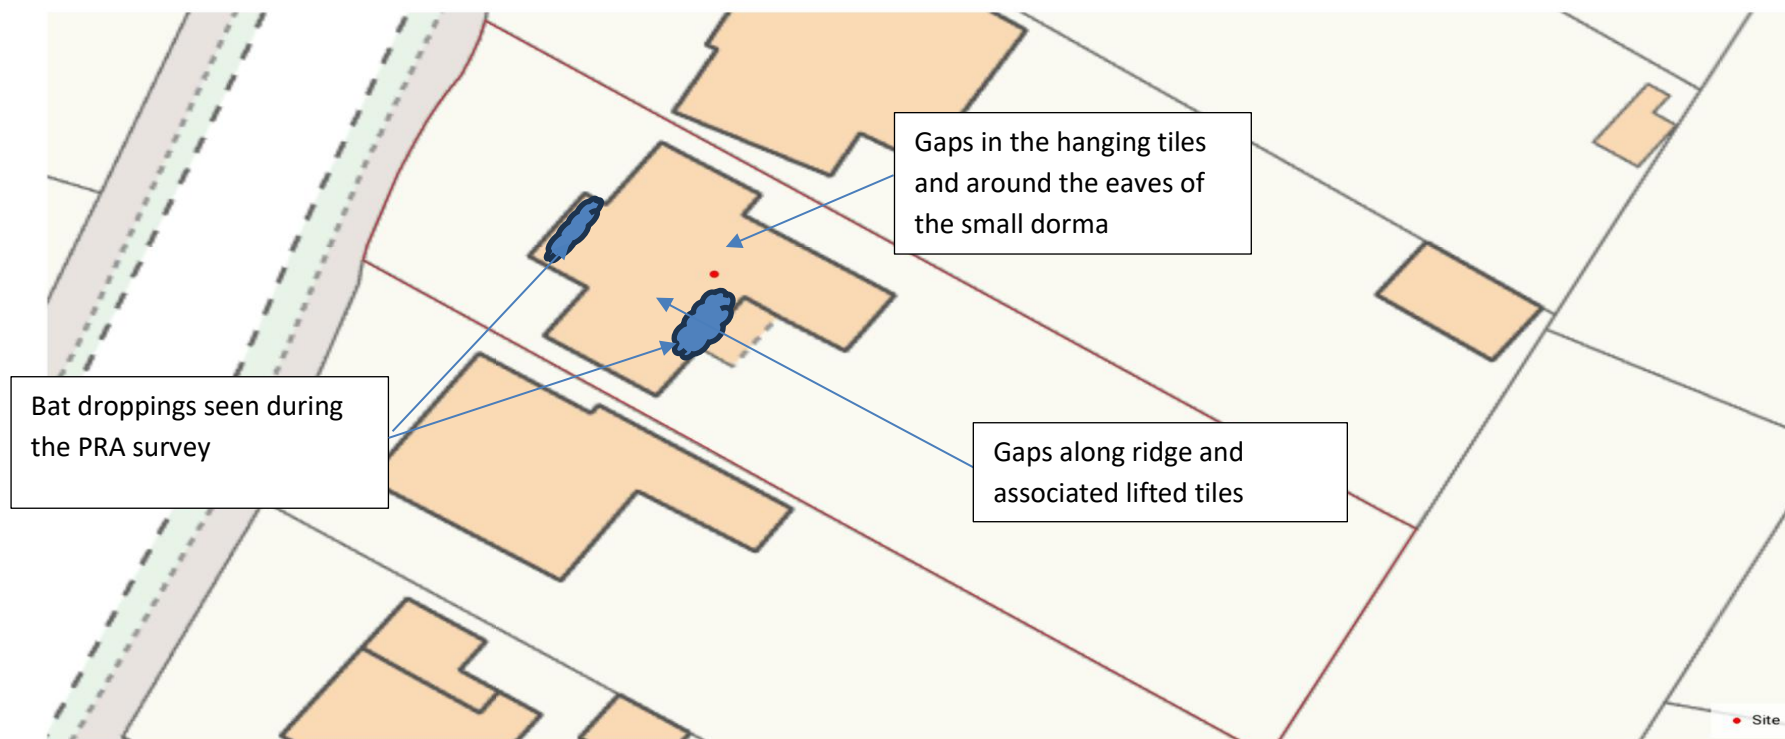
- 2.16 Bat droppings were found at the rear of the property under the ridge beam, there are about 50 droppings in total, some were taken for DNA analysis. Older bat droppings were found against the front gable; this gable has been replaced at some point in the recent past.

**Figure 1:** Showing the area where bat droppings were found

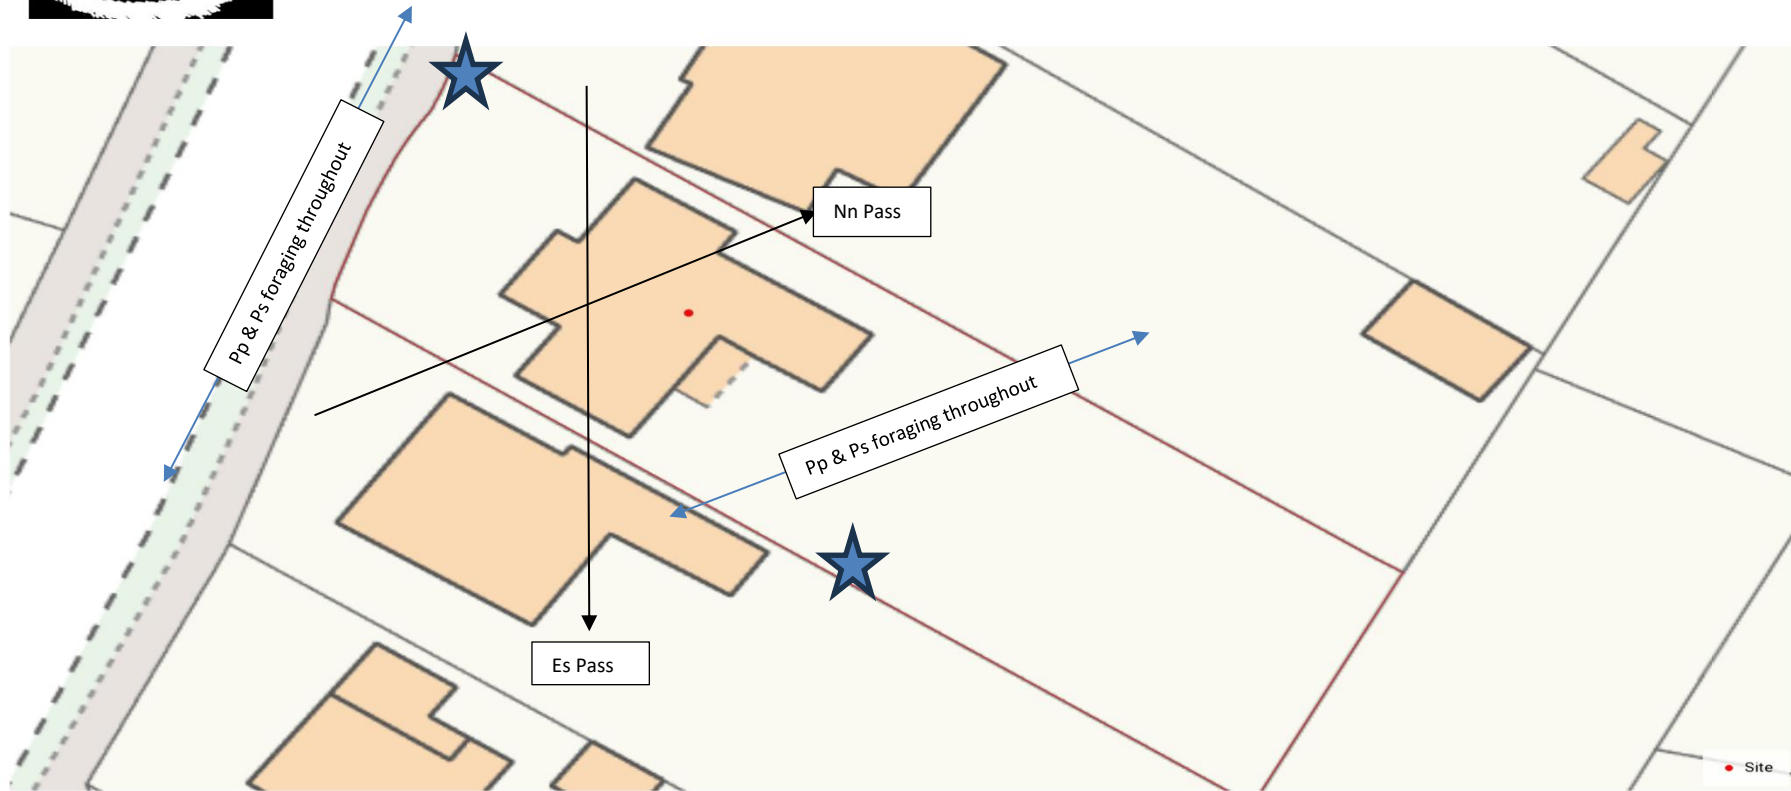
3.4 During the first survey (**11/06/25**) 4 species were recorded (Common & Soprano Pipistrelle, Serotine and Noctule bats). **No bats** were seen emerging from the building. There was a lot of activity around the property and along the road. (See figure 3) (Dr Des Purdy and Pete Allen).

Figure 3: BAS 11/06/2025

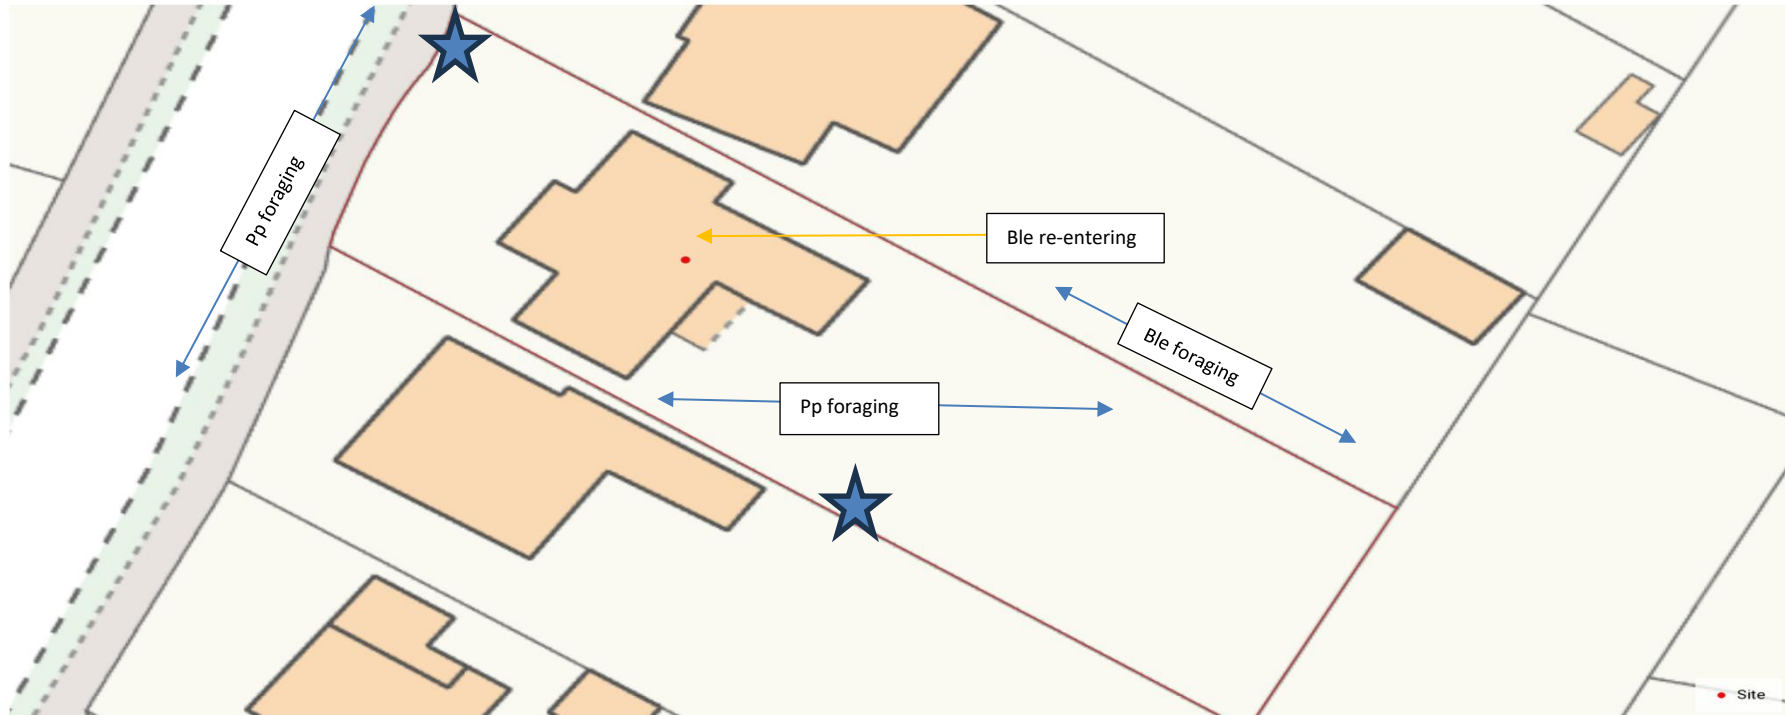
3.5 During the second survey (**09/07/25**) 5 Species of bat were recorded (Common/Soprano Pipistrelle, Serotine, Brown Long eared and Myotis sp. bats), **1 x Brown Long eared bats** re-entered the building in to the small dorma

on the eastern elevation (rear). The foraging activity was recorded around the building and along the road. (See figure 4) (Rob West and Pete Allen).

**Figure 4:** BAS 09/07/2025

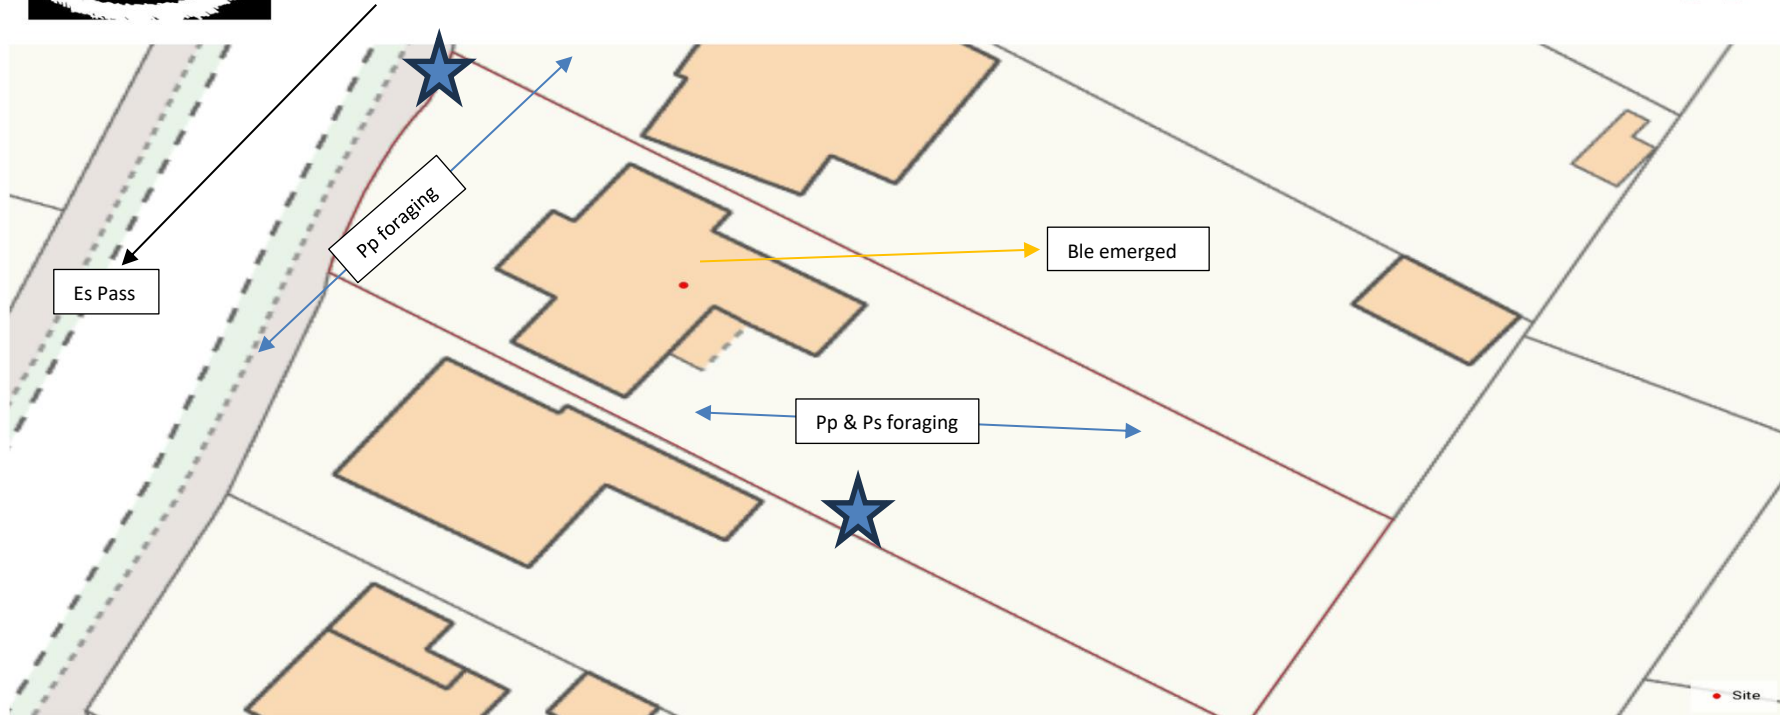
- 3.6 During the third survey (**30/07/25**) 4 species were recorded (Common & Soprano Pipistrelle, Serotine and Brown Long eared bats), **1 x Brown Long eared** bat were seen emerging from the small dormer on the eastern elevation (rear). There was a lot of foraging along the road and in the rear garden (See figure 5). (Rob West and Pete Allen)
- 3.7 During the activity surveys bats were seen emerging from the building. The number of the emerging Brown Long eared bats suggests this is a non-maternity day roost.

Figure 5: BAS 30/07/2025

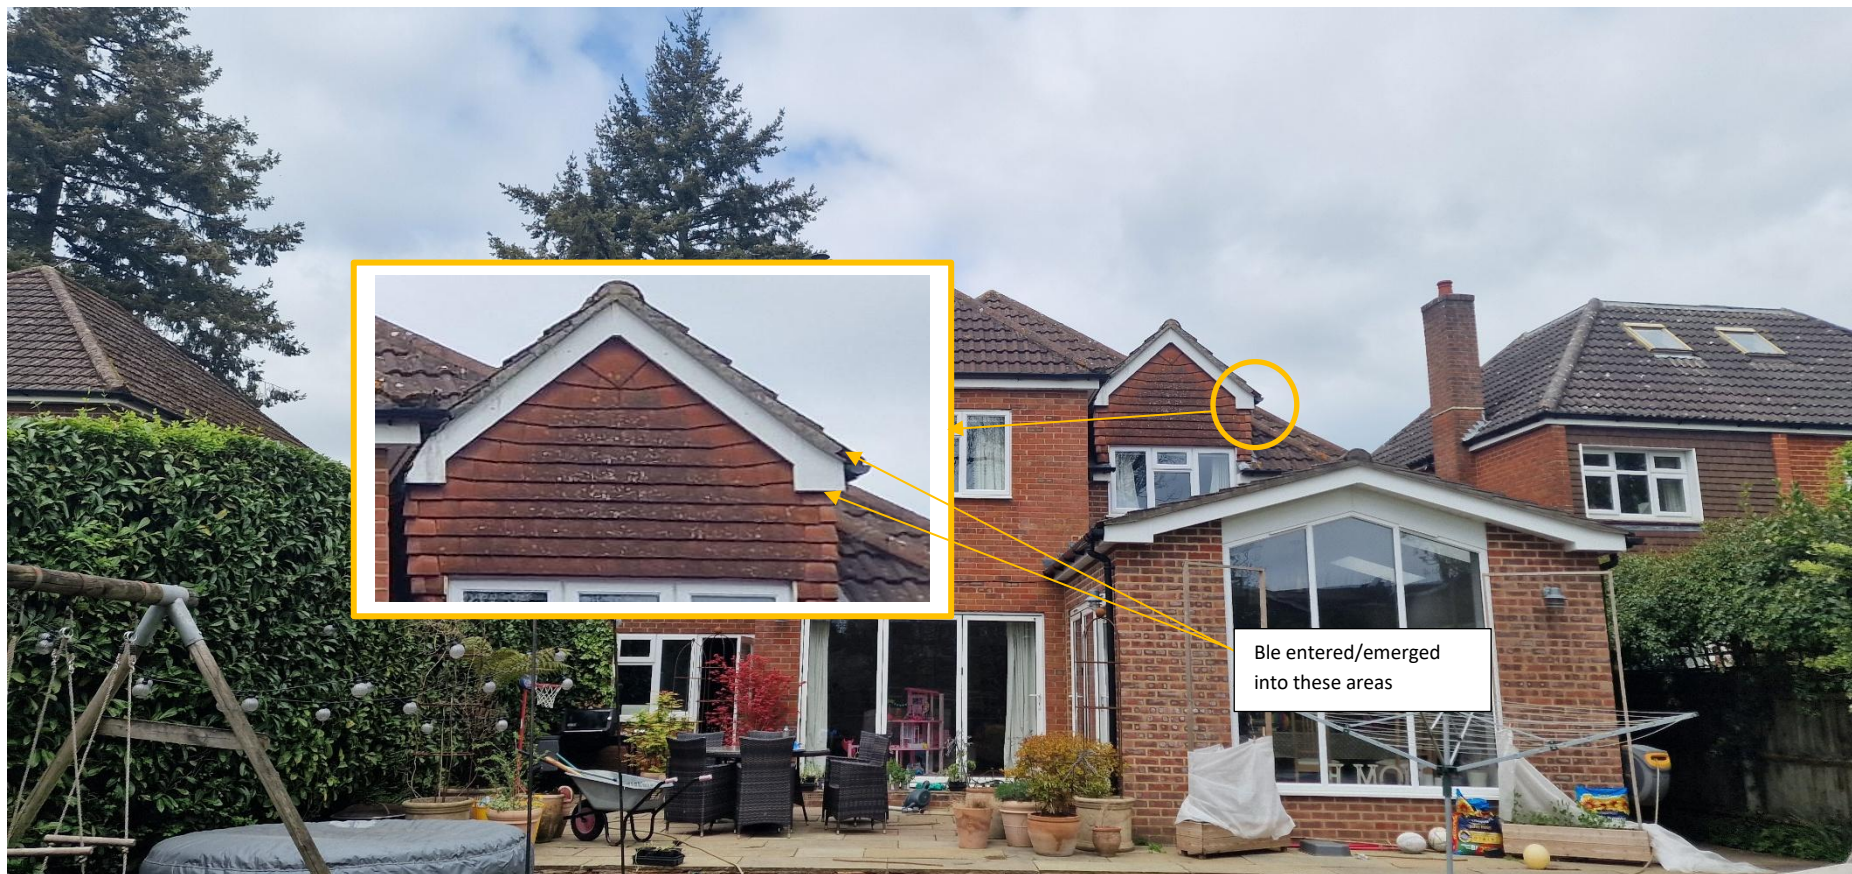
**Figure 6:** Showing where the Brown Long eared bat was seen re-entering/emerging

- 3.9 There are no priority habitats and or designated sites on or near by that would be affected by the proposed works
  - 3.10 The bat activity surveys showed that a single Brown Long eared bat was seen re-entering and emerging from the rear small dormer.

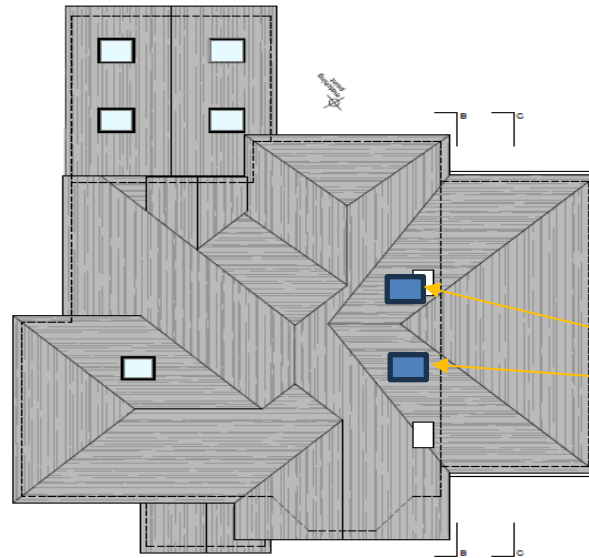
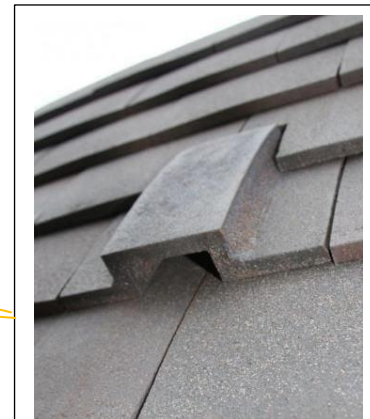
Figure 8: Proposed bat enhancements

The Habibat Access Tile is a roof tile which has been modified to allow bats either under the roof felt or under the roof void.

- 3.13 The **addition of two bat access tiles into the new roof** on the eastern and western elevations, these should have a hole cut in the felt behind to allow access into the roof void beyond. (figure 8)
-

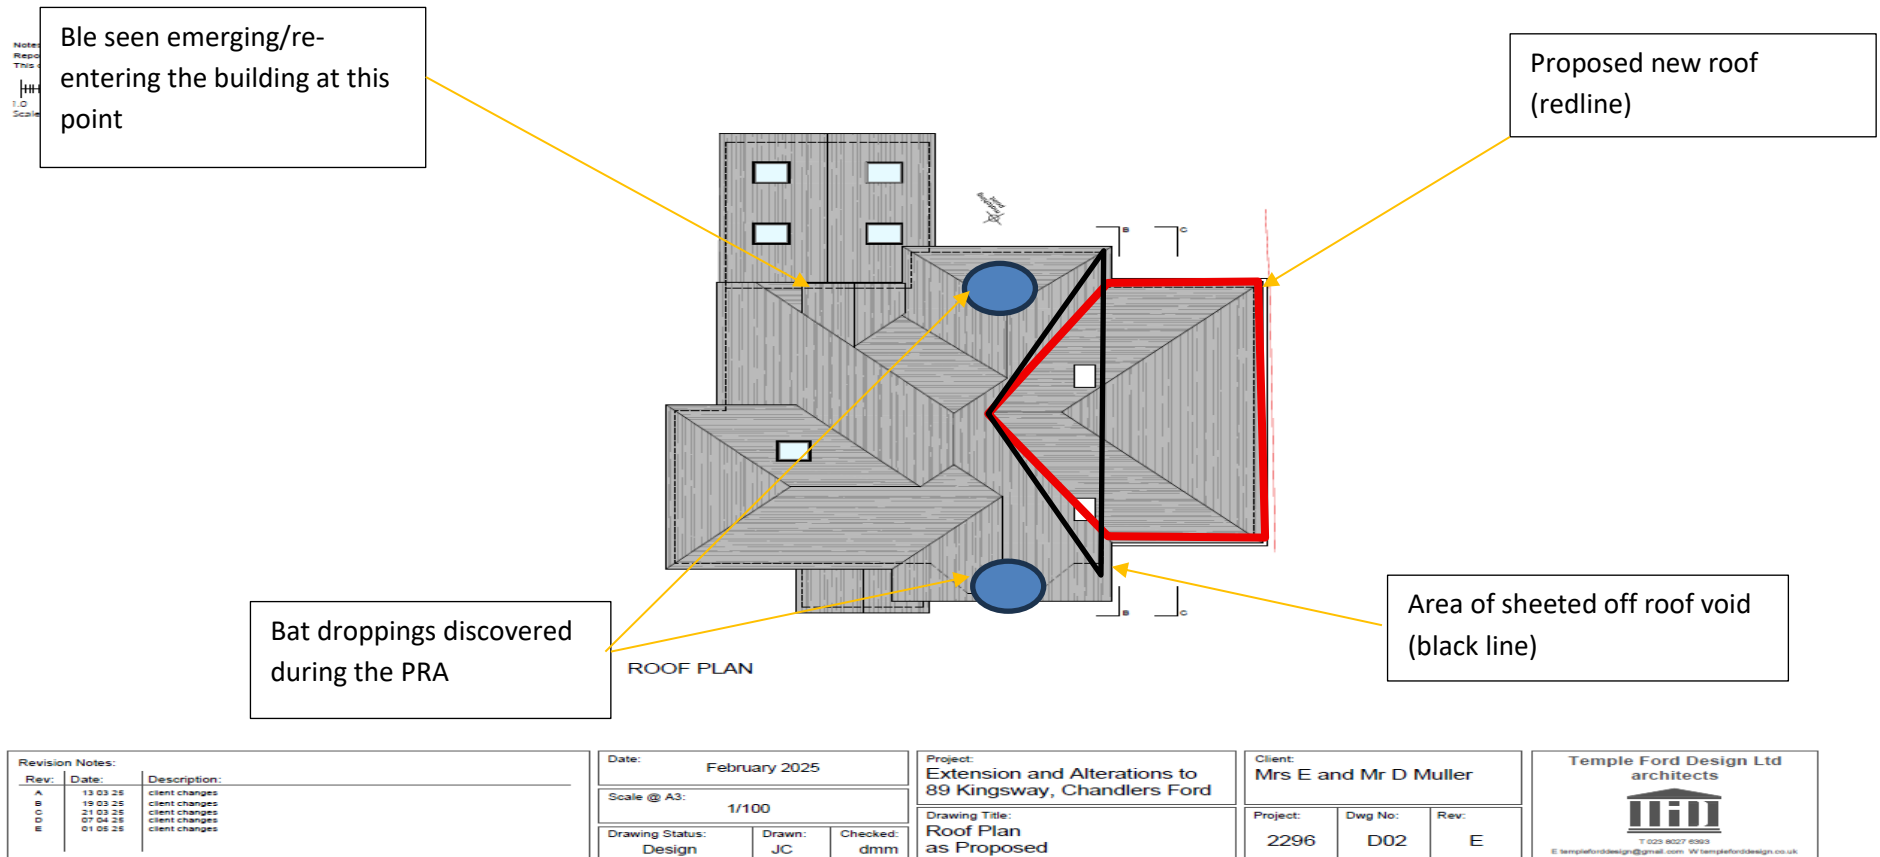
**Figure 9:** Showing the area of sheeting and proposed works

- 4.1 The proposed work will breach into the roof void when the new roof is attached. The impacts on the roosting bat within the building can be reduced by timings of the work (ie breaching into the roof in the winter months) and creating a sheeted off area so not disturb the internal roof void.

- 4.5 Just before the construction period starts the area of roof near to the proposed works will have a plastic sheet installed so to separate the work area from the rest of the main roof to reduce any disturbance during. This will be done under supervision of an ecologist to make sure limited noise, and light is used in the main roof area.

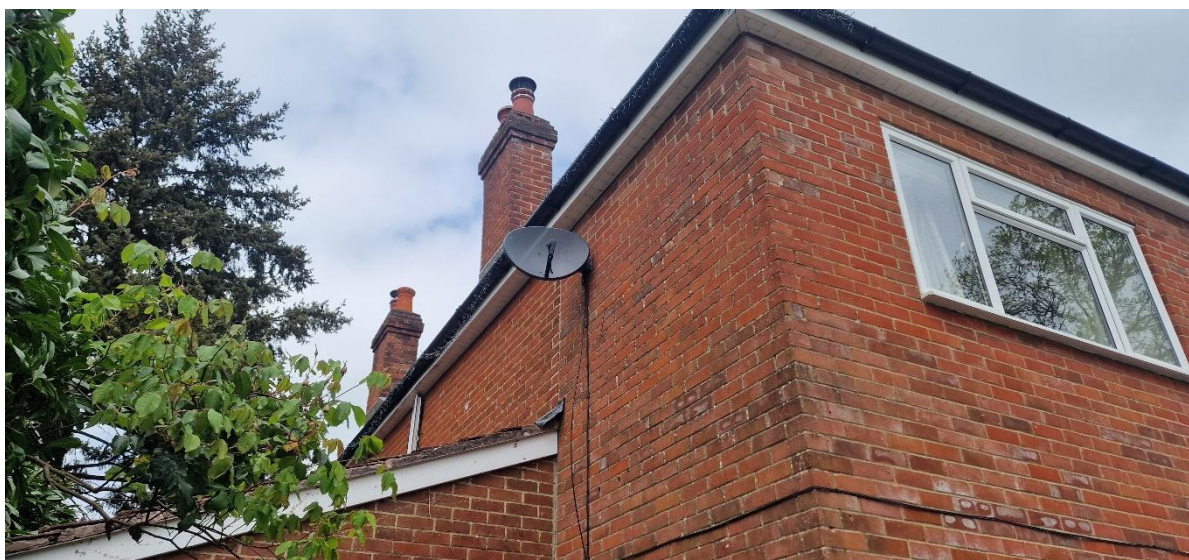
**Picture 3:** Showing soffit and eaves.

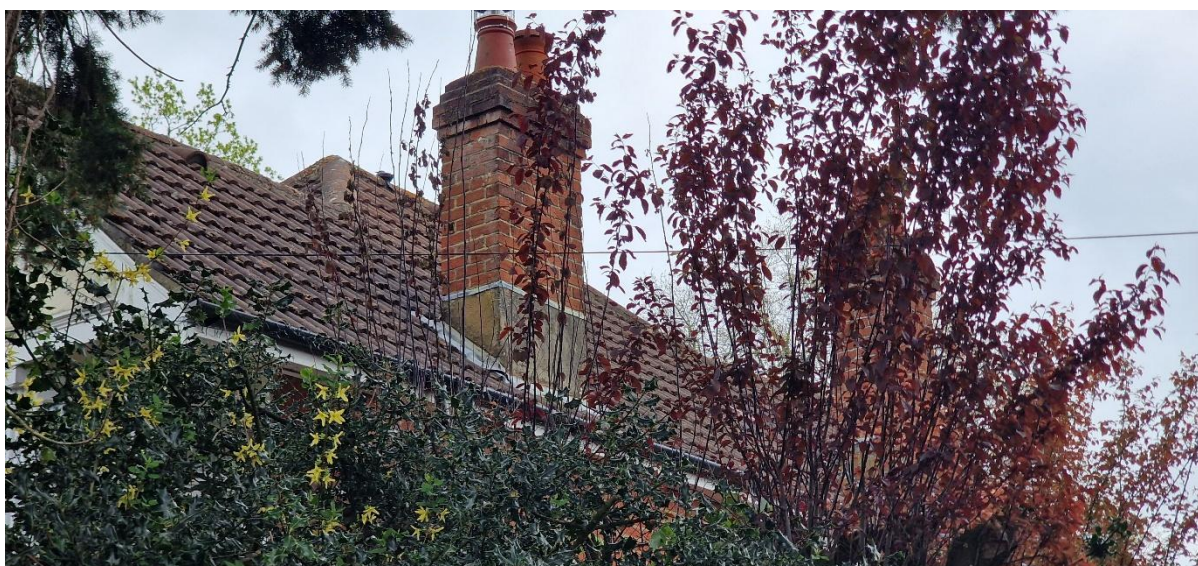
- 
- 2.10 The chimneys are in good order with no missing cement the lead flashing is in good order with no obvious gaps or holes that would allow access into the building.
  - 2.11 The eaves and soffits are UPVC, they are in good order with no obvious gaps or holes around the building

**Picture 4:** Showing the side elevation and flashing around chimney

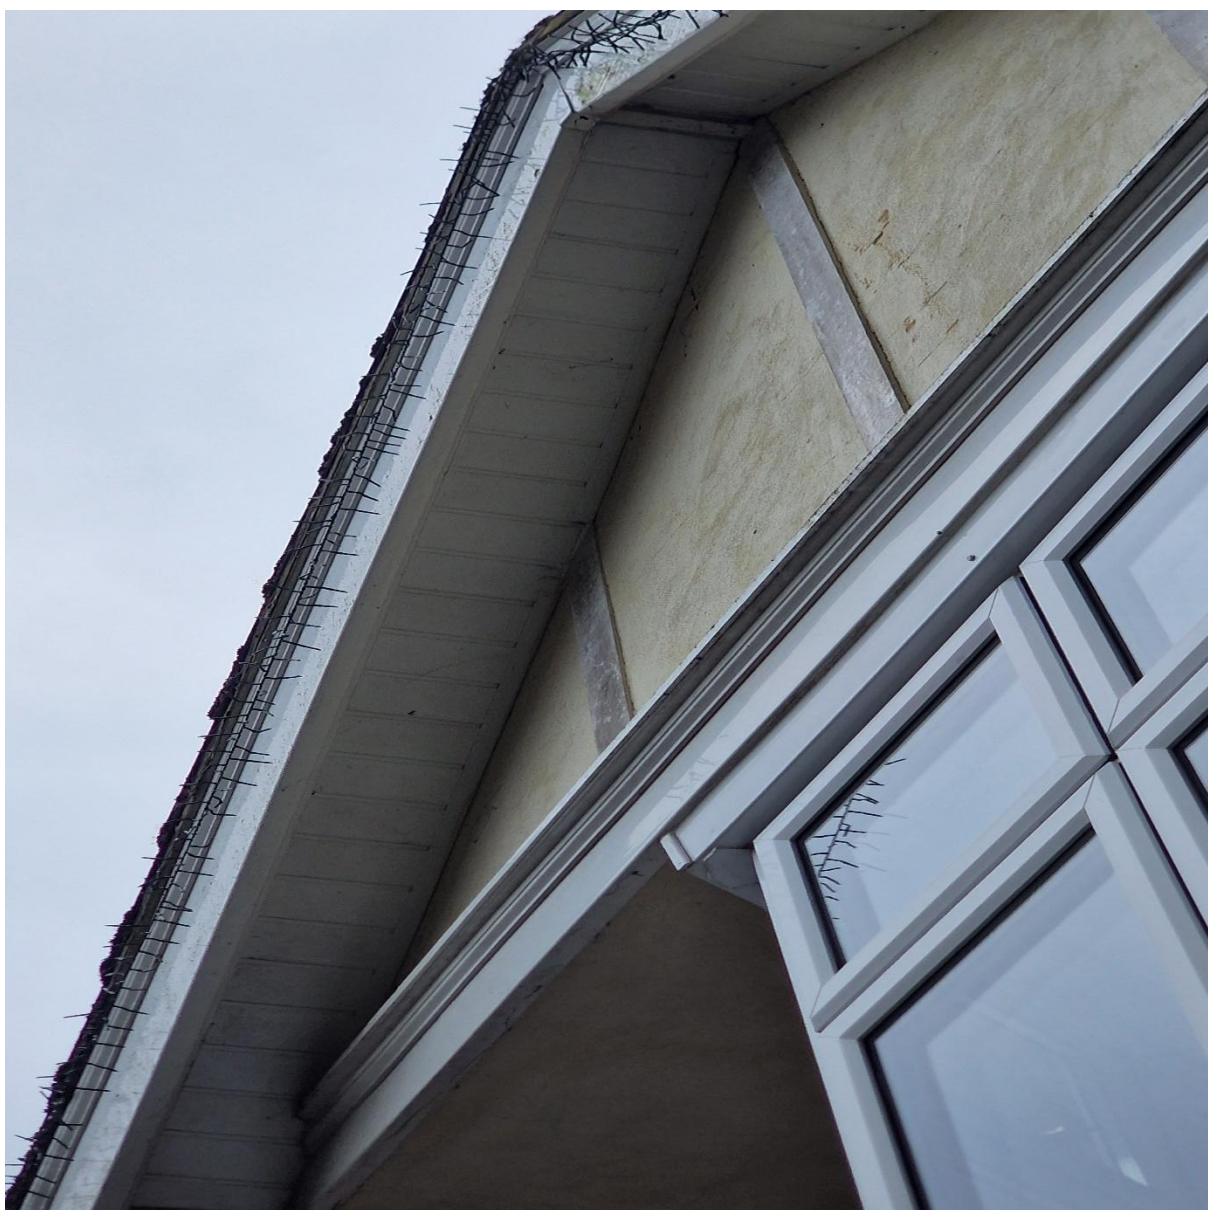
**Picture 5:** Showing the eaves on the front gable wall

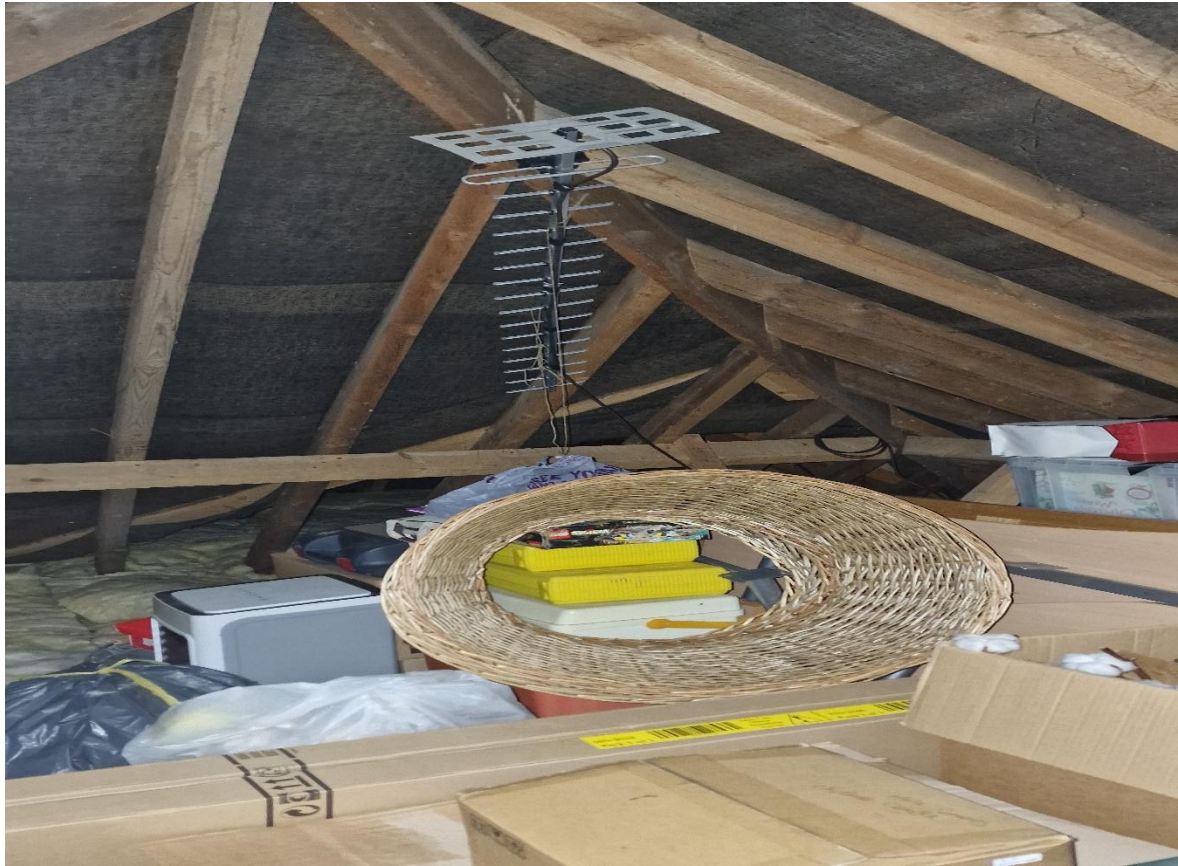
- 2.12 There is a single roof space that cover the whole of the main house access was good throughout, the floor of the roof was partial boarded.
- 2.13 The roof floor is covered with a thick layer of insulation which goes right into the eaves. There are no obvious gaps or holes that allow light into the roof space.

- 2.14 The tiles are backed with bitumen felt, this is in good condition, the roof has several vents cut into the felt which could allow ingress into the building.

**Picture 6:** Showing the internal roof structure of the house.

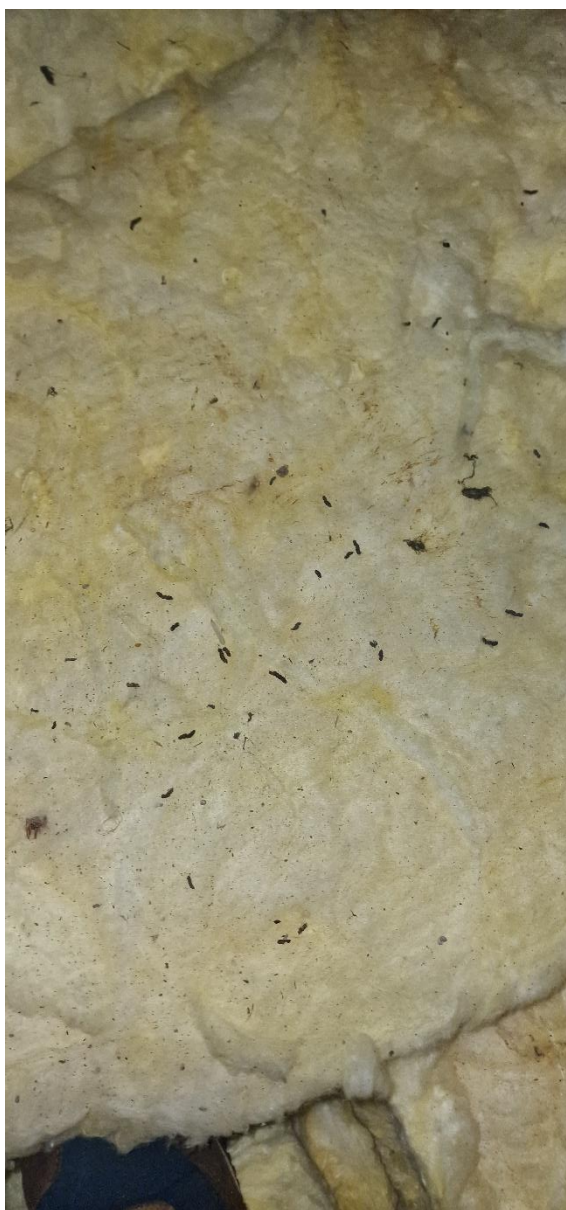
**Picture 7:** Showing the bat droppings on the insulation
