**Project:** 25\_PEA\_07\_27  
**Site:** Four Winds, Allington Lane, Fair Oak, Eastleigh, SO50 7DD  
**Client:** Luke Richards

| Report Type: | Preliminary Ecological Appraisal Report (PEAR) |

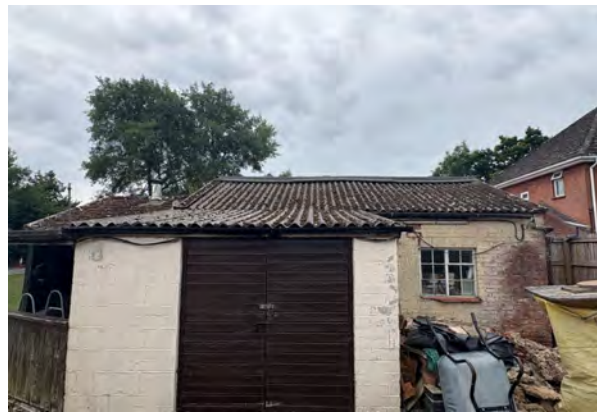
The eastern elevation of Building B1 comprises a timber-framed extension clad with vertical timber boarding. This elevation exhibits several structural gaps at the bargeboards and along the timber-plinth junction, particularly where weathering has degraded the materials, potentially allowing access for crevice-dwelling bat species such as *Pipistrellus* spp. The roofline here interfaces with the original brick structure, creating linear features and potential ingress points beneath the asbestos sheeting and felt layers.

| Habitats and Target Notes | Description | Supporting Photo |
|---|---|---|
| Habitat 1: u1b - developed land; sealed surface | HAB 1 comprises areas of built environment, including residential buildings, hardstanding, and domestic patio space. The surfaces are predominantly impervious, consisting of poured concrete, paving slabs, and compacted gravel set within a domestic context. Surrounding structures and patio borders are well-maintained, with little to no accumulation of debris or organic matter that might support ruderal flora or structural colonisers. No vascular plant growth was observed within the hardstanding joints or cracks at the time of survey, indicating regular maintenance and low ecological value. | <br>Photo 1 - B1 |

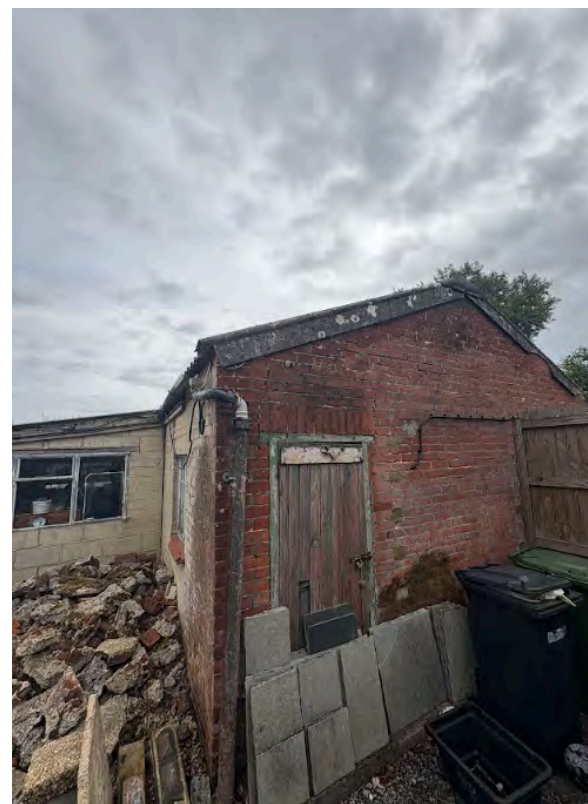
Photo 2

The northern elevation is a brick-built lean-to, abutting the original structure and showing signs of weathered mortar joints and crevices at the brickwork interface. These brickwork voids, especially in the upper courses and at points where structural movement has resulted in cracks or displacement, offer low to moderate potential roosting opportunities for solitary or transitional bat use. No direct evidence of bat activity (e.g., droppings, feeding remains) was recorded internally or externally during the survey.

The western elevation forms the rear aspect of the original building and incorporates aged corrugated asbestos sheeting forming the pitched roof. Visible daylight through sections of displaced roof material and gaps beneath ridge capping and gable ends present PRFs for light-tolerant bat species. However, the level of internal cobwebbing, absence of droppings, and non-insulated loft void suggest minimal historic use. The roof itself is in a degraded state, with under-cloaking felt partially detached, which may allow bat ingress but reduces thermal stability, thus limiting its suitability for maternity colonies.

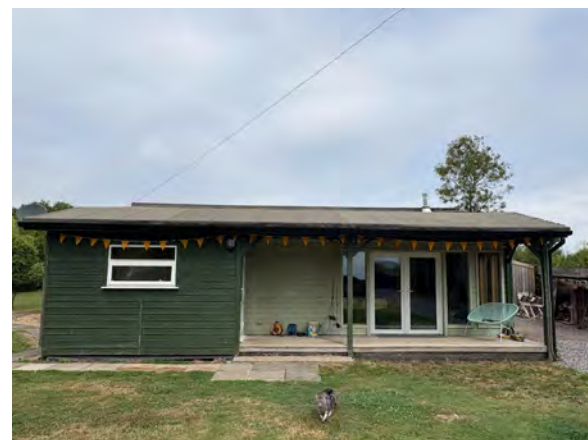
Photo 7 - B2

The eastern elevation of Building B2 comprises well-maintained horizontal timber cladding with no visible weathering, structural damage or gaps that could support entry or roosting by bats. The base of the cladding is firmly sealed to the concrete footing, eliminating opportunities for access by small mammals, reptiles, or amphibians. The overall condition of the structure provides negligible ecological value.

The pitched roof is covered uniformly in bitumen felt, showing no signs of lifting, tearing, or weather-related damage. All edges, ridges, and junctions are well-bonded, offering no PRFs or ingress points. Internally, the loft void is tightly insulated and sealed, with minor cobwebbing but no evidence of bat presence or use. The structure's thermal and physical conditions provide negligible suitability for roosting bats or other protected fauna.

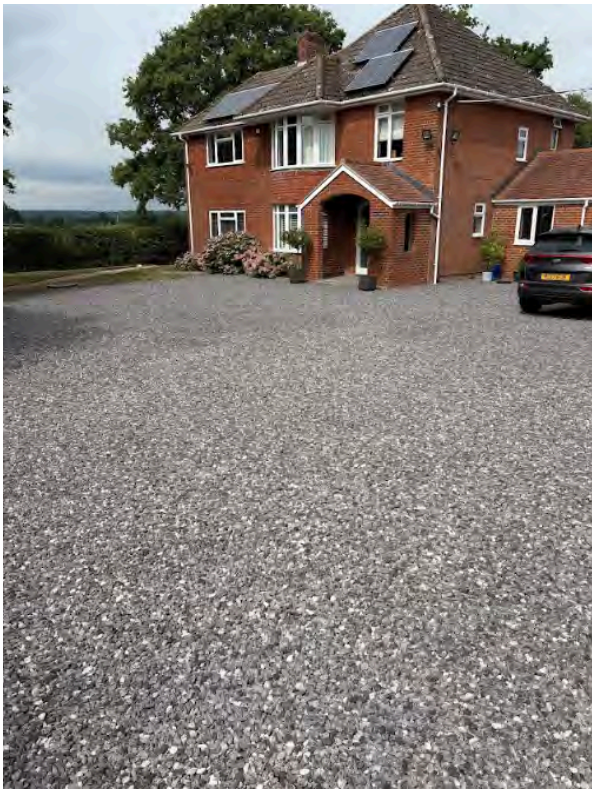
| <p>Habitat 2: u1c - artificial unvegetated, unsealed surface</p> | <p>HAB 2 consists of a gravel driveway and associated compacted gravel pathways that run through parts of the site. These areas are unsealed yet subject to frequent domestic use, leading to compaction and minimal vegetative colonisation. The aggregate is coarse to medium-grade and laid over a hard sub-base, typical of private residential access routes. The gravel surface is largely free of organic debris and does not support significant floral growth, though small localised patches of disturbance-tolerant species such as annual meadow-grass (<i>Poa annua</i>), creeping cinquefoil (<i>Potentilla reptans</i>), and dandelion (<i>Taraxacum officinale</i> agg.) were noted in more compacted or less-trafficked margins.</p> <p>Given the low structural complexity and lack of permanent vegetation, the habitat offers minimal value to invertebrates or small mammals and provides no cover or resources for breeding birds or reptiles. The ecological value is negligible, although potential exists for colonisation by pioneer species over time in less disturbed microhabitats. In its current state, the habitat remains heavily modified and of low ecological significance.</p> | <p>Photo 11</p> |

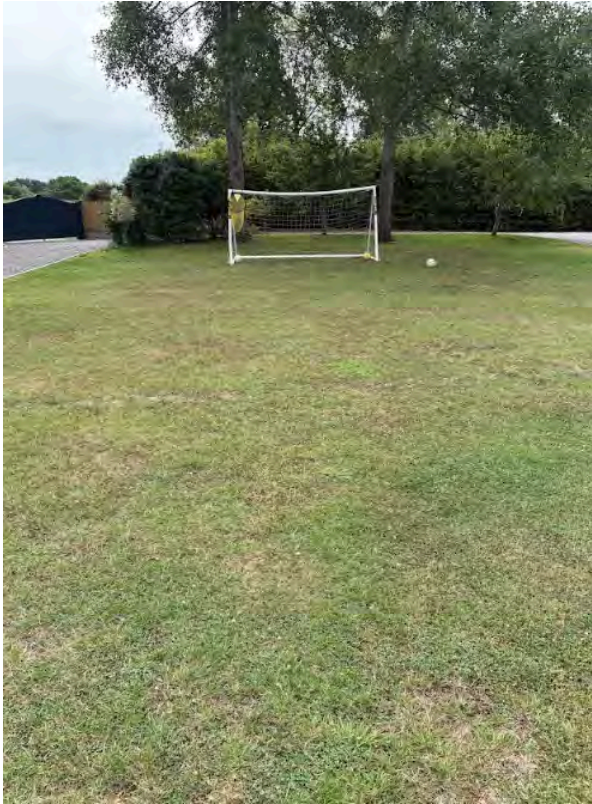
| <p>Habitat 3: u1 - vegetated garden</p> | <p>This habitat comprises the surrounding vegetated garden of grass, ornamental planting and boundary hedgerow. Amenity grassland within the curtilage of the property comprises a regularly mown lawn of low sward height, consistent with residential garden use. The sward is dominated by perennial ryegrass (<i>Lolium perenne</i>) and common bent (<i>Agrostis capillaris</i>), with abundant presence of broadleaved species including daisy (<i>Bellis perennis</i>), white clover (<i>Trifolium repens</i>), and creeping buttercup (<i>Ranunculus repens</i>). Lesser amounts of ribwort plantain (<i>Plantago lanceolata</i>) and self-heal (<i>Prunella vulgaris</i>) are also present, particularly along the transitional edges with planted borders and pathways. The lawn shows evidence of moderate trampling and recreational use but is structurally homogenous, offering limited botanical diversity and negligible potential for protected species. No anthills, bare patches or damp areas were noted. The habitat is managed and isolated from surrounding semi-natural habitats, reducing its potential to act as an ecological corridor.</p> <p>Ornamental shrub planting (HAB 2) is established along the margins of the property, primarily adjacent to built structures and bordering the driveway and patio areas. The planting is composed of a mix of non-native and native species maintained in a formal garden setting. Dominant species observed include cherry laurel (<i>Prunus laurocerasus</i>), butterfly bush (<i>Buddleja davidii</i>), and spotted laurel (<i>Aucuba japonica</i>), interspersed with occasional hydrangea (<i>Hydrangea macrophylla</i>) and cultivated varieties of rose (<i>Rosa</i> spp.). The shrub layer is structurally simple, with a uniform height due to regular pruning, and lacks a developed</p> | <p>Photo 14</p> |

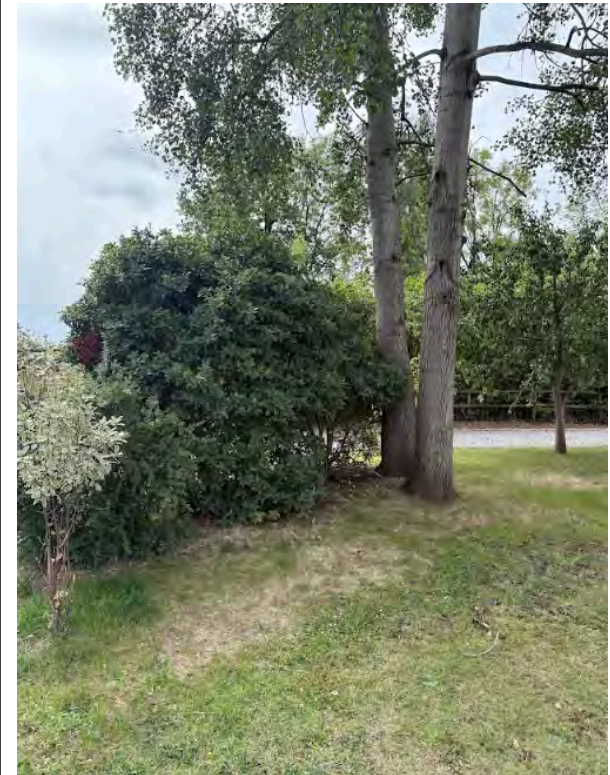
Photo 15

understorey. Ground cover in these beds is sparse, with some leaf litter and low-growing ornamental species such as hosta (*Hosta* spp.) and creeping jenny (*Lysimachia nummularia*). This habitat offers limited ecological value but may provide occasional shelter or foraging opportunities for common bird species and invertebrates, particularly where nectar-bearing ornamental species such as Buddleja are present.

The hedgerows are composed primarily of hawthorn (*Crataegus monogyna*), elder (*Sambucus nigra*), and bramble (*Rubus fruticosus* agg.), forming a discontinuous but functional shrub layer. The ground flora is restricted in diversity due to shading, though areas of common nettle (*Urtica dioica*), ivy (*Hedera helix*), and lords-and-ladies (*Arum maculatum*) are present.

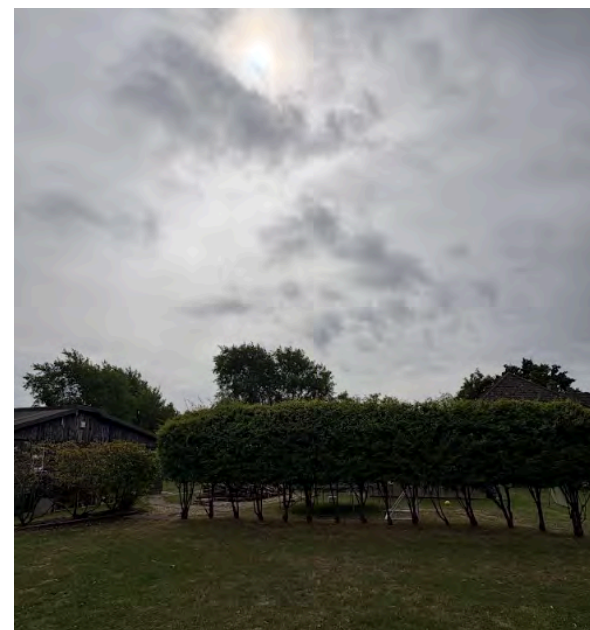
Photo 21

The ground layer includes common species typical of neutral garden grasslands, such as perennial ryegrass (*Lolium perenne*), daisy (*Bellis perennis*), creeping buttercup (*Ranunculus repens*), and common dandelion (*Taraxacum officinale* agg.), alongside localized patches of bare earth.

The orchard boundaries are defined by wooden fencing and ornamental planting, with limited structural connectivity to adjacent semi-natural habitats. There is no evidence of traditional orchard-associated features such as standing deadwood, fallen limbs, unmanaged hedgerows, or nectar-rich understory flora that would support a higher ecological value. Nonetheless, the orchard offers moderate value for invertebrates, birds, and pollinators due to the flowering and fruiting nature of the trees during seasonally active periods. Overall, the habitat is considered to be of low to moderate ecological value under UK Habitat Classification standards.

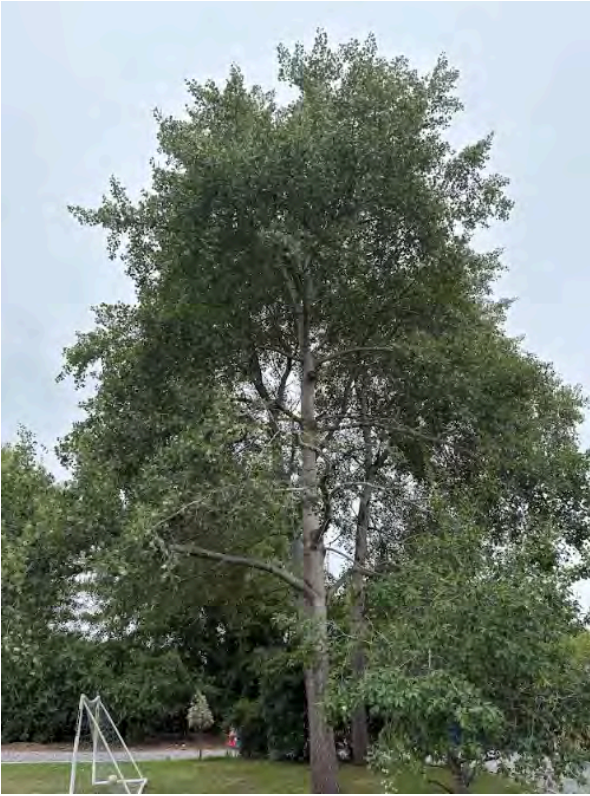
| <p>Habitat 5: g4 - scattered trees</p> | <p>The deciduous boundary scattered trees (HAB 5) provides a visual and ecological buffer from adjacent agricultural land. Species include mature English oak (<i>Quercus robur</i>), goat willow (<i>Salix caprea</i>) and Aspen (<i>Populus tremula</i>). Several of the mature trees support features such as rot holes, flaking bark, and split limbs that offer moderate potential for roosting bats and nesting birds. The trees function as a connective corridor within the wider landscape and contribute to the site's ecological connectivity. However, none are directly impacted by the proposed works.</p> <p><i>Species, Diameter at Breast Height (DBH), Grid reference, PRFs</i></p> <p>T1 - Aspen, 66cm, SU48371793, pruning wound<br/> T2 - Aspen, 65cm, SU48411794<br/> T3 - Aspen, 58cm, SU48411794<br/> T4- Aspen, 68cm, SU48411796, pruning wound<br/> T5 - Ash, could not access<br/> T6 - Willow, 75cm, SU48361798<br/> T7 - Oak, 100cm, SU48361797, ivy covered<br/> T8 - Oak, 120cm, SU48351795, cavities and split branches<br/> T9 - Oak, 110cm, SU48361794</p> | <p>Photo 25 - T1</p> |

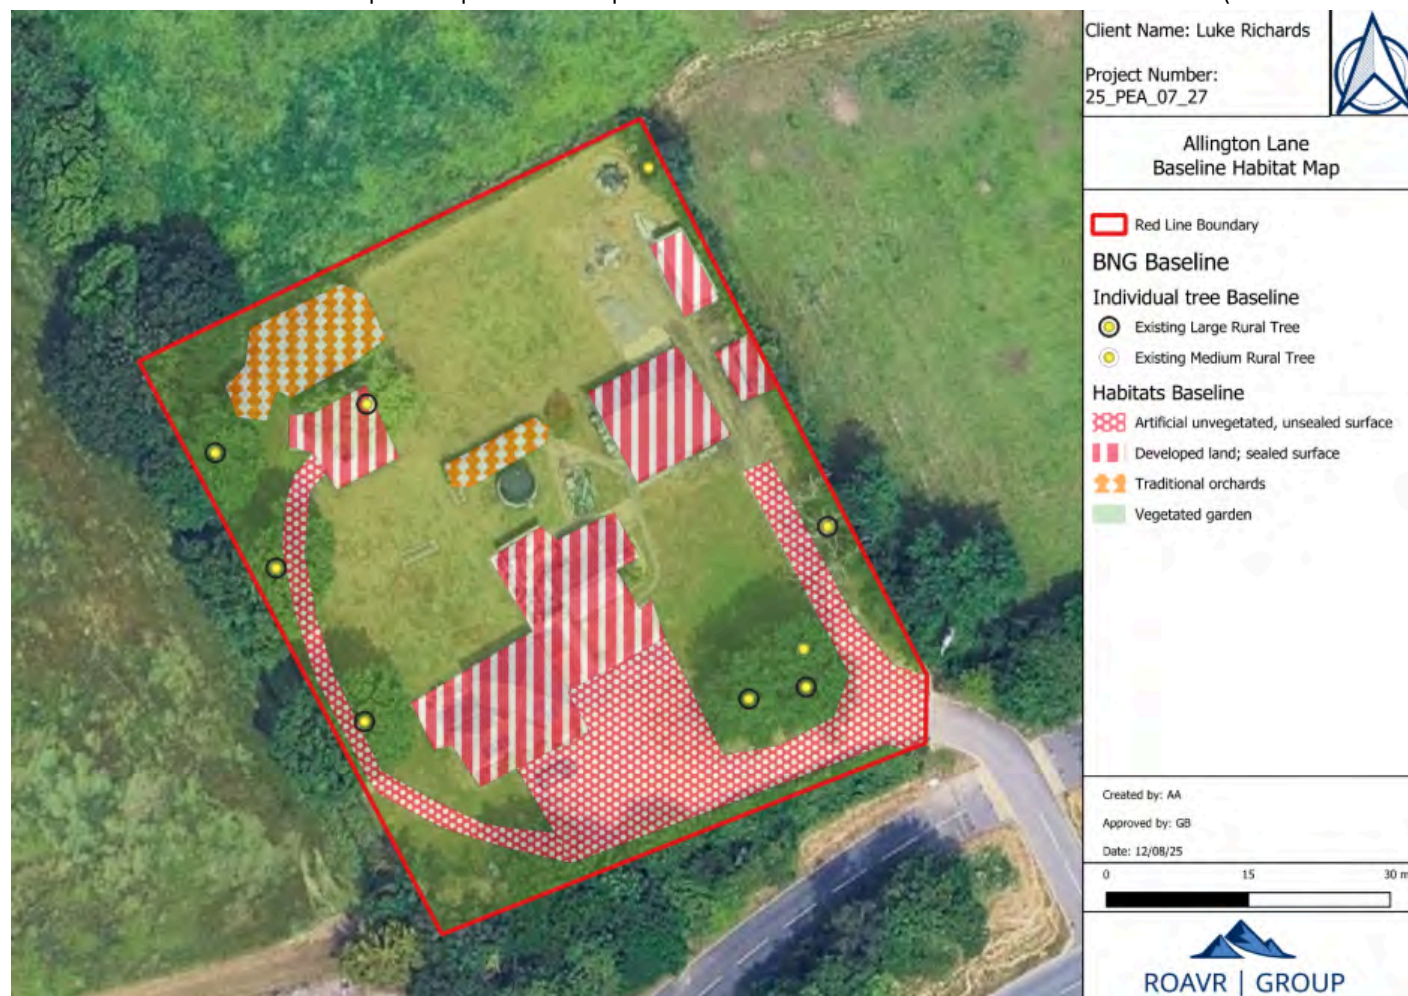
A3.1 The Site Habitat Map was produced per the UK Habitat Classification Manual (Butcher et al., 2020).
