## Preliminary Ecological Appraisal and Roost Assessment

253 Winchester Road, Chandler's Ford, Eastleigh, Hampshire, SO53 2DX

**Project:** This report is prepared to inform a planning application with the Eastleigh District Council. The proposal is described as:  
The destruction of the current detached dwelling and the building of two semi-detached properties with associated gardens.  
[Unsubmitted]

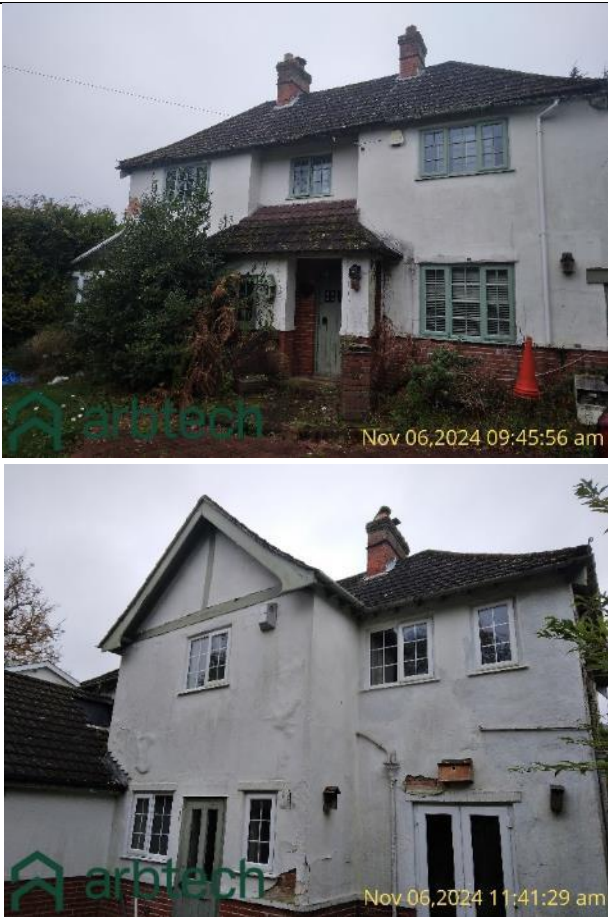
| <p><i>Summary</i></p> <p>B1 is a detached residential property. The building has not been currently lived in for at least 4 years. The building is two-storey, however, has one-storey extensions on the northeast elevation and a one-storey conservatory attached on the west elevation.</p> <p>It is a red brick building, with rendering on the walls. The main roof is a t-shaped roof with hipped east and west ends and a gable-ended roof on the north elevation. The one-storey extension has a single-pitch northern gable-ended roof. However, where this joins onto B1 this forms an extended end to the east hipped roof down to one-storey in height.</p> <p>There are two central red-brick chimneys.</p> <p>There is also a hipped porch on the south elevation.</p> <p>Plans include the demolition of this building and the construction of a pair of semi-detached residential properties in its place.</p> | | | |

| <i>Recommendations</i> | <p><b>Roosting habitat [Buildings]</b><br/> One bat emergence/re-entry surveys are required on B1 during the active bat season (May – September) to confirm presence/likely-absence of bats roosting in or on the building.<br/> These survey visits should be completed during the optimal survey period mid-May to August inclusive. The survey visits should be at least three weeks apart.<br/> Sub-optimal: early May and September. Would require greater justification of timing e.g., weather conditions, known local bat activity.</p> <p>Three surveyors are required to provide full coverage of the building's elevations to look for emerging/re-entering bats. An infrared camera should also be employed as part of the survey to see where any specific roost locations are located.</p> <p>If any bat roosts are confirmed from this survey schedule additional two surveys will be required and a bat licence would be required to demolish the buildings as it would involve the destruction of roosts. This is applied for with the help of a class 2 licensed bat ecologist after planning permission is granted, but before commencement of works.</p> <p><b>Foraging and commuting habitat</b></p> |

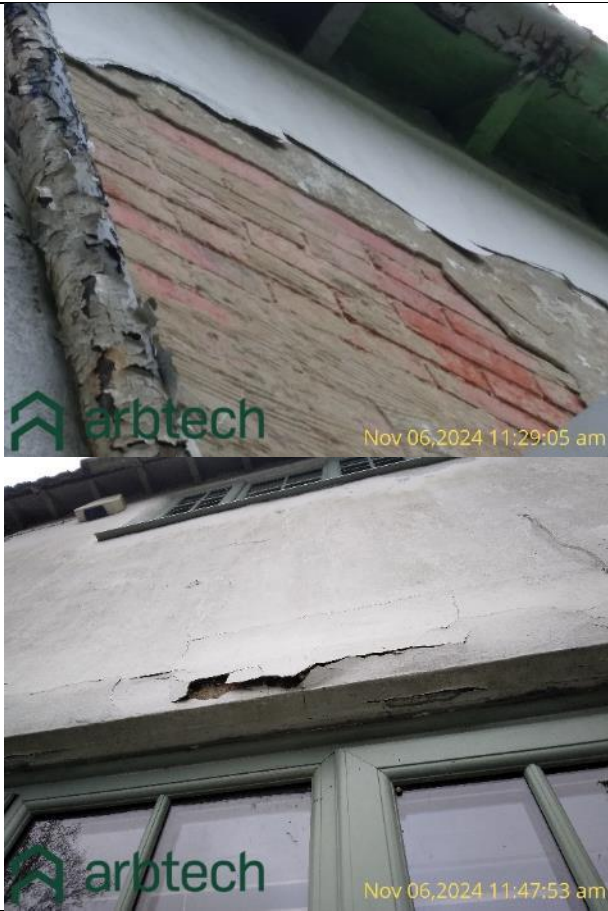
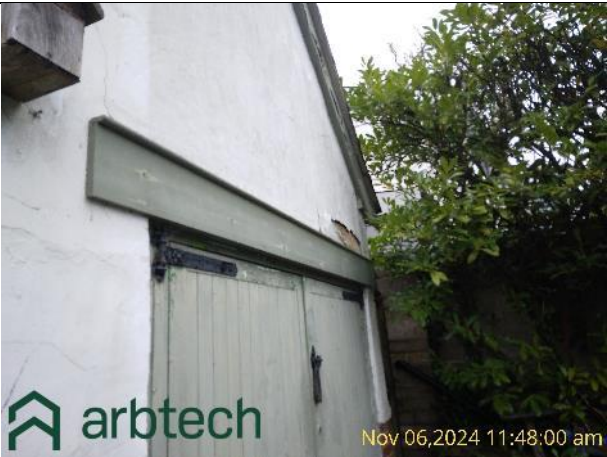
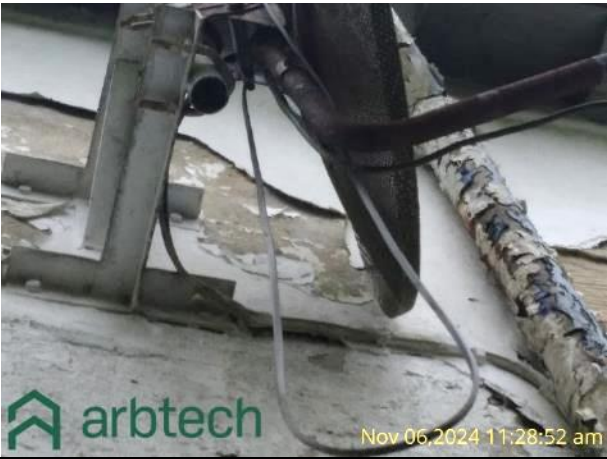
| Walls | Red brick-rendering., | <p><b>Condition/description</b></p> <p>Numerous locations on the walls where the plaster has fallen from the walls. Leaving accessible gaps under the plaster, this was seen on the south, north and west wall elevations on both the ground and first floor heights. It is unknown how long the plaster has been in this condition.</p> <p><b>Suitability/access/evidence of bats</b></p> <p>Larger gaps under the plaster can support an ideal roosting habitat for crevice dwelling. However, due to lack of continuous suitable depth throughout the plaster, this would not be large enough to support any maternity roosting. This has the potential to support single-number, day-roosting bats such as pipistrelle .</p> | |

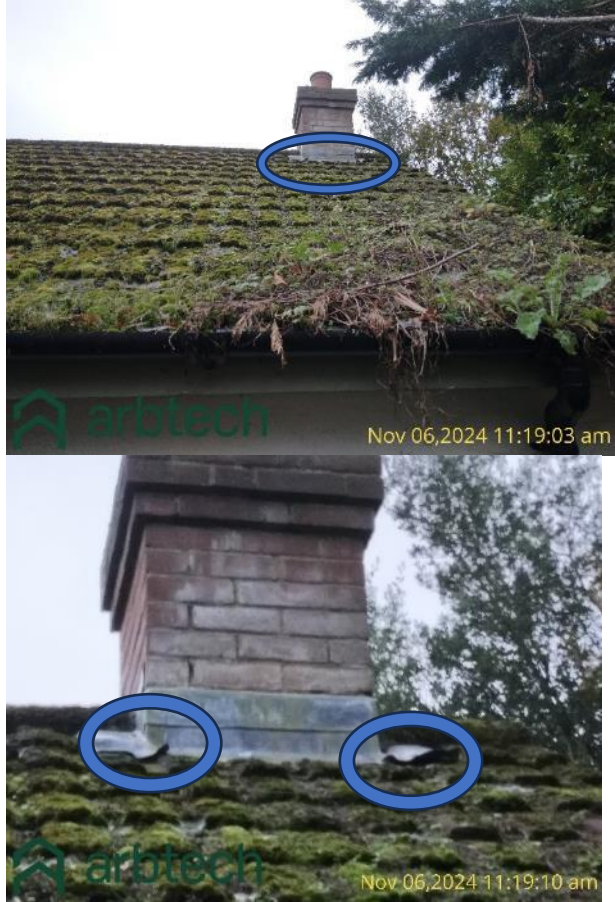
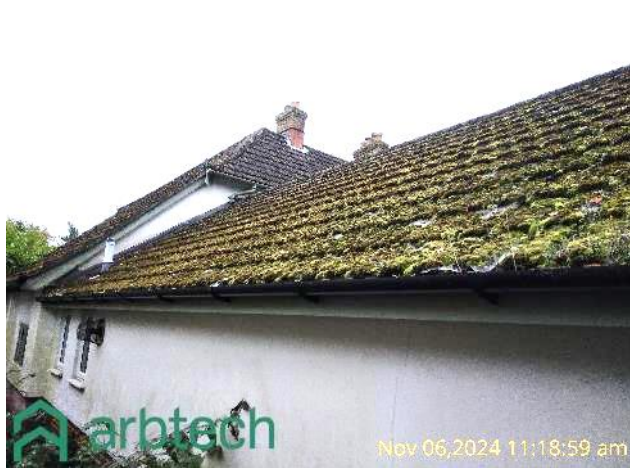
| Roof | Clay | <p><b>Condition/description</b><br/>Interlocking cement tiles on both roof elevations. No lifting or missing tiles observed.</p> <p><b>Suitability/access/evidence of bats</b><br/>Space under tiles could accommodate crevice dwelling bats. due to the size of the roof and the sheer volume of available habitat, this is suitable to support maternity roosts of crevice dwelling bats. No evidence found but recent and current rain would wash this away externally</p> | |

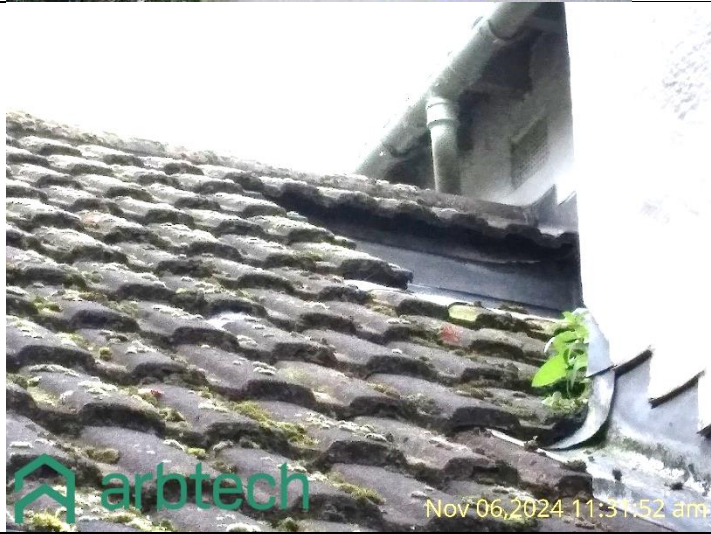
| Eaves | Overhanging, wooden, no soffit present | <p><b>Condition/description</b></p> <p>There is one notable gap within the eaves of the one-storey roof where the roof connects to the two-storey wall in the northern corner. The design is due to a window on the wall to allow space to open. The eaves within this design area are open.</p> <p>No other gaps within the eaves were observed within the one-storey roof. Eaves of the two-storey roof is wooden overhanging eaves with no soffit box.</p> <p><b>Suitability/access/evidence of bats</b></p> <p>Provides possible bat access into tiles of the one-storey roof for crevice dwelling bats.</p> | |

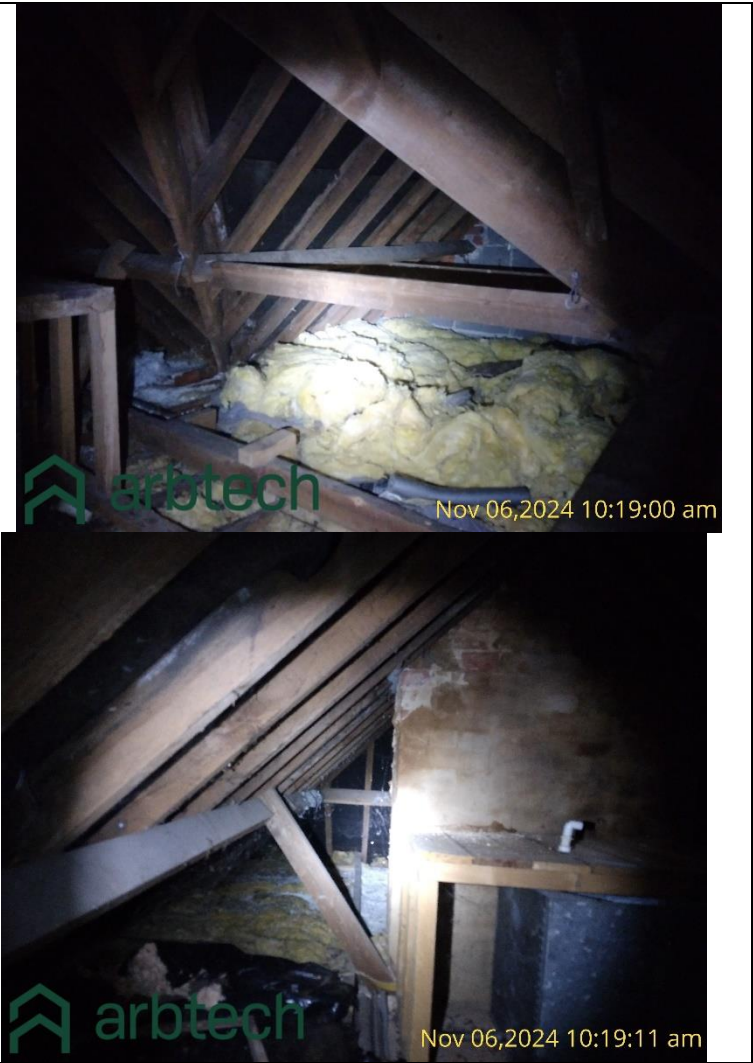
| Internal voids | Timber rafters and ridge beam. Open floor to ridge. Supporting struts and trusses. Two central chimneys. Loose wool roll insulation. | <p><b>Condition/description</b></p> <p>1.9m high, 8m long and 4.8m wide at the T-junction. The two chimneys are present within the central space of the loft, but navigation was possible around to fully access all spaces.</p> <p>There is a loose wool insulation which shows a lot of signs of chewing and tearing due to rodents.</p> <p>The roof lining is a bitumen felt, with no major rips or tears observed. The loft space has a high volume of undisturbed cobwebs indicating there hasn't been any recent flying activity inside.</p> <p><b>Suitability/access/evidence of bats</b></p> <p>No direct evidence of void-dwelling bats was observed in this loft space. However, the entire loft space was covered in a very high volume of rat and mouse droppings. There is a chance that bat droppings may have been overlooked as a result.</p> <p>Looking in key areas, such as focusing against gable walls, around the two chimneys and under the ridge line did not yield any bat-dropping findings.</p> | |

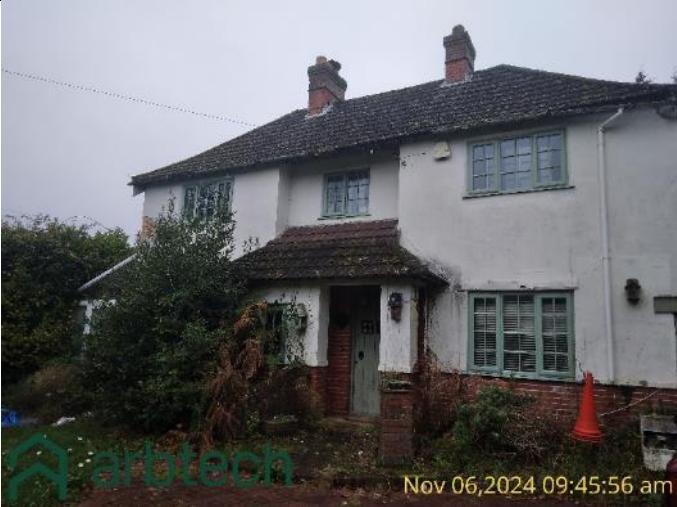
| Buildings | |
|---|---|
| | Figure 1: Main dwelling (B1) on site |

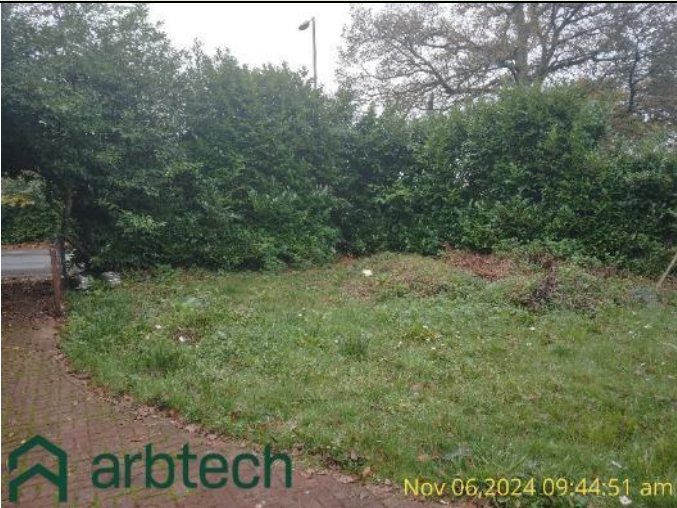
| Buildings | |
|---|---|
| | Figure 2: Amenity grass lawn on site (south lawn) |

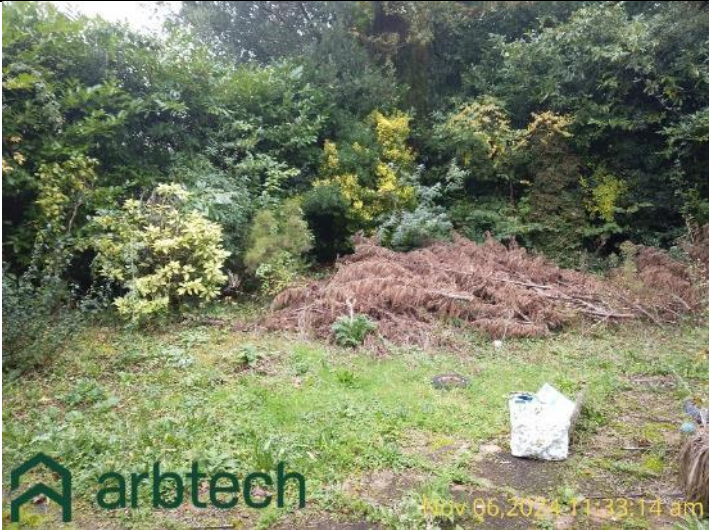
| Introduced shrubs | |
|---|---|
| | <p>Figure 3: Introduced shrubs on site withing northern garden, partially covered by an overgrown hedgerow boundary, also showcasing piled up cleared shrubs</p> |

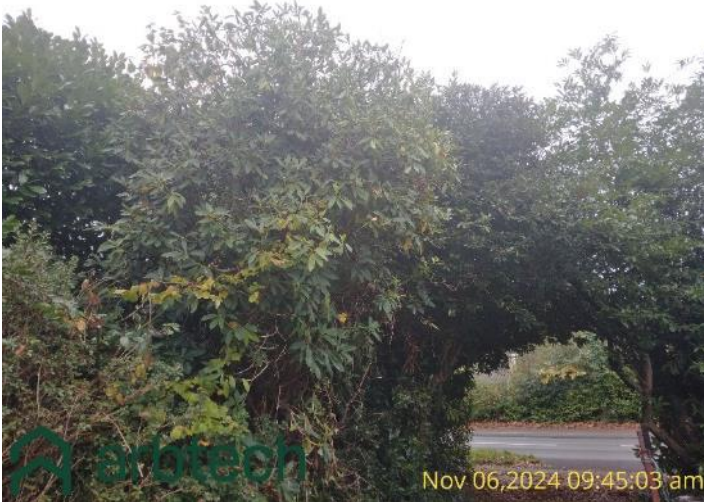
| Non native hedgerows | |
|---|---|
| <p>Figure 5: Scattered trees present on site (along southern site boundary)</p> | |

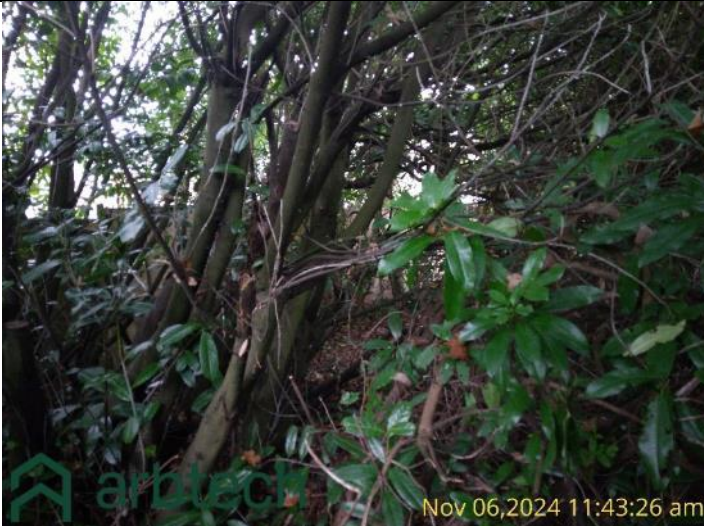
| Non native hedgerows | |
|---|---|
| <p>Figure 6: Showing the density of cherry laurel along the northern boundary, as it has been left unmanaged in a hedgerow appearance.</p> | |

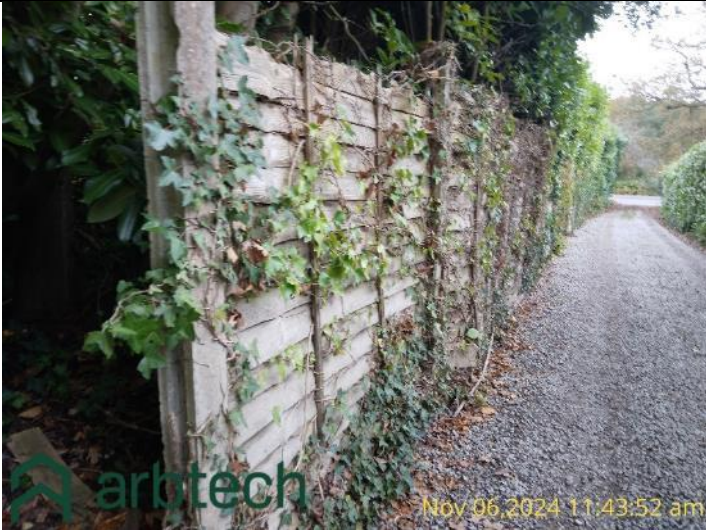
| Fence boundary | |
|---|---|
| | <p>Figure 7: Fence boundary on the west boundary</p> |

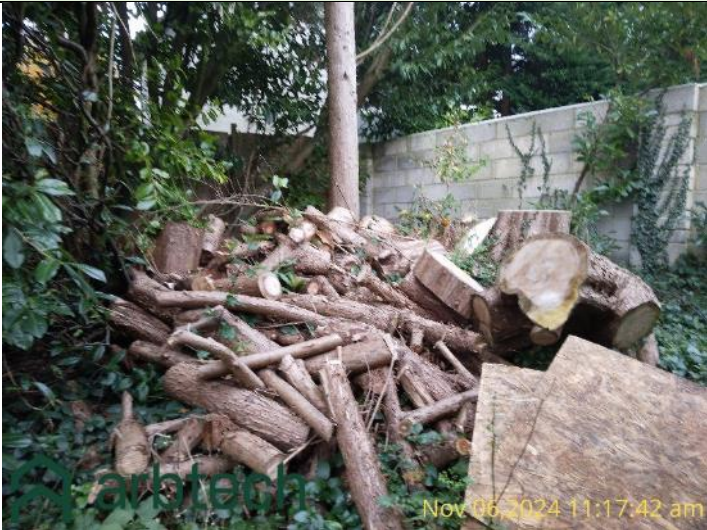
| <i>Summary of Survey Findings</i> | <p>The garden on-site offers foraging and hibernation opportunities for hedgehogs. There was evidence of hedgehogs visiting the southern garden as a single hedgehog droppings was observed within the grass area. Access to this part of the site would be easily achieved through the laurel hedgerow, as there is a lack of fencing surrounding the southern garden. Access to the northern garden is more limited due to the fence and wall boundary, but there are some broken gaps of the western fence.</p> <p>There are several log and brash piles in both the southern and northern gardens (See Fig 8-10) which would serve as hibernation opportunities for hedgehogs.</p> |

| Fence boundary | |
|---|---|
| | <p>Figure 8: Log piles northeastern corner from a felled tree breeze block wall boundary also viewable</p> |

| <i>Recommendations</i> | <p>A precautionary working method will be implemented during construction, including the following measures:</p> <ul style="list-style-type: none"> <li>Any excavations will be covered overnight, or a ramp will be installed to enable any trapped animals to escape.</li> <li>Brash, rubble and log piles will be removed and dismantled by hand. This should be undertaken outside of the hedgehog hibernation season (Nov-March) to avoid harm to hibernation individuals.</li> <li>Any chemicals or pollutants used or created by the development should be stored and disposed of correctly according to COSHH regulations.</li> </ul> <p>If any hedgehogs are found in the working area these should be allowed to disperse of their own accord or, if at immediate risk, should be moved by hand to a sheltered, vegetated area away from disturbance. If hibernating hedgehogs are discovered, then advice must be sought from local rescues</p> <p><b>Suggested biodiversity enhancements</b></p> <p>The following habitat creation and enhancement opportunities could be incorporated into the proposed development which would be beneficial for hedgehogs:</p> <ul style="list-style-type: none"> <li>Use the clear brash to create a hibernation pile. This can be done in one of the northern corners underneath the laurels</li> <li>Installation of gaps under boundary fencing to enable hedgehogs to move freely through the site.</li> </ul> |

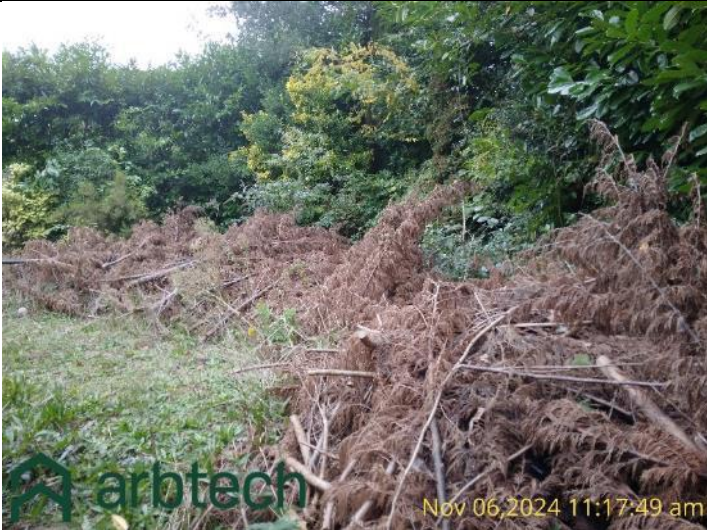
| Brash piles | |
|---|---|
| | Figure 9: Brash and wood piles left scatterd in northern garden |

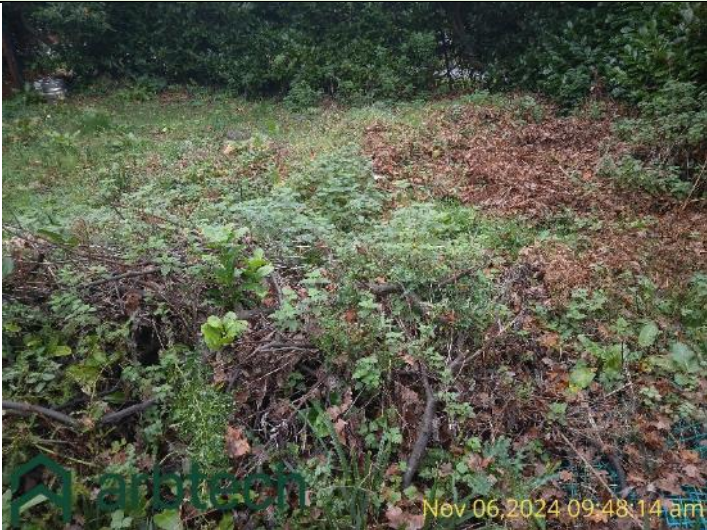
| Brash piles | |
|---|---|
| | Figure 10: Old rubble pile covered in vegetation, and brash pile, southern garden |
