# **Land at Denham's Corner, Horton Heath**

*Active Travel Assessment*

15<sup>th</sup> September 2025  
DN/NS/24478-05a AT Assessment

Southern Strategic Limited

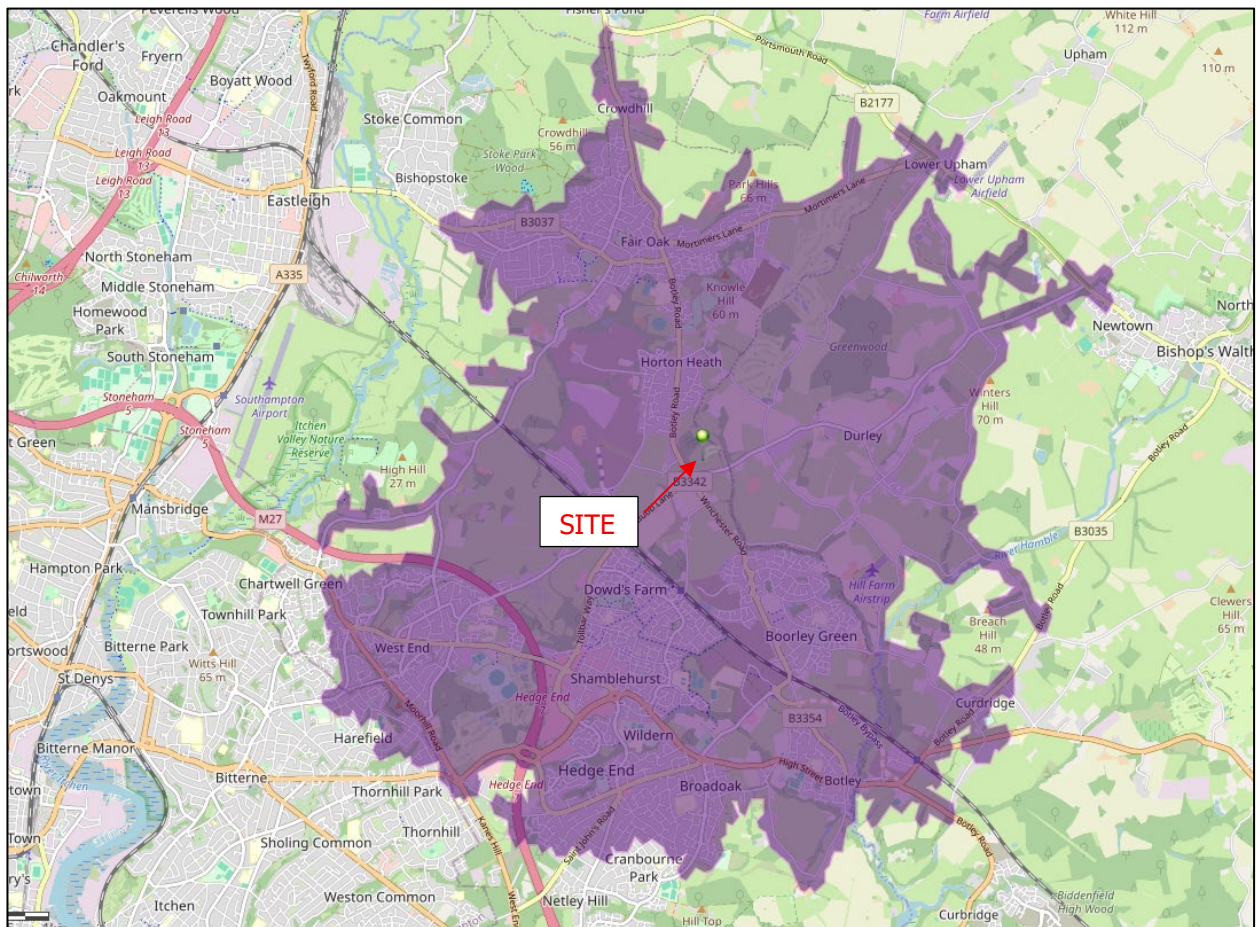
**Figure 2: Active Travel Zone**

- 4.1.1 The defined area stretches around the proposed development encompassing a zone within a 20-minute cycle journey. The AT area extent for the application site is illustrated in **Figure 2** below.

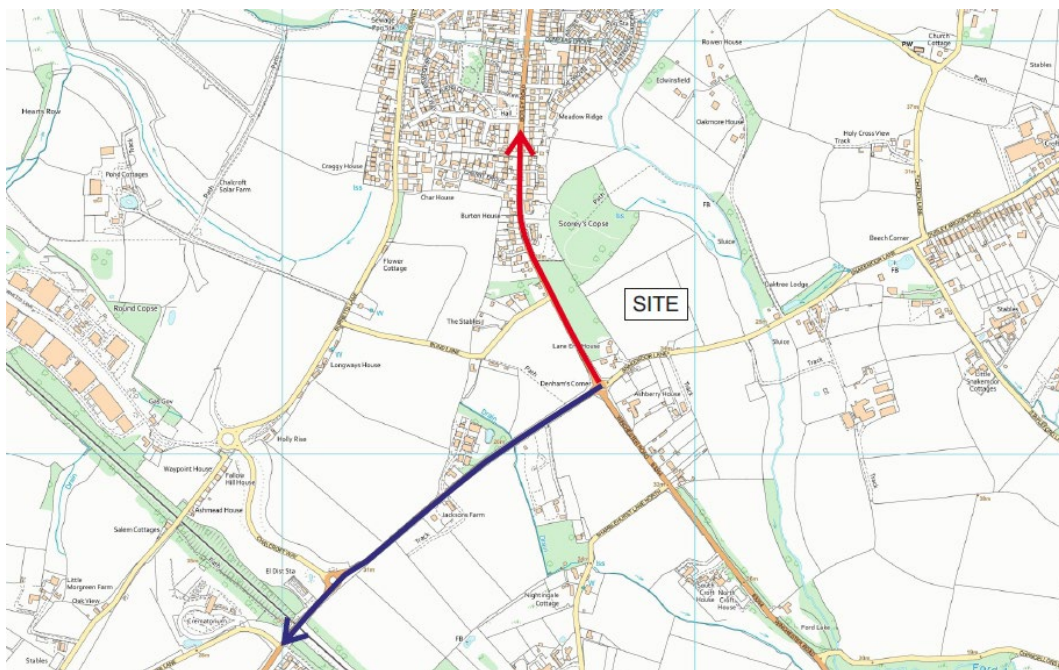
**Figure 3:** AT Area Routes for Assessment

4.3.1 Based on the priority of key destinations within the AT area, five routes have been identified to capture the key destinations that will most likely be undertaken frequently by future users. These routes are as follows:

4.3.3 The AT area routes are presented in **Figure 3** and assessment results are presented following on.

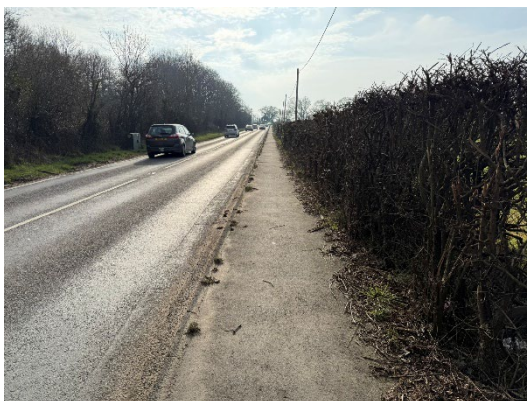
**Photograph 1:** Botley Road

- 4.3.4 The pedestrian and cycle route to Wyvern College is approximately 2km from the centre of the site via the proposed access onto Botley Road. The petrol filling station with Londis is c1km from the centre of the site along the same route. This stock top up convenience goods as well as some limited fresh produce. The nearest bus stops are c250m from the centre of the site on Botley Road. The route along Botley Road provides an off carriageway footway with cyclists being required to travel within the carriageway. The footway is located on the southern side of the carriageway near to the site with a northern footway also being provided further north. This is shown on **Photograph 1** and **Photograph 2**. The route has been assessed against the eight healthy streets criteria below.

| Healthy Streets Indicator | Route Appraisal & Suggested Area for Improvement |
|---|---|
| Easy to cross | There is a continuous footway along the southern/western side of Botley Road. A footway commences on the eastern side of the carriageway beyond the Brigadier Gerald public house. A new Toucan Crossing will be provided by the pedestrian and cycle access into the site. There are central pedestrian refuges to the north that facilitate safer crossing. The central refuges could benefit from replacement/ provision of tactile paving. |
| People feel safe | The majority of the journey feels generally safe. Street lighting is present north of the site within the 30mph section of Botley Road. The footway is generally of sufficient width for pedestrians to stay an adequate distance away from passing traffic. There are some local pinch points where the footway narrows. |

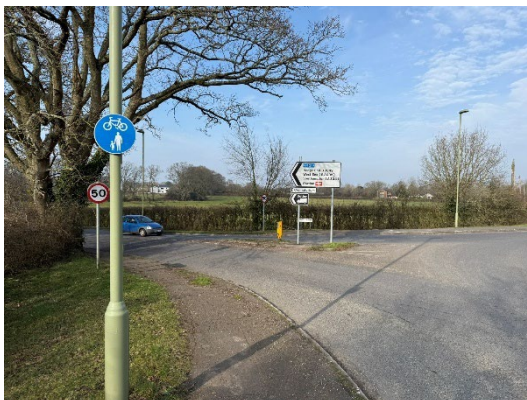
**Photograph 3:** Bubb Lane Roundabout

- 4.3.6 The distance to the railway station is approximately 2km (5 mins cycle and 30 mins walk) from the site access with the centre of the business and retail park being 3km (11 min cycle and 42 mins walk). The route is a shared footway/ cycleway on the eastern side of the carriageway. The surface of the route is overall of good quality, however, in places, mainly to the north, the route is c1.5m in width, however, during the site visit the use of the route was low and likely to lead to little conflict. The existing crossing point at the northern end of Bubb Lane and the route in the vicinity are shown on **Photograph 3** and **Photograph 4**.

| Healthy Streets Indicator | Route Appraisal & Suggested Area for Improvement |
|---|---|
| Easy to cross | There is a continuous footway/ cycleway with occasional side road crossings via either signalised crossings or splitter islands. |

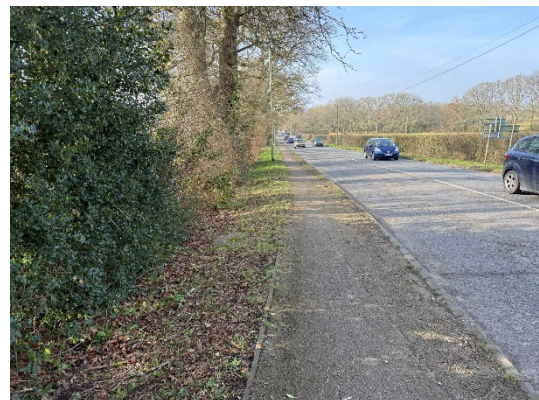
**Photograph 4:** Bubb Lane Shared Facility

- 4.3.5 The existing shared use facility runs along Bubb Lane for either connecting to a path parallel to the Eastleigh-Fareham rail line for access to the railway station or continuing along Tollbar Way to the Herald Industrial Estate and Hedge End Retail Park.

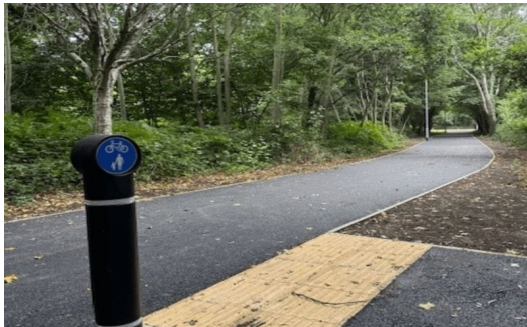
**Photograph 5:** Hedge End Railway Connection

- 4.3.7 The connection from Bubb Lane towards Railway Station and the crossing along Tollbar Way at Maunsell Way roundabout are shown on **Photograph 5** and **Photograph 6**.
- 4.3.8 Importantly, the link between the railway station and Bubb Lane has been widened to 3 metres and will be lit, offering a shared space for walkers, cyclists, buggies, wheelchairs, and mobility scooters. This upgrade improves safety and accessibility, making it easier to commute to and from the station as a more sustainable option.
