## Detailed UXO Risk Assessment

**FIG Reference:** 3997R

**Project:** Hedge End

**Site Location:** Kings Copse Avenue, Hedge End

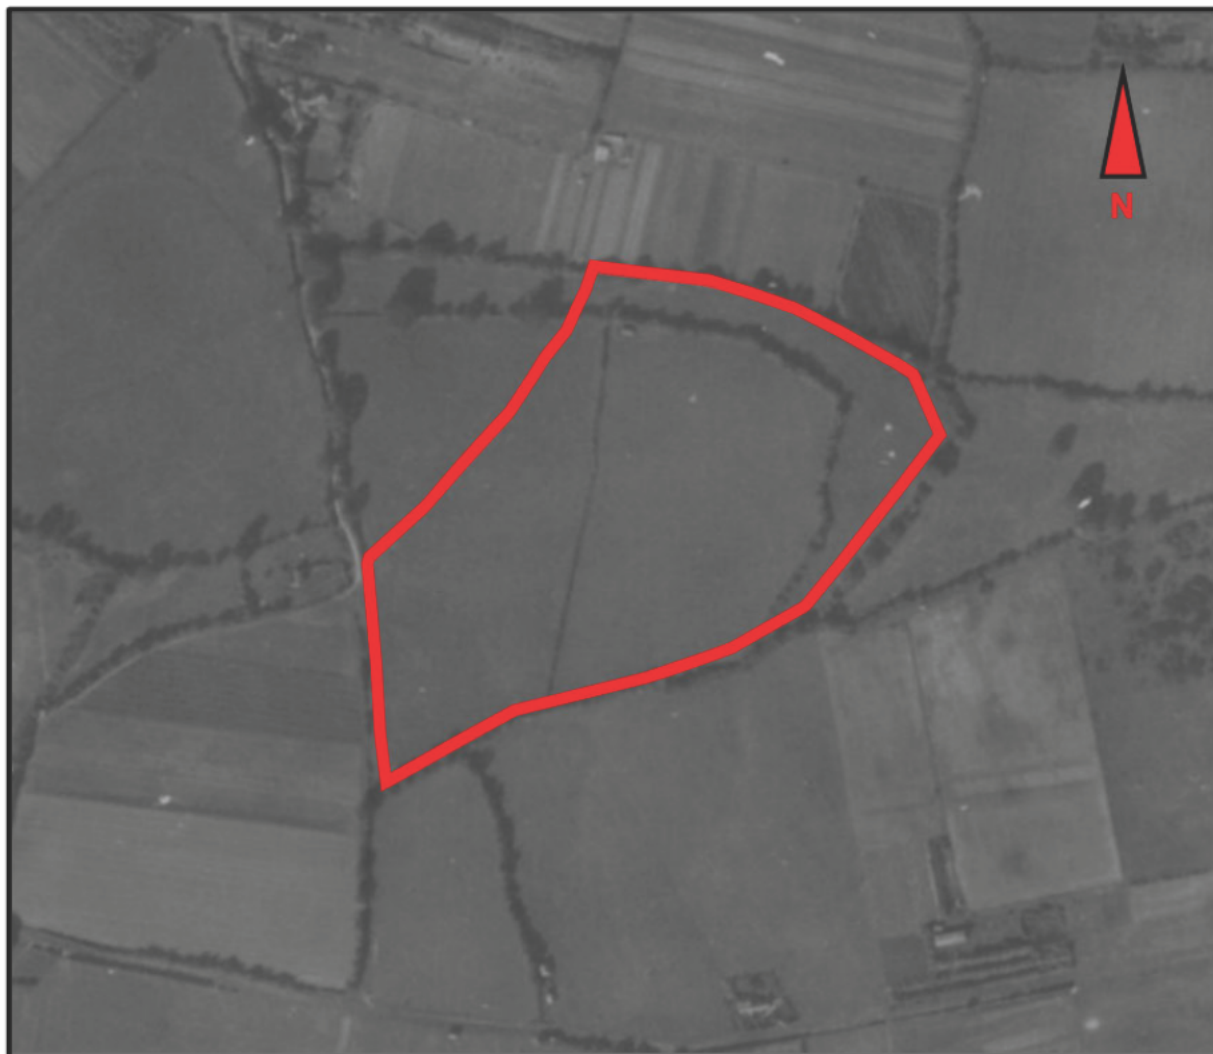
Figure 2. Showing a September 1940 dated air photograph detailing the site and the surrounding area.

During WW2 the site comprised open ground east of Tanhouse Lane associated with agriculture with mature vegetation present in the north and northeast.

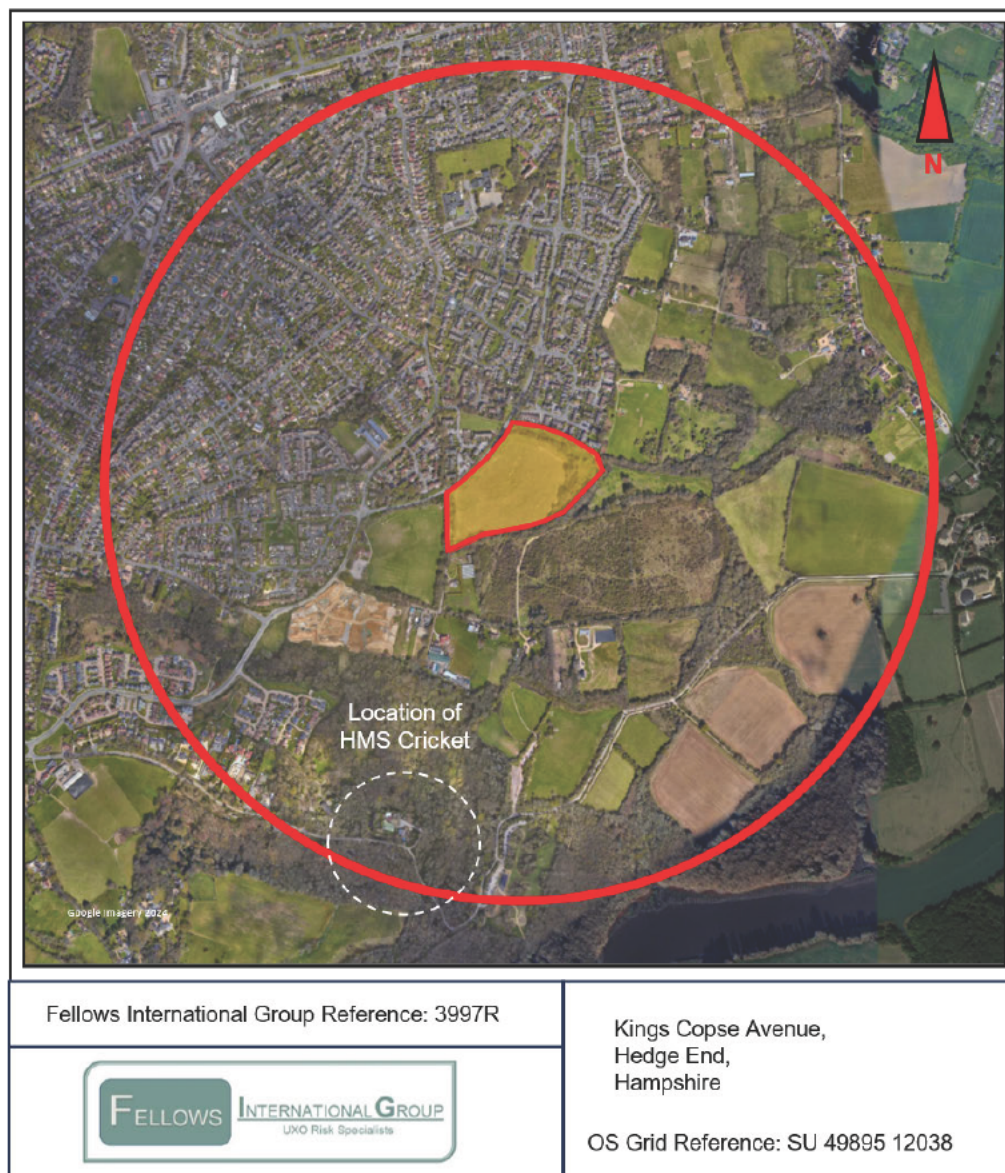
Figure 4. Showing the location of the WW2 sites in context to the Site.

Research has not identified any military use of the site. The nearest military sites in a 1km radius to the site were HMS Cricket, a Combined Operations Base and landing craft training and marshalling site and WW2 D-Day temporary camp identified as Camp C3. These sites are not considered to pose any significant UXO risk. The risk of encountering other munitions is therefore assessed as **low**.

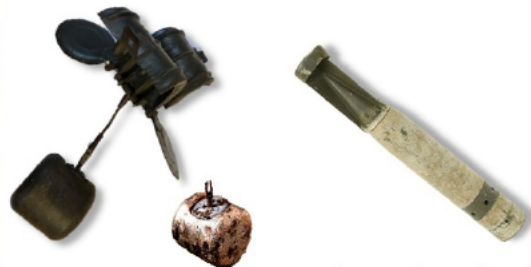
German 'Butterfly' Bomb

German Incendiary Bomb

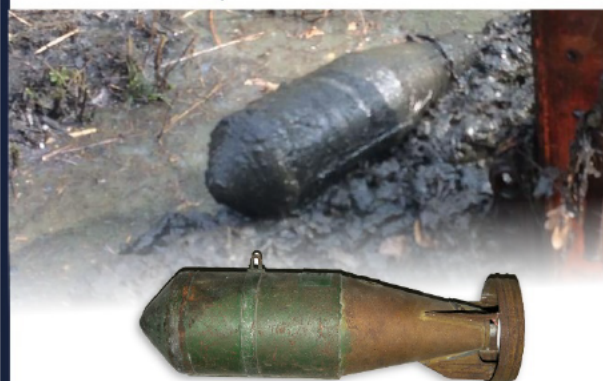
British Pyrotechnic Smoke Float

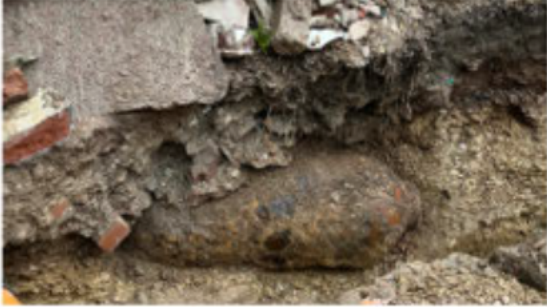
| | <p><b><u>Plymouth - Devon - February 2024</u></b></p> <p>An unexploded German SC500 bomb was discovered by a homeowner digging in the back garden of the property.</p> <p><b>Removed and disposed of at sea</b></p> <p><b>Left Image:</b> showing the bomb partially recovered.</p> |

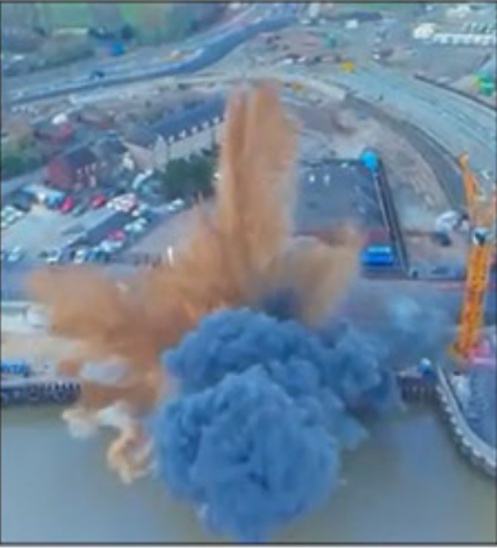
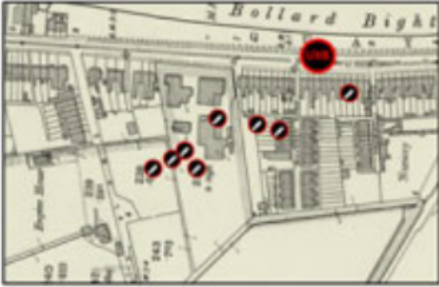
| | <p><b><u>Great Yarmouth - February 2023</u></b></p> <p>An unexploded German 250kg bomb discovered during construction works. <b>Context:</b> Sea wall.</p> <p><b>Destroyed in situ</b></p> <p><b>Left Image:</b> Showing the bomb detonating during the render safe procedure</p> <p><b>Below image:</b> showing the location where the bomb was destroyed.</p> |

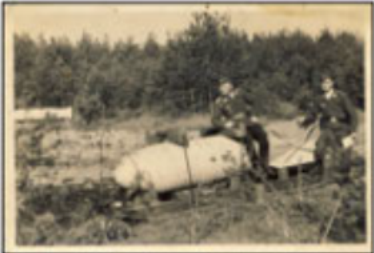
| | <p><b><u>Exeter, Devon - March 2021</u></b></p> <p>An unexploded German 1,000kg bomb discovered during construction works. <b>Context:</b> Open ground, undeveloped since WWII.</p> <p><b>Destroyed in situ.</b></p> <p><b>Left Image:</b> Where the bomb was discovered. <b>Right image:</b> an example of the bomb found.</p> |
