**5015142/RJH/815**

**Planning Application F/19/84937**  
**Maddoxford Phase 2 – Verification Report**

**Ridge 2025**

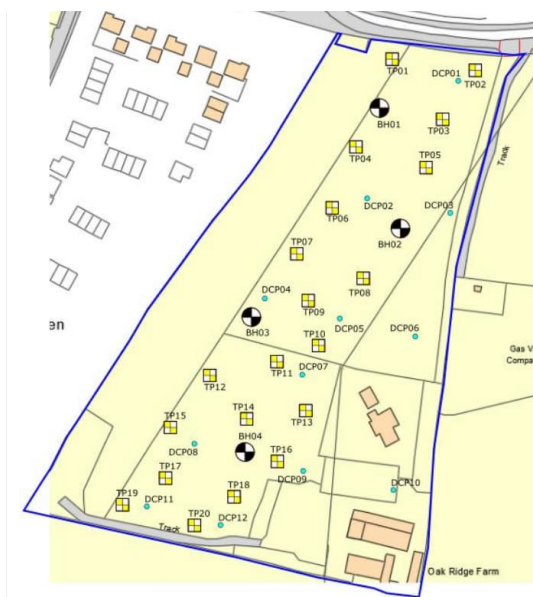
Figure 1 Ridge 2021-22 Exploratory Hole Locations

Four cable percussive boreholes sample boreholes (BH01 - 04) were advanced through the base of their respective inspection pits to a maximum intrusive depth of 15.00mbgl.

Twenty machine excavated trial pits (TP01-20) were advanced across the development area, targeting proposed building footprints, carparking areas, access roads and areas of public open space. These were excavated to a maximum depth of 2.60mbgl to provide an assessment of the underlying ground conditions and also permit soil sampling.

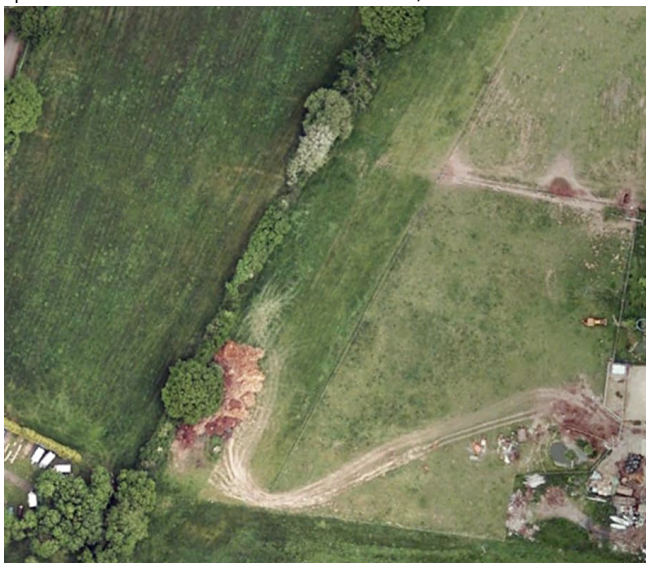
Plate 1. 1/1/2005

Aerial imagery of the area in question is shown in chronological order below. The image from 2005 clearly shows the mound to be farmyard waste, manure, stable clearings etc likely from the cleaning out of the adjacent farm buildings with a vehicle route to the stockpile clearly shown. It is apparent in the last two images that the area in question has been reduced in level, with the mound having been removed.

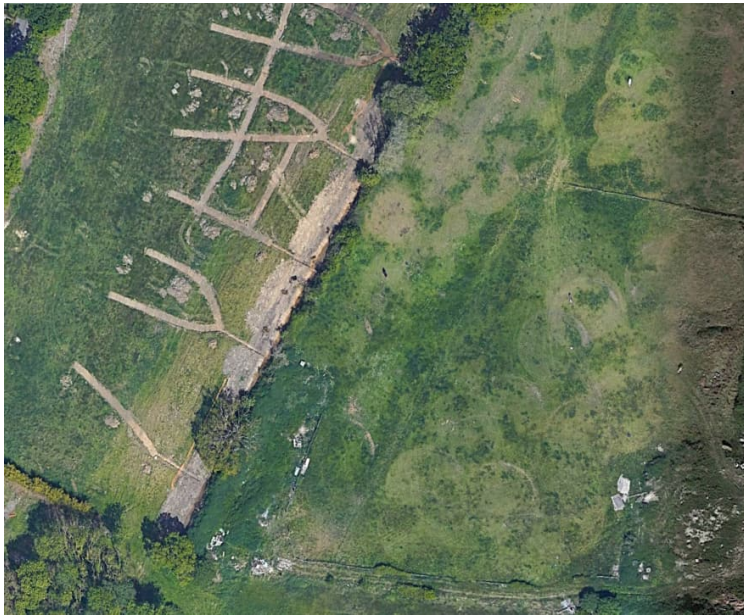
Plate 3. 5/6/2020

By 2020 this area is grassed and appears to be fenced off and does not appear to be being used.

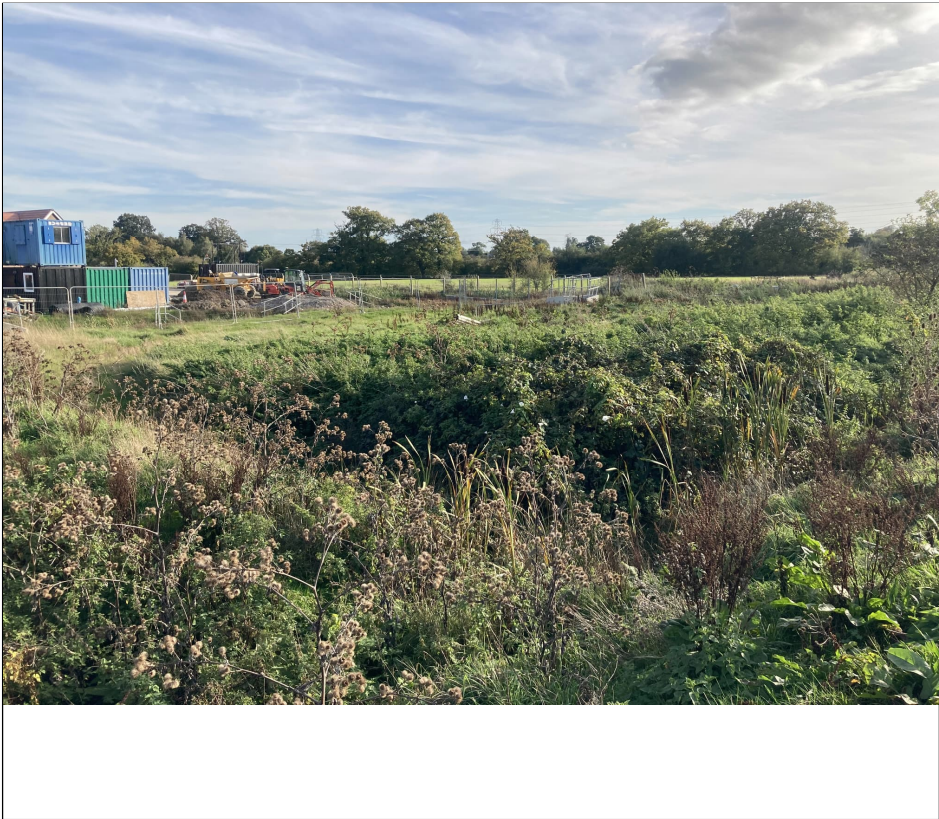
| Photo No. | Date | |
|---|---|---|
| 1 | 7/10/25 | |

A Geo-Environmental Engineer from Ridge visited the site on 7/10/25 and inspected the area in question. It is apparent that the former mound and associated manure / compost heaps have been removed from site. Photographs showing this area are enclosed. It is clearly visible that this area is level and aligns topographically with land to the north and south. A separate bund is present between Fieldfare Crescent and the Phase 2 development to the east, outside of the P2 redline boundary.

| Photo No. | Date | |
|---|---|---|
| <p>Photo Title<br/>View south-east across the former bund area.</p> | | |

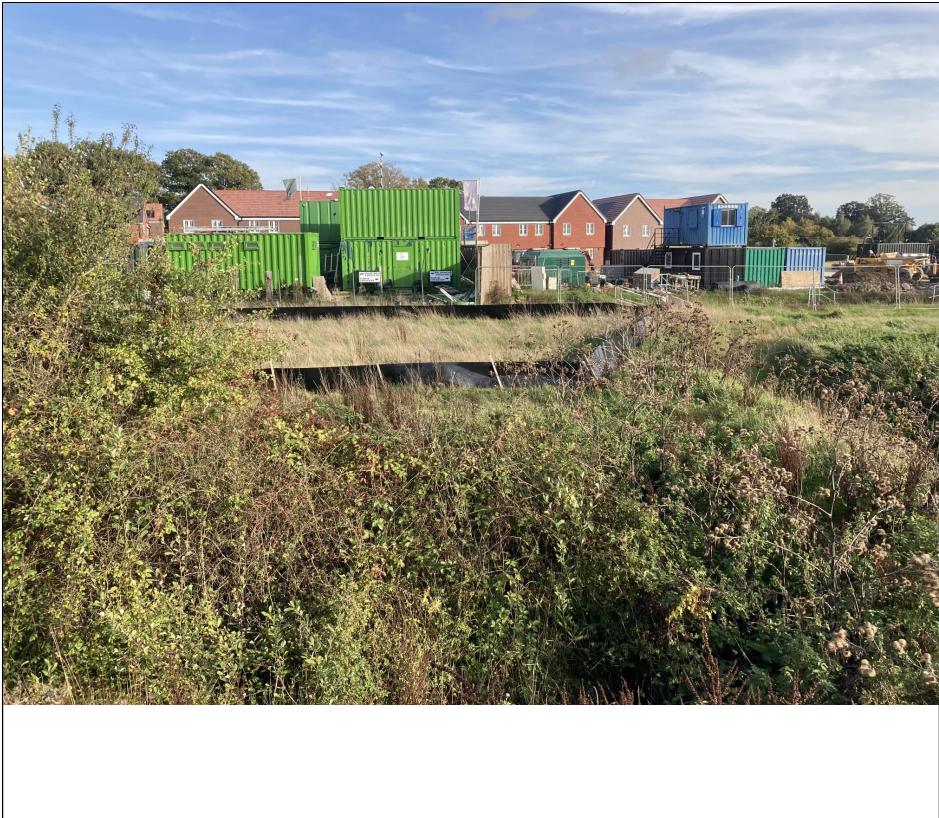
| Photo No. | Date | |
|---|---|---|
| 2 | 7/10/25 | |

| Photo No. | Date | |
|---|---|---|
| <p>Photo Title<br/>View east across former bund area. Previous reptile barrier in centre-ground.</p> | | |

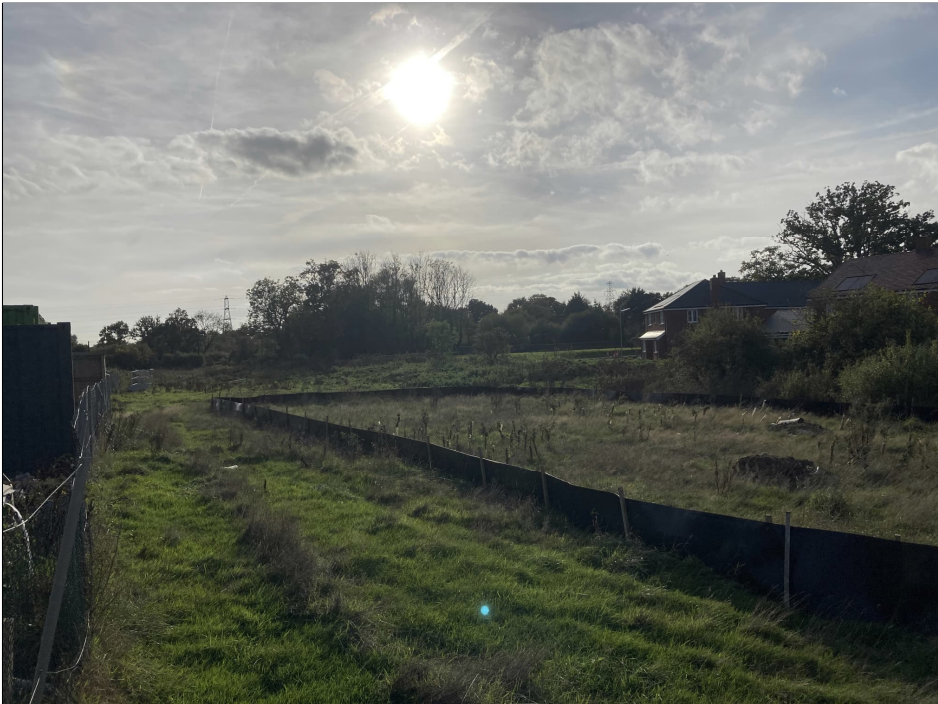
| Photo No. | Date | |
|---|---|---|
| 3 | 7/10/25 | |

| Photo No. | Date | |
|---|---|---|
| <p>Photo Title</p> <p>View south across former bund area. Level area clearly shown.</p> | | |

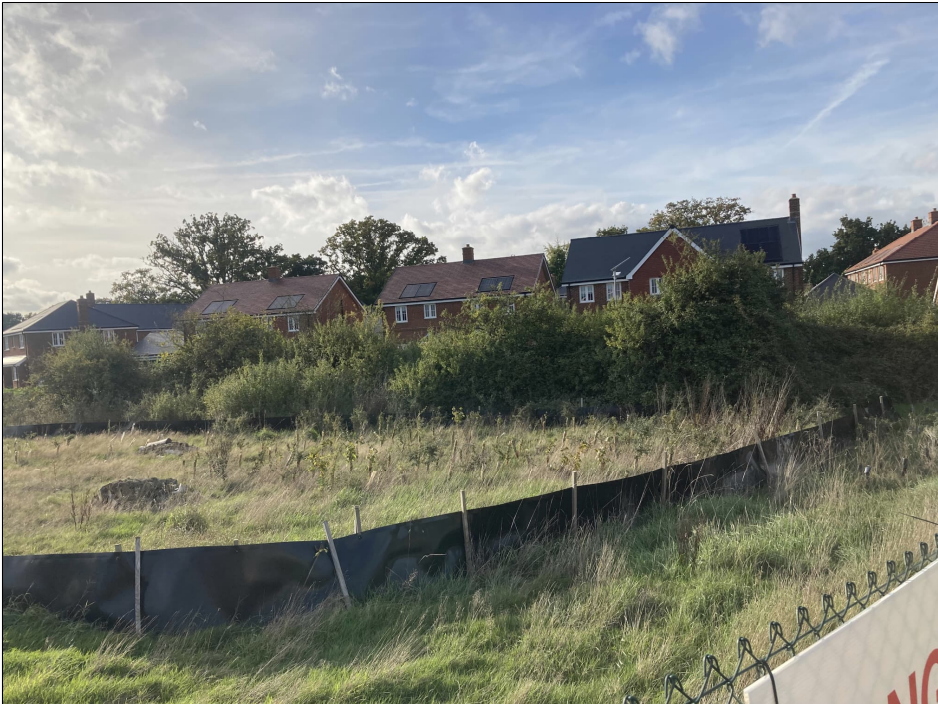
| Photo No. | Date | |
|---|---|---|
| 4 | 7/10/25 | |

| Photo No. | Date | |
|---|---|---|
| <p>Photo Title</p> <p>View west across former bund area to Phase 1 Development.</p> | | |
