**GROUND INVESTIGATION REPORT**

**ONE HORTON HEATH – QUOBLEIGH BREACH AND FIR TREE FARM,**

**EASTLEIGH BOROUGH COUNCIL**

| Reference: | GE19906-GIRv2.0-MAR22 |

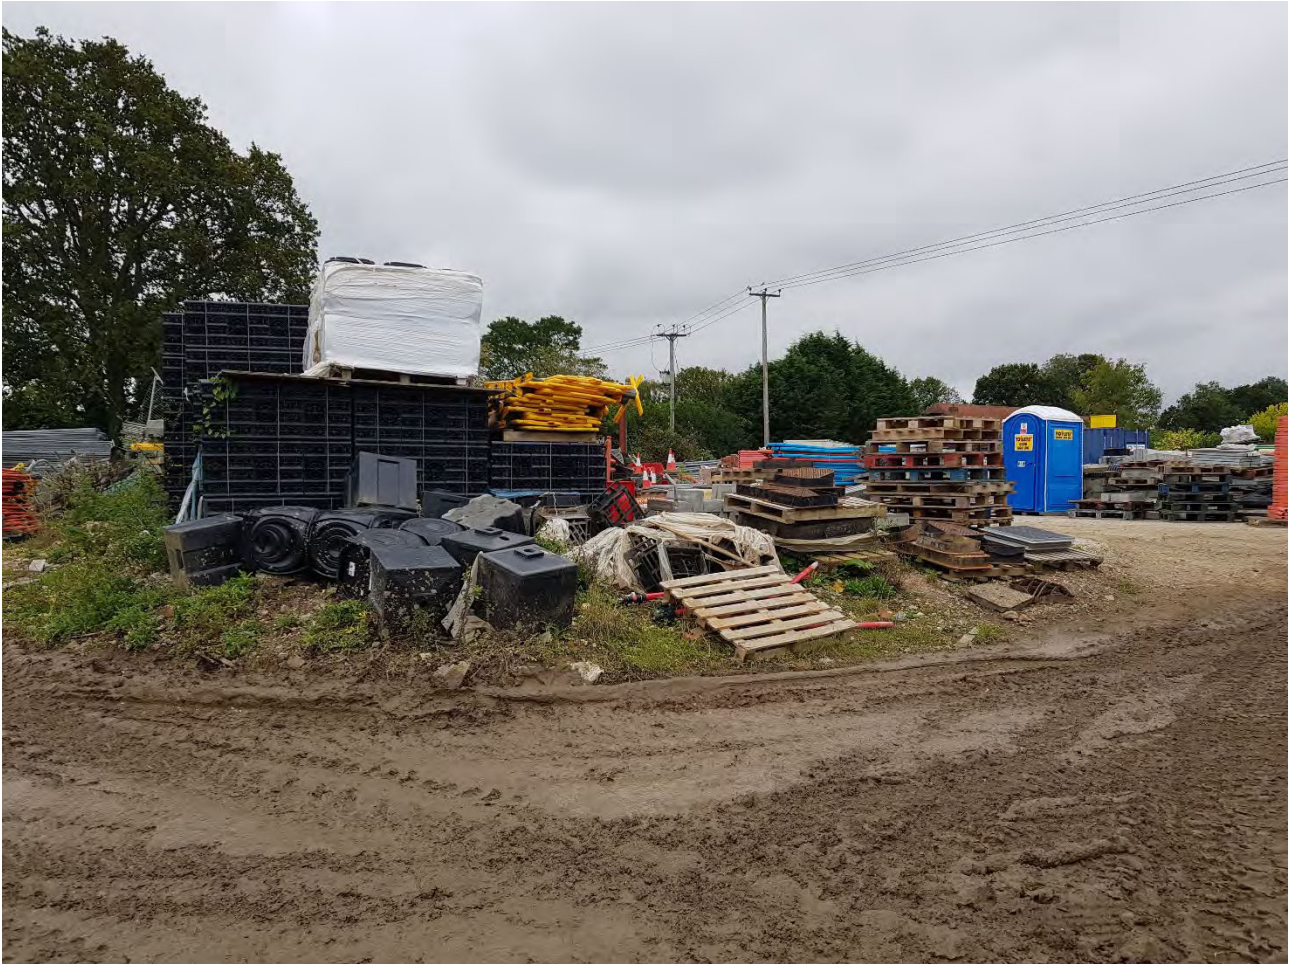
Plate 13 - Photograph showing material storage in the site compound area

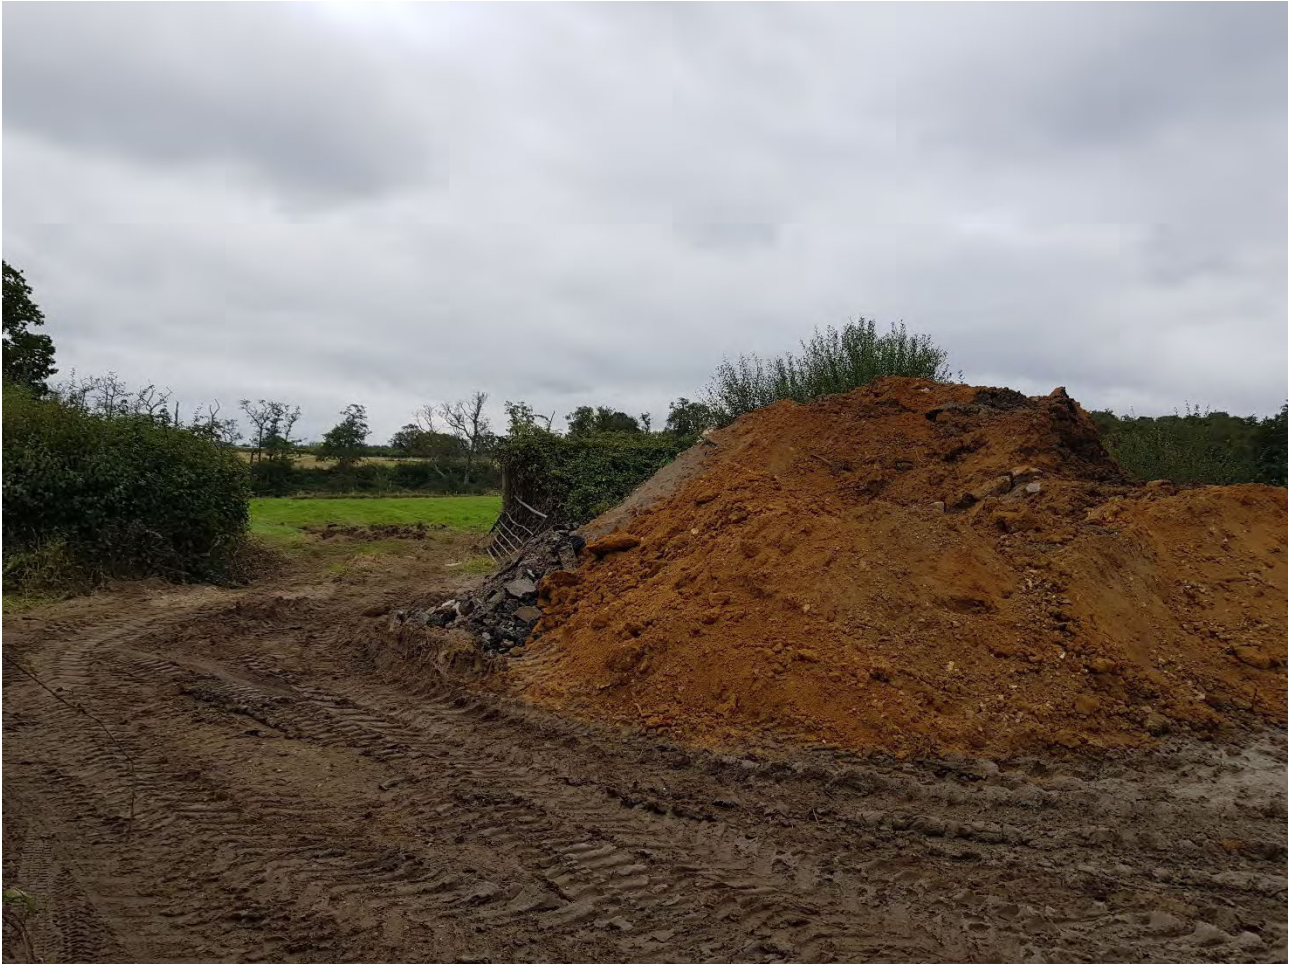
Plate 15 - Photograph showing material storage in the site compound area
