# **Parkside, One Horton Heath, Hampshire**

## **Preliminary Ground Investigation Report**

**December 2025**

Prepared for:  
Eastleigh Borough Council

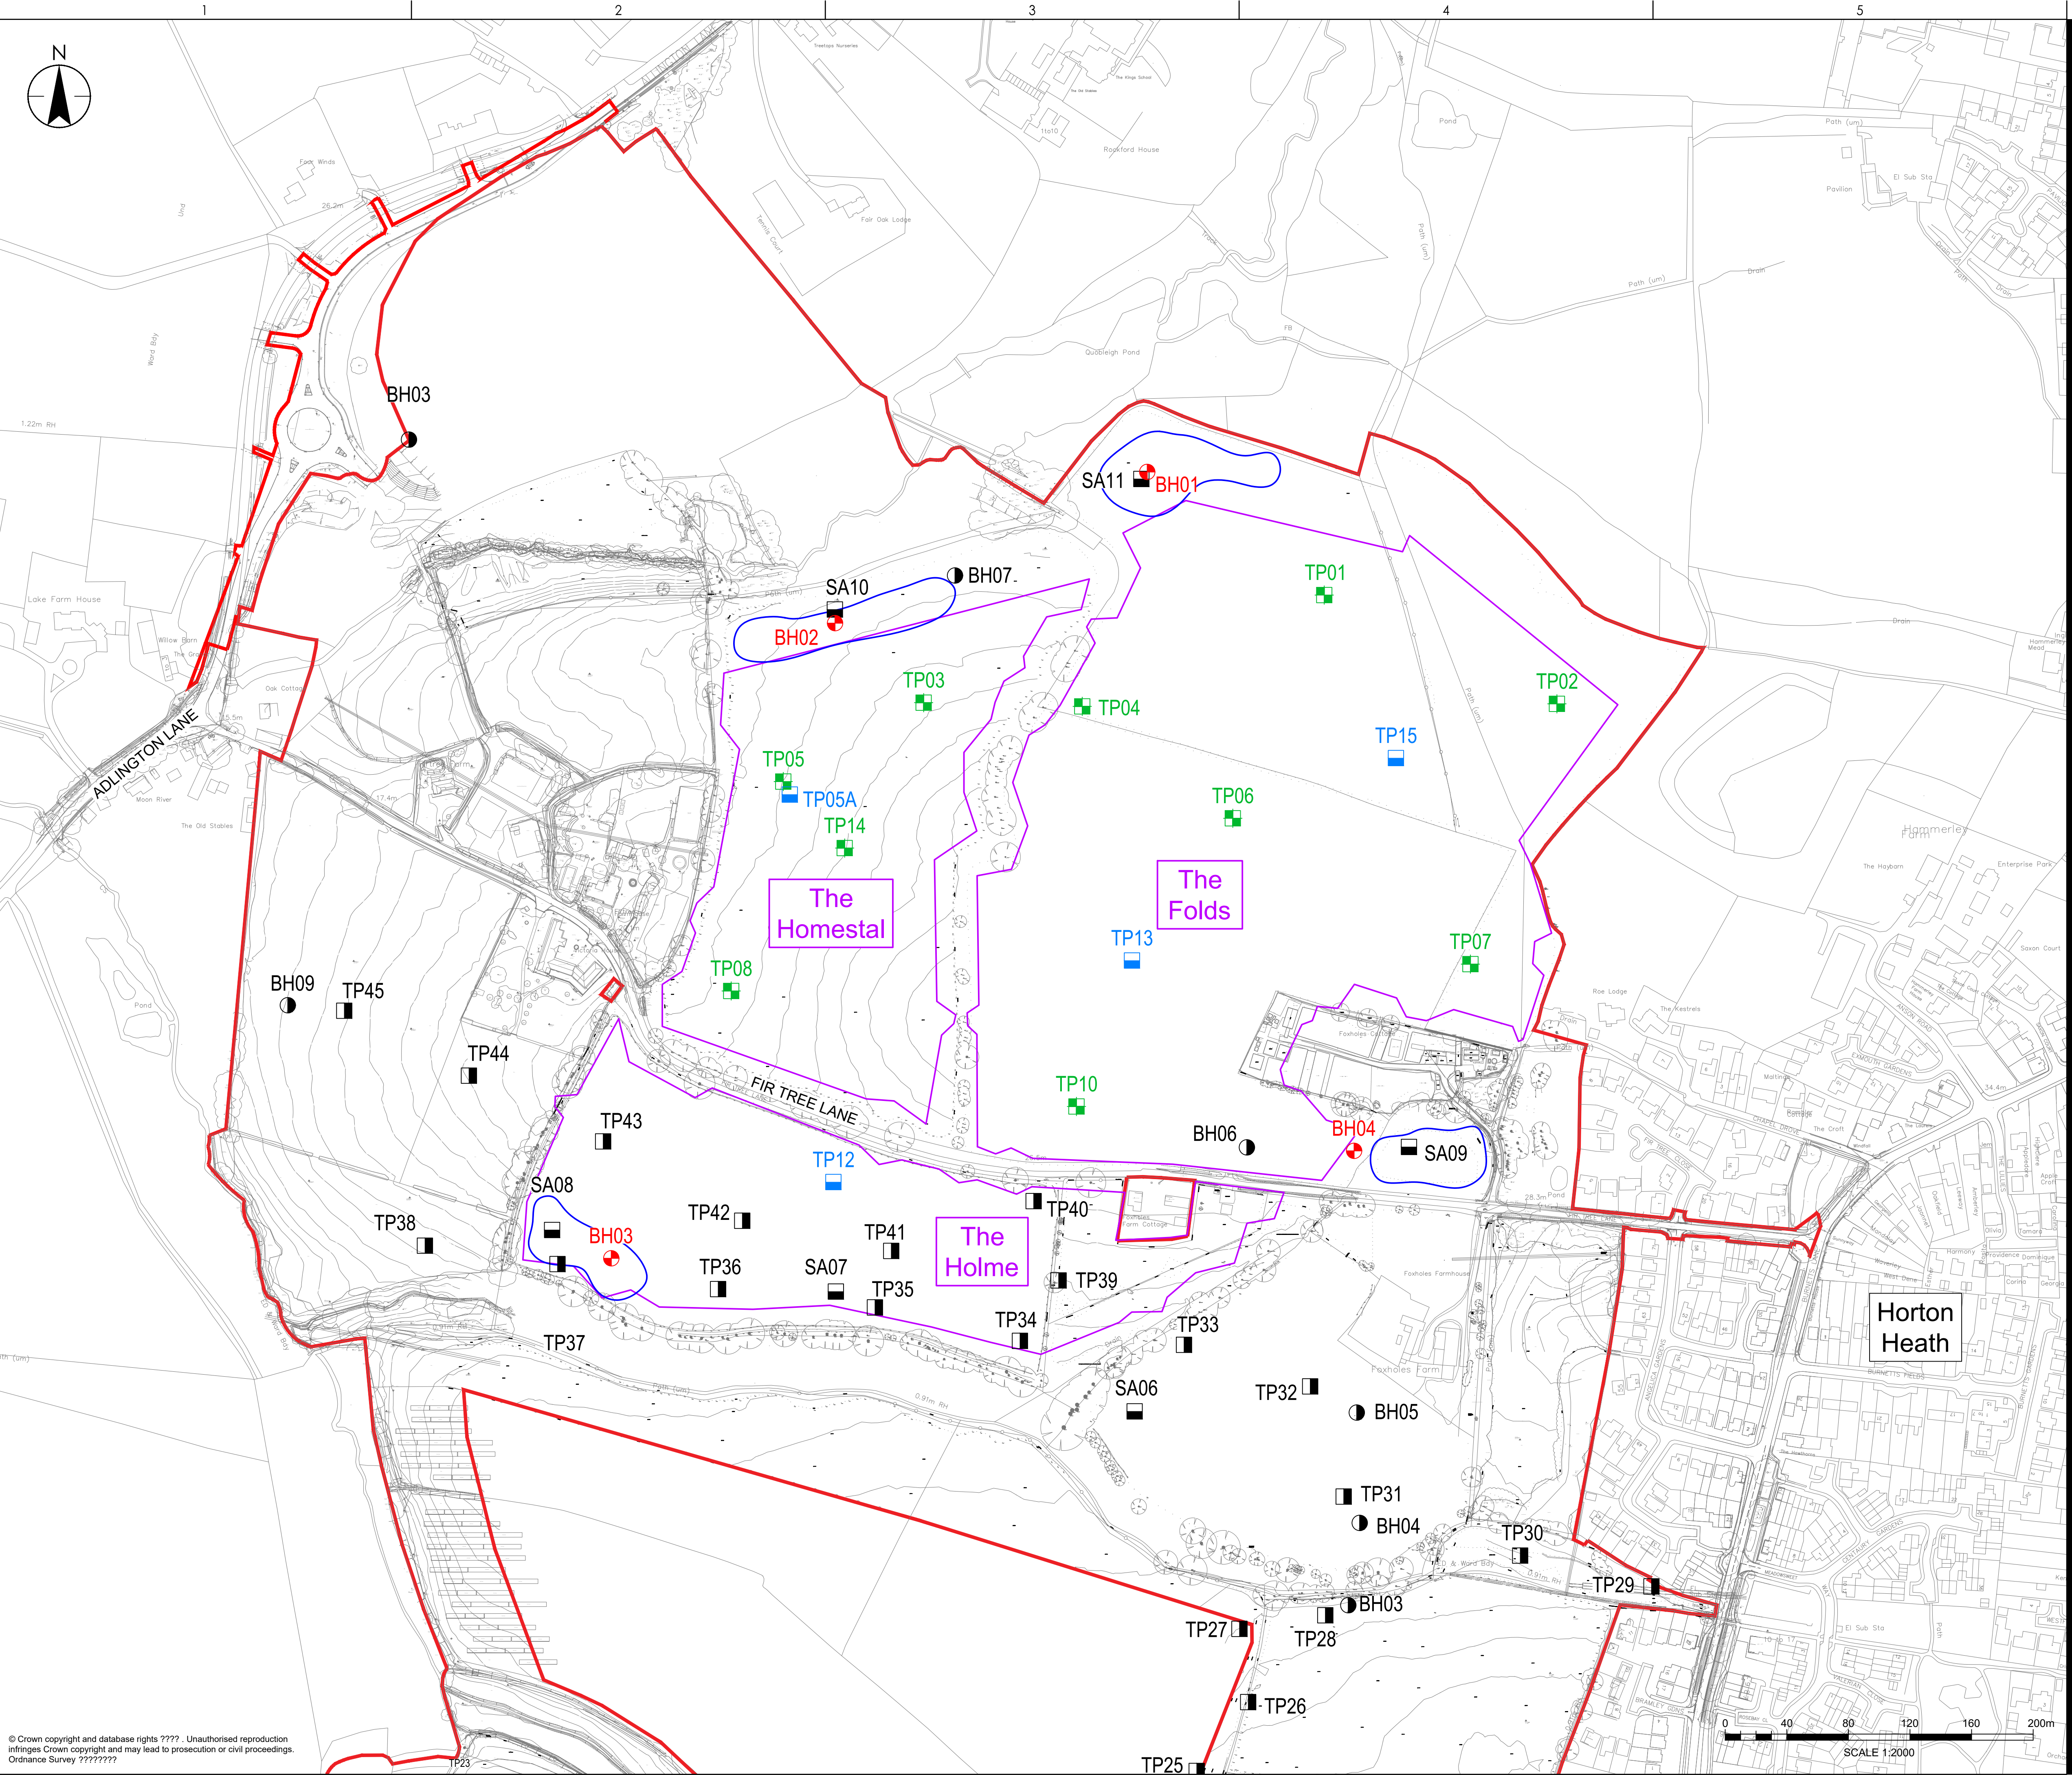
| Revision<br>P01 | Figure No.<br>Figure 2 |

- Borehole Location
- Trial Pit Location
- Trial Pit with Infiltration Test
- Historical Borehole
- Historical Trial Pit
- Historical Trial Pit with Infiltration Test

- 1.2.2 A site location plan is included as **Figure 1** whilst the layout of the site is shown on the Exploratory Hole Location Plan included as **Figure 2**.

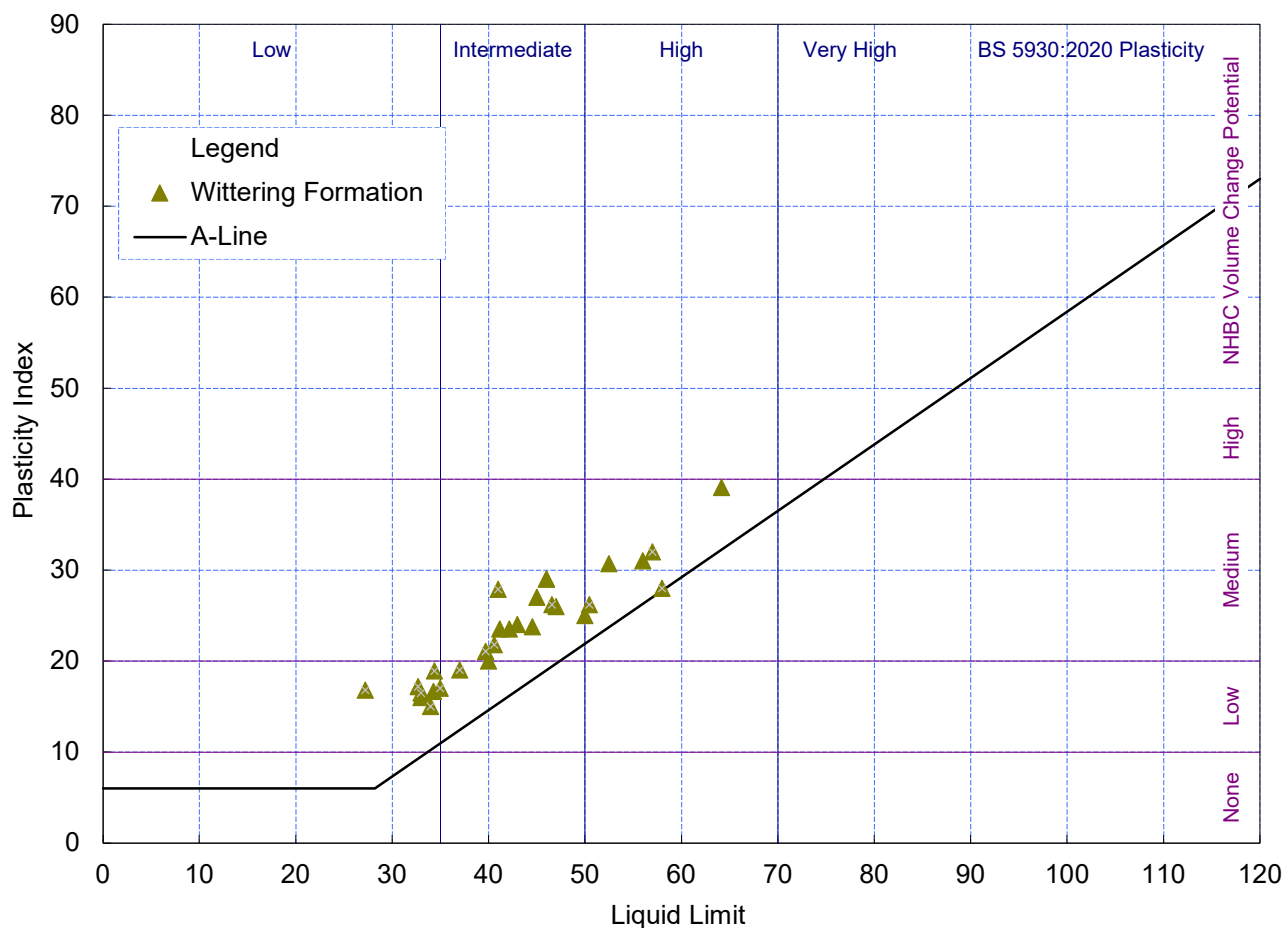
3

- 1 Values of liquid limit and plasticity index have been modified by the percentage of particles less than 425µm.
- 2 Symbols marked x denote data from historical ground investigations

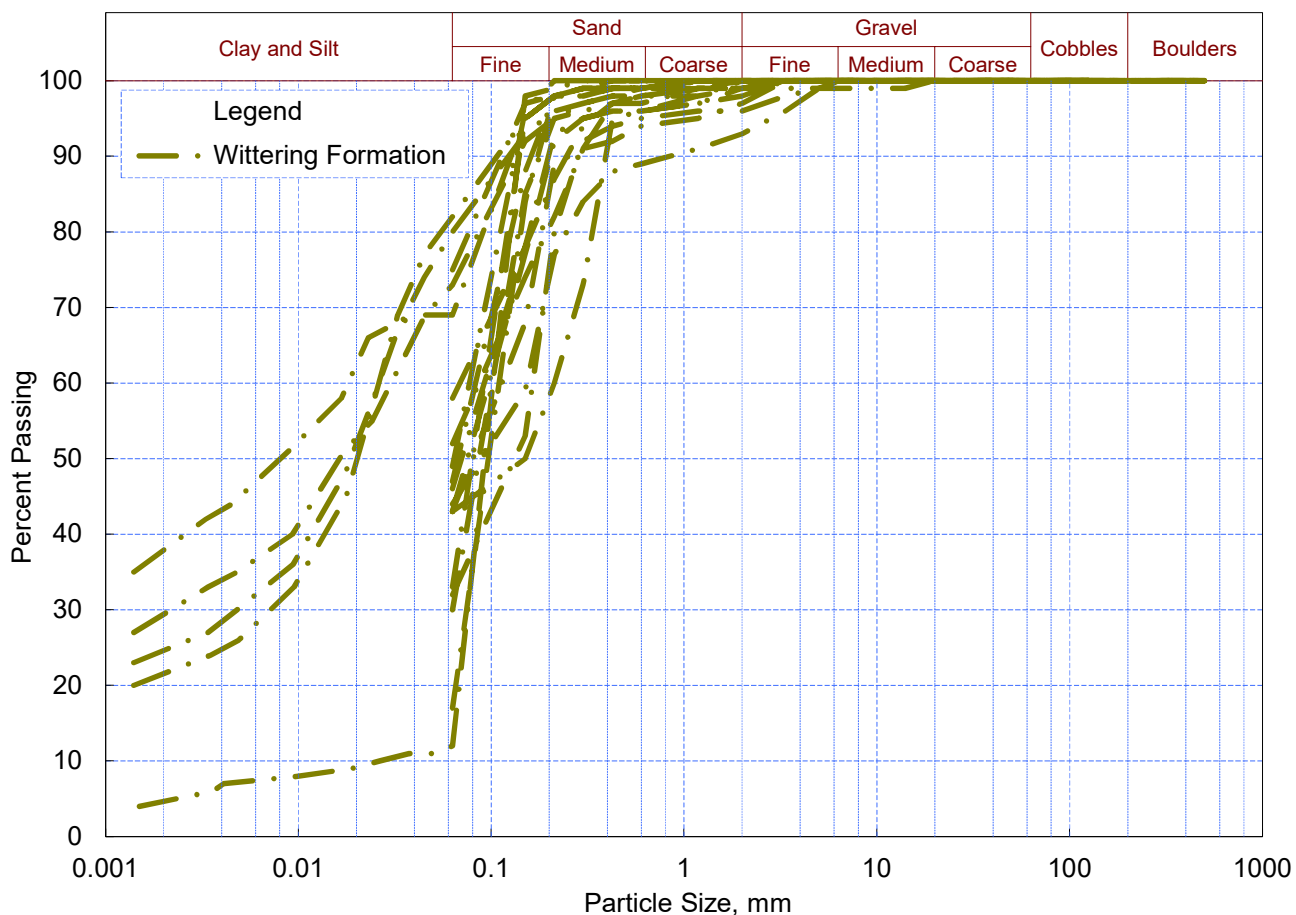
**4**

1 Selected Data: Stantec 2025, Ridge 2023

- 4.3.4 **Material Properties** Results of particle size distribution analyses for the Wittering Formation are presented on **Figure 4** and indicate the gravel sized fraction is up to 7 per cent. The sand size fraction is between about 18 and 88 per cent. The samples tested were found to contain up to between 12 and 82 per cent fines fraction ( $<63 \mu\text{m}$ ). The majority of the samples tested contain more than 30% fines, supporting the engineering log descriptions which typically recorded the material as predominately cohesive, with less frequent granular layers. It should be noted that the majority of the testing undertaken on the material recovered during the Ridge Investigation was recorded as a fines dominated material. However, four of the eight samples tested within the Stantec investigation were on samples of granular dominated material.

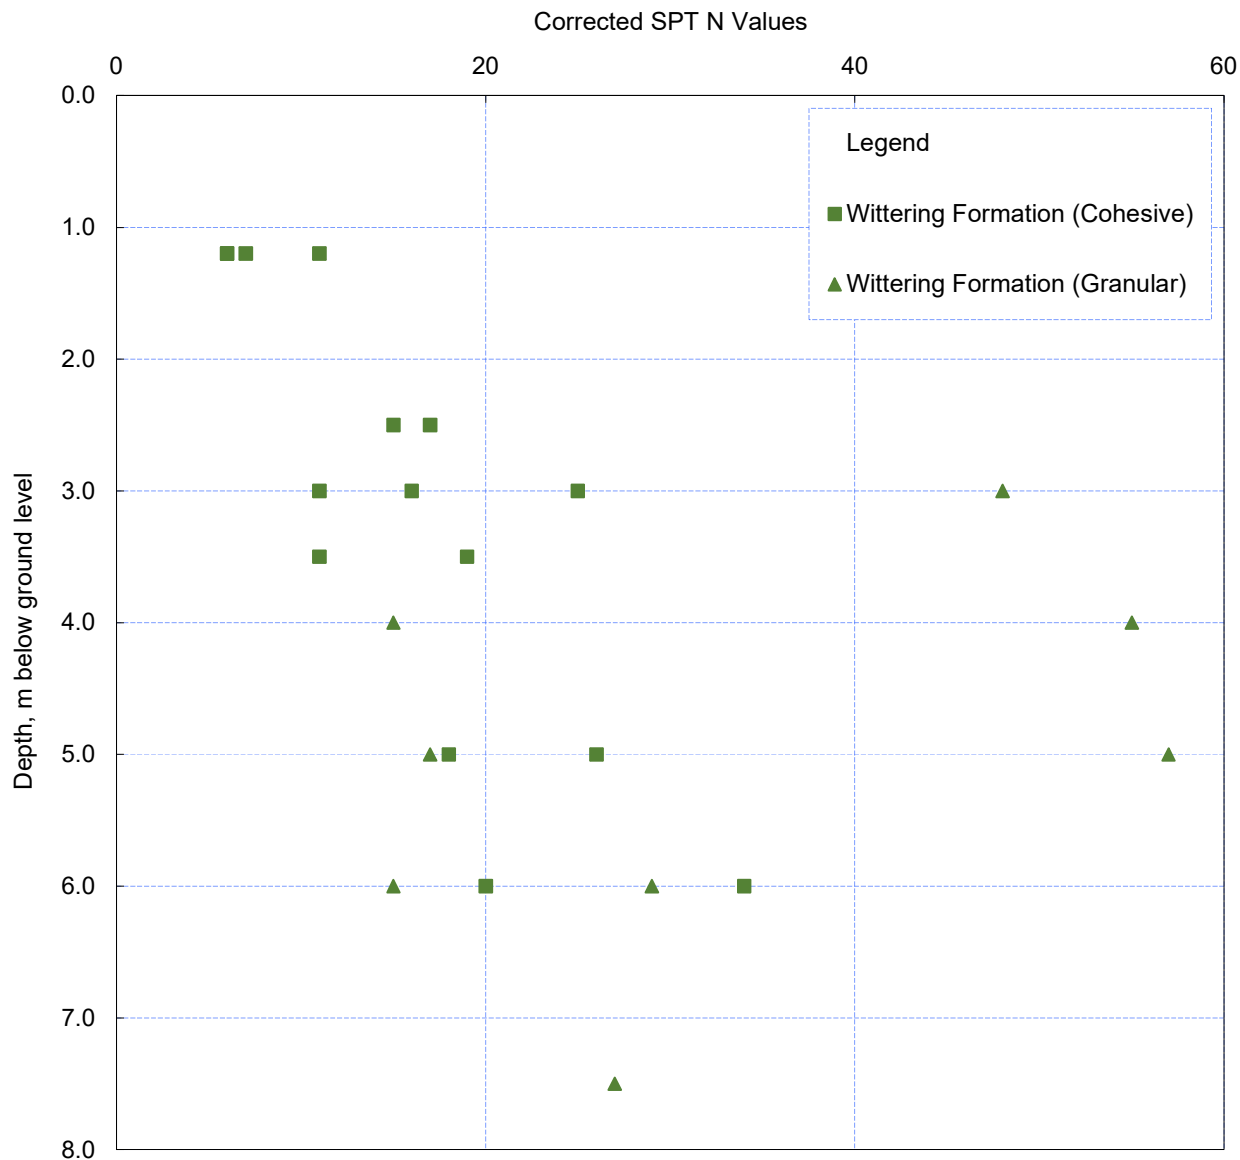
**5**

- 1 SPT N values have been normalised for hammer efficiency and corrected for overburden pressure in accordance with BS EN 22476-3 (2005)

- 4.3.6 **Penetration Resistance** Eight Standard Penetration Tests (SPTs) were undertaken across the granular dominated Wittering Formation soils. The results of the SPTs, normalised for overburden pressure and hammer efficiency (SPT  $N_{60}$ ) ranged between 14 blows and  $>50$  blows within the granular horizons corresponding to a loose to very dense granular soil (BS ,2020) SPT  $N_{60}$  values recorded within the cohesive horizons were recorded between 6 and 34 blows. Values of SPT  $N_{60}$  are presented on a plots vs depth as shown on **Figure 5**. It is noted that the majority of the Wittering Formation was encountered as a predominately cohesive material, as discussed in the **Section 4.4.6**.

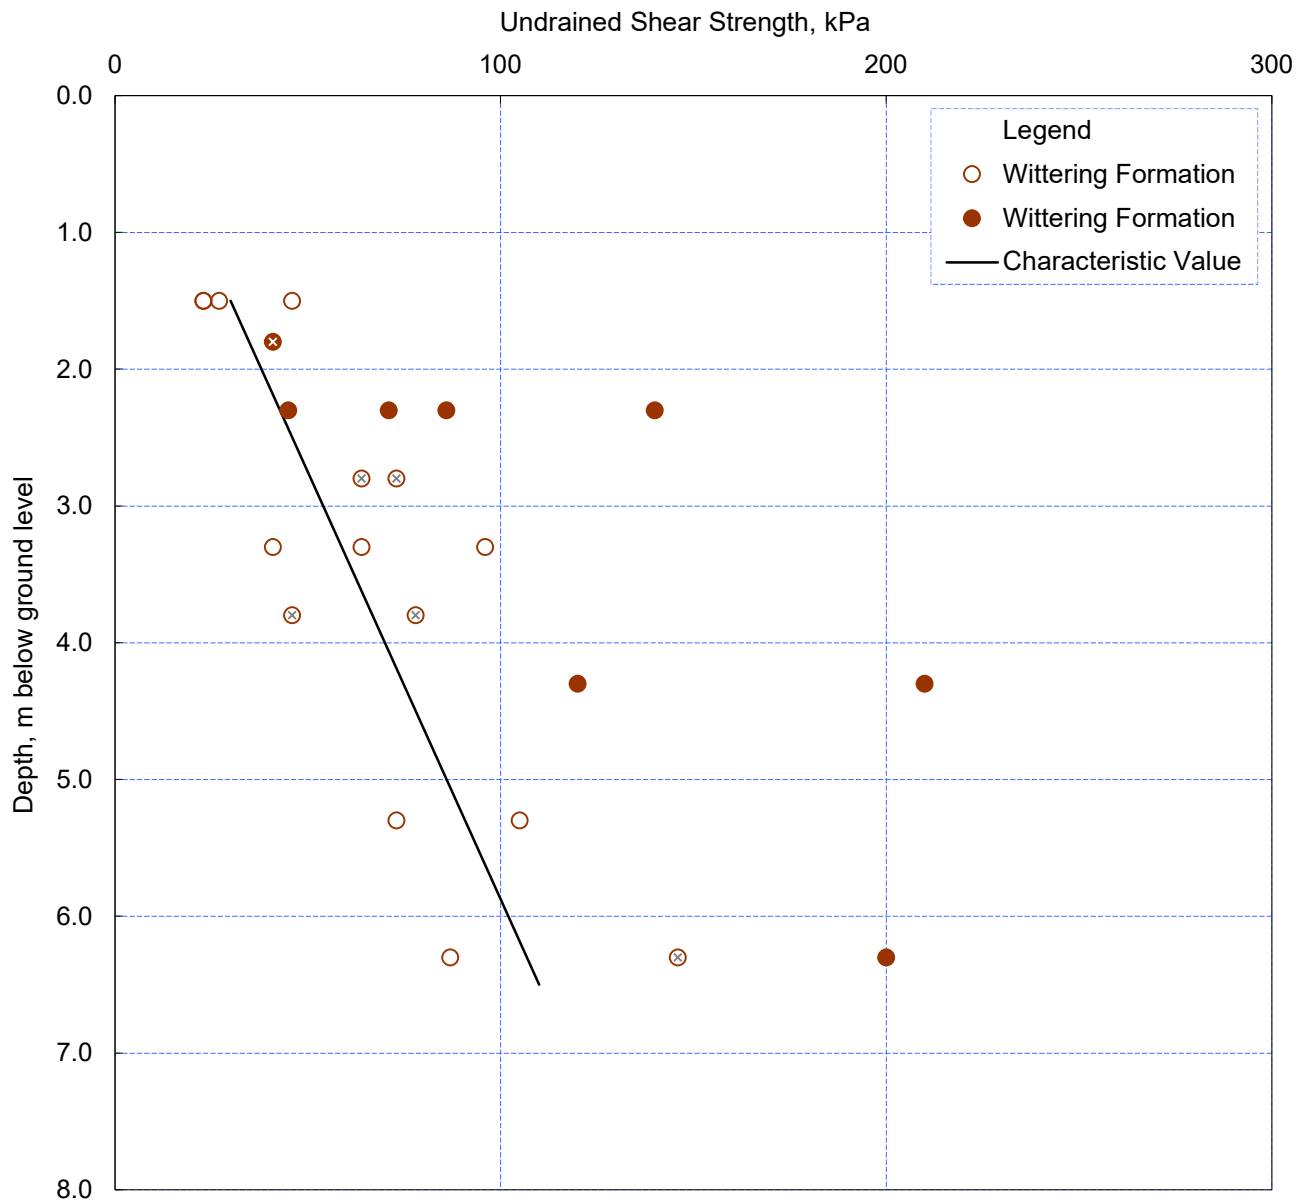
- 1 Open symbols denote values of undrained shear strength determined using the empirical correlation with SPT N values (Stroud, 1989) with a factor  $N_c$  of 4.5 and SPT N values normalised for hammer efficiency.
- 2 Closed symbols denote values of undrained shear strength determined by laboratory triaxial testing of 100 mm diameter specimens
- 3 Symbols marked x denote data from historical ground investigations

- 4.3.7 **Undrained Shear Strength** Visual examination of the material indicates the material is typically firm in consistency although locally the material was described as very soft or very stiff in consistency. It is expected that the variation in noted consistency reflects the variable nature and degree of saturation of the material. Measured values of undrained shear strength of, as determined by laboratory unconsolidated undrained triaxial testing of 100 mm diameter specimens, is presented as a plot against reduced level on **Figure 6** together with values of undrained shear strength determined using an empirical correlation with SPT  $N$  values (Stroud, 1989). The measured and determined values typically increase with depth with values range typically between 40 and 120 kPa and locally between 30 to greater than 200 kPa.
