## Preliminary Roost Assessment

36 Stoke Common Road, Eastleigh SO50 6DU

Removal of 2 storey extension at the back of the property. Erecting a larger 2 storey extension in its place.

[H/25/100161]

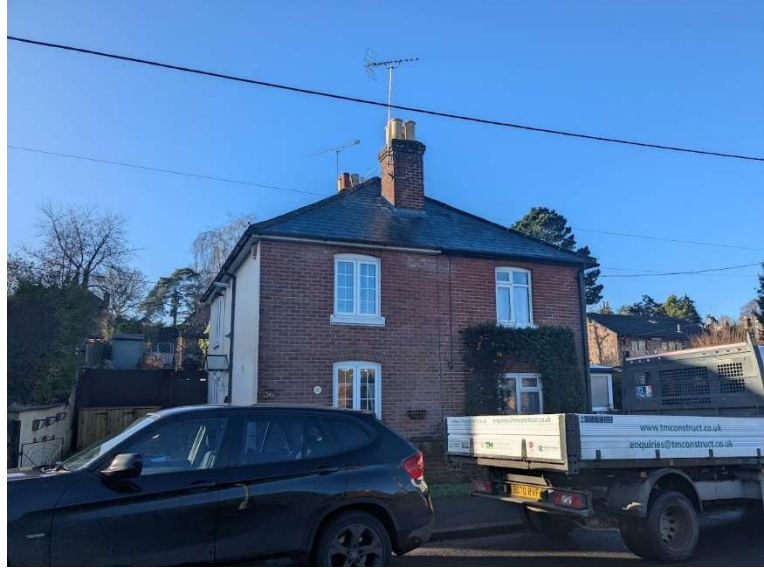
| | <p><b>Foraging and commuting habitat</b></p> <p>The site is situated within a suburban residential area and is dominated by hardstanding with limited vegetated cover, providing low suitability for bat foraging and commuting. Small areas of garden planting and scattered trees may be used occasionally by common urban-tolerant species; however, the lack of continuous linear features limits commuting value. In the wider landscape, the River Itchen SAC and SSSI lies approximately ~412 m northwest of the site, and a wooded parcel located ~100 m north-east connects to the river via open grassland and arable land, offering suitable foraging and commuting habitat. Despite this proximity, the site is fragmented from these higher quality habitats by surrounding residential development and urban infrastructure and associated street and security lighting and overall offers low suitability for bat foraging and commuting.</p> <p><b>Roosting habitat</b></p> <p>Buildings and trees to be impacted by the proposed development are assessed for their suitability to support roosting bats below. No evidence of roosting bats was identified on or within B1.</p> |
|---|---|
| <p><b>Summary</b></p> <p>B1 is a two-storey semi-detached residential building with a hipped roof featuring two brick chimneys, sealed with lead flashing. There is a shed-style roof to the rear from a uPVC clad extension (southwestern elevation) and further to this is a conservatory. The building is constructed from rendered brick on the southern and southwestern elevation, plain red brick front (northern elevation). The roof is clad in slate tiles with clay hip ridges. Soffit boxes, windows, doors and the conservatory are of uPVC construction.</p> <p><b>Suitable Roosting Features</b></p> <p>The building was thoroughly inspected, and no visible roosting features were identified externally. The building fabric is generally modern, well maintained</p> | |

and tightly constructed throughout. The slate roof tiles and clay hip ridges are flush and intact, with no lifted, slipped or missing tiles, and all roof junctions are well sealed. The two brick chimneys are finished with continuous lead flashing, which is closely fitted and gapless, offering no access points or crevices suitable for bat roosting. The shed-style roof to the rear extension is similarly well sealed at all junctions. External walls of rendered and plain brickwork are in good condition, with no visible cracks, cavities or areas of deterioration that could provide roosting features. Eaves, soffits and fascias are of uPVC construction and are fully enclosed, with no gaps or warping. Where the building adjoins the neighbouring semi-detached property, the soffits align seamlessly across the party wall and, despite appearing to be of differing construction, form a continuous, well-sealed junction with no gaps or voids. Windows, doors and the conservatory are also of uPVC construction and tightly fitted.

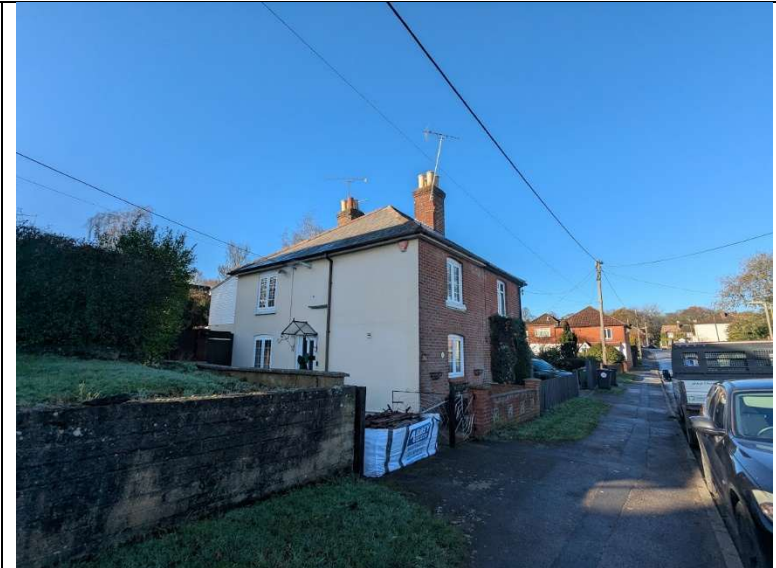
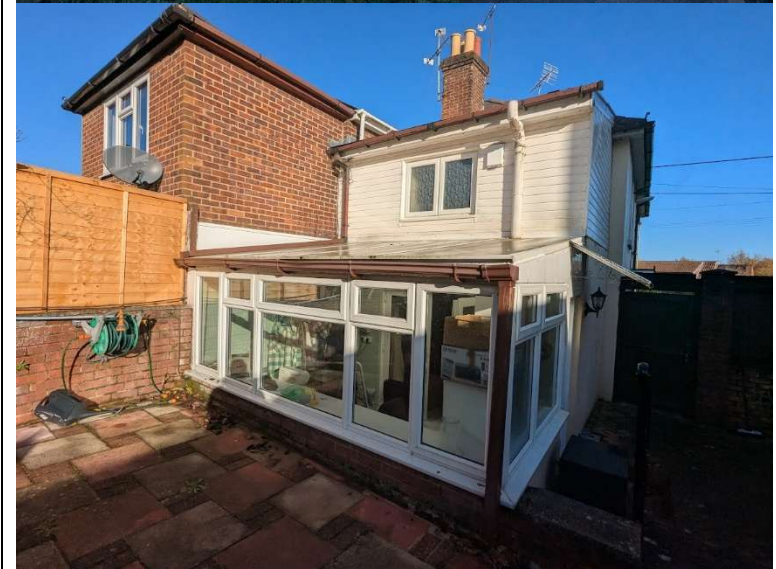
The void of B1 is constructed from a rendered parti-wall wooden beams, bare slate tiles with partial insulation from Styrofoam blocks wedged between beams where the loft is unlined by bitumen felt. The loft is partially boarded and has mineral wool insulation. The internal dimensions are approximately 7.0m in length, 2.5m (maximum, from floor to ridge) in height, and 2.7m in width. Abiotic readings recorded an ambient temperature of 6.2°C and a ridge

temperature of 15.6°C, with condensation formed on slate tiles indicating high humidity. No bat droppings, staining, or other evidence of bat presence were observed at the time of the inspection. There was no light ingress into the loft, therefore, no obvious visible access features were observed.

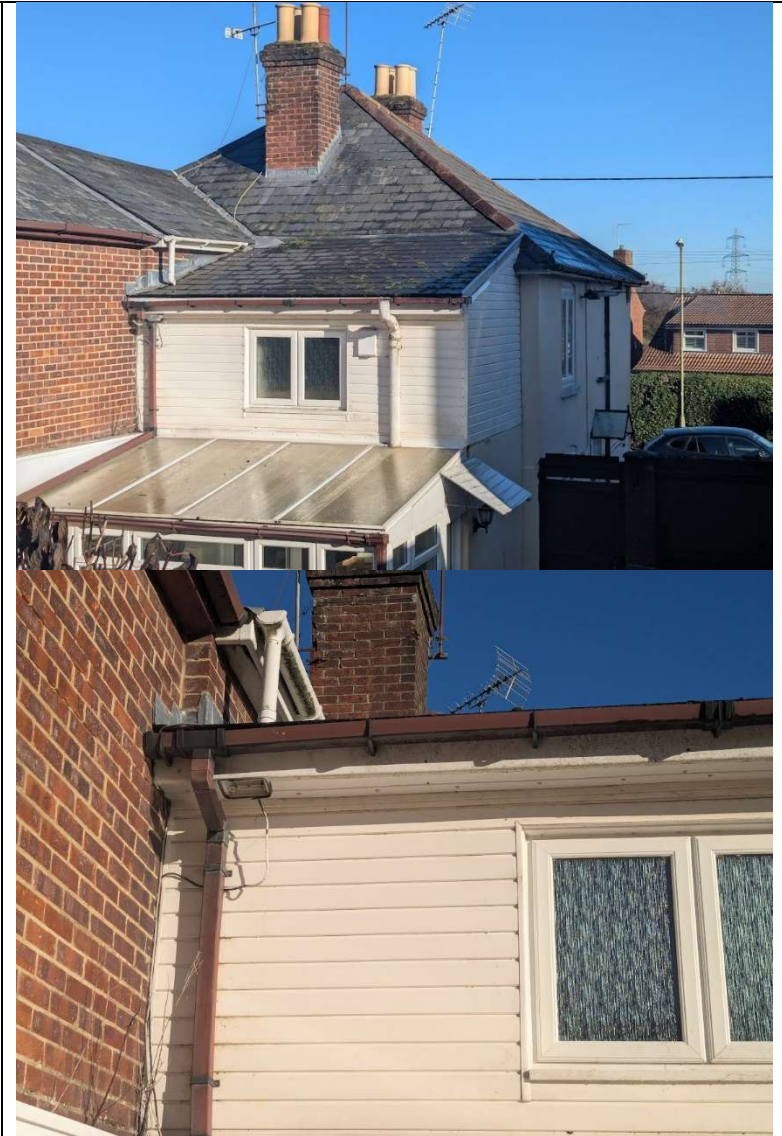
Overall, the site is considered to be of **negligible to low value** for bats. The building offers **negligible suitability for roosting and hibernating bats** due to its modern, well-maintained and tightly sealed construction, with no external or internal features providing suitable access, crevices or stable roosting conditions, and no evidence of bat use recorded during inspection. The internal loft space is well insulated, partially boarded and lacks suitable access points, further limiting its suitability for roosting or hibernation. The surrounding site context provides **low suitability for foraging and commuting**, being dominated by hardstanding and fragmented suburban development with limited vegetation and no functional linear features. While higher-quality foraging and commuting habitat is present in the wider landscape, including the River Itchen SAC/SSSI and nearby woodland, the site itself is functionally separated from these areas by intervening residential development, urban infrastructure and artificial lighting.

| <i>Recommendations</i> | <p><b>Roosting habitat [Buildings]</b><br/>In the unlikely event that a bat or evidence of bats is discovered during the development all work must stop and a bat licensed ecologist contacted for further advice.</p> <p><b>Roosting habitat [Trees]</b><br/>No further surveys are required.</p> <p><b>Foraging and commuting habitat</b><br/>No further surveys are required.</p> <p><b>Artificial lighting</b><br/>A low impact lighting strategy will be adopted for the site during post-development which outlines the areas of the site that will be retained as dark corridors. Parameters can be found on the Bat Conservation Trust website: <a href="https://www.bats.org.uk/our-work/buildings-planning-and-development/lighting-2">https://www.bats.org.uk/our-work/buildings-planning-and-development/lighting-2</a></p> <p><b>Suggested biodiversity enhancements</b><br/>The installation of one bat box at the site will provide additional roosting habitat for bats.</p> |

| | <p>The bat boxes will be incorporated into the fabric of the new dwelling. They will be suitable for pipistrelles (which have been identified locally through EPSL data). Suitable bat boxes include Habibat Bat Box, Ibstock Enclosed Bat Box or similar alternative brand.</p> <p>Bat boxes should be positioned 3-5m above ground level facing in a south or south-westerly direction with a clear flight path to and from the entrance, away from artificial light.</p> |
