## PRELIMINARY BAT ROOST ASSESSMENT

5 ABBEY HILL, NETLY ABBEY, SOUTHAMPTON, SO31 5FB

FINAL REPORT

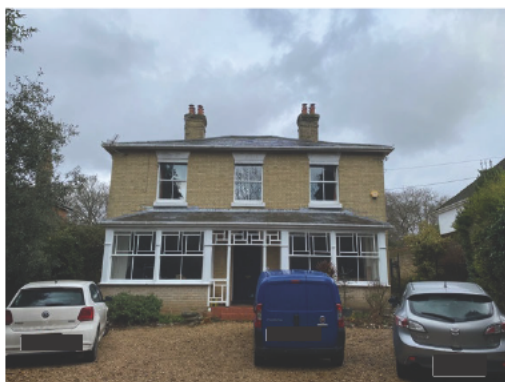
**Figure 1** – Southern elevation of the dwelling.

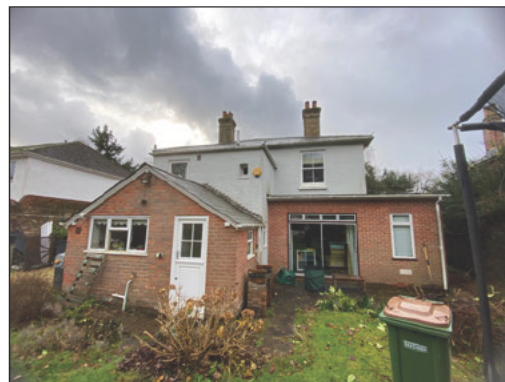
**Figure 2** – Northern elevation of the dwelling with northern extensions.

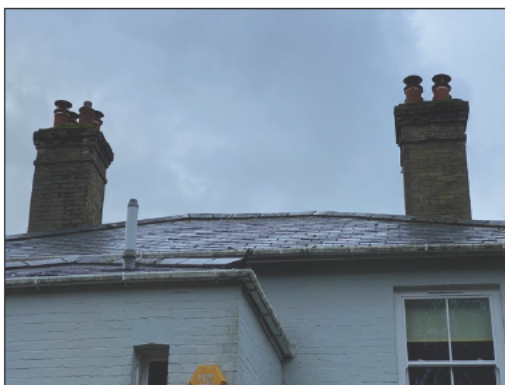
**Figure 3** – Northern slate roof of the main house.

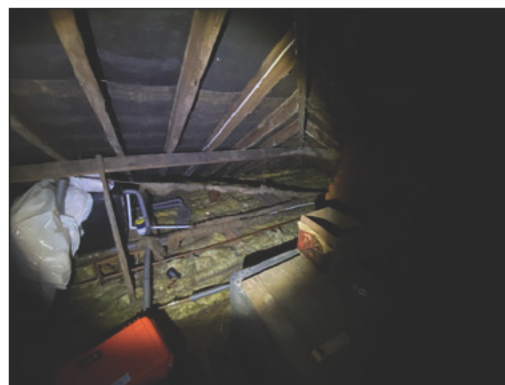
The interior of the structure contains a single void. The roof is lined with bitumen felt and the floor with rockwool insulation. The space is partly boarded and used for storage with light cobwebbing around the rafters.

**Figure 4** – Interior roof void of the main house.

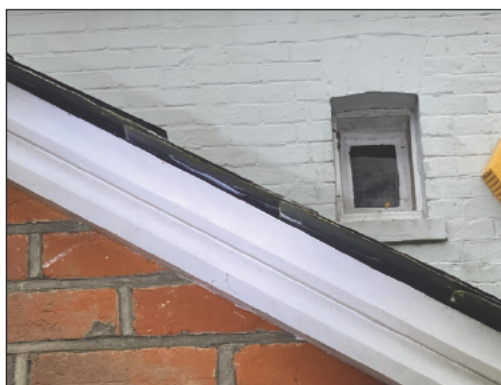
| <b>Suitability</b> | <b>Evidence</b> |
|---|---|
| <p><b>Exterior</b></p> <p>The following suitable access/egress and roosting features were recorded externally during the survey:</p> <p>Inside the ZOI:</p> <ul style="list-style-type: none"> <li>- Some gaps are present between the barge board and slate tiles at the gable end of the northern single-storey extension (Figure 5). These gaps were visually inspected during the survey and were found to be mostly cobwebbed and clear of any bat evidence.</li> </ul> <p>Outside the ZOI:</p> | <p>No evidence of roosting activity was recorded externally during the survey.</p> |

**Figure 5** – Gaps present between the barge boards and slate roof tiles.

When assessed against the criteria in Table 1, the features identified and lack of recorded activity are considered consistent with negligible suitability for bat roosting i.e. *“the structure has no reasonable likelihood of supporting roosting bats.”*
