ADDENDUM TECHNICAL REPORT
Crawford Reference: SU1304166

Mrs Ruth Farr
2 Oakfields
Eastleigh
Hampshire
SO50 4RP

Claim Reference 201310032227
SUBSIDENCE CLAIM

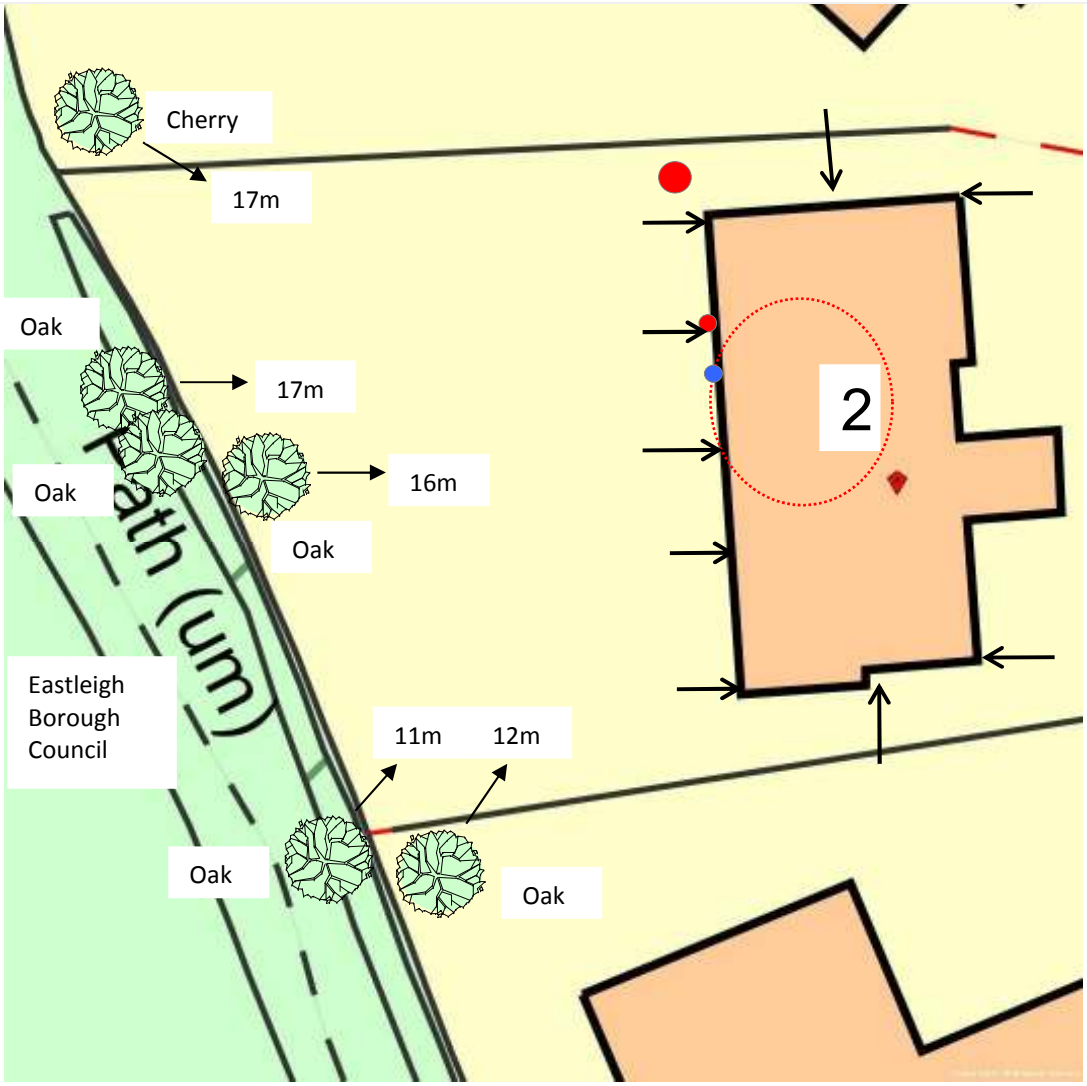
Site Plan	This plan is Not to Scale

It is our view that the Oak tree, T4, is seen as the effective and substantive cause of the claim. This view is supported by the following:-

The Oak T1 tree needs to be crown reduced to allow the property to stabilise. An application shall be submitted to reduce the tree, which we hope the Council are more willing to accept instead of tree felling. The Oak tree can be reduced without risk of heave related damage occurring.

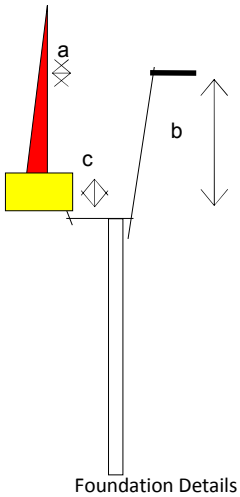
Foundation Details

A trial hole was excavated to expose the foundations - see site plan for location and the diagram below for details. A trial hole was excavated to expose the foundations - see site plan for location and the diagram below for details. Trial Hole 1 revealed a medium compact dark brown/orange, mottled grey, silty clay with occasional brick pieces and fine to medium gravel 1.0m below ground level which bears onto firm, mid brown/orange grey veined silty CLAY with partings of orange silt and fine sand and very occasional fine to medium gravel.

Trial Hole 2 revealed medium compact, dark brown/orange, mottled orange, silty clay with brick fragments, occasional timber pieces and fine to medium gravel 0.87m below ground level which bears onto firm, mid brown/orange, grey veined, silty CLAY with partings of orange silt and fine sand and occasional fine to medium gravel.

Root activity of live appearance was noted to the underside of the foundations of trial hole 2.

No.	Borehole Depth	Footing (a)	Underside (b)	Thickness (c)
TH1	3.00 m.	250 mm.	1,950 mm.	800 mm.
TH2	3.00 m.	230 mm.	1,630 mm.	630 mm.
