SITE VISIT RECORD		SHEET NO: 1
Project: Kestrel Park, Burlesdon Road, Southampton		Date of Visit: 07.10.2020
Client: Taylor Wimpey UK Ltd.	**Weather Conditions:** Sunny, light breeze	
Contract No.: C-08162		
Visit Carried Out By: Yacklin Panza		
Present: Hydrock Consultants

SITE VISIT RECORD	SHEET NO: 4

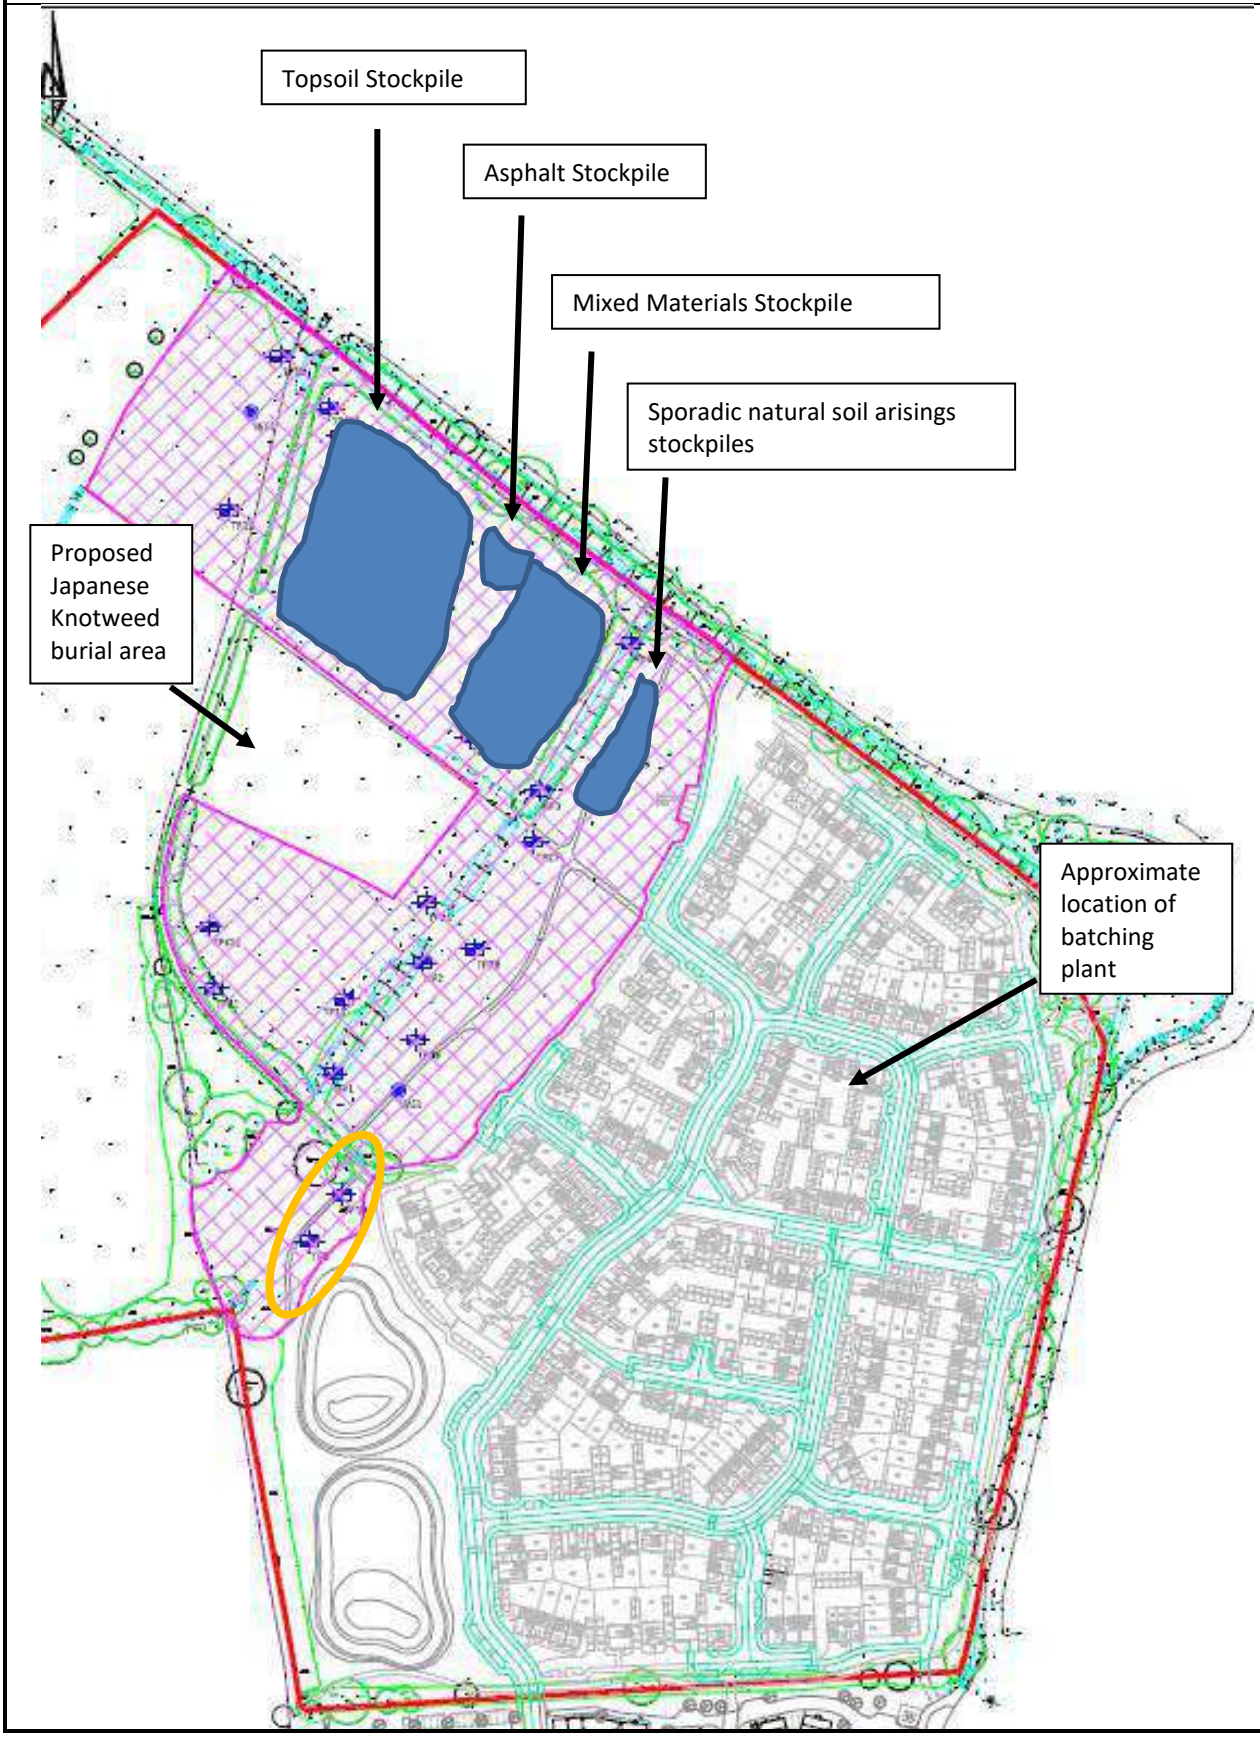
- Inspection of open excavations have not indicated the presence of any onerous materials.
-

- Undertake regular watching brief visits.

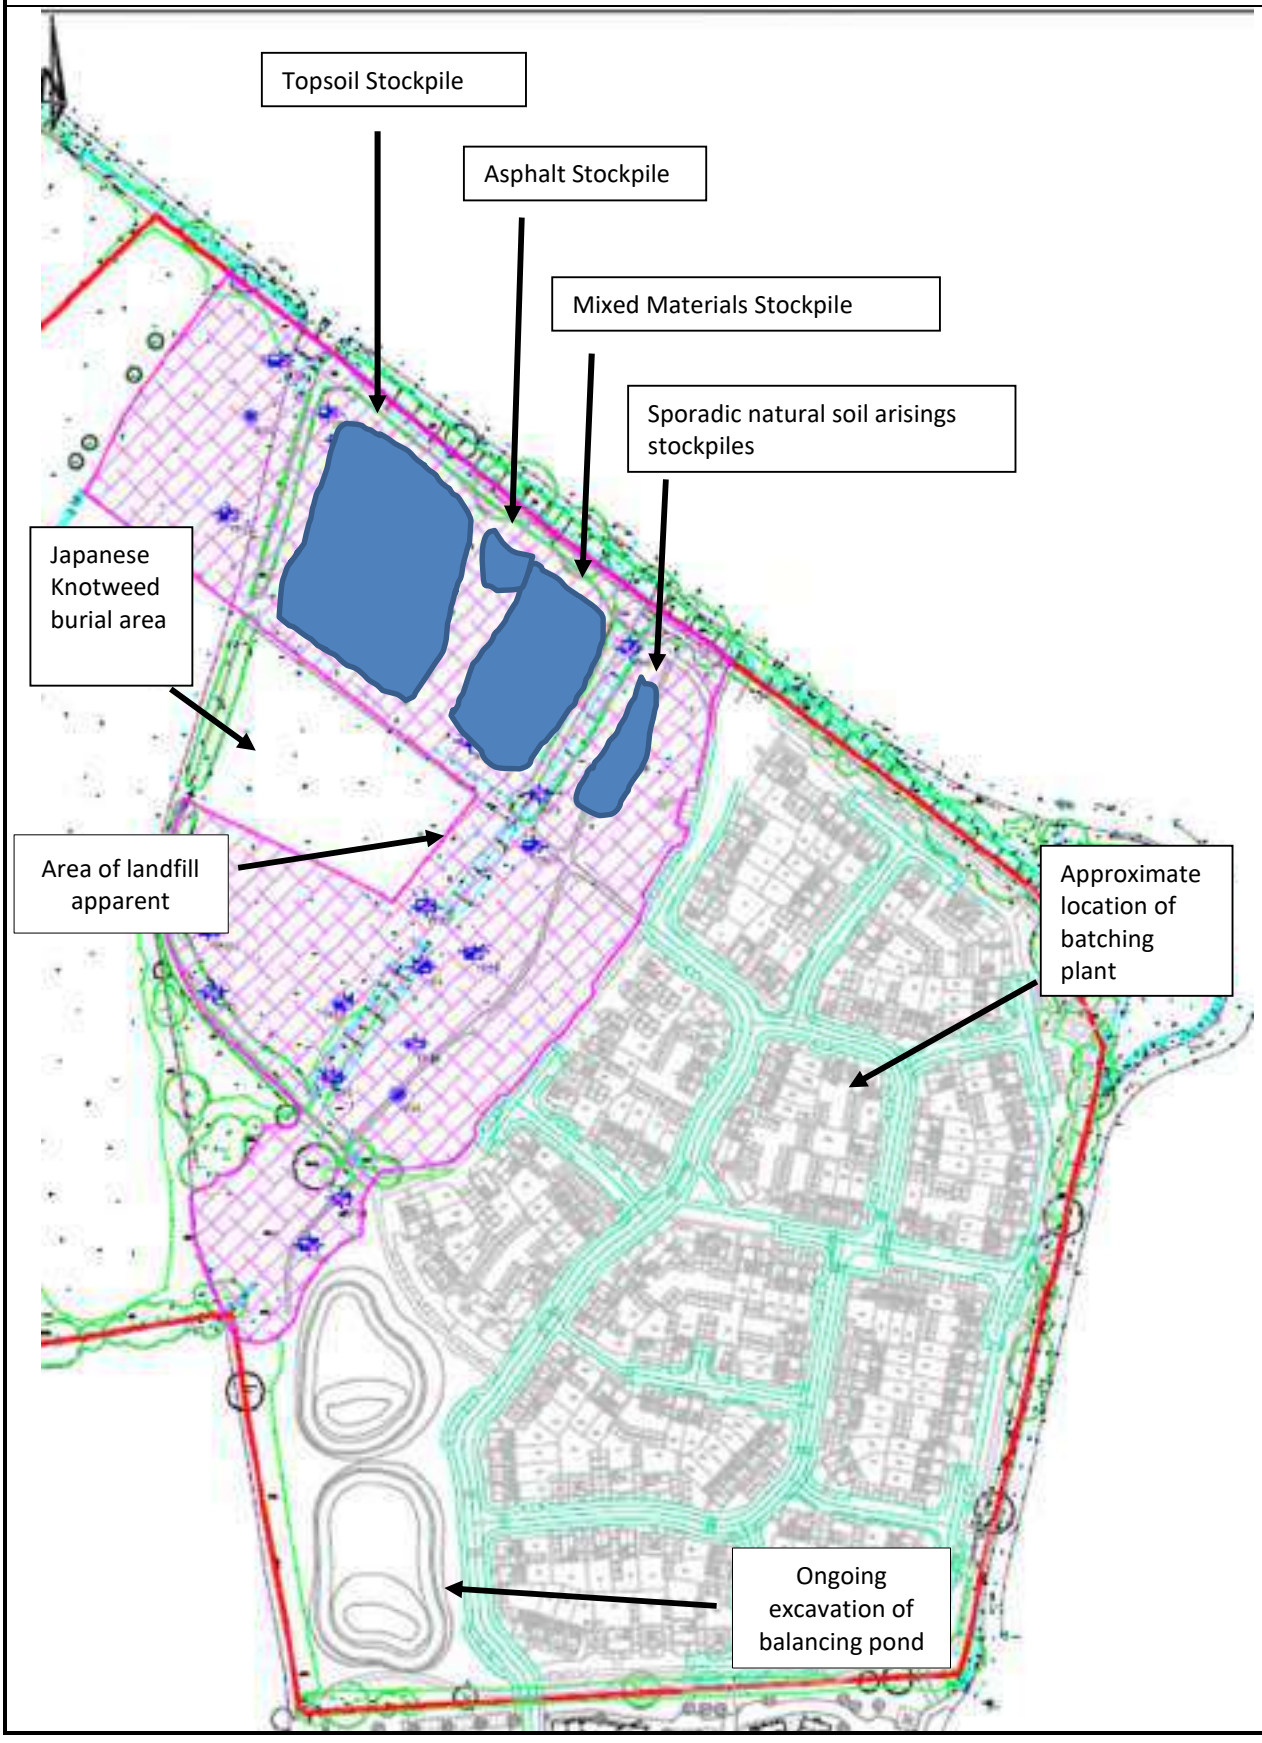
- Inspection of open excavations have not indicated the presence of any onerous materials excluding the area of infilling/landfilling between the japanese knotweed burial pit area and the Taylor Wimpey compound.
- Site conditions are generally damp.
- Gas membrane installations to date are in good condition.

- Undertake regular watching brief visits.
