Desk study and preliminary risk assessment report

Cockpit Barn, Knowle Lane, Horton Heath

Alderbury Homes Ltd

July 2021

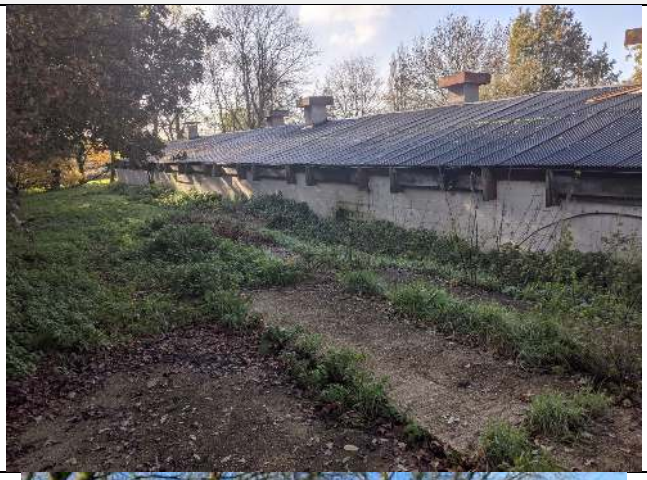
Zone A	
Eastern side of poultry house looking south

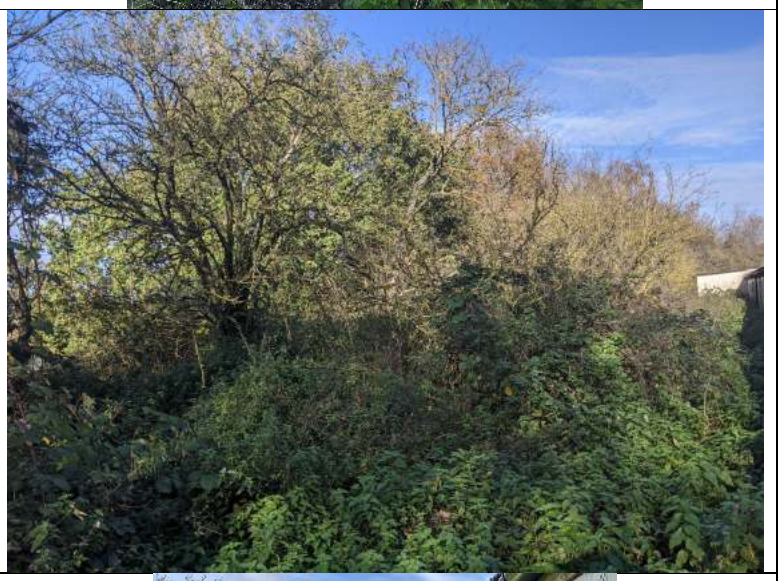
Western side of poultry house. Discarded material includes asbestos cement roof sheet, metal storage drum, metal, plastic and wood

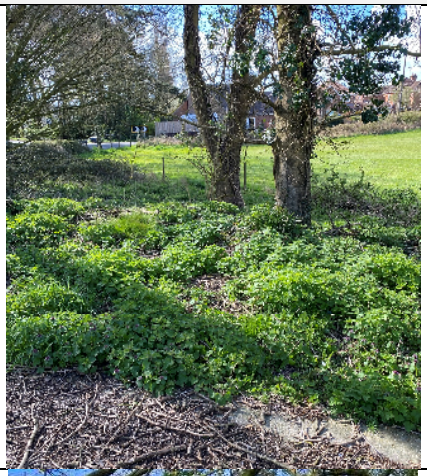
Site walkover photographs and commentary – Zone B	
Western edge of A towards southern boundary of B. Piece of asbestos cement roofing on ground, no additional pieces in the vicinity.

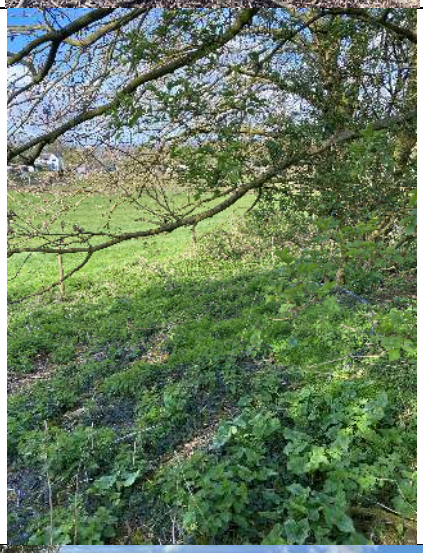
Slope and change in levels from A towards B looking west

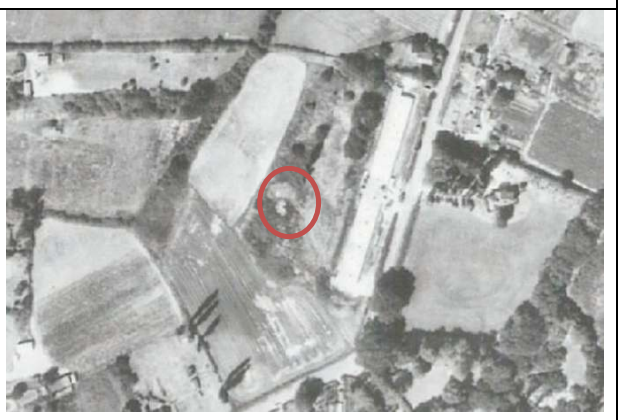
c. 1979-1984 aerial photograph courtesy of EBC As above, with the exception of some potential ground disturbance within the area of rough vegetation.
