# Arboricultural Implications Assessment and Method Statement for 'Greywell', High Street, Bursledon

**'Greywell', High Street, Bursledon**

Report Ref: **211433 - AIA**

Report Date: **24 June 2022**

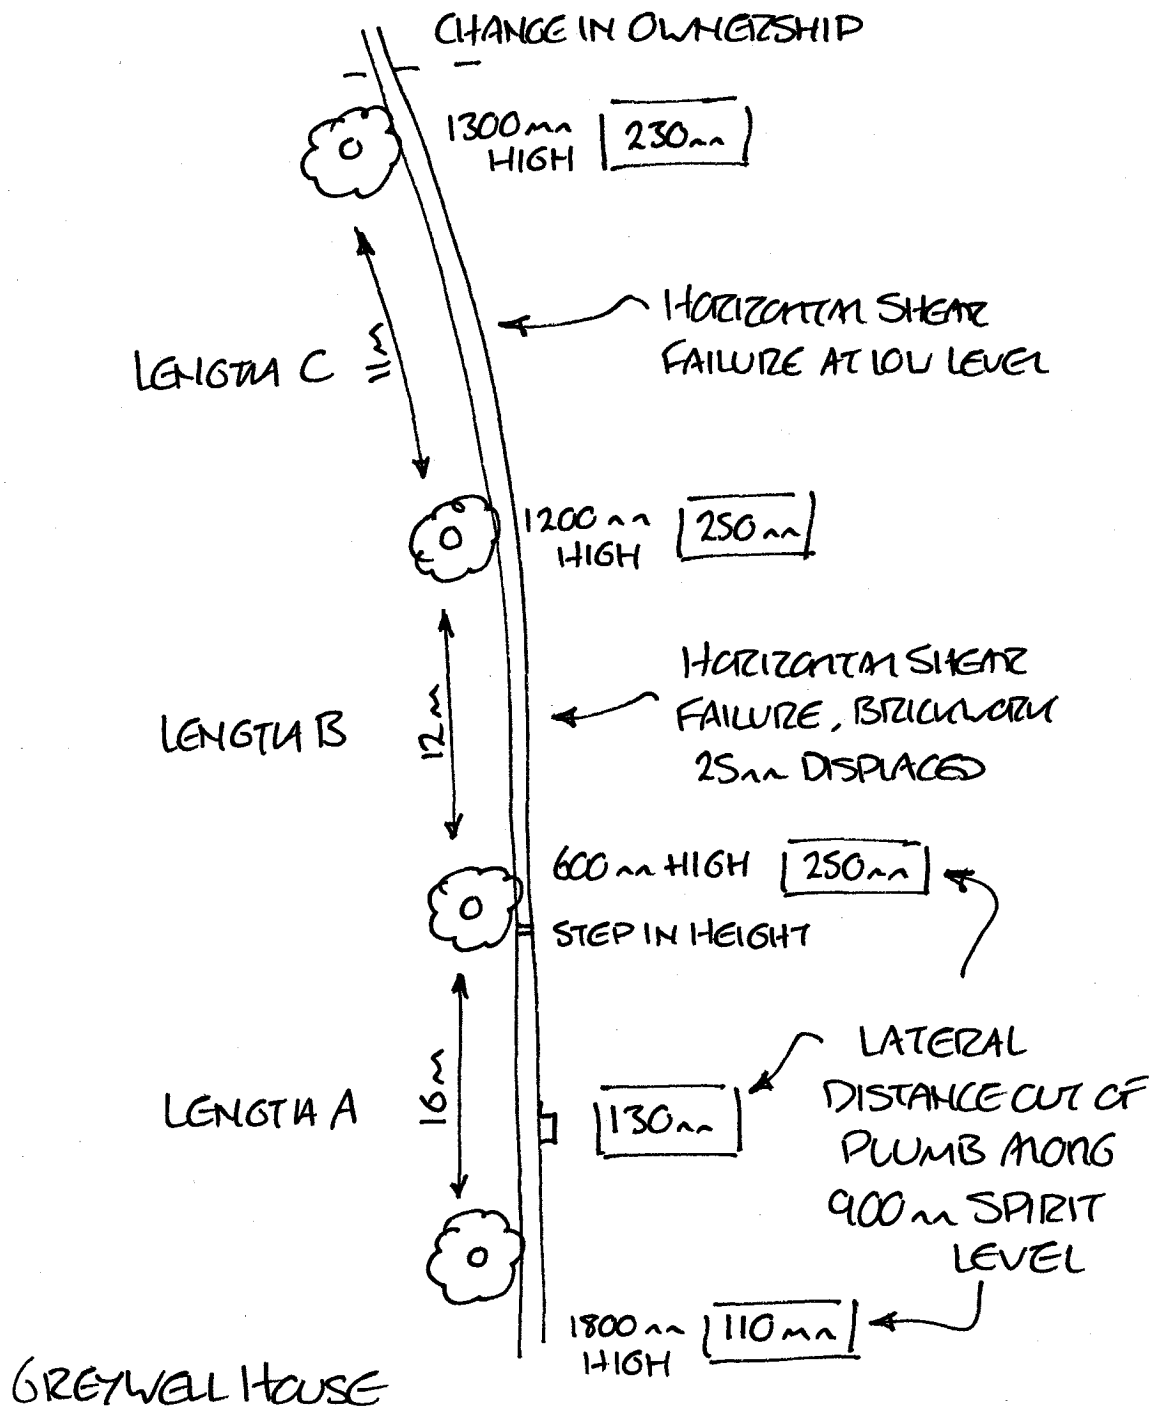
Photograph 7 – View along wall Length C

The last stretch of the wall between the two mature trees was fairly constant in height, increasing to be 1300mm high at the Northern end. At this point the wall was 230mm out of alignment. Please refer to Photograph 7. Again, horizontal shear failure was noted in the base of this wall, occurring close to the third of the mature trees.
