Our Ref.: 18831/LR/Validation Plots 1-50 and 81-93

**Re: Additional Gas Membrane Validation Plots 1-50 and 81-93, Abbey Fruit Farm, Netley, SO31 5FF**

# Gas Membrane Validation Certificate

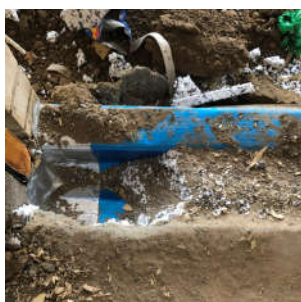
Photograph 4

The ground floor was raised with suitable insulation materials to the level of the membrane edge and therefore minimized the potential for further damage. No damage or puncture was noted in or on the visible membrane and all corners and joints appeared appropriately and suitably emplaced in line with the appropriate guidance (Photograph 4).

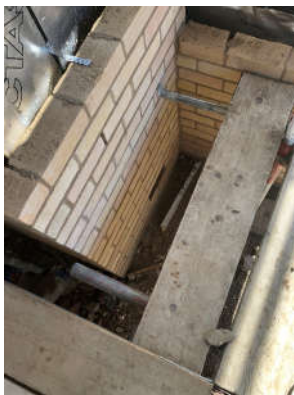
Photograph 1

A suitable membrane has been installed and taped as per recommended guidance and standards and rises from the floor to a level in the outer course of the building above the ventilation course (Photograph 1) and onto any access points at the same level.

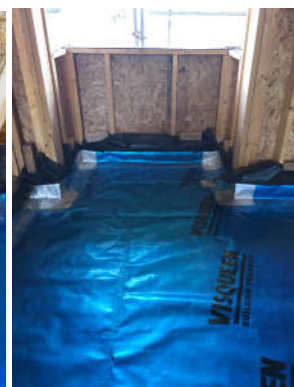
Photograph 4

The ground floor is to be raised with suitable insulation materials to the level of the membrane edge and therefore minimize the potential for further damage. No damage or puncture was noted in or on the visible membrane and all corners and joints appeared appropriately and suitably emplaced in line with the appropriate guidance (Photograph 4).

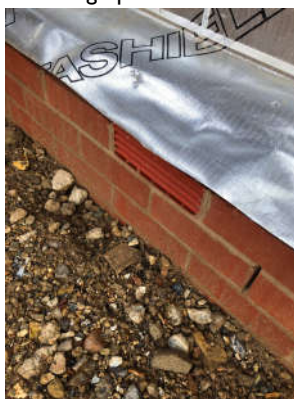
Photograph 1

A suitable membrane has been installed and taped as per recommended guidance and standards and rises from the floor to a level in the outer course of the building above the ventilation course (Photograph 1) and onto any access points at the same level.

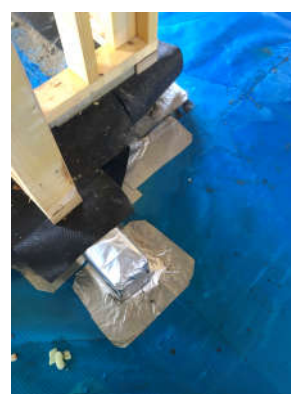
Photograph 4

The floor is to be raised with suitable insulation materials and underfloor heating to the level of the membrane edge and therefore minimize the potential for further damage. No damage or puncture was noted in or on the visible membrane and all corners and joints appeared appropriately and suitably emplaced in line with the appropriate guidance (Photograph 4).

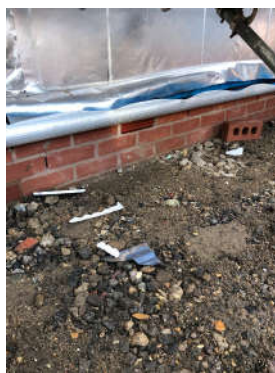
Photograph 1

A suitable membrane has been installed and taped as per recommended guidance and standards and rises from the floor to a level in the outer course of the building above the ventilation course (Photograph 1) and onto any access points at the same level.

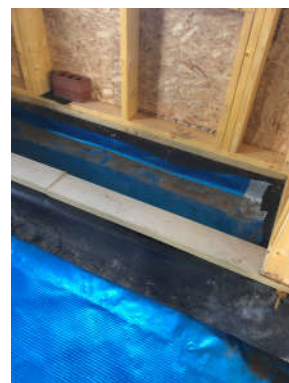
Photograph 4

The floor is to be raised with suitable insulation materials and underfloor heating to the level of the membrane edge and therefore minimize the potential for further damage. No damage or puncture was noted in or on the visible membrane and all corners and joints appeared appropriately and suitably emplaced in line with the appropriate guidance (Photograph 4).

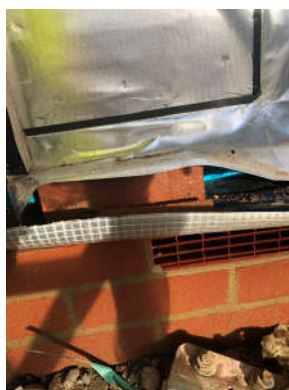
Photograph 1

A suitable membrane has been installed and taped as per recommended guidance and standards and rises from the floor to a level in the outer course of the building above the ventilation course (Photograph 1) and onto any access points at the same level.

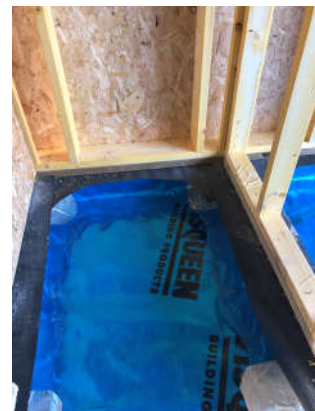
Photograph 4

The floor is to be raised with suitable insulation materials and underfloor heating to the level of the membrane edge and therefore minimize the potential for further damage. No damage or puncture was noted in or on the visible membrane and all corners and joints appeared appropriately and suitably emplaced in line with the appropriate guidance (Photograph 4).

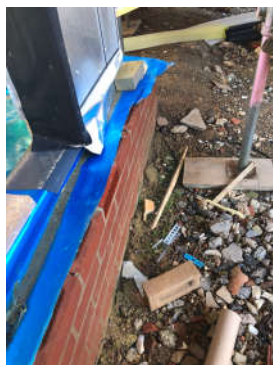
Photograph 1

A suitable membrane has been installed and taped as per recommended guidance and standards and rises from the floor to a level in the outer course of the building above the ventilation course (Photograph 1) and onto any access points at the same level.

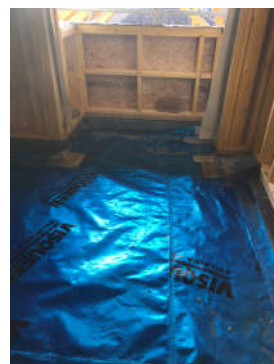
Photograph 4

The floor is to be raised with suitable insulation materials and underfloor heating to the level of the membrane edge and therefore minimize the potential for further damage. No damage or puncture was noted in or on the visible membrane and all corners and joints appeared appropriately and suitably emplaced in line with the appropriate guidance (Photograph 4).

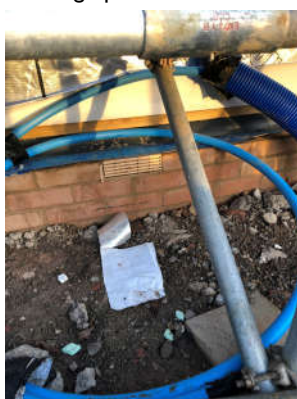
Photograph 1

A suitable membrane has been installed and taped as per recommended guidance and standards and rises from the floor to a level in the outer course of the building above the ventilation course (Photograph 1) and onto any access points at the same level.

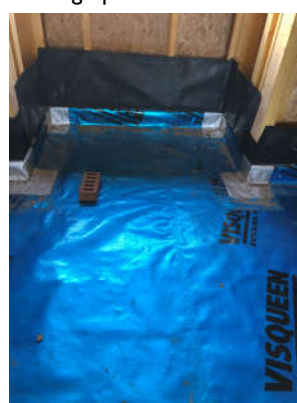
Photograph 4

The floor is to be raised with suitable insulation materials and underfloor heating to the level of the membrane edge and therefore minimize the potential for further damage. No damage or puncture was noted in or on the visible membrane and all corners and joints appeared appropriately and suitably emplaced in line with the appropriate guidance (Photograph 4).

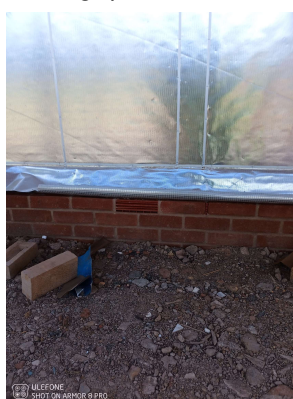
Photograph 1

A suitable membrane has been installed and taped as per recommended guidance and standards and rises from the floor to a level in the outer course of the building above the ventilation course (Photograph 1) and onto any access points at the same level.

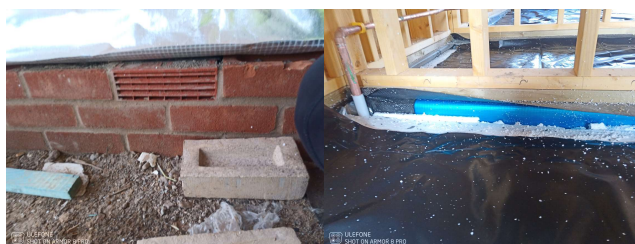
A suitable membrane has been installed and taped as per recommended guidance and standards and rises from the floor to a level in the outer course of the building above the ventilation course (Photograph 1) and onto any access points at the same level.

This has been covered as appropriate and taped in place as required by the manufacturer's guidance and the agreed method statements using hot weld methods to secure the tape and join membranes (Photograph 2). Where required, drainage has been installed through the membrane in an appropriate manner consistent with current guidance and appears to be secure and fit for purpose. (Photograph 3).

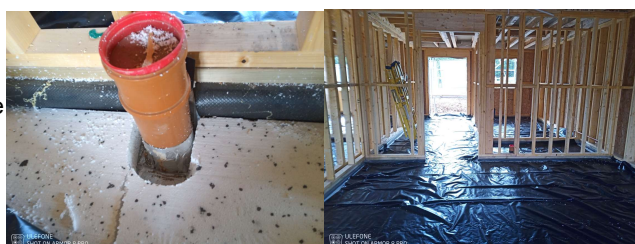
The ground floor is to be raised with suitable insulation materials to the level of the membrane edge and therefore minimize the potential for further damage. No damage or puncture was noted in or on the visible membrane and all corners and joints appeared appropriately and suitably emplaced in line with the appropriate guidance (Photograph 4).

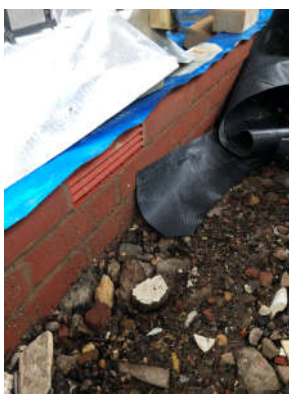
Photograph 1

A suitable membrane has been installed and taped as per recommended guidance and standards and rises from the floor to a level in the outer course of the building above the ventilation course (Photograph 1) and onto any access points at the same level.

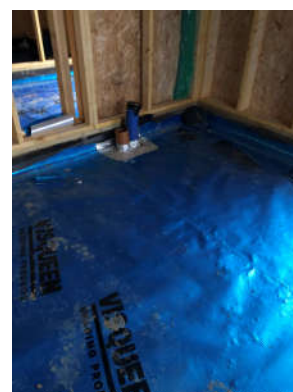
Photograph 4

The floor is to be raised with suitable insulation materials and underfloor heating to the level of the membrane edge and therefore minimize the potential for further damage. No damage or puncture was noted in or on the visible membrane and all corners and joints appeared appropriately and suitably emplaced in line with the appropriate guidance (Photograph 4).

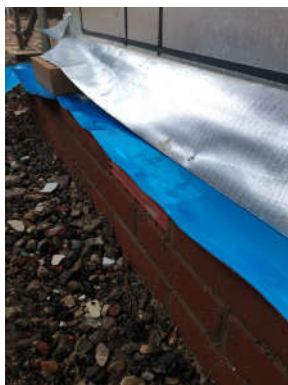
Photograph 1

A suitable membrane has been installed and taped as per recommended guidance and standards and rises from the floor to a level in the outer course of the building above the ventilation course (Photograph 1) and onto any access points at the same level.

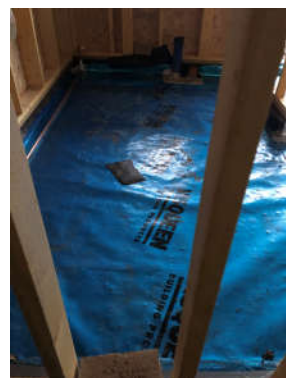
Photograph 4

The floor is to be raised with suitable insulation materials and underfloor heating to the level of the membrane edge and therefore minimize the potential for further damage. No damage or puncture was noted in or on the visible membrane and all corners and joints appeared appropriately and suitably emplaced in line with the appropriate guidance (Photograph 4).

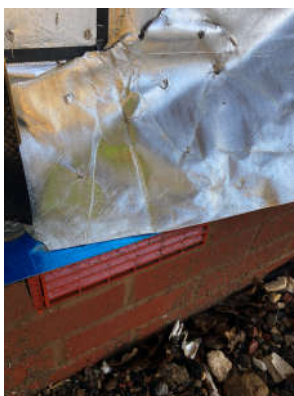
Photograph 1

A suitable membrane has been installed and taped as per recommended guidance and standards and rises from the floor to a level in the outer course of the building above the ventilation course (Photograph 1) and onto any access points at the same level.

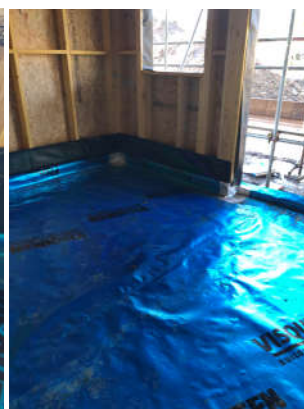
Photograph 4

The floor is to be raised with suitable insulation materials and underfloor heating to the level of the membrane edge and therefore minimize the potential for further damage. No damage or puncture was noted in or on the visible membrane and all corners and joints appeared appropriately and suitably emplaced in line with the appropriate guidance (Photograph 4).

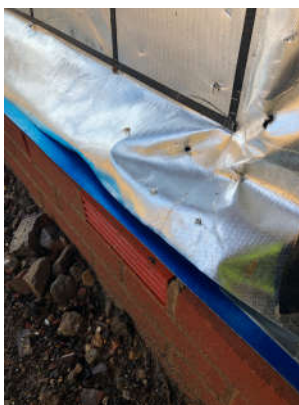
Photograph 1

A suitable membrane has been installed and taped as per recommended guidance and standards and rises from the floor to a level in the outer course of the building above the ventilation course (Photograph 1) and onto any access points at the same level.

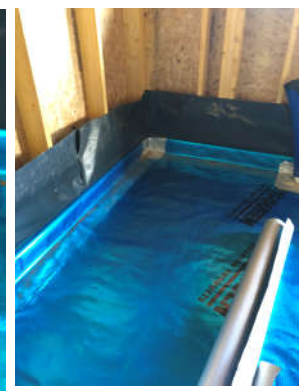
Photograph 4

The floor is to be raised with suitable insulation materials and underfloor heating to the level of the membrane edge and therefore minimize the potential for further damage. No damage or puncture was noted in or on the visible membrane and all corners and joints appeared appropriately and suitably emplaced in line with the appropriate guidance (Photograph 4).

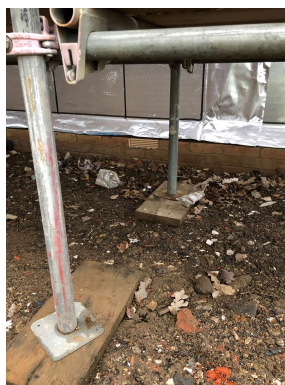
Photograph 1

A suitable membrane has been installed and taped as per recommended guidance and standards and rises from the floor to a level in the outer course of the building above the ventilation course (Photograph 1) and onto any access points at the same level.

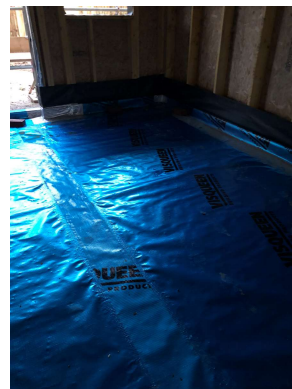
Photograph 4

The floor is to be raised with suitable insulation materials and underfloor heating to the level of the membrane edge and therefore minimize the potential for further damage. Damage or puncture was noted in or around one of the drainage pipe installations which appeared to have been undertaken post installation in a very rough manner invalidating the protection which was made aware to the developer.

This has been rectified as of 20<sup>th</sup> December 2021 as evidenced in Photograph 4. The works now appear compliant with provision of precautionary Amber 1 or CS2 levels of gas risk protection and are validated as being suitable and appropriate as such by this inspection, the works to date and the materials used.

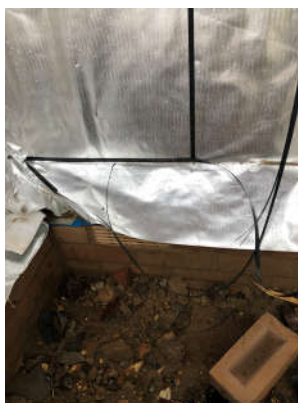
Photograph 1

A suitable membrane has been installed and taped as per recommended guidance and standards and rises from the floor to a level in the outer course of the building above the ventilation course (Photograph 1) and onto any access points at the same level.

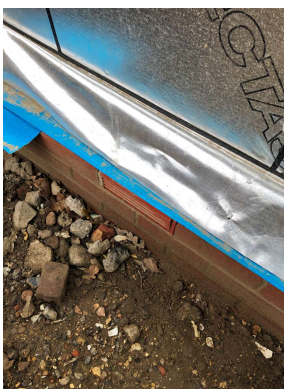
Photograph 1

A suitable membrane has been installed and taped as per recommended guidance and standards and rises from the floor to a level in the outer course of the building above the ventilation course (Photograph 1) and onto any access points at the same level.

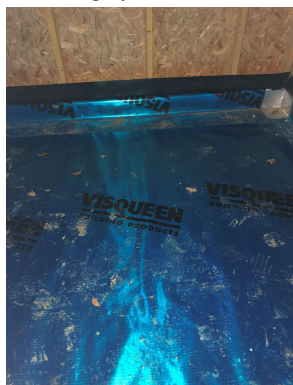
Photograph 4

The floor is to be raised with suitable insulation materials and underfloor heating to the level of the membrane edge and therefore minimize the potential for further damage. No damage or puncture was noted in or on the visible membrane and all corners and joints appeared appropriately and suitably emplaced in line with the appropriate guidance (Photograph 4).

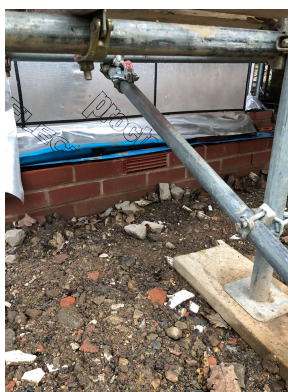
Photograph 1

A suitable membrane has been installed and taped as per recommended guidance and standards and rises from the floor to a level in the outer course of the building above the ventilation course (Photograph 1) and onto any access points at the same level.

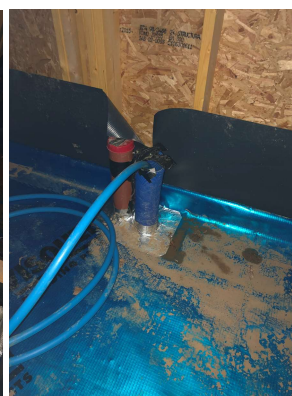
Photograph 4

The floor is to be raised with suitable insulation materials and underfloor heating to the level of the membrane edge and therefore minimize the potential for further damage. No damage or puncture was noted in or on the visible membrane and all corners and joints appeared appropriately and suitably emplaced in line with the appropriate guidance (Photograph 4).

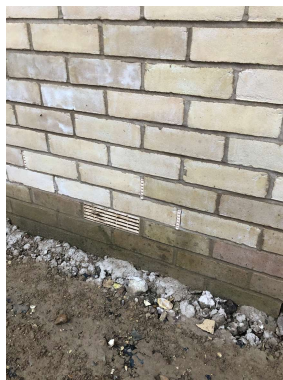
Photograph 1

A suitable membrane has been installed and taped as per recommended guidance and standards and rises from the floor to a level in the outer course of the building above the ventilation course (Photograph 1) and onto any access points at the same level.

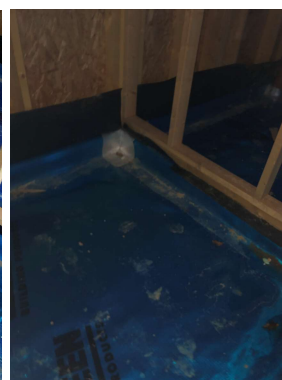
Photograph 4

The floor is to be raised with suitable insulation materials and underfloor heating to the level of the membrane edge and therefore minimize the potential for further damage. No damage or puncture was noted in or on the visible membrane and all corners and joints appeared appropriately and suitably emplaced in line with the appropriate guidance (Photograph 4).

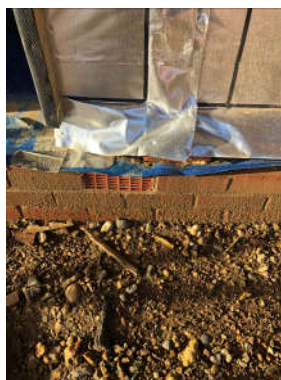
Photograph 1

A suitable membrane has been installed and taped as per recommended guidance and standards and rises from the floor to a level in the outer course of the building above the ventilation course (Photograph 1) and onto any access points at the same level.

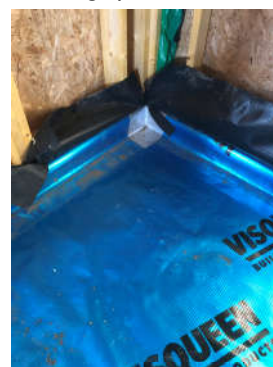
Photograph 4

The floor is to be raised with suitable insulation materials and underfloor heating to the level of the membrane edge and therefore minimize the potential for further damage. No damage or puncture was noted in or on the visible membrane and all corners and joints appeared appropriately and suitably emplaced in line with the appropriate guidance (Photograph 4).

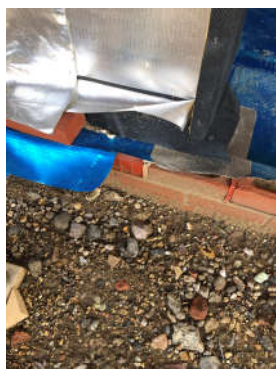
Photograph 1

A suitable membrane has been installed and taped as per recommended guidance and standards and rises from the floor to a level in the outer course of the building above the ventilation course (Photograph 1) and onto any access points at the same level.

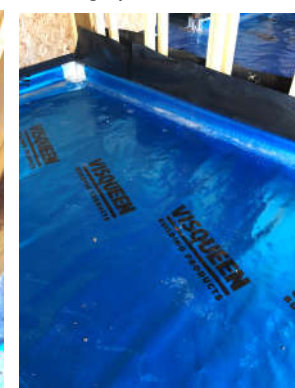
Photograph 4

The floor is to be raised with suitable insulation materials and underfloor heating to the level of the membrane edge and therefore minimize the potential for further damage. No damage or puncture was noted in or on the visible membrane and all corners and joints appeared appropriately and suitably emplaced in line with the appropriate guidance (Photograph 4).

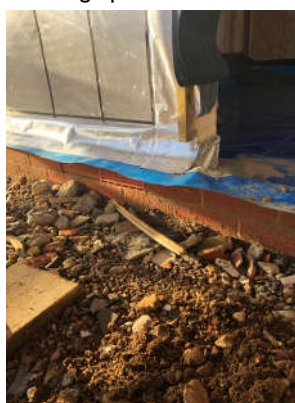
Photograph 1

A suitable membrane has been installed and taped as per recommended guidance and standards and rises from the floor to a level in the outer course of the building above the ventilation course (Photograph 1) and onto any access points at the same level.

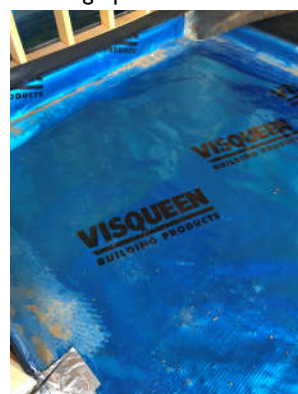
Photograph 4

The floor is to be raised with suitable insulation materials and underfloor heating to the level of the membrane edge and therefore minimize the potential for further damage. No damage or puncture was noted in or on the visible membrane and all corners and joints appeared appropriately and suitably emplaced in line with the appropriate guidance (Photograph 4).

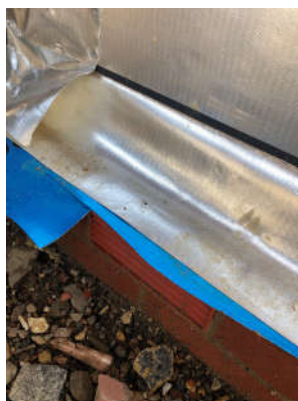
Photograph 1

A suitable membrane has been installed and taped as per recommended guidance and standards and rises from the floor to a level in the outer course of the building above the ventilation course (Photograph 1) and onto any access points at the same level.

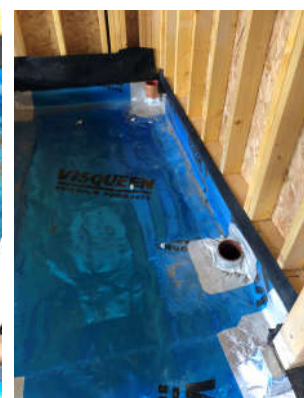
Photograph 4

The floor is to be raised with suitable insulation materials and underfloor heating to the level of the membrane edge and therefore minimize the potential for further damage. No damage or puncture was noted in or on the visible membrane and all corners and joints appeared appropriately and suitably emplaced in line with the appropriate guidance (Photograph 4).

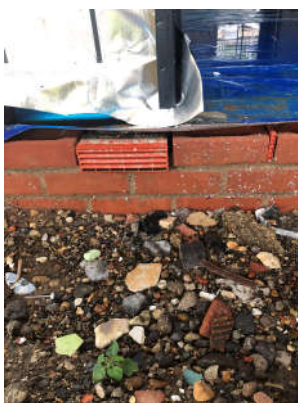
Photograph 1

A suitable membrane has been installed and taped as per recommended guidance and standards and rises from the floor to a level in the outer course of the building above the ventilation course (Photograph 1) and onto any access points at the same level.

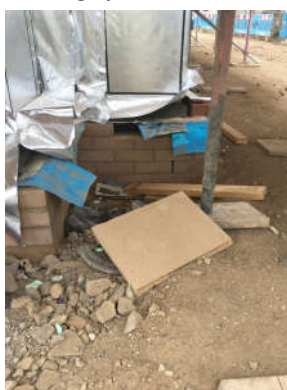
Photograph 1

A suitable membrane has been installed and taped as per recommended guidance and standards and rises from the floor to a level in the outer course of the building above the ventilation course (Photograph 1) and onto any access points at the same level.

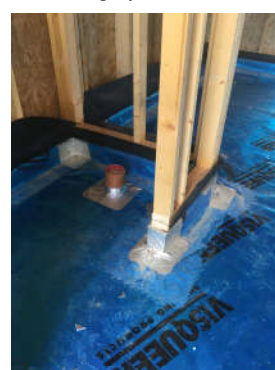
Photograph 4

The floor is to be raised with suitable insulation materials and underfloor heating to the level of the membrane edge and therefore minimize the potential for further damage. No damage or puncture was noted in or on the visible membrane and all corners and joints appeared appropriately and suitably emplaced in line with the appropriate guidance (Photograph 4).

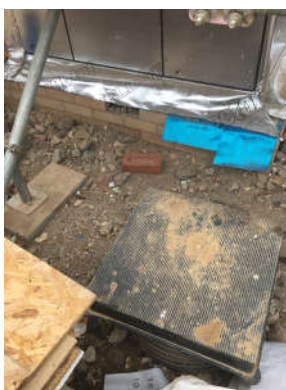
Photograph 1

A suitable membrane has been installed and taped as per recommended guidance and standards and rises from the floor to a level in the outer course of the building above the ventilation course (Photograph 1) and onto any access points at the same level.

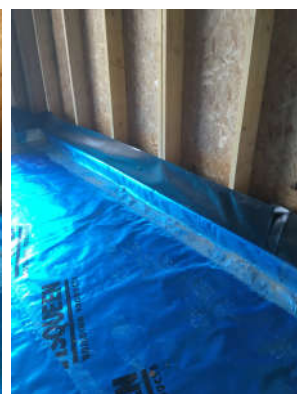
Photograph 4

The floor is to be raised with suitable insulation materials and underfloor heating to the level of the membrane edge and therefore minimize the potential for further damage. No damage or puncture was noted in or on the visible membrane and all corners and joints appeared appropriately and suitably emplaced in line with the appropriate guidance (Photograph 4).

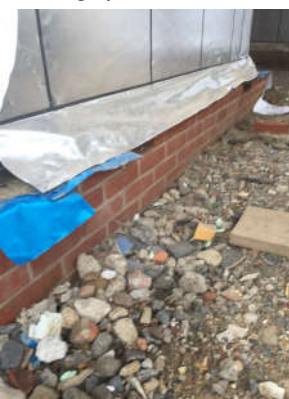
Photograph 1

A suitable membrane has been installed and taped as per recommended guidance and standards and rises from the floor to a level in the outer course of the building above the ventilation course (Photograph 1) and onto any access points at the same level.

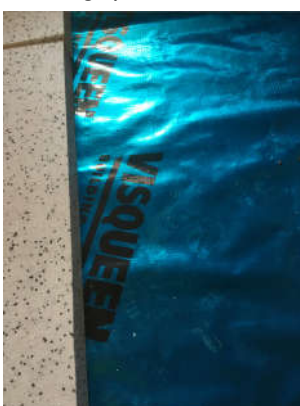
Photograph 4

The floor is to be raised with suitable insulation materials and underfloor heating to the level of the membrane edge and therefore minimize the potential for further damage. No damage or puncture was noted in or on the visible membrane and all corners and joints appeared appropriately and suitably emplaced in line with the appropriate guidance (Photograph 4).

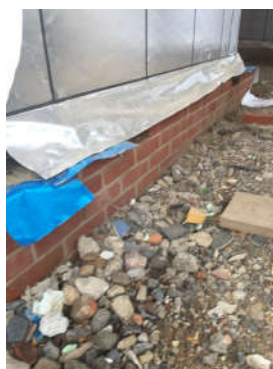
Photograph 1

A suitable membrane has been installed and taped as per recommended guidance and standards and rises from the floor to a level in the outer course of the building above the ventilation course (Photograph 1) and onto any access points at the same level.

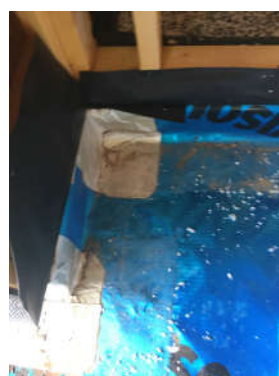
Photograph 4

The floor is to be raised with suitable insulation materials and underfloor heating to the level of the membrane edge and therefore minimize the potential for further damage. No damage or puncture was noted in or on the visible membrane and all corners and joints appeared appropriately and suitably emplaced in line with the appropriate guidance (Photograph 4).

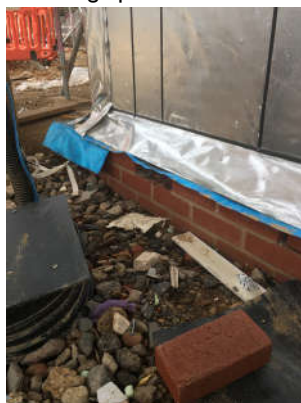
Photograph 1

A suitable membrane has been installed and taped as per recommended guidance and standards and rises from the floor to a level in the outer course of the building above the ventilation course (Photograph 1) and onto any access points at the same level.

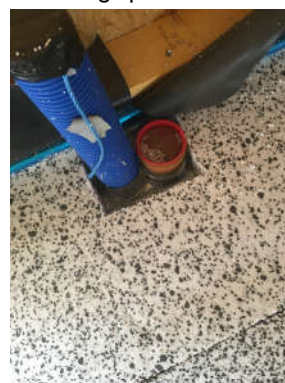
Photograph 4

The floor is to be raised with suitable insulation materials and underfloor heating to the level of the membrane edge and therefore minimize the potential for further damage. No damage or puncture was noted in or on the visible membrane and all corners and joints appeared appropriately and suitably emplaced in line with the appropriate guidance (Photograph 4).

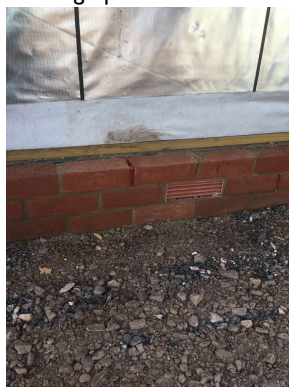
Photograph 1

A suitable membrane has been installed and taped as per recommended guidance and standards and rises from the floor to a level in the outer course of the building above the ventilation course (Photograph 1) and onto any access points at the same level.

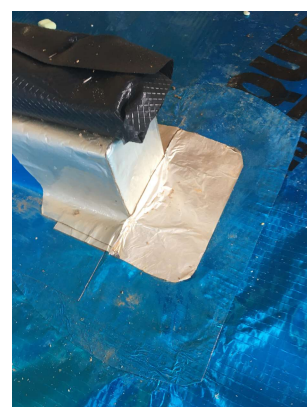
Photograph 4

The floor is to be raised with suitable insulation materials and underfloor heating to the level of the membrane edge and therefore minimize the potential for further damage. No damage or puncture was noted in or on the visible membrane and all corners and joints appeared appropriately and suitably emplaced in line with the appropriate guidance (Photograph 4).

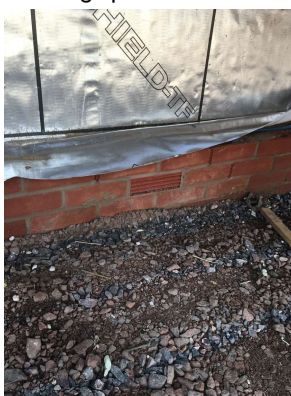
Photograph 1

A suitable membrane has been installed and taped as per recommended guidance and standards and rises from the floor to a level in the outer course of the building above the ventilation course (Photograph 1) and onto any access points at the same level.

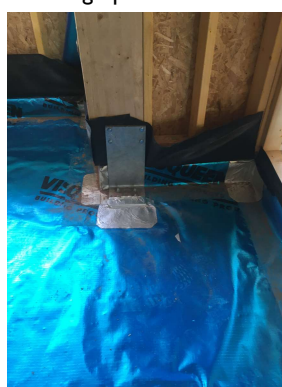
Photograph 4

The floor is to be raised with suitable insulation materials and underfloor heating to the level of the membrane edge and therefore minimize the potential for further damage. No damage or puncture was noted in or on the visible membrane and all corners and joints appeared appropriately and suitably emplaced in line with the appropriate guidance (Photograph 4).

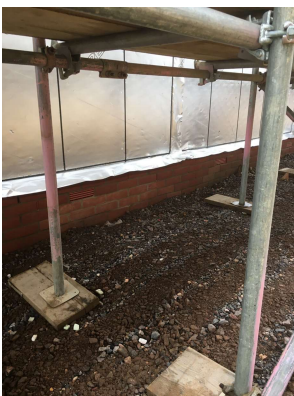
Photograph 1

A suitable membrane has been installed and taped as per recommended guidance and standards and rises from the floor to a level in the outer course of the building above the ventilation course (Photograph 1) and onto any access points at the same level.

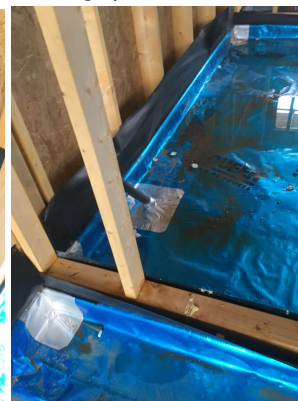
Photograph 4

The floor is to be raised with suitable insulation materials and underfloor heating to the level of the membrane edge and therefore minimize the potential for further damage. No damage or puncture was noted in or on the visible membrane and all corners and joints appeared appropriately and suitably emplaced in line with the appropriate guidance (Photograph 4).

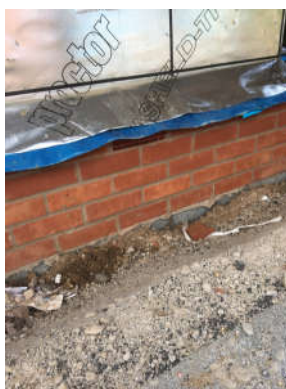
Photograph 1

A suitable membrane has been installed and taped as per recommended guidance and standards and rises from the floor to a level in the outer course of the building above the ventilation course (Photograph 1) and onto any access points at the same level.

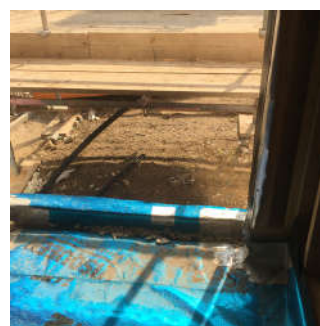
Photograph 4

The floor is to be raised with suitable insulation materials and underfloor heating to the level of the membrane edge and therefore minimize the potential for further damage. No damage or puncture was noted in or on the visible membrane and all corners and joints appeared appropriately and suitably emplaced in line with the appropriate guidance (Photograph 4).

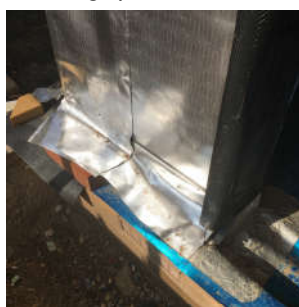
Photograph 1

A suitable membrane has been installed and taped as per recommended guidance and standards and rises from the floor to a level in the outer course of the building above the ventilation course (Photograph 1) and onto any access points at the same level.

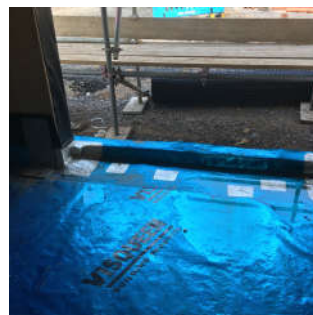
Photograph 4

The floor is to be raised with suitable insulation materials and underfloor heating to the level of the membrane edge and therefore minimize the potential for further damage. No damage or puncture was noted in or on the visible membrane and all corners and joints appeared appropriately and suitably emplaced in line with the appropriate guidance (Photograph 4).

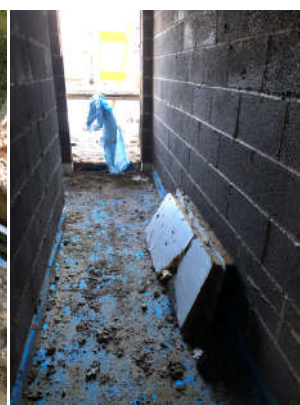
Photograph 4

The floor is to be raised with suitable insulation materials to the level of the membrane edge and therefore minimize the potential for further damage. No damage or puncture was noted in or on the visible membrane and all corners and joints appeared appropriately and suitably emplaced in line with the appropriate guidance (Photograph 4).

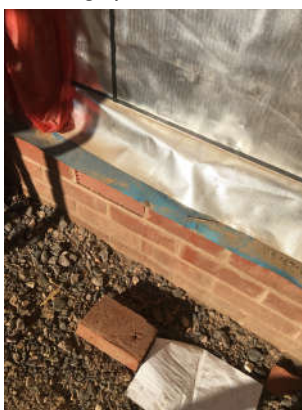
Photograph 1

A suitable membrane has been installed and taped as per recommended guidance and standards and rises from the floor to a level in the outer course of the building above the ventilation course (Photograph 1) and onto any access points at the same level.

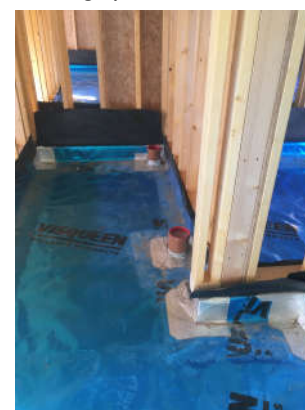
Photograph 4

The floor is to be raised with suitable insulation materials and underfloor heating to the level of the membrane edge and therefore minimize the potential for further damage. No damage or puncture was noted in or on the visible membrane and all corners and joints appeared appropriately and suitably emplaced in line with the appropriate guidance (Photograph 4).

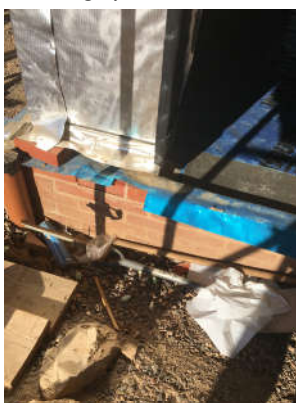
Photograph 1

A suitable membrane has been installed and taped as per recommended guidance and standards and rises from the floor to a level in the outer course of the building above the ventilation course (Photograph 1) and onto any access points at the same level.

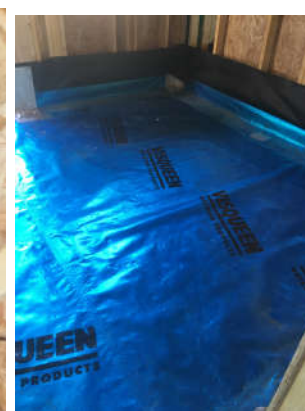
Photograph 4

The floor is to be raised with suitable insulation materials and underfloor heating to the level of the membrane edge and therefore minimize the potential for further damage. No damage or puncture was noted in or on the visible membrane and all corners and joints appeared appropriately and suitably emplaced in line with the appropriate guidance (Photograph 4).

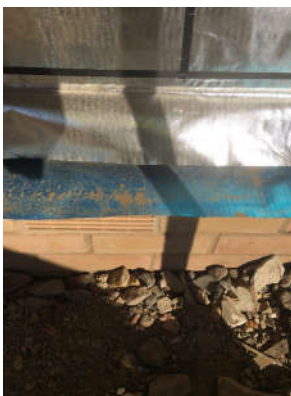
Photograph 1

A suitable membrane has been installed and taped as per recommended guidance and standards and rises from the floor to a level in the outer course of the building above the ventilation course (Photograph 1) and onto any access points at the same level.

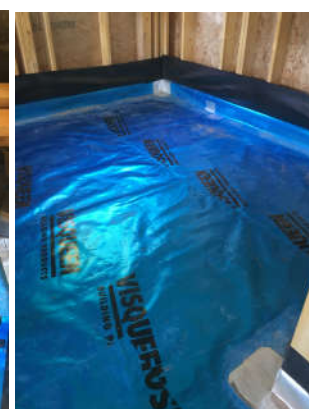
Photograph 4

The floor is to be raised with suitable insulation materials and underfloor heating to the level of the membrane edge and therefore minimize the potential for further damage. No damage or puncture was noted in or on the visible membrane and all corners and joints appeared appropriately and suitably emplaced in line with the appropriate guidance (Photograph 4).
