# Ross Consulting

**CLIENT-** Mr and Mrs Youngman

**SITE-** Larkby, Kew Lane, Bursledon

**PROJECT-** Tree Report Based on Recommendations in BS 5837 2012

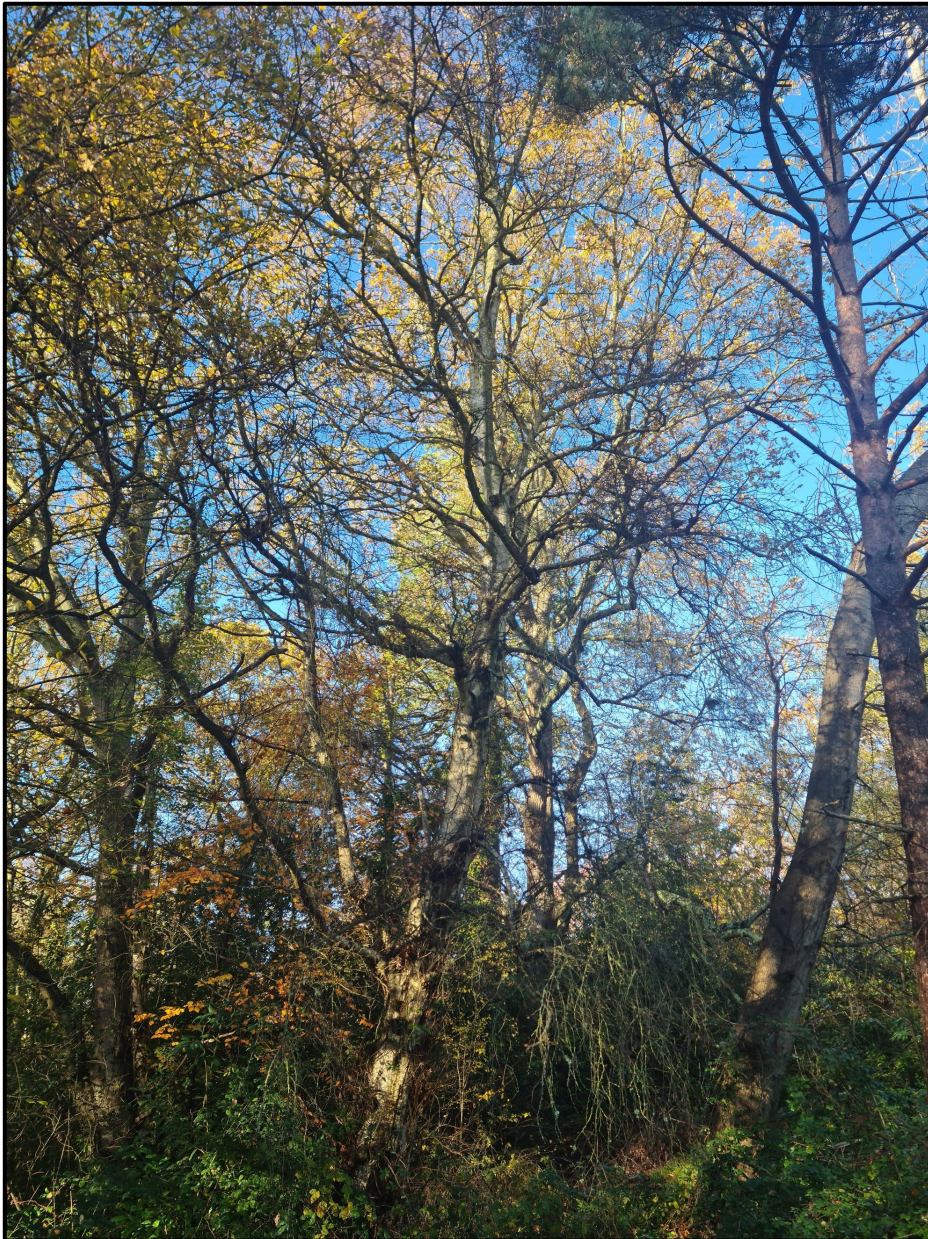
**Photograph Five – T8**

- 6.1.9 T9 Goat Willow** – To the South of T8, as above.
- 6.1.10 T10 Apple** – To the North of H11a to be retained, fruit tree pruning required.
- 6.1.11 H11a Laurel/Lawsons Hedge** – Outside the direct influence of proposed development, only necessary work required is the replacement of dead conifers and gapping up of the hedge.

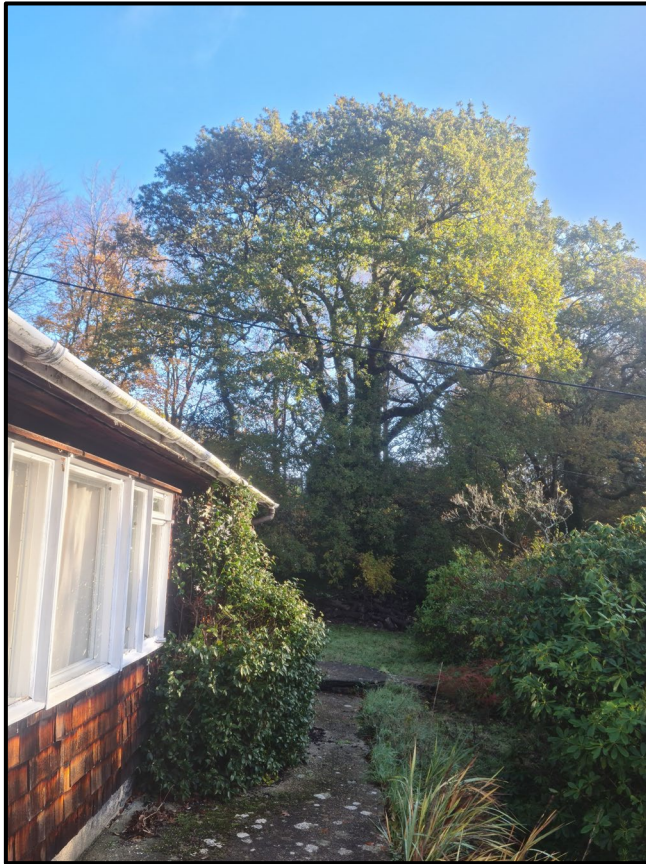
**Photograph Nine** – H11a in the foreground and T14 in the background

| Tree | Species | Recommendations | Tree | Species | Recommendations |
|---|---|---|---|---|---|
| H11a | Lawsons Cypress and Laurel | <b>Establish Ownership</b><br><b>Option One</b> – Cut back/prune and replace dead conifers<br><b>Option Two</b> – Fell and replace with | H11b | Rhodo, Yew, Beech | Formative pruning to retain and planting up any gaps |
