# Site Investigation Report

140472.1.1.BSI

Auger were commissioned by Quadra to undertake a site investigation and CCTV inspection of the underground drainage within the area of concern (AOC) at the property.

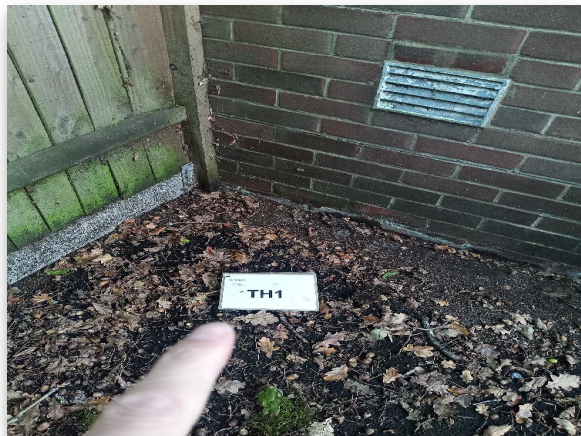
Fig 1.1: Trial Hole 1 Location

TH1 and TH2 were completed to the required depth and the requested soil and root samples were collected whilst on site.

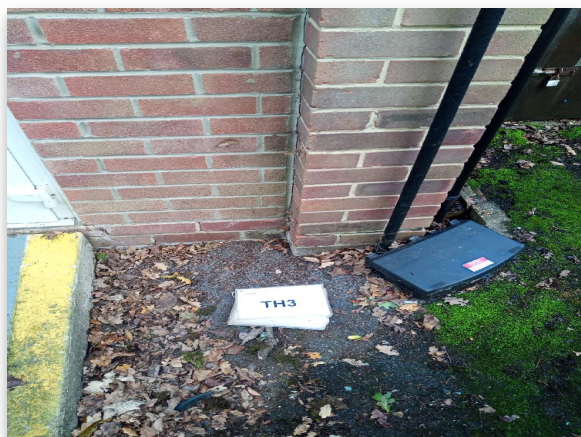
Fig 3.1: Trial Hole 3 Location

TH3 was moved to front elevation on same corner because of a gas mains box and drainage within originally proposed area (Fig 5.3). TH3 was completed to the required depth and the requested soil and root samples were collected whilst on site.

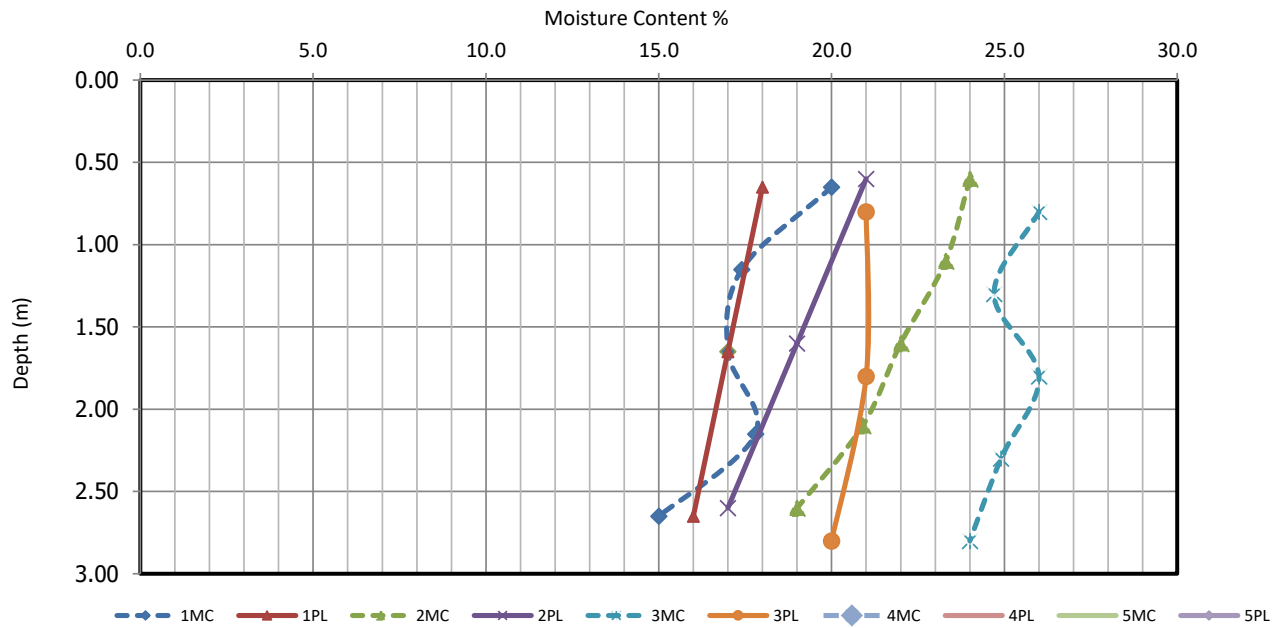
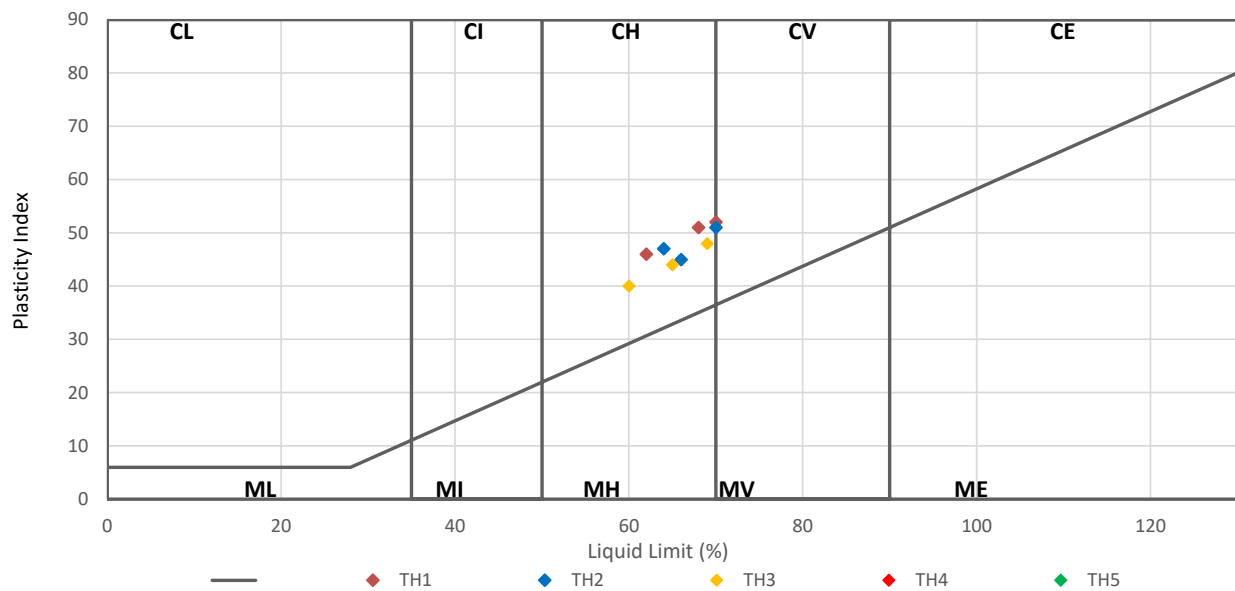
PLASTICITY CHART FOR CASAGRANDE CLASSIFICATION  
BS 5930:1999+A2:2010

Modified Plasticity Index (PI) <10 : Non Classified  
 Modified PI = 10 to <20 : Low volume change potential (LOW VCP)  
 Modified PI = 20 to <40 : Medium volume change potential (Med VCP)  
 Modified PI = 40 or greater : High volume change potential (HIGH VCP)
