# Tree Management plan - 2023 update

12 Hamblewood

# River Copse

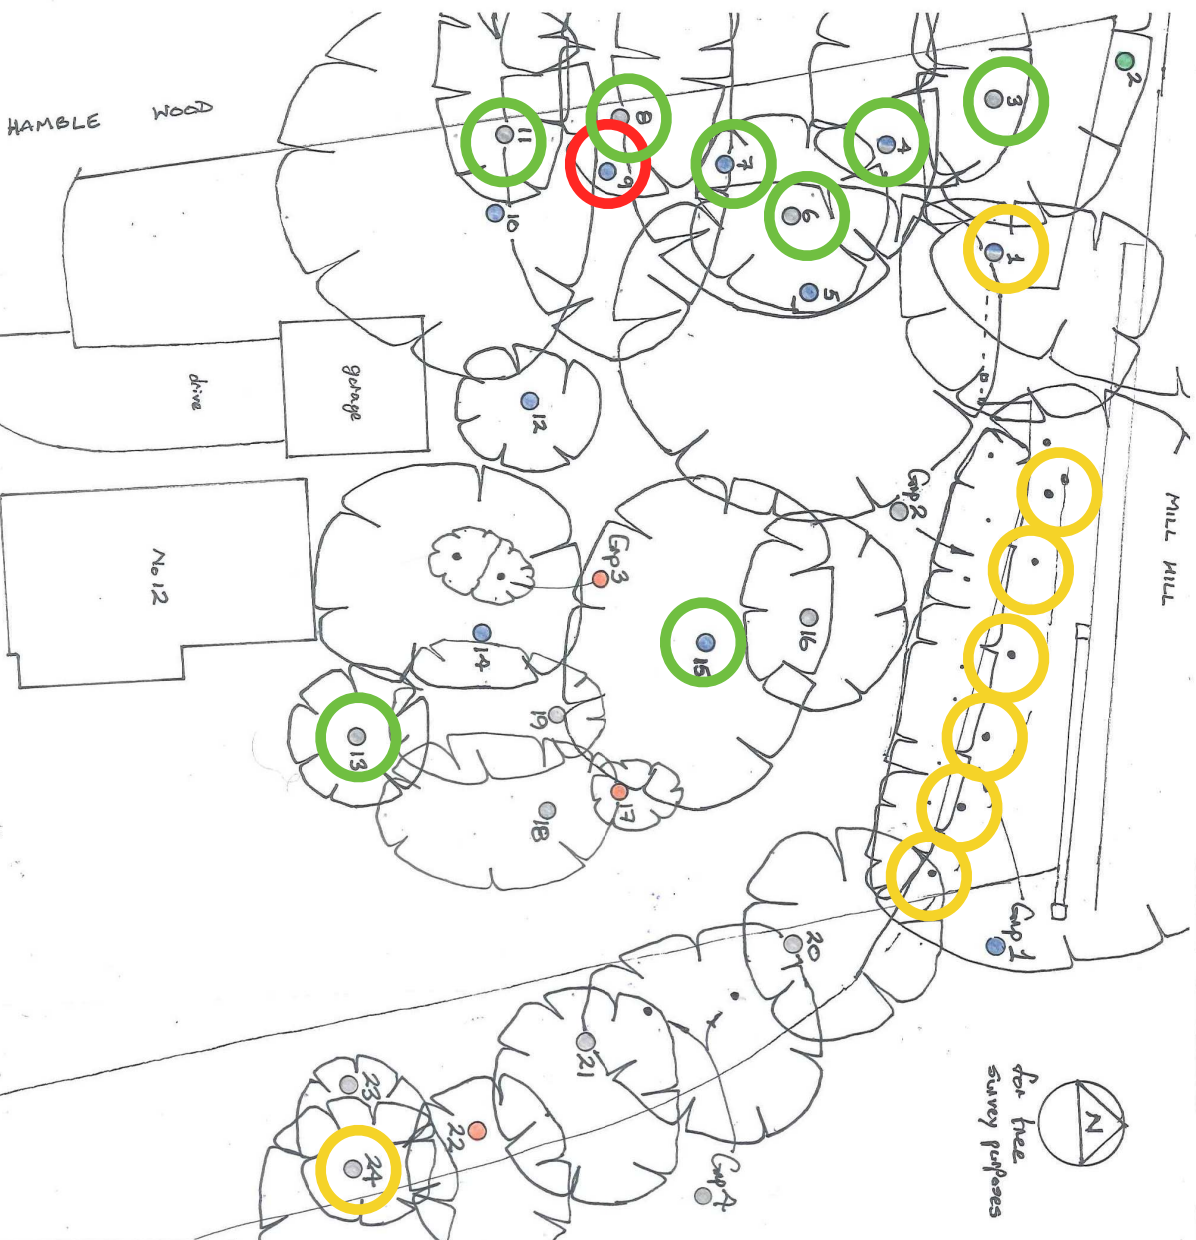
Topographical & tree survey

Red  
Disease - Future  
removal

Yellow  
Intervention - revive

Green & Yellow  
Trees being developed
