**BISHOPSTOKE MEMORIAL HALL**

**17 RIVERSIDE, BISHOPSTOKE**

**STRUCTURAL SURVEY & APPRAISAL**

**EXISTING COMMUNITY HALL**

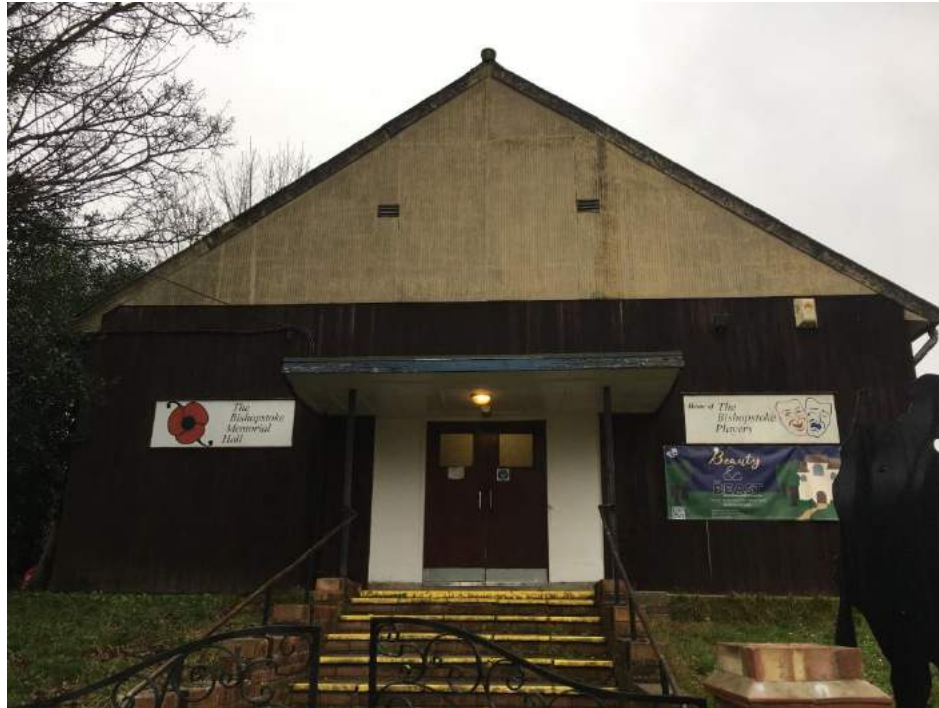
Photograph 1:- Front - Southern Elevation

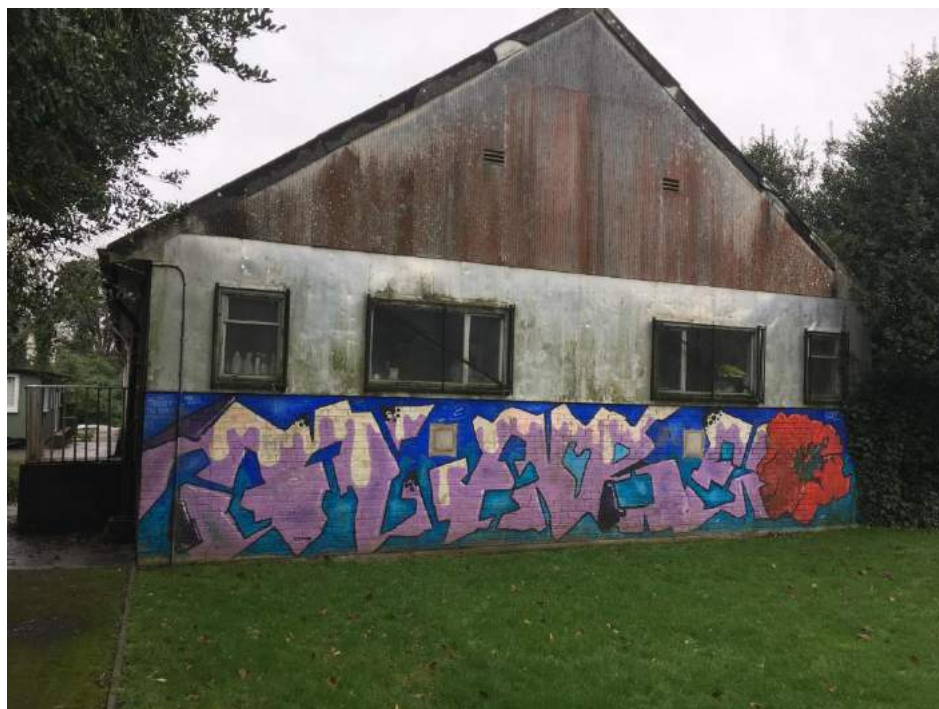
Photograph 2:- Rear - Northern Elevation

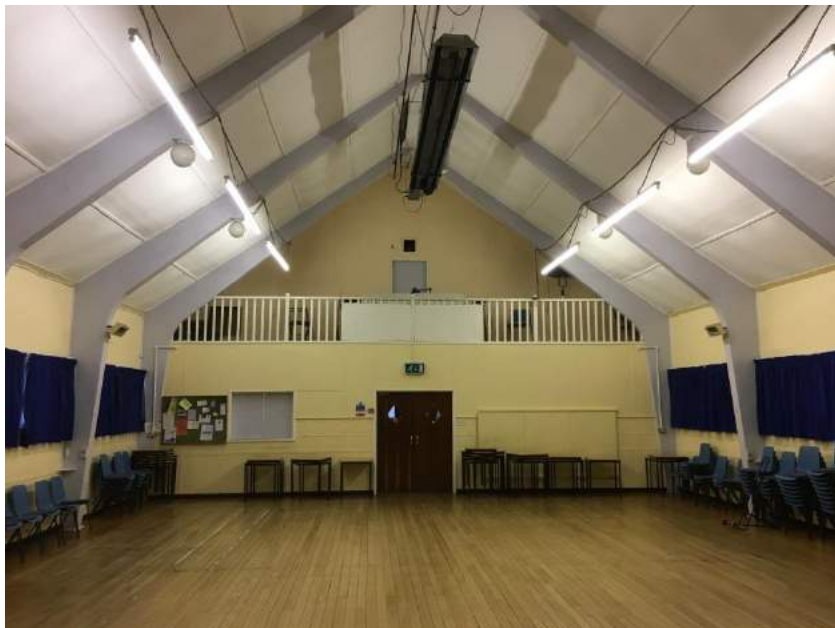
Photograph 6:- Hall viewed towards entrance

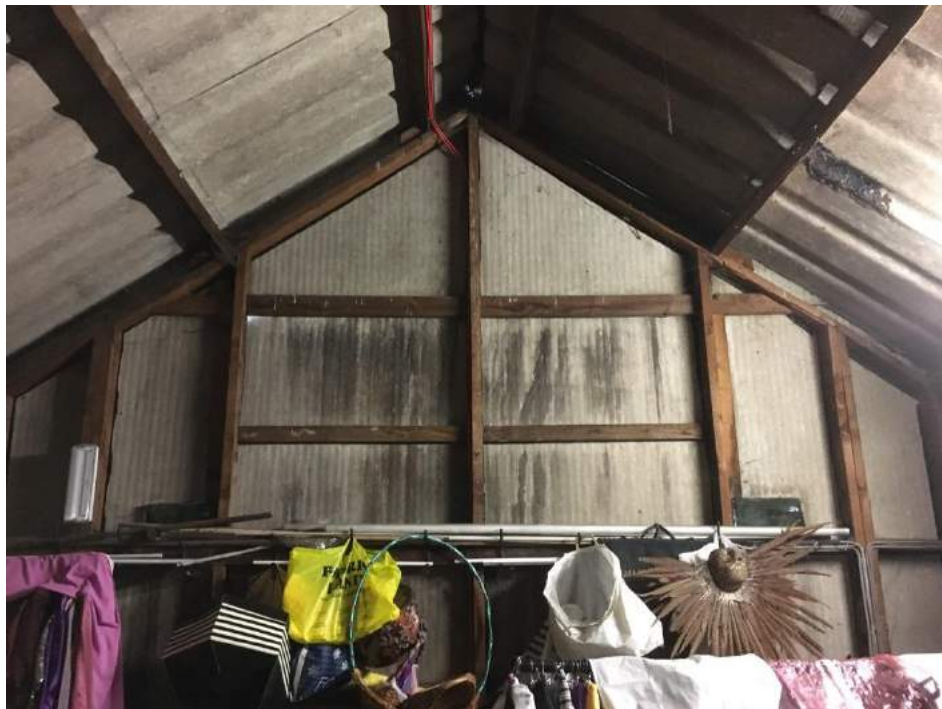
Photograph 10:- Front gable framing

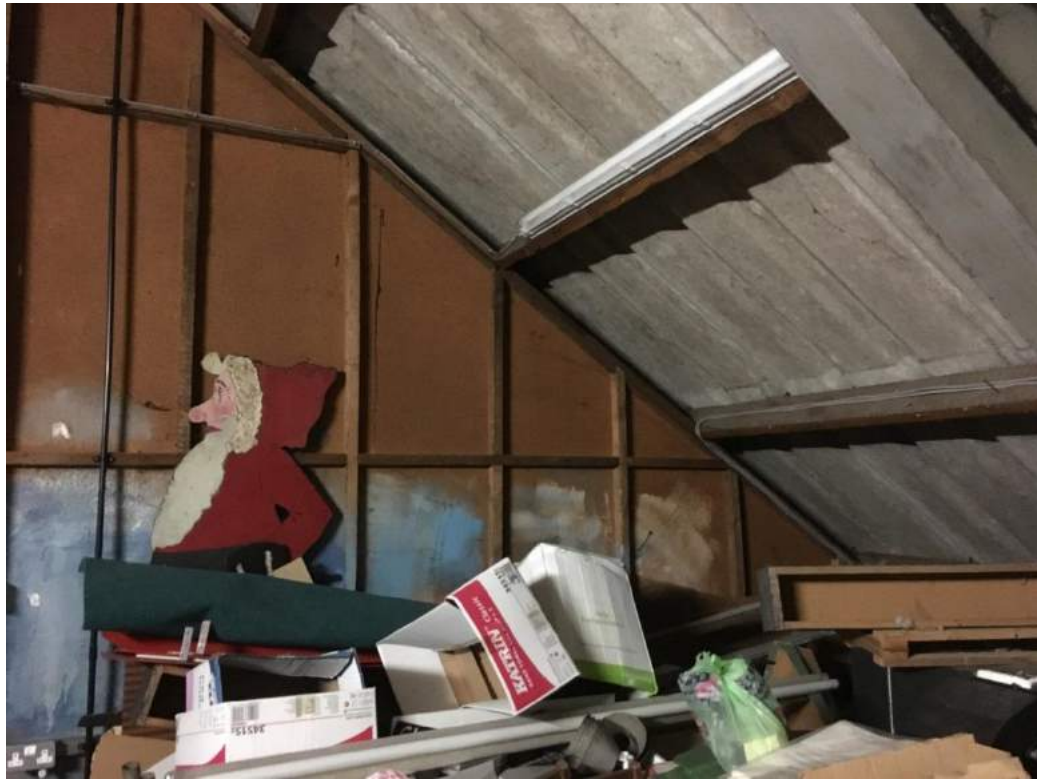
Photograph 11:- Internal wall to balcony and roof purlin / covering

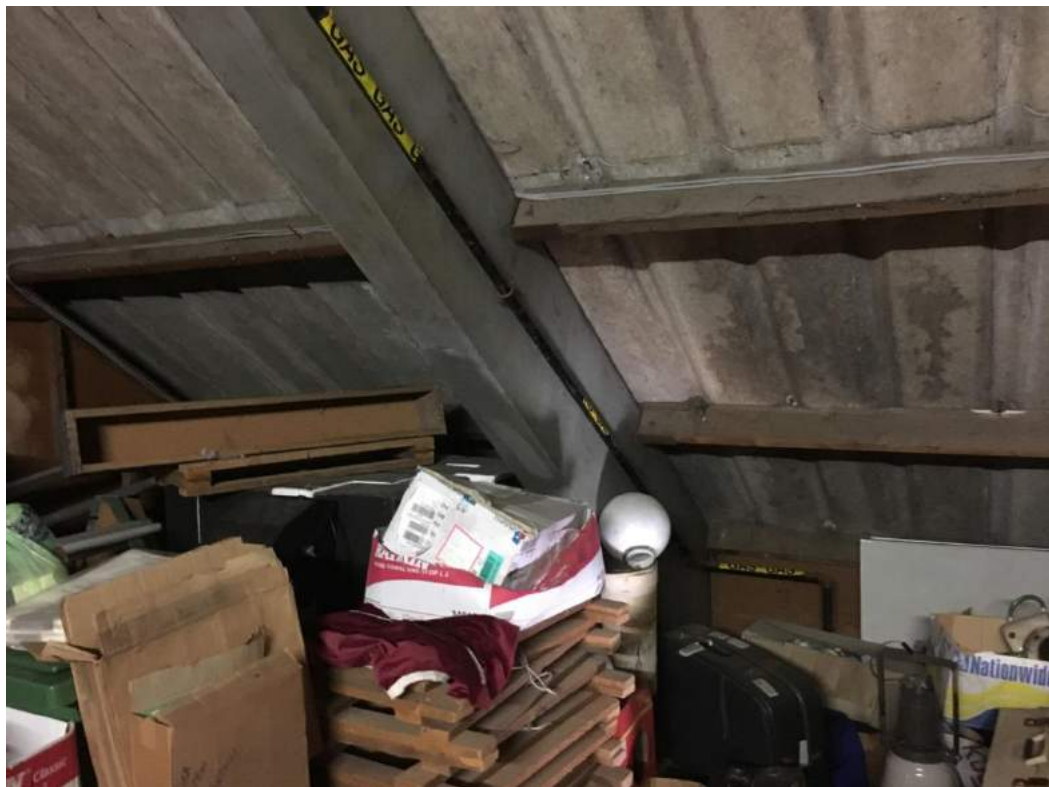
Photograph 12:- Typical purlin to portal rafter connection

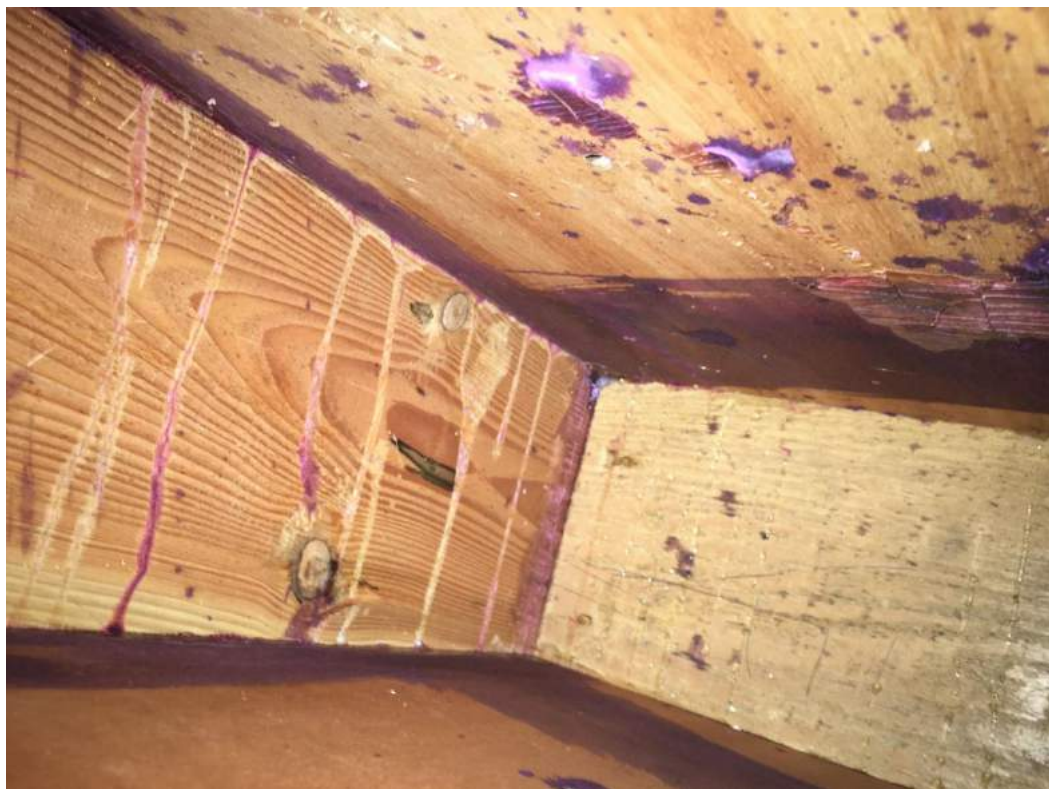
Photograph 14:- Internal view of portal construction

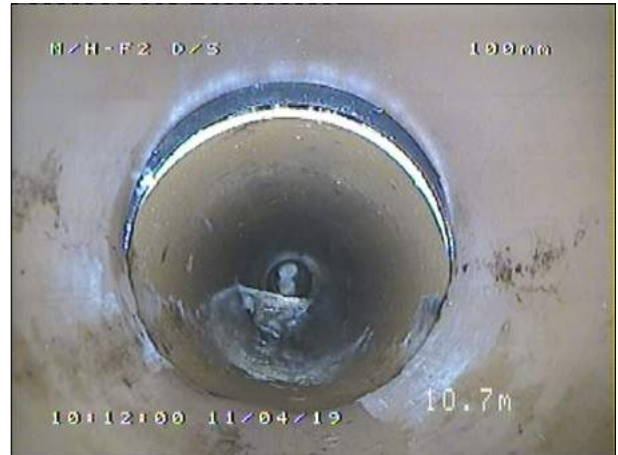
Photo: 1\_1\_17\_A.JPG  
10.7m, Sewer material changes

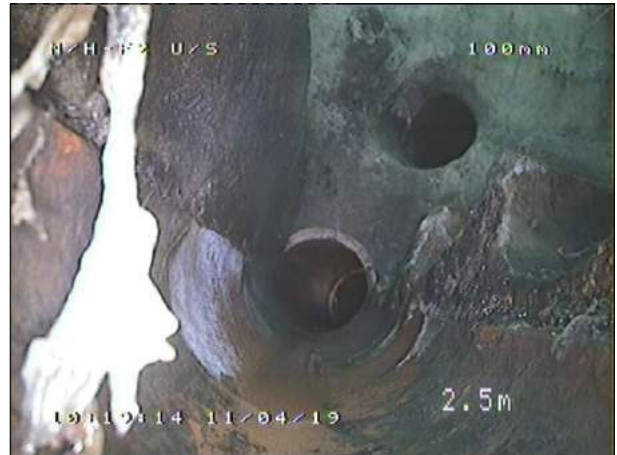
Photo: 3\_3\_32\_A.JPG  
2.5m, Manhole

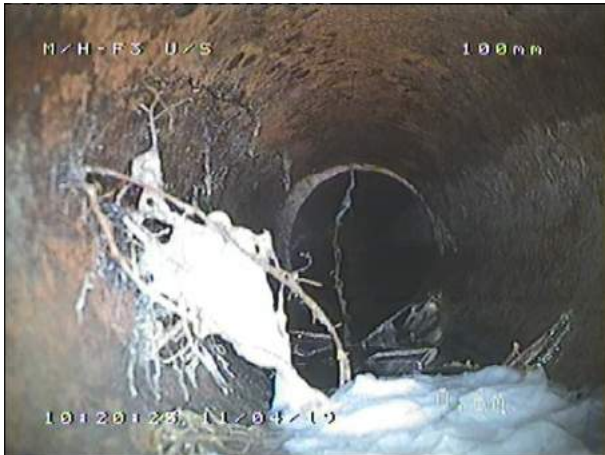
Photo: 4\_4\_37\_A.JPG  
0.2m, Roots, fine at joint, Start

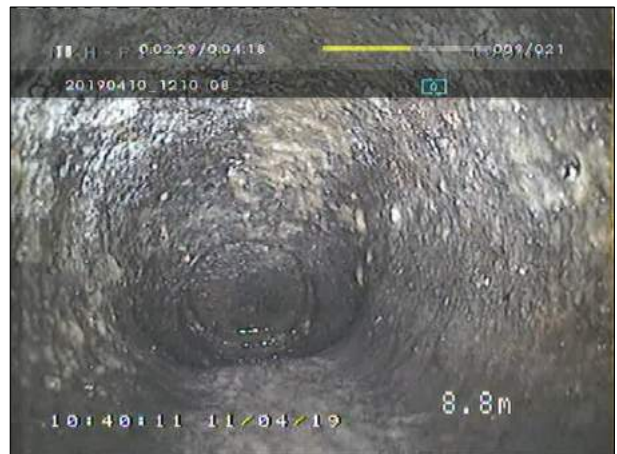
Photo: 9\_9\_69\_A.JPG  
8.8m, Manhole

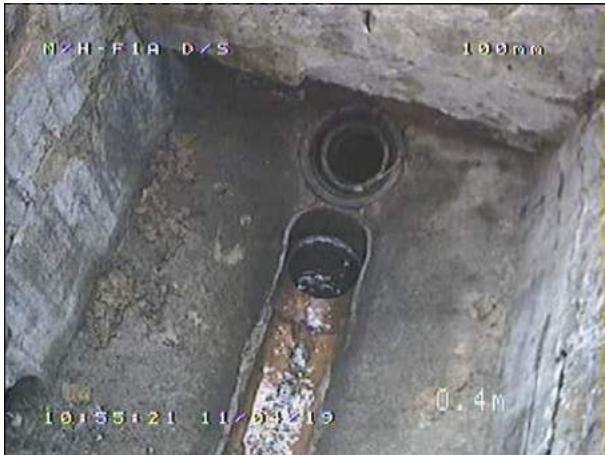
Photo: 11\_11\_77\_A.JPG  
0m, Start of survey

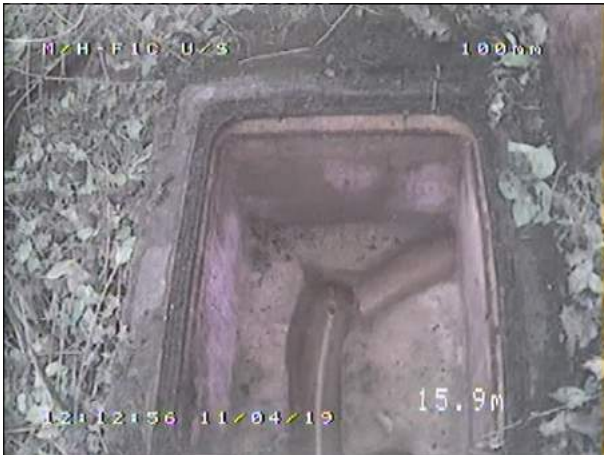
Photo: 14\_14\_108\_A.JPG  
 0m, Start of survey

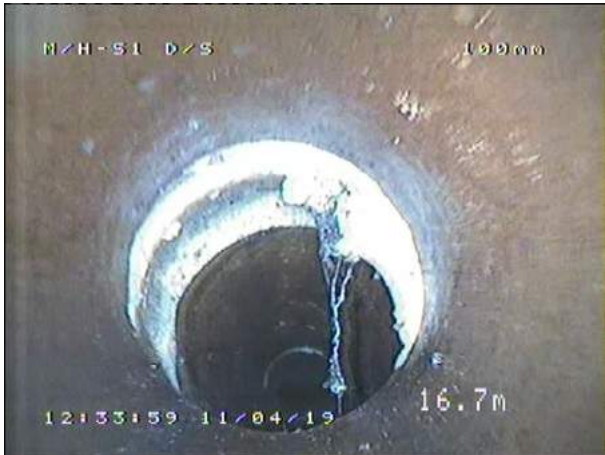
Photo: 18\_18\_144\_A.JPG  
15.7m, Line of sewer deviates down, Start

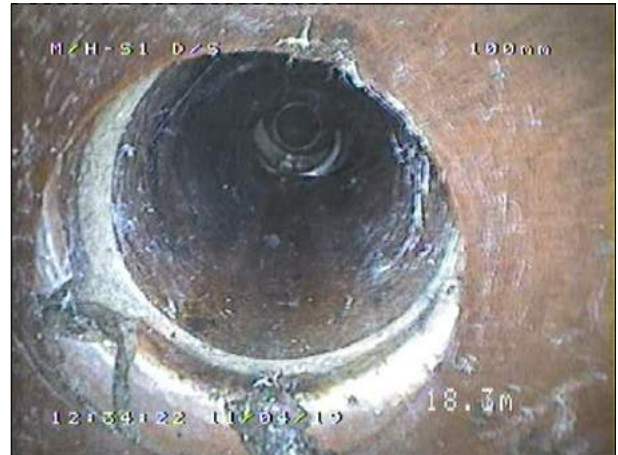
Photo: 18\_18\_146\_A.JPG  
18.3m, Line of sewer deviates down, End

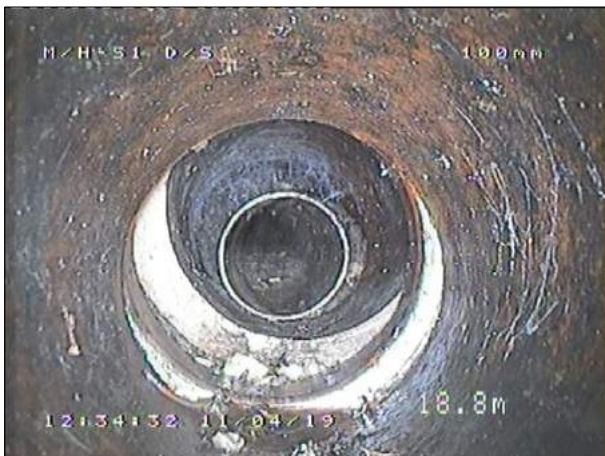
Photo: 18\_18\_147\_A.JPG  
18.8m, Joint displaced, large (over 1.5 times the pipe wall thickness)
