**Desk study and preliminary risk assessment report**

**Cockpit Barn, Knowle Lane, Horton Heath**

Alderbury Homes Ltd

July 2021

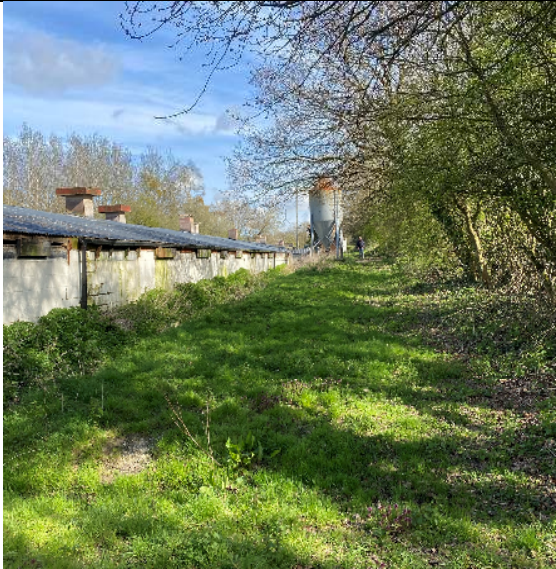
| Zone A | | |
|---|--|---|
| Eastern boundary of the site.<br>Raised bank to the east<br>which reduces to the south,<br>separating site from Knowle<br>Lane | | |

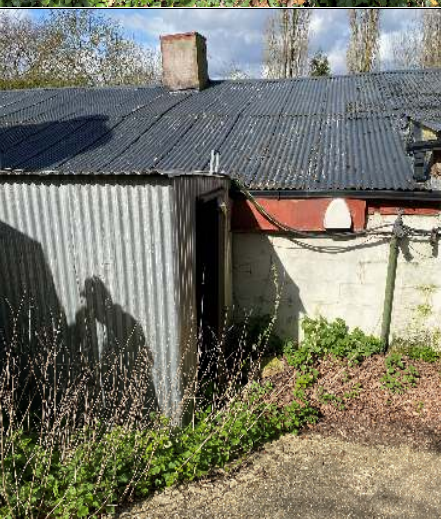
| Zone A | | |
|---|--|---|
| Corrugated metal covered storage area towards the centre of the east side of poultry house, immediately south of entrance | | |

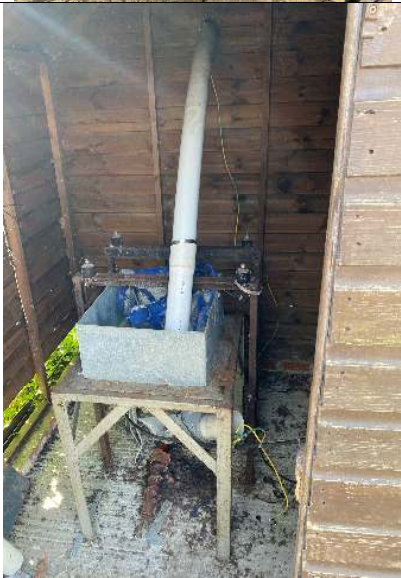
| Zone A | | |
|---|--|---|
| <p>Inside of wooden shed, a hopper used to transfer grain from the silo to the poultry house. The grain falls from the silo into the hopper, where augers drive the grain up to the roof of the poultry house to be automatically distributed to the feeders (Archimedes screw principle) driven by an electric motor. Concrete floor to shed.</p> | | |

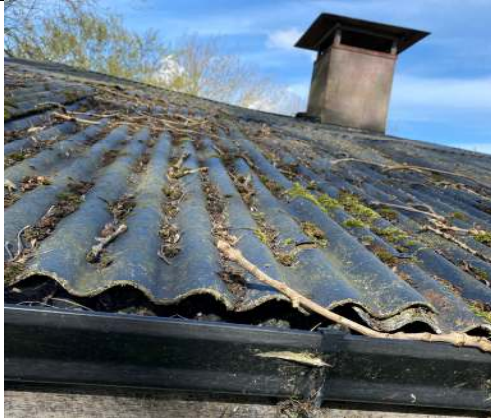
| Zone A | | |
|---|--|---|
| <p>Asbestos cement roof sheets on poultry house</p> | | |

It is recommended that a preliminary targeted and general site coverage intrusive investigation is undertaken, to be supervised by an appropriately qualified and experienced engineer. Additionally, an asbestos survey should be undertaken on the structures.

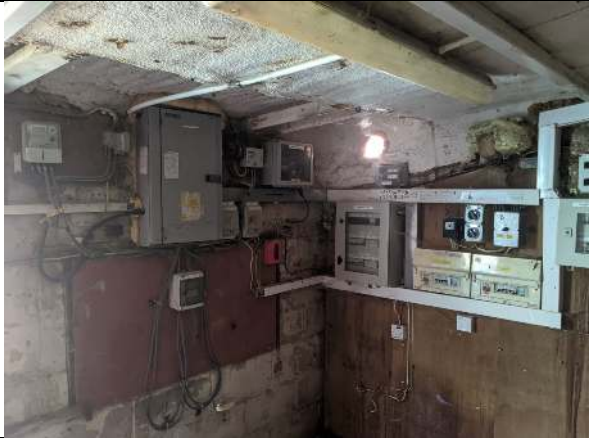
| Zone A | | |
|---|--|---|
| Electrical controls immediately left inside entrance. | | A photograph showing a corner of a room with concrete walls. On the left wall, there are several electrical control panels, including a large grey one and a red one. A single light bulb is visible on the ceiling. To the right, there are more electrical components and a wooden door or partition. |

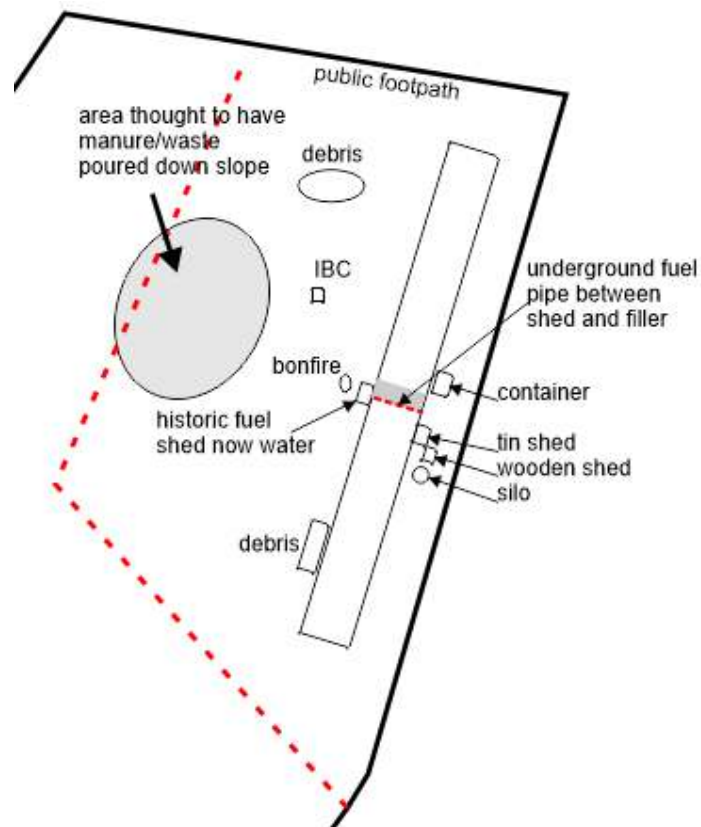
**Figure 3: Approximate locations of features identified within Table 1**

poultry house is a block-built structure which reportedly formerly contained a fuel oil tank for heating the building, and currently contains a tank which stores water and antibiotics for distribution to the poultry. In the north are abandoned materials including plastic pipes, a metal trailer, and an intermediate bulk container (IBC). The IBC was upside down and appeared to be empty, there was no evidence to what its former contents were, although it is considered likely to be cleaning chemicals. The area is generally soft standing with rough vegetation, small to large bushes, and small to large trees. The exception to groundcover in this area is concrete adjacent to the eastern middle area of the poultry house at and in the vicinity of the site entrance. The perimeter of Zone A is bound to the north, south and west by wooden and wire fencing most of which is covered by bushes, and trees. The eastern perimeter is bound by bushes and trees, with three metal access gates. The site can be accessed off Knowle Lane via these gates, the first set of gates are located near the southeast corner of the poultry house, the second is opposite the middle of the east side of the poultry house, the third set is located towards the northeast corner of the site next to a public footpath which runs along the northern boundary from east to west. The approximate location of the features described above and presented within Table 1 are marked on Figure 3 below.

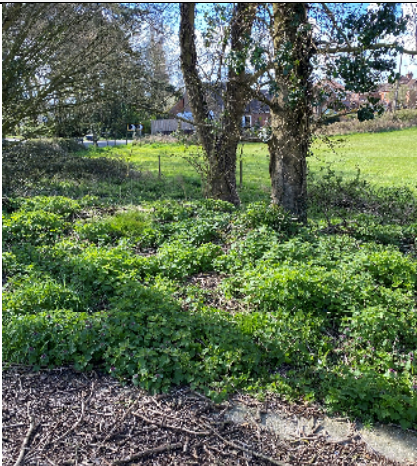
| <b>Site walkover photographs and commentary – Zone B</b> | | |
|---|--|---|
| <p>Western edge of A towards southern boundary of B. Piece of asbestos cement roofing on ground, no additional pieces in the vicinity.</p> | | |

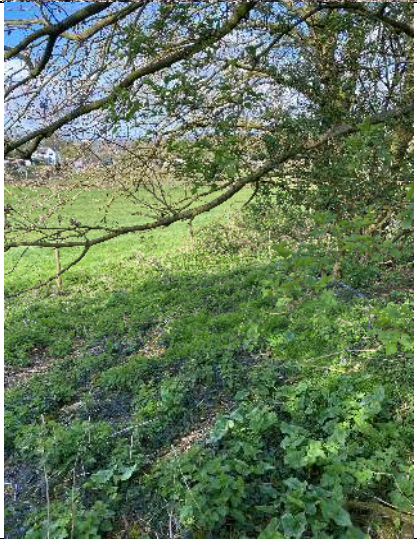
| <b>Site walkover photographs and commentary – Zone B</b> | | |
|---|--|---|
| <p>Slope and change in levels from A towards B looking west</p> | | |

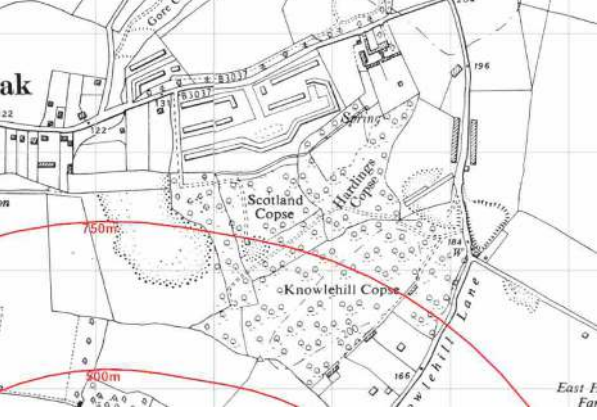
| Commentary | Extracts from historic maps |
|---|---|
| <p>c. 1957 1:10,560<br/>700m to the north of the site extensive sand extraction activities are occurring.</p> | |

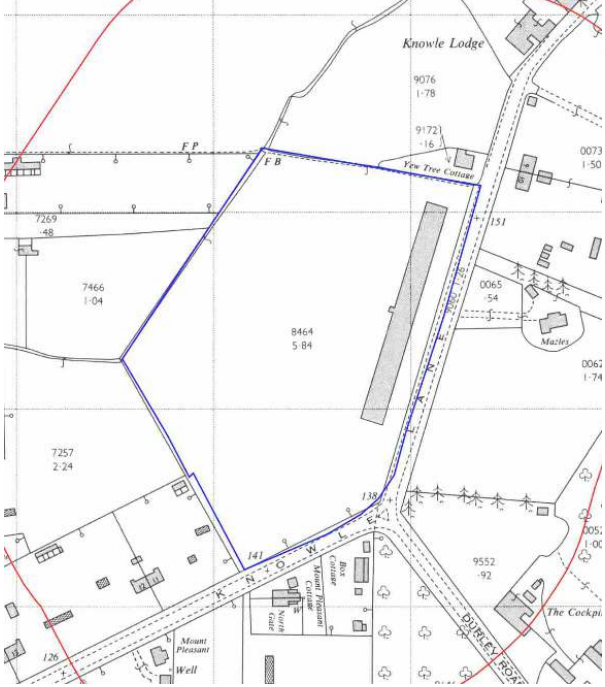
| Commentary | Extracts from historic maps |
|---|---|
| <p>c. 1962 1:2,500</p> <p>The poultry house has been constructed in its current day layout.</p> | |

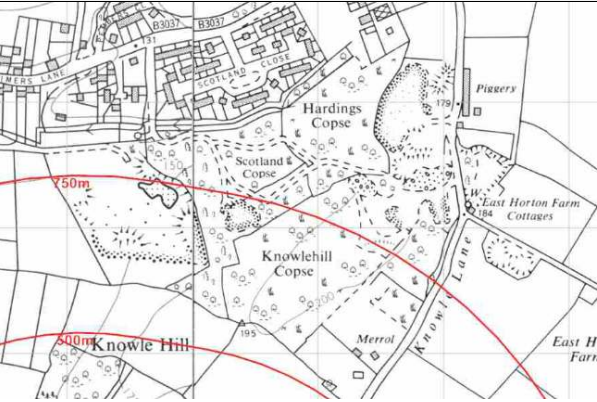
| Commentary | Extracts from historic maps |
|---|---|
| <p>c. 1968 1:10,560<br/>Sand extraction to the north is more extensive, extending to within 650m of the site boundary</p> | |

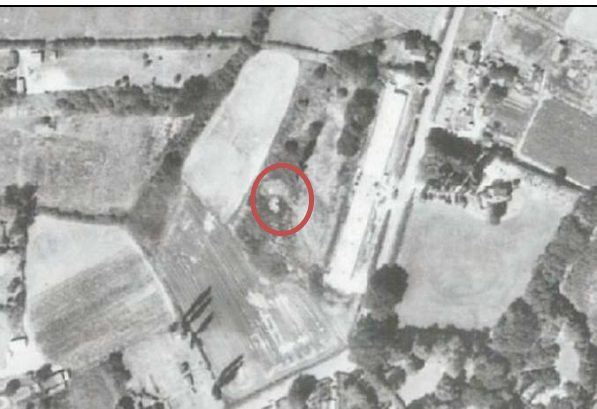
| Commentary | Extracts from historic maps |
|---|---|
| <p>c. 1979-1984 aerial photograph courtesy of EBC<br/>As above, with the exception of some potential ground disturbance within the area of rough vegetation.</p> | |

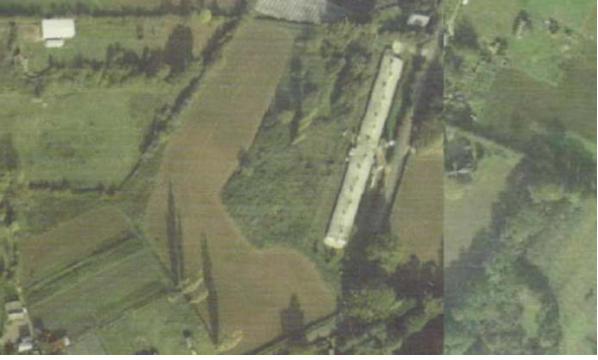
| Commentary | Extracts from historic maps |
|---|---|
| <p>c. 1989 aerial photograph courtesy of EBC</p> <p>No significant changes. Some additional structures on the eastern face of the poultry house.</p> | |

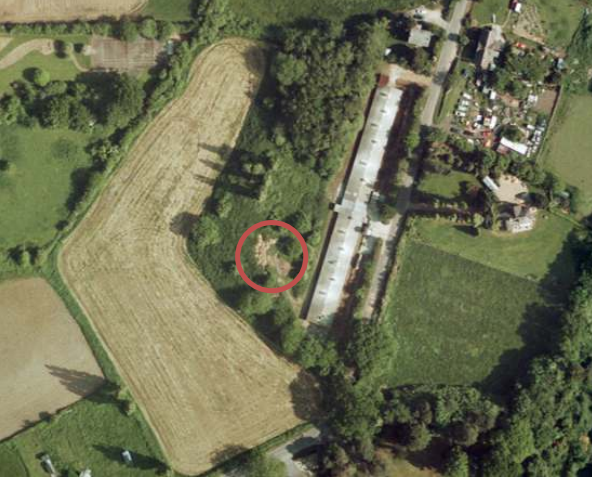
| Commentary | Extracts from historic maps |
|---|---|
| <p>c. 2005 aerial photograph courtesy of EBC</p> <p>No significant changes. The area of potential disturbed ground is reduced in size.</p> | |

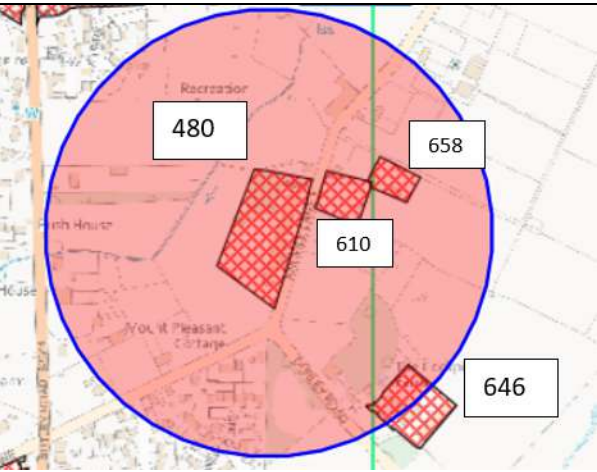
| Commentary | Extracts from historic maps |
|---|---|
| <p>Extract from Eastleigh Borough Council Environmental Services geographical information service</p> <p>480 – the site - identified 'of interest' due to application to convert poultry house to residential usage in 2008</p> <p>610 – land at 10 Knowle Lane – identified 'of interest' due to the presence of multiple vehicles</p> <p>658 – land to the rear of 10 Knowle Lane – identified 'of interest' due to of the presence of multiple vehicles</p> <p>646 – Cockpit Farm – identified 'of interest' due to farm usage</p> | |

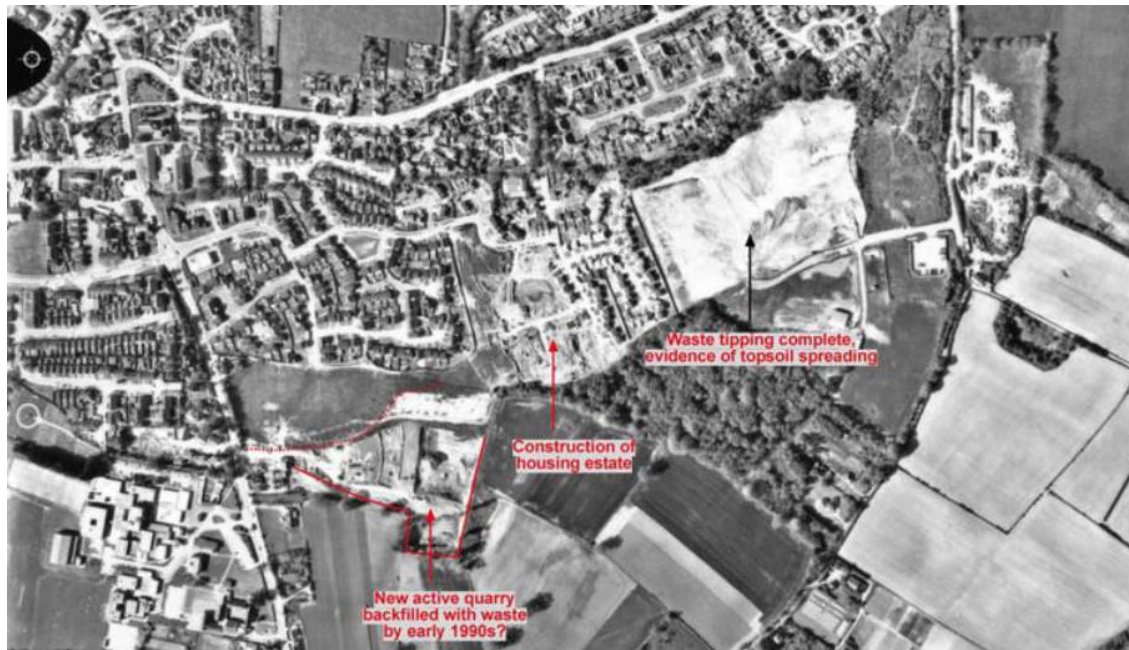
**Figure 4: Extract from Review of archival information Fair Oak Landfill Complex**

The reports identify that the area to the north was subjected to significant sand extraction and subsequent landfilling activities. An extract from the desk study report presented below as Figure 4 identifies that the area of landfilling closest to the site (approximately 650m to the north) was backfilled by the early 1990s.

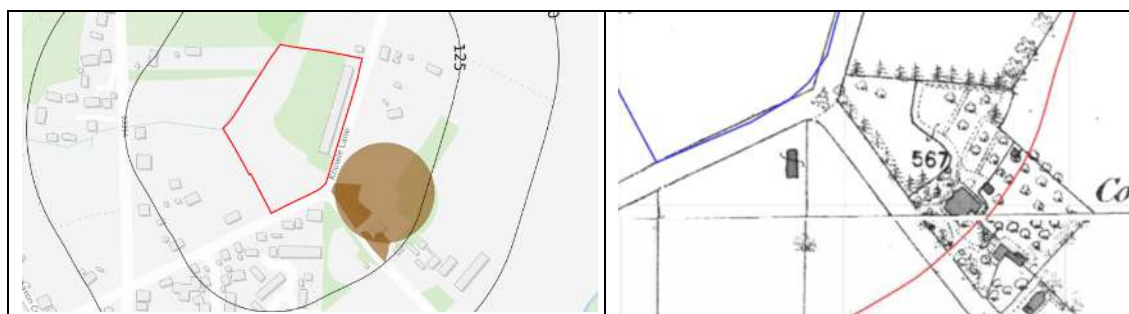
**Figure 5: Extract from Groundsure report identifying two potential refuse heaps identified on 1868 map**

The Groundsure report identifies two refuse heaps on the 1868 edition map to the east and southeast of the site at distances of 10m and 76m respectively. The location of these features as presented within the Groundsure report is shown in Figure 5 below, with an extract from the 1869 larger scale map for comparison.

It is evident that there are no such features present, and as such this will not be considered further within this report.
