July 2023  
CBA11759 v1

# ARBORICULTURAL REPORT

Site: 71 Lakewood Road  
Chandlers Ford  
SO53 5AE

**Client:** Paul Skiba – Lakewood Tree Surgeons  
**Site:** 71 Lakewood Road, Chandlers Ford, SO53 5AE  
**Principal Consultant:** Stefan Rose *BSc (Hons), Tech Cert ArborA, TechArborA*  
**Date:** July 2023

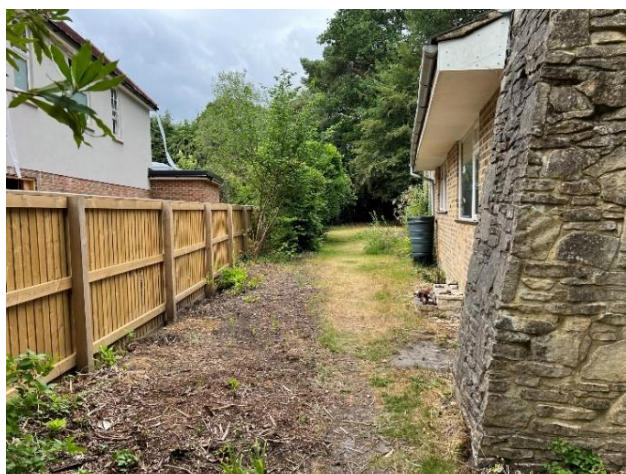
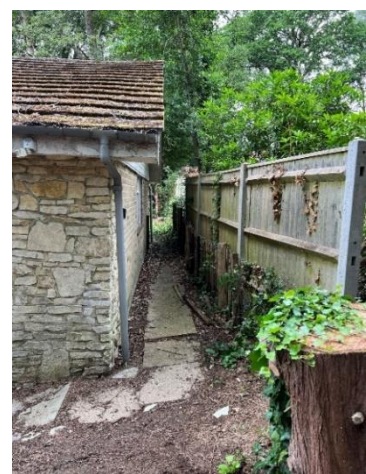
1.7 **Photograph 1 and 2:** Showing the clear and obvious side access to the rear garden on both sides of the property

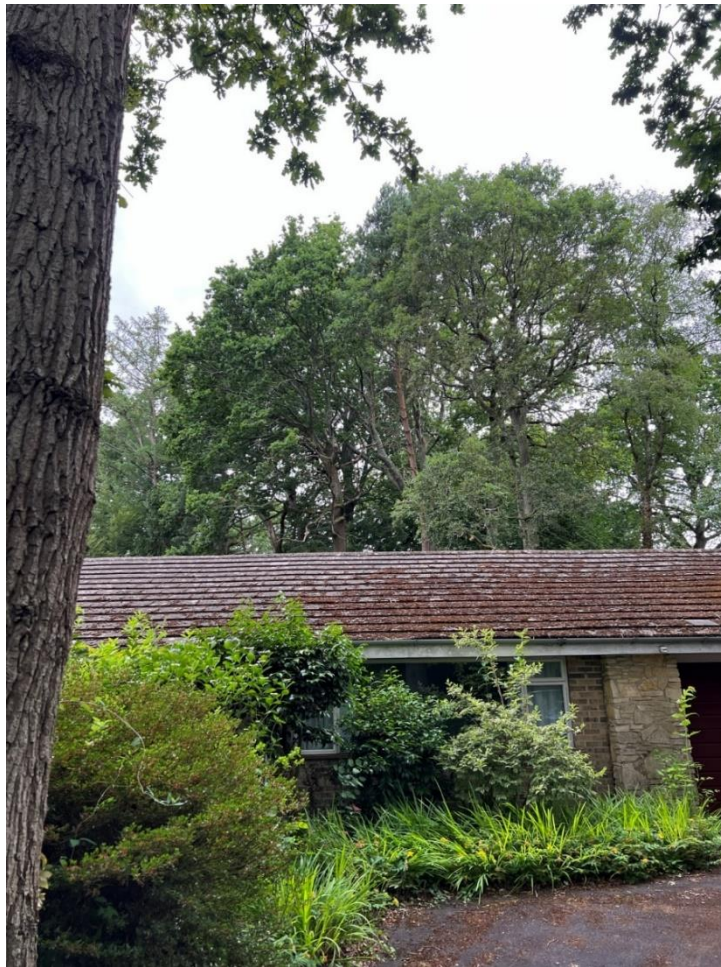
- 1.8 **Photograph 3:** Showing the group of trees containing the Beech and Oak from the driveway

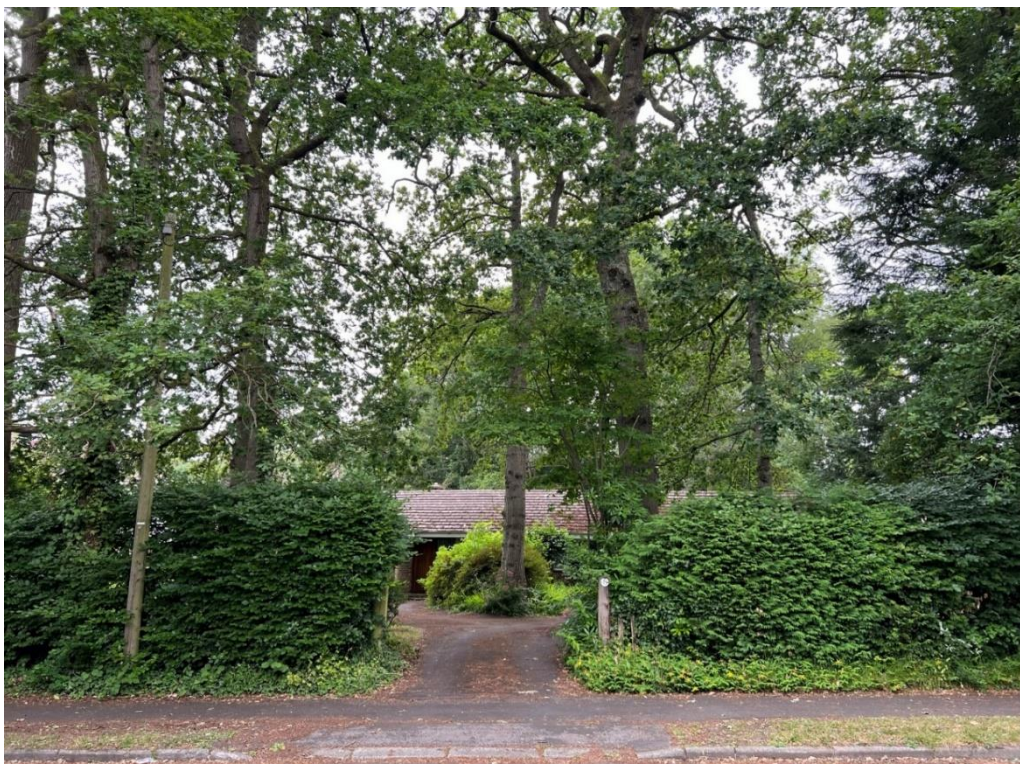
- 1.9 **Photograph 4:** Showing the group of trees containing the Beech and Oak (beyond the property) opposite the driveway entrance on Lakewood Road

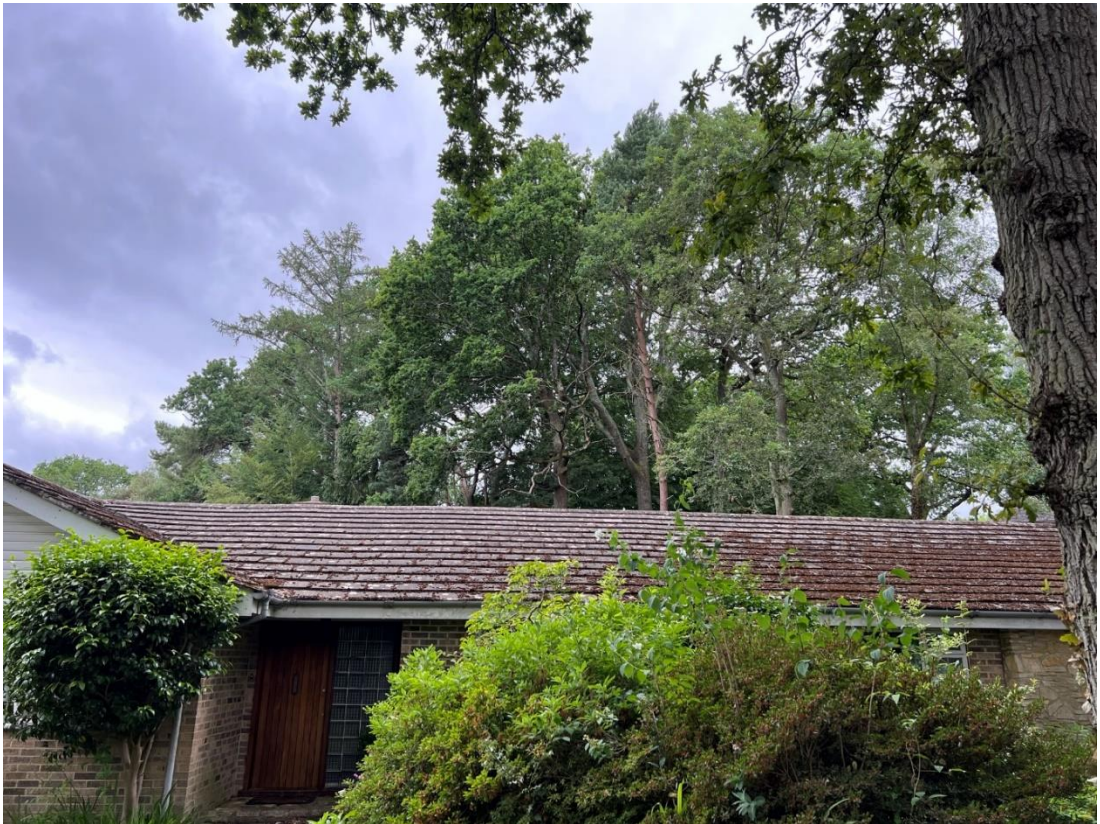
- 1.10 **Photograph 5:** Showing the group of trees containing the Beech and Oak from the driveway

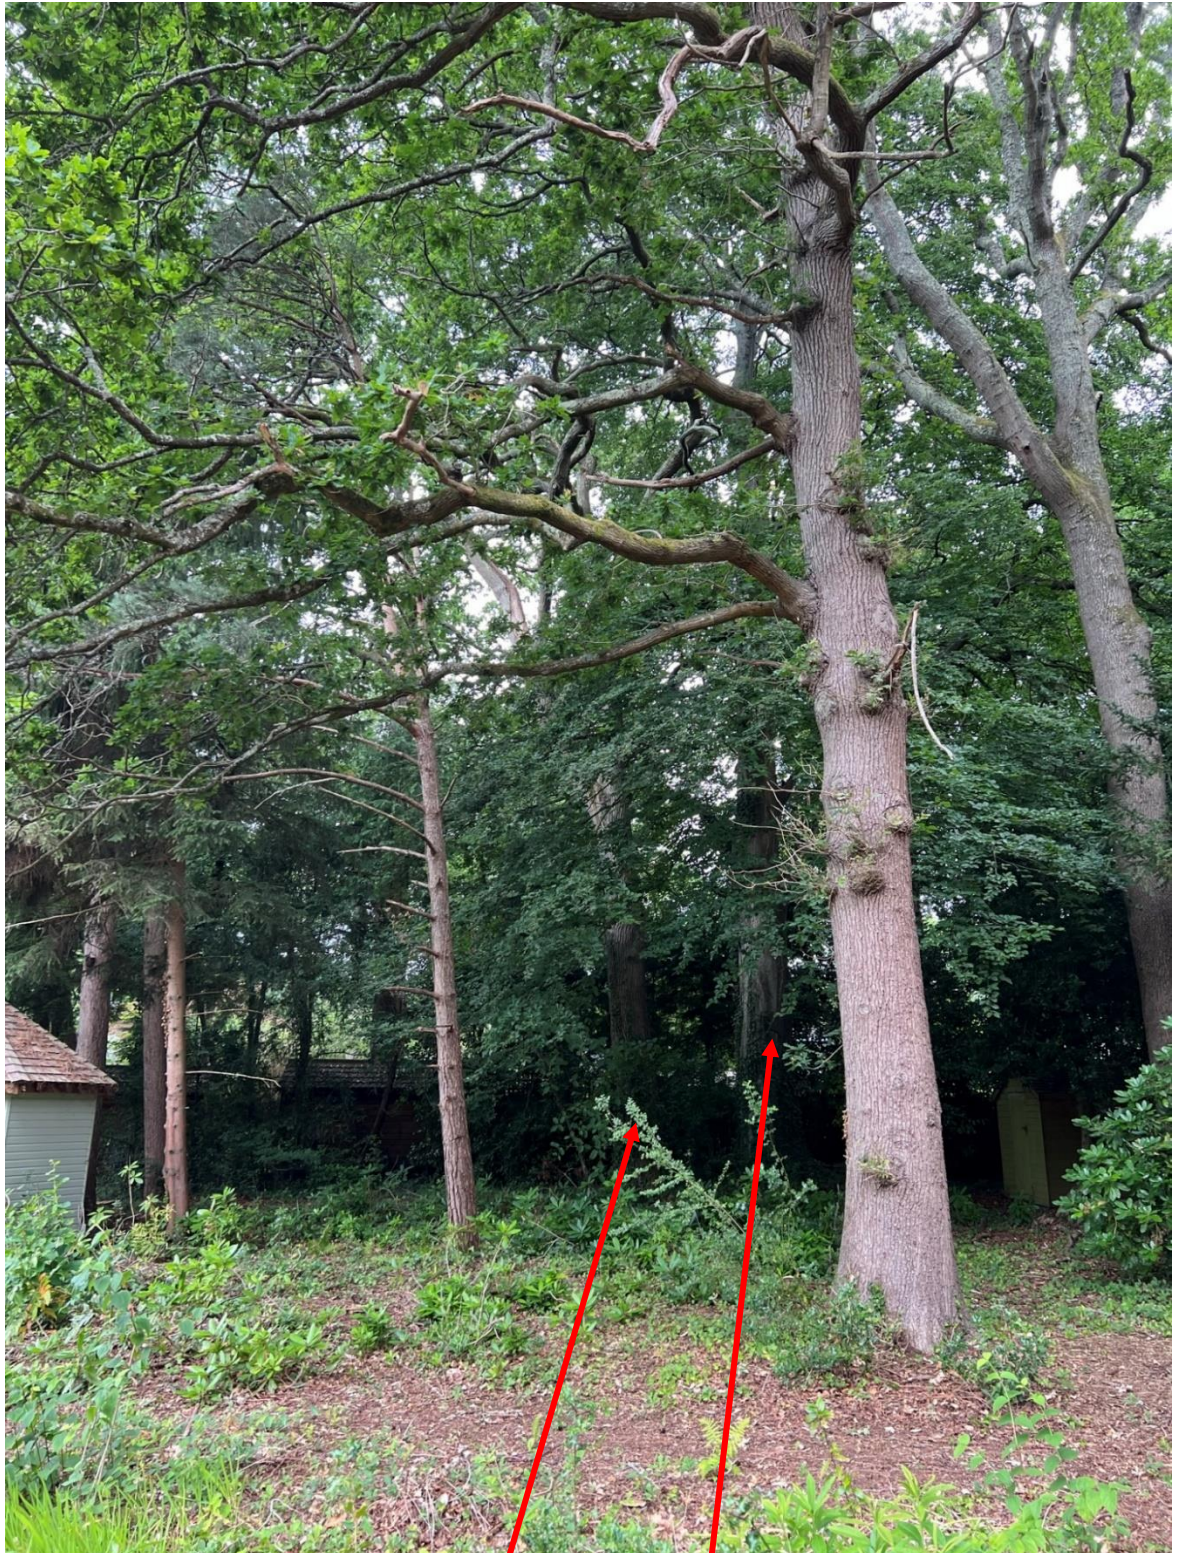
1.11 **Photograph 6:** Showing the group of trees with the trunks of the Beech and Oak highlighted

Oak (T2)

Beech (T1)

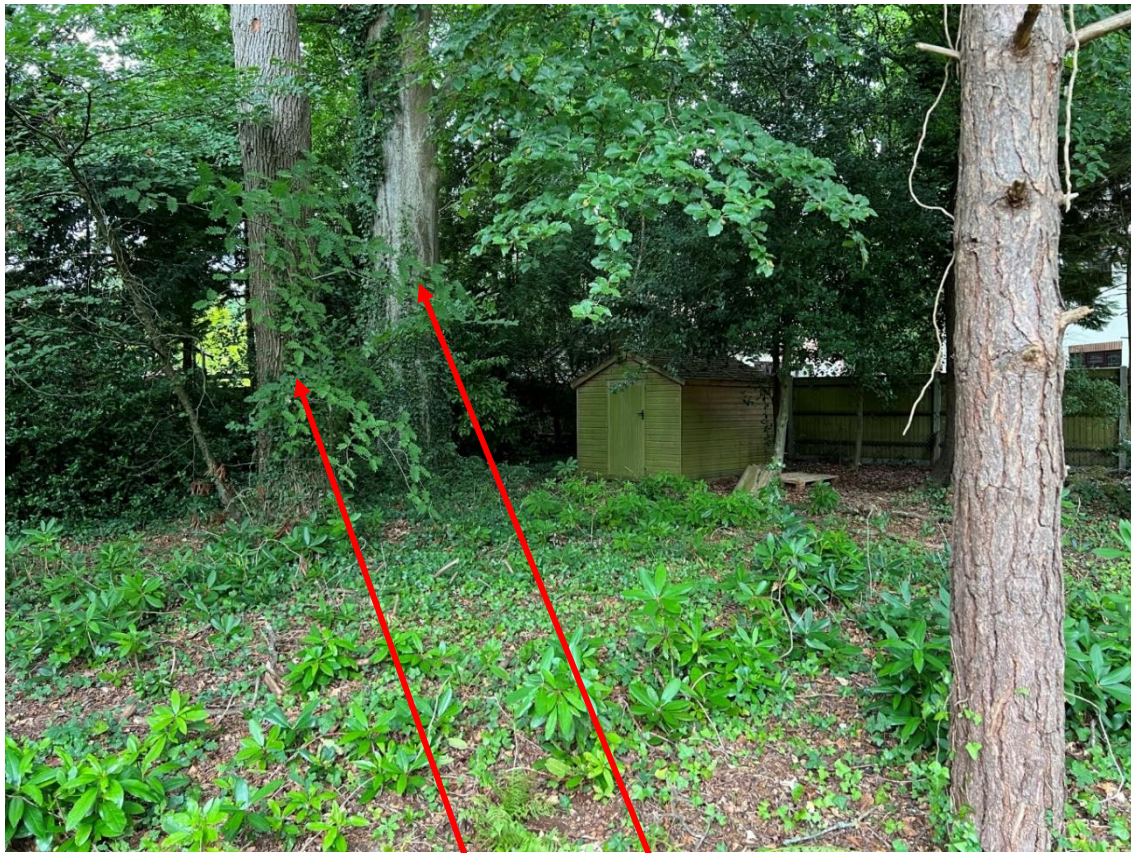
- 1.12 **Photograph 7:** Showing the group of trees with the trunks of the Beech and Oak highlighted

Oak (T2) Beech (T1)

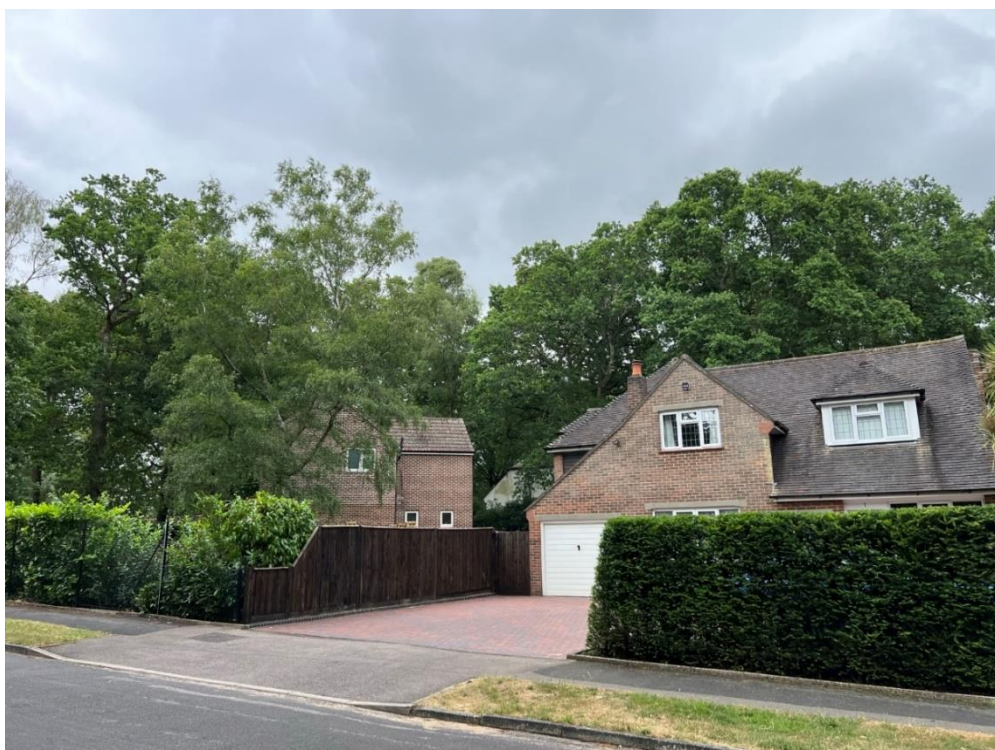
- 1.13 **Photograph 8:** Showing the group of trees (beyond the houses) from Gordon Road
