## **Resistograph Report**

**Vivid Housing Limited**

**No.135,  
Woodlands Way,  
Bursledon,  
Hampshire, SO31 8LG**

**Prepared by  
Richard Daubeney  
Our Ref 0823-RD  
22nd of August 2023**

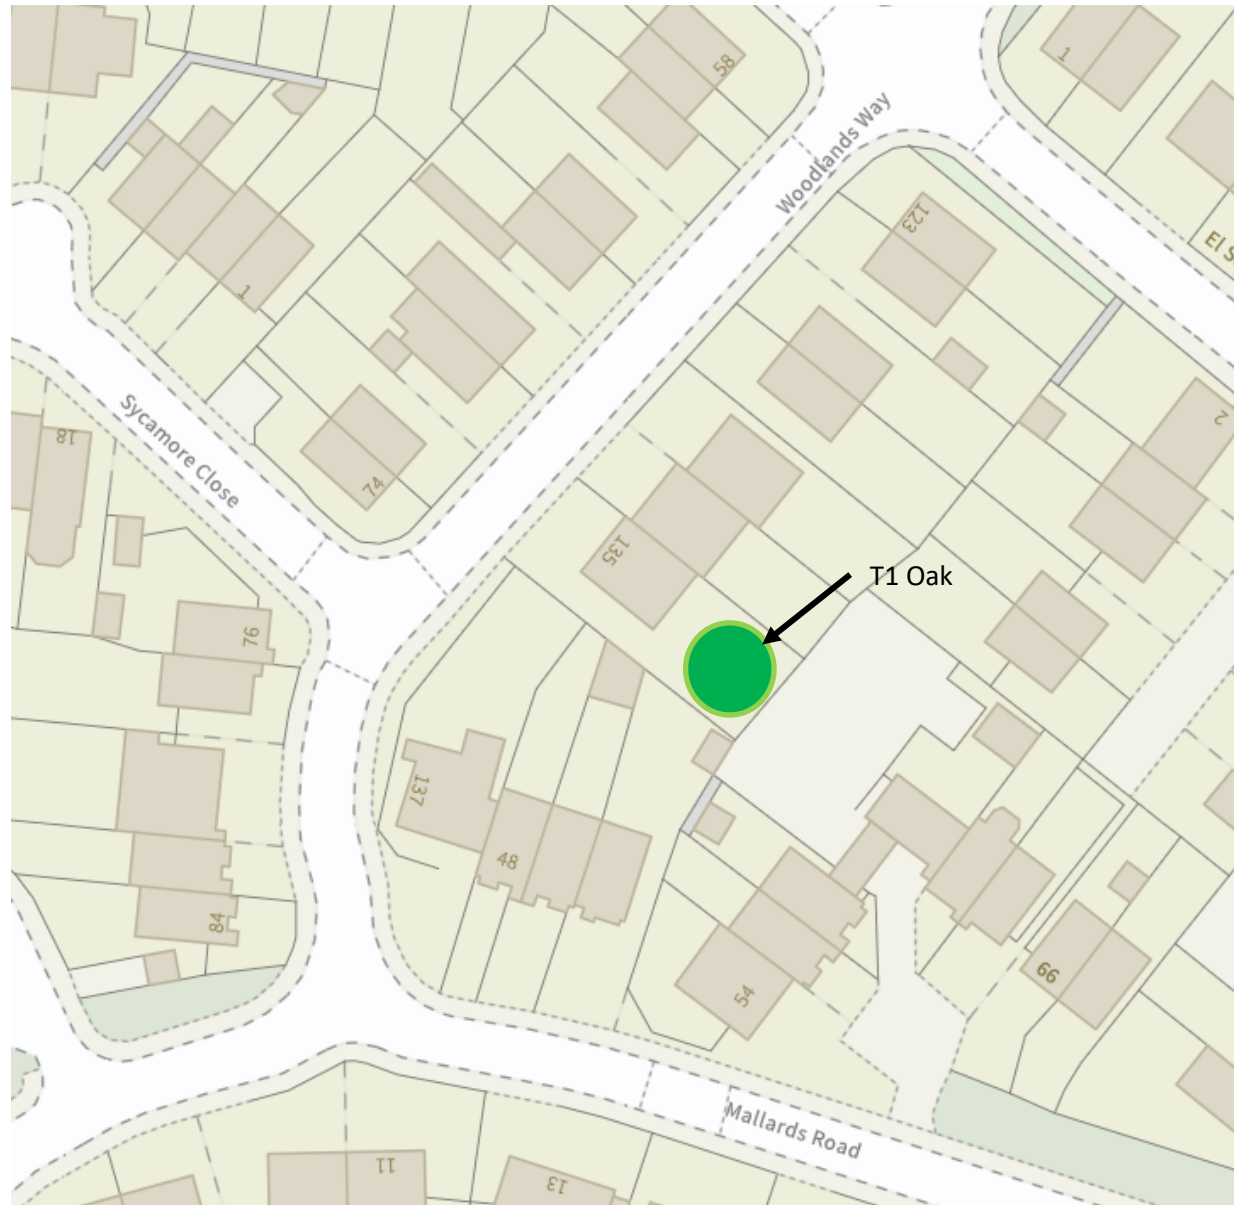
## T1, Measurement 3

T1 English Oak held no gross defect upon resistograph inspection with a T/R ratio of over the industry recommended 30% point. Based on the readings provided it would suggest that the likelihood of failure at test point is not significant. However, following the readings taken from the resistograph, it showed that there is a small column of decay within the stem to the North and the Southwest side, the decay to the North side would correlate with the fruiting body *Ganoderma australe* located in close proximity on the stem, but, there are good areas of reaction wood surrounding the sections of decay within the stem. *Ganoderma* spp. Fruiting bodies are known to cause hollowness within the stem, which in turn can lead to stem or whole tree failure.

Based on the above information. I would recommend a crown reduction in 3m in height and lateral spread to be reduced by 2m to be carried out, this would help to lessen the pressure to the lower section of the stem. I advise an inspection 3 years from the date of this report to ensure there are no further changes to the tree's health and condition.
