## **Resistograph Report**

**Vivid Housing Limited**

**No.133,  
Woodlands Way,  
Bursledon,  
Hampshire, SO31 8LG**

**Prepared by  
Richard Daubeney  
Our Ref 0823-RD  
22nd of August 2023**

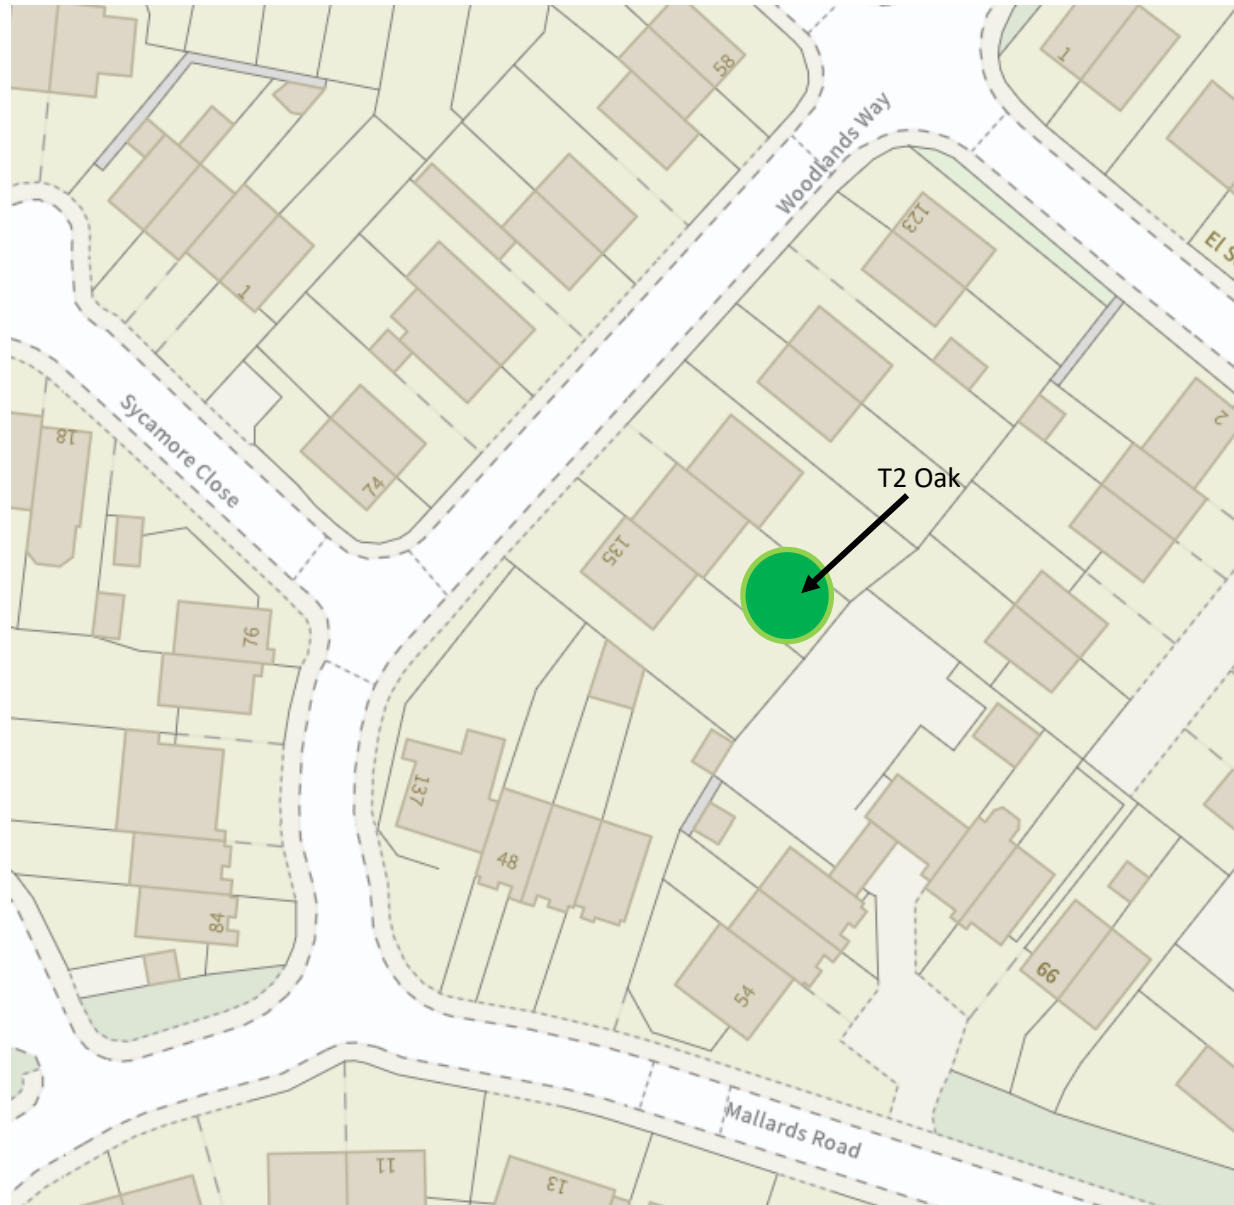
## T1, Measurement 3

T2 English Oak held no gross defect upon resistograph inspection with a T/R ratio of over the industry recommended 30% point. Based on the readings provided it would suggest that the likelihood of failure at test point is not significant. However, following the readings taken from the resistograph, it showed that there is a small column of decay within the stem to the Northwest side, but not significant at this time, there are good areas of reaction wood within the remaining areas of the stem.

Following the above results including the observations of the large tear out wound and stem cavity, it would be therefore be advisable to crown reduce by 3m all round, subject to outcome of a climbing inspection for the cavity and tear out wound. Once the crown reduction is completed this will help to reduce the end loading to the canopy spread reducing the pressure to the stem particularly where the wounds/cavity are located, I would recommend a further inspection 3 years from the date of this report to ensure there are no further changes to the tree's health and condition.
