## **Tree Survey and Recommendations**

**DELEMERE GARDENS, FAIROAKS**

**28th October 2021**

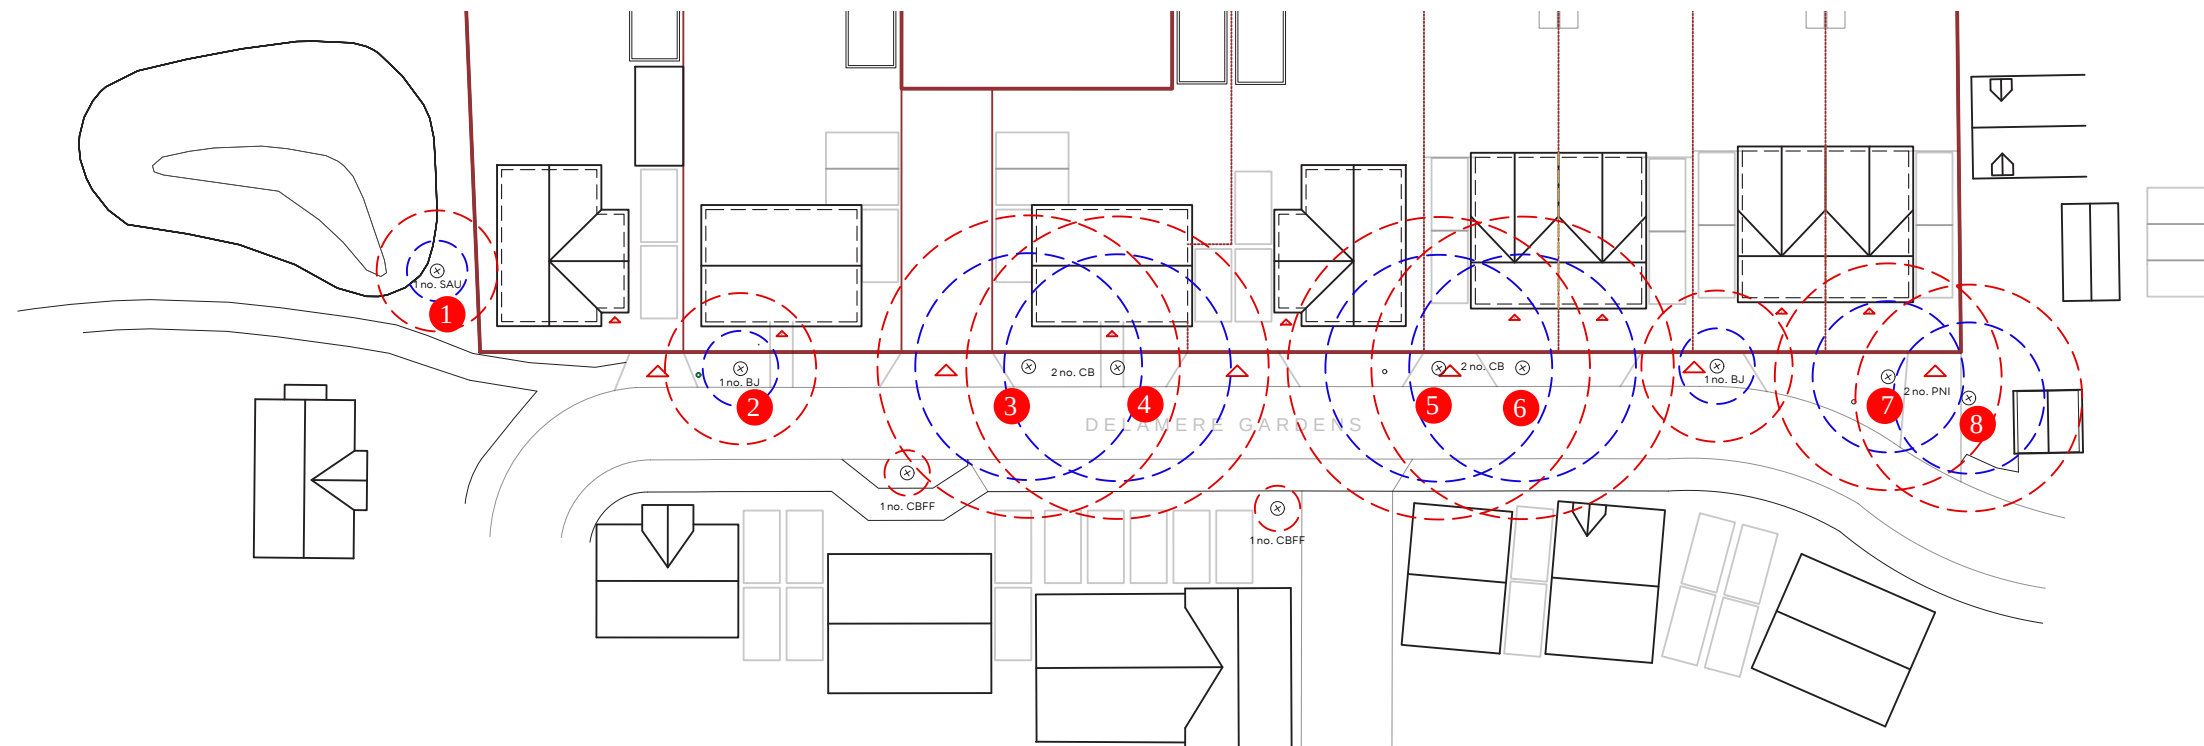
## 1. EXISTING TREE PLAN

The numbers in red relate to the following review of existing trees.

One of the *Betula utilis Jacquemontii* between 6 and 7 is no longer present on site.
