# Arboricultural Consultancy for Lloyds Bank

**Re: Mr & Mrs Penny , 56 Wilderness Heights, West End, SO18 3PS**

# GEOTECHNICAL

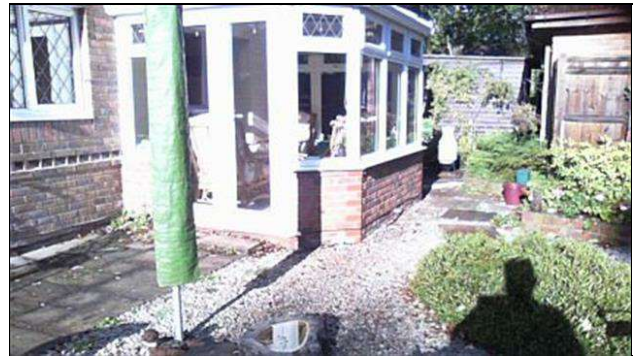
TG3 - Oak

General Site

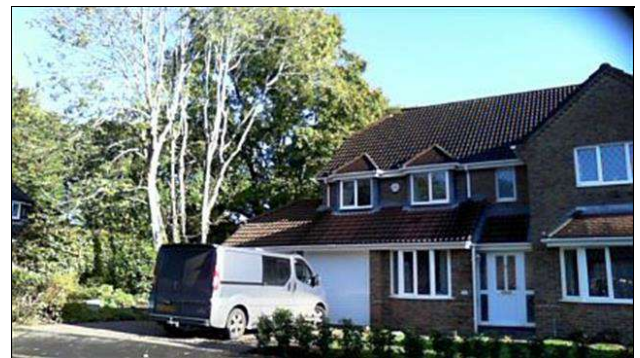
TG3 - Oak

Front

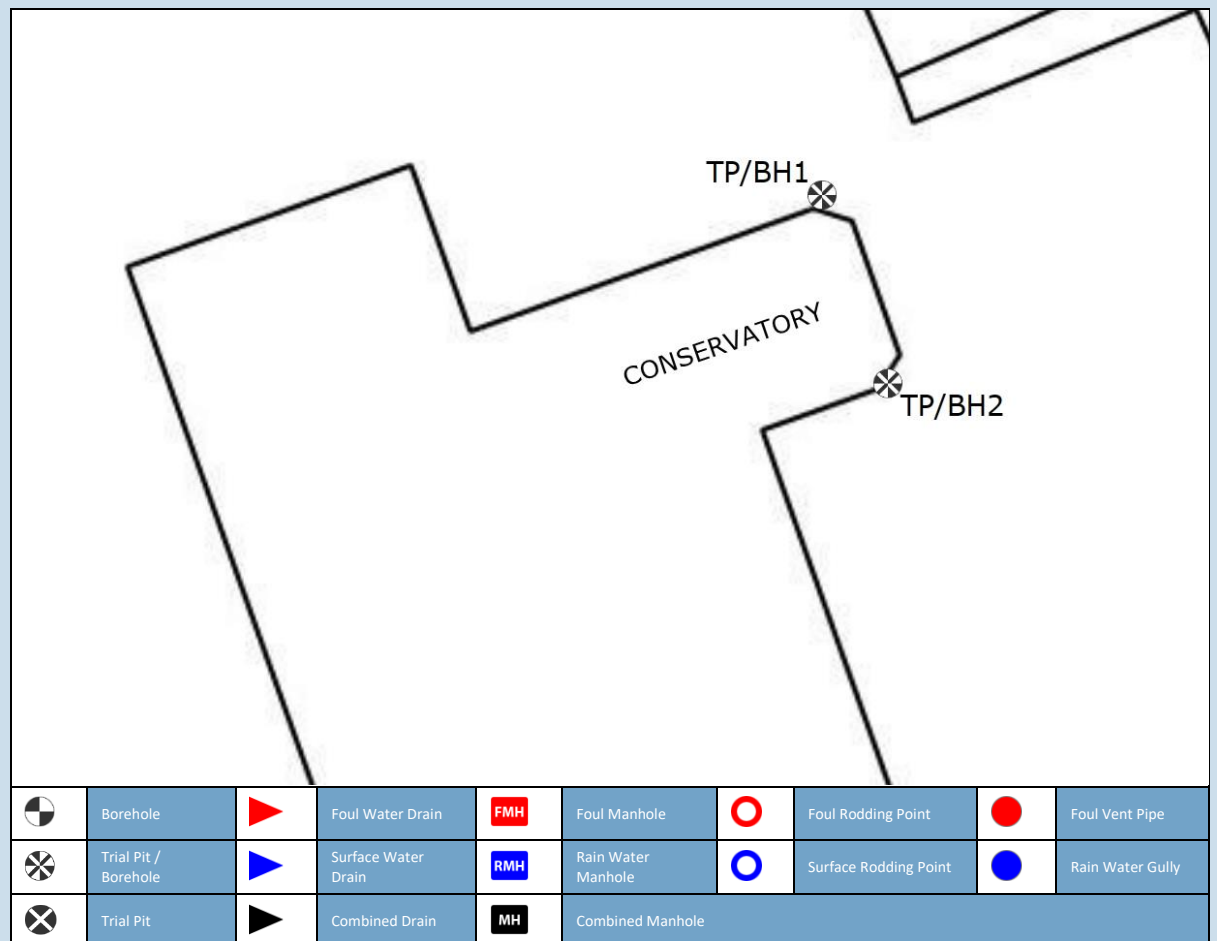
#### Site Plan

Conservatory foundation comprised of concrete to 600mm bgl, with a total projection of 150mm from the elevation. Underside of foundation (USF) was exposed to 100mm back from the face of the foundation and probed 500mm back from the face of the foundation.

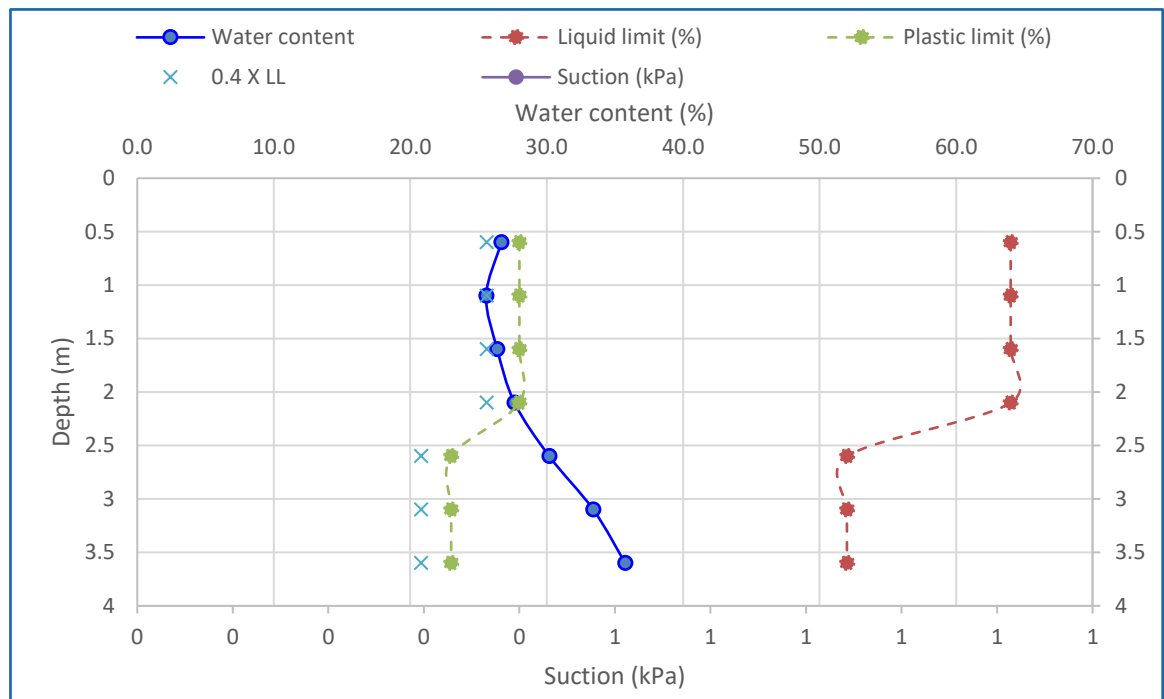
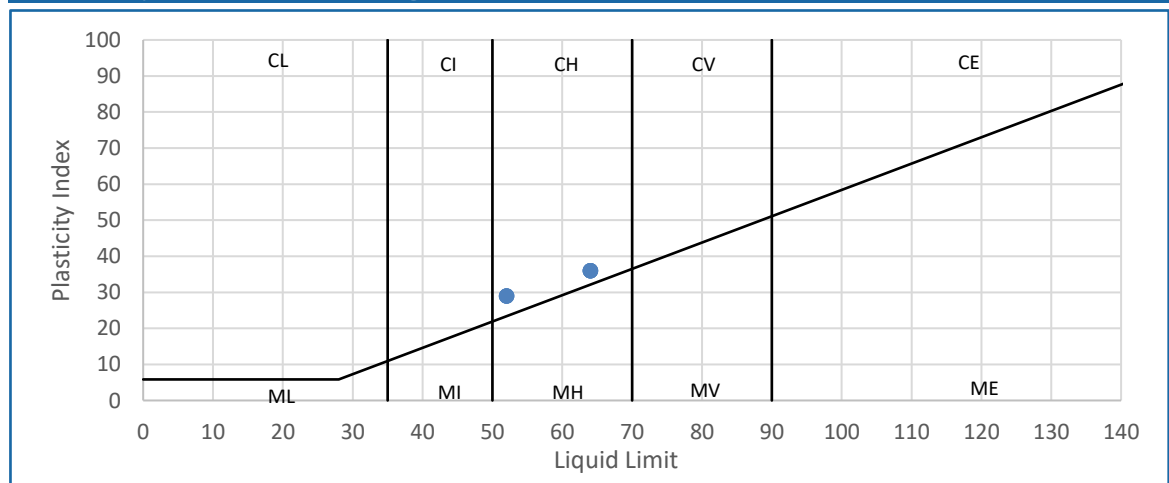
## Plasticity Chart for Casagrande Classification

| Lab Ref | Depth (m) | WC (%) | LL (%) | PL (%) | PI (%) | .425 mm(%) | mod. PI (%) | Av. Suc. (kPa) | Description |
|---|---|---|---|---|---|---|---|---|---|
| 6 | 3.1 | 33.4 | 52 | 23 | 29 | 94 | 27 | | Soft brown silty CLAY with rare gravel. Gravel is fine |
| 7 | 3.6 | 35.7 | 52 | 23 | 29 | 94 | 27 | | Soft brown silty CLAY with rare gravel. Gravel is fine |

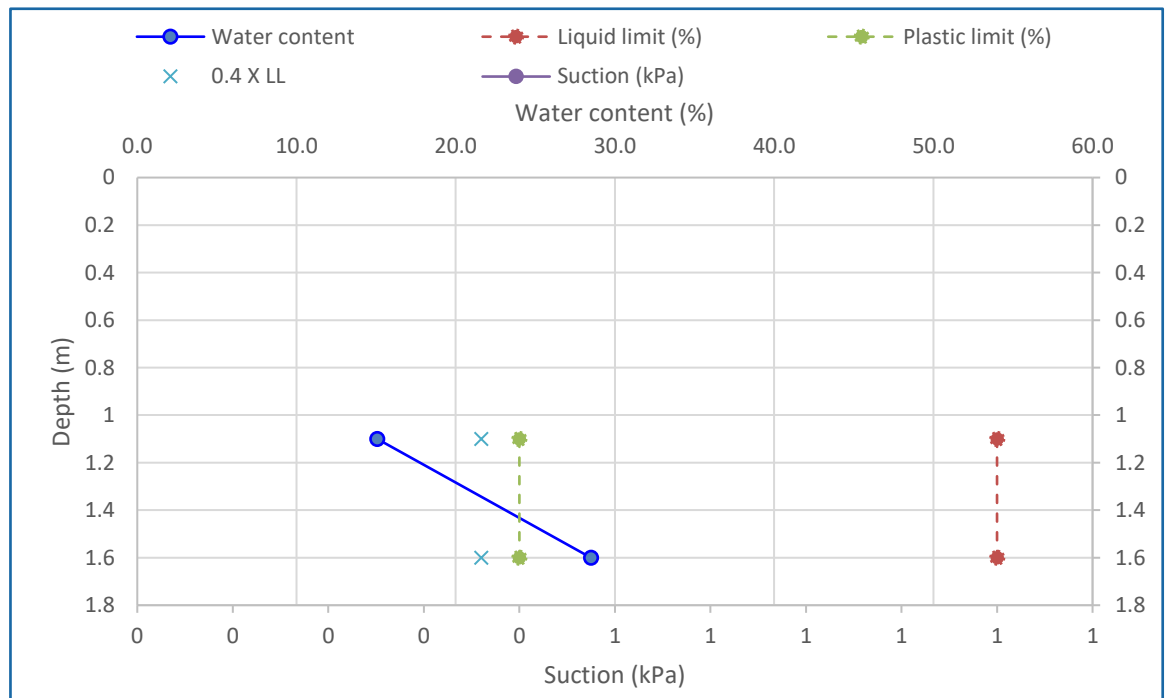
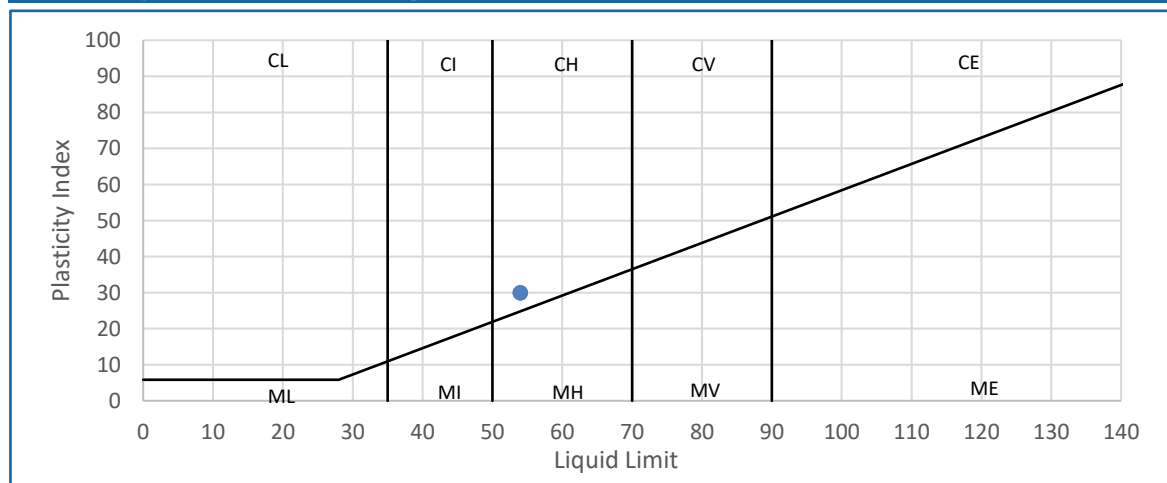
## Samples from BH2

| Lab Ref | Depth (m) | WC (%) | LL (%) | PL (%) | PI (%) | .425 mm(%) | mod. PI (%) | Av. Suc. (kPa) | Description |
|---|---|---|---|---|---|---|---|---|---|
| 8 | 1.1 | 15.1 | 54 | 24 | 30 | 37 | 11 | | Soft orange-brown/dark grey very gravelly silty CLAY . Gravel is fine and medium. |
| 9 | 1.6 | 28.5 | 54 | 24 | 30 | 37 | 11 | | Very soft orange-brown/grey/dark grey very gravelly silty CLAY . Gravel is fine and medium. |
