# Arboricultural Report

SUBSIDENCE INVESTIGATION AT:

34 Lakewood Road  
Eastleigh  
Hampshire  
SO53 1EW

| Reference No: | SU2206173 |

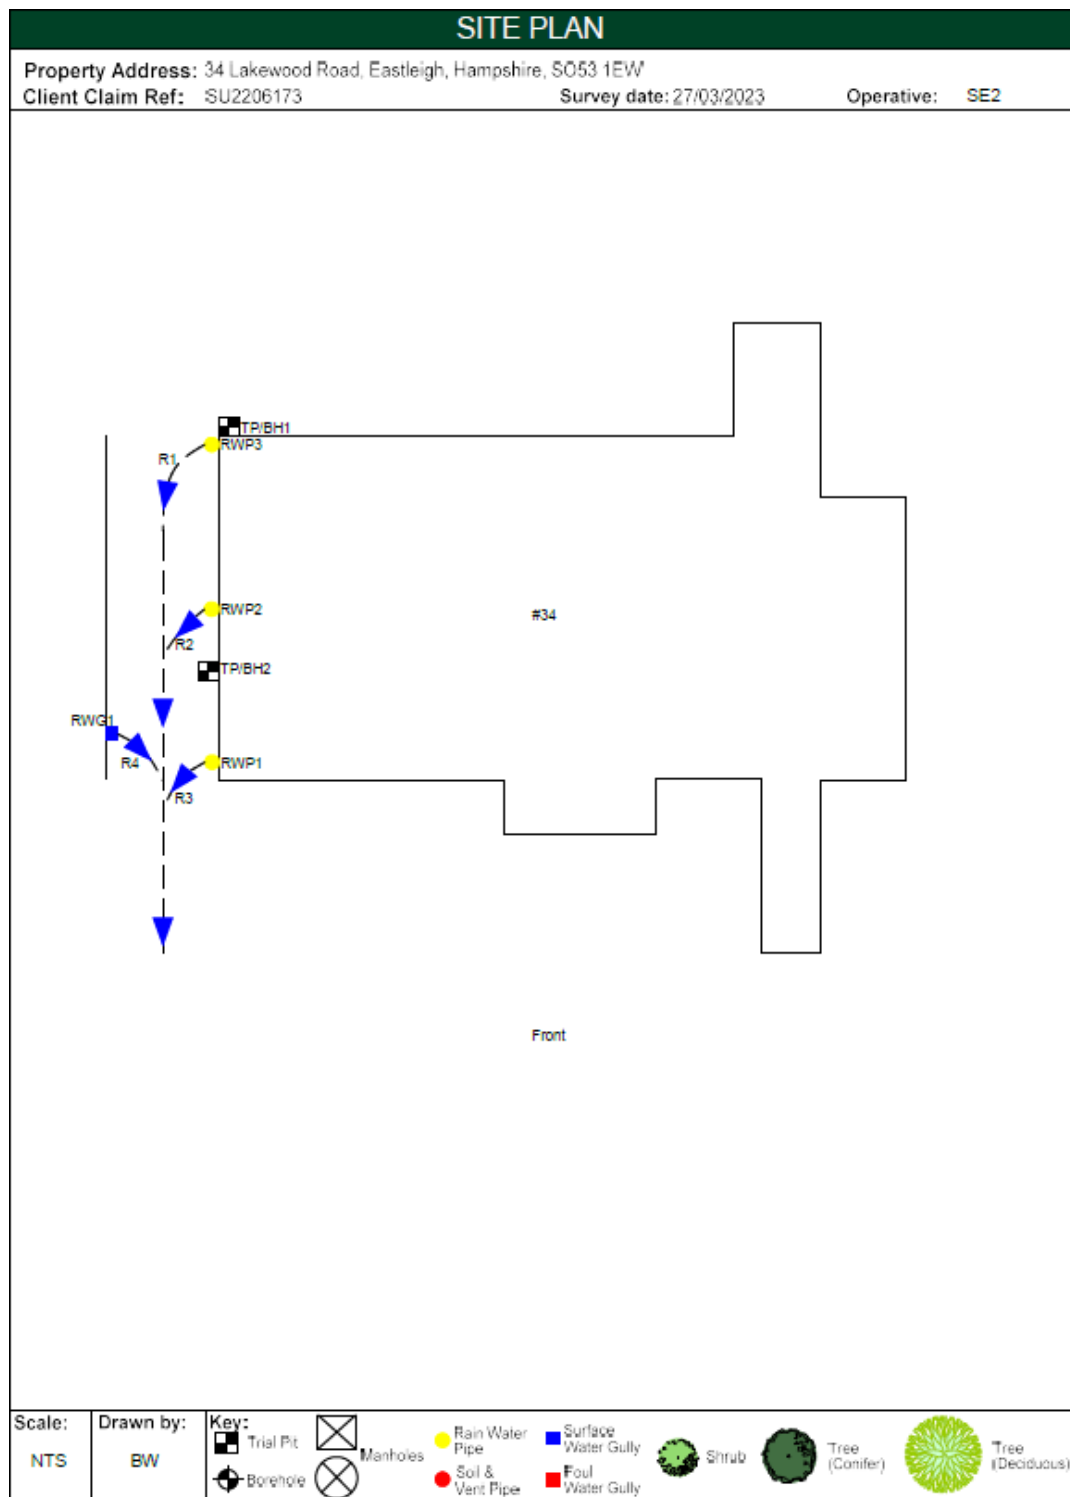
## Site investigation plan showing location of boreholes

Site investigations were carried out by Fastrack 27/03/23 when trial pits were excavated to reveal the foundations, with a borehole sunk through the base of each trial pit to determine subsoil conditions. The results are summarised in the plan and tables below.
