# Arboricultural Consultancy for Esure

| Insured | Mrs Dawn Linington | Address | 19 Beechwood Rise, Southampton, Hampshire, SO18 3PW | | |
| Client | Subsidence Management Services | Contact | Richard Bryant | Claim No. | IFS-ESU-SUB-22-0103393 |
| Report Date | 03/05/2023 | | | | |

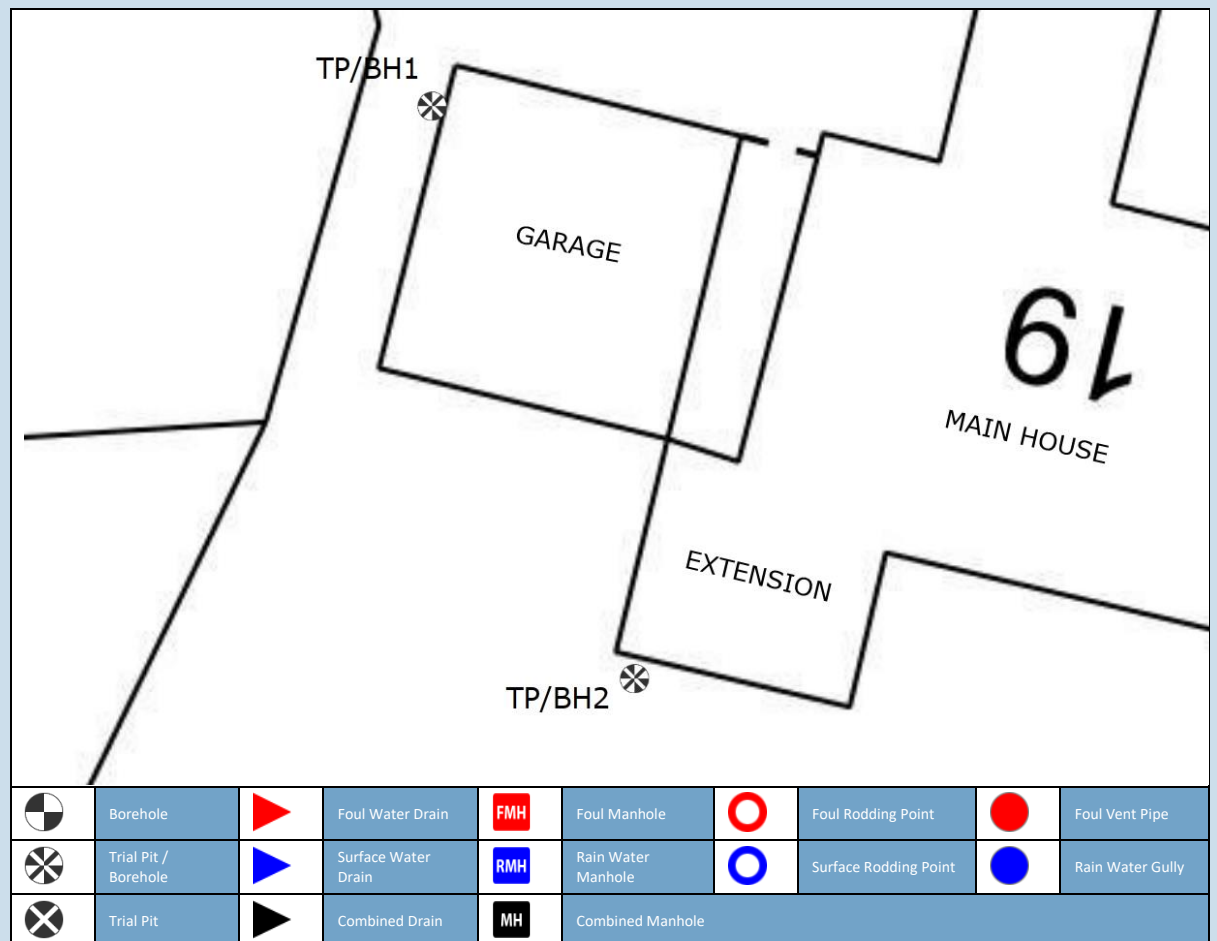
### Site Plan

Garage foundation was exposed and the underside of foundation (USF) recorded to be 0.8m bgl (TP/BH 1).

Extension foundation was exposed and the underside of foundation (USF) recorded to be 1.06m bgl (TP/BH 2).

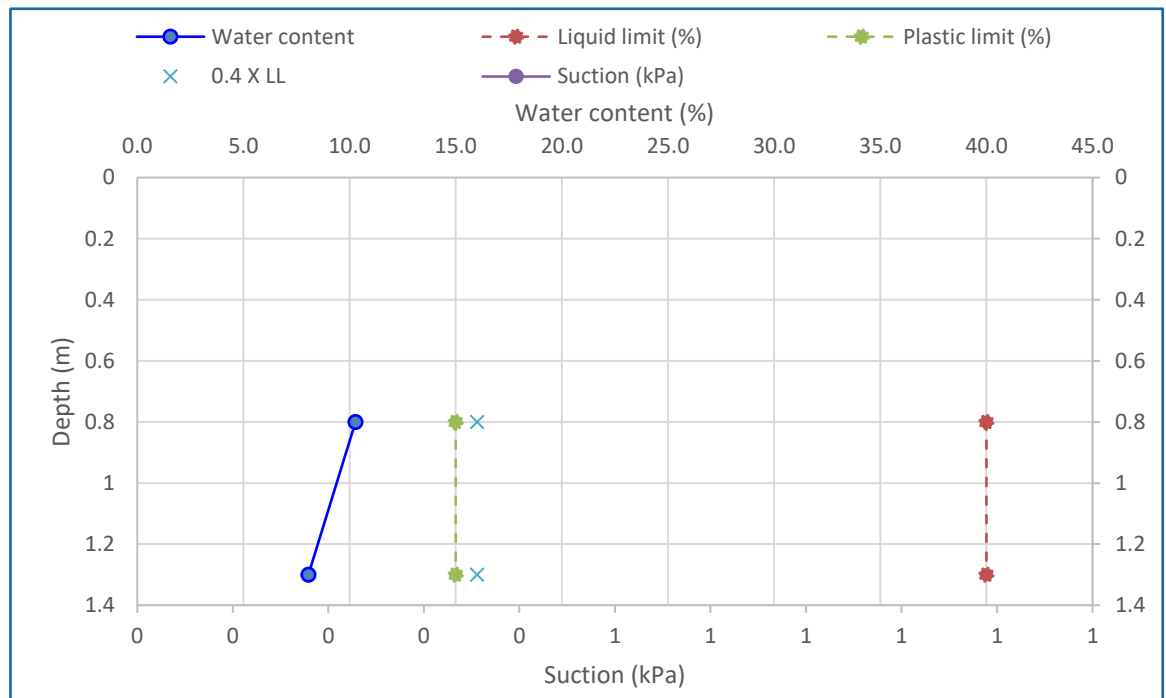
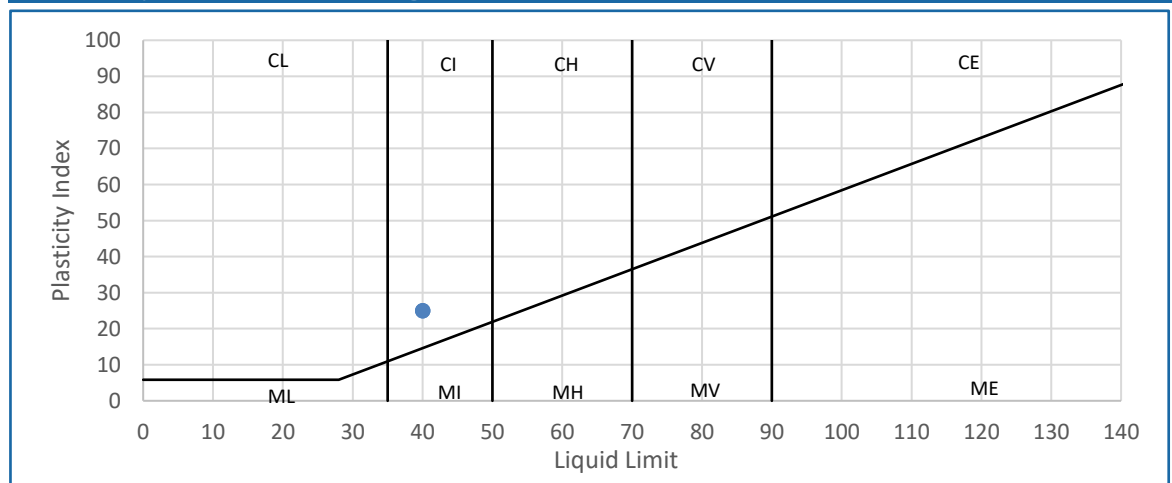
| Lab Ref | Depth (m) | WC (%) | LL (%) | PL (%) | PI (%) | .425 mm(%) | mod. PI (%) | Av. Suc. (kPa) | Description |
|---|---|---|---|---|---|---|---|---|---|
| 1 | 0.8 | 10.3 | 40 | 15 | 25 | 25 | 6 | | Moist brown clayey SAND and GRAVEL . Gravel is fine, medium and coarse. |
| 2 | 1.3 | 8.1 | 40 | 15 | 25 | 25 | 6 | | Moist brown clayey SAND and GRAVEL . Gravel is fine, medium and coarse. |

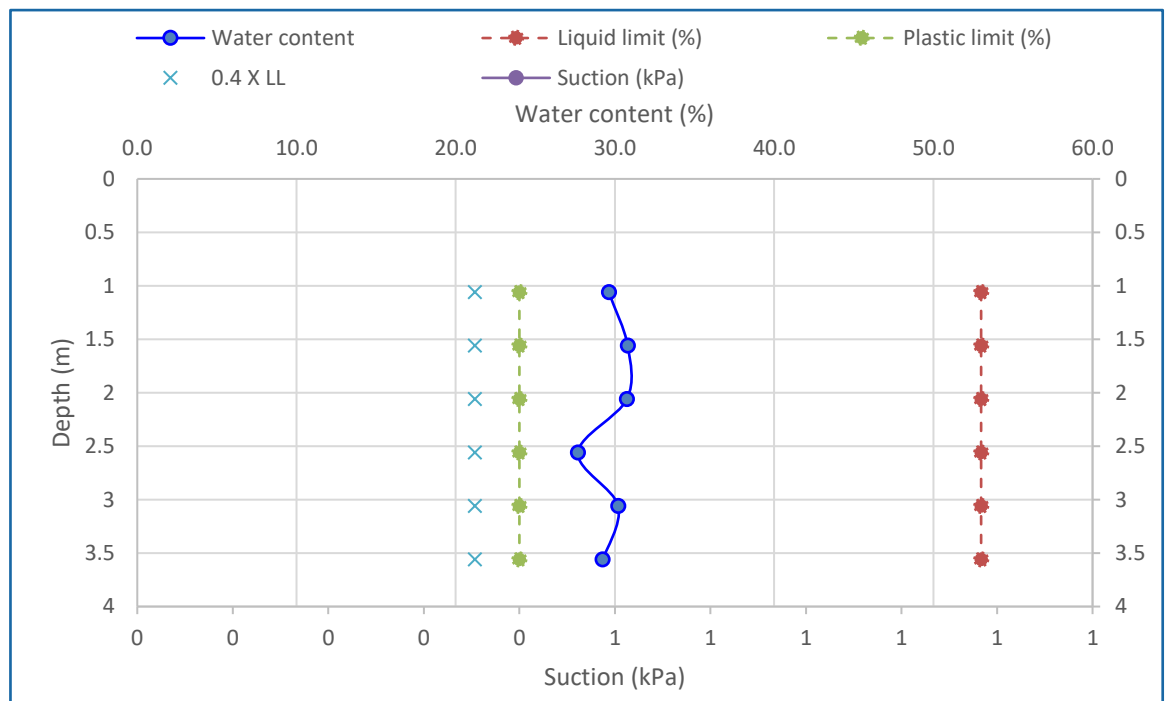
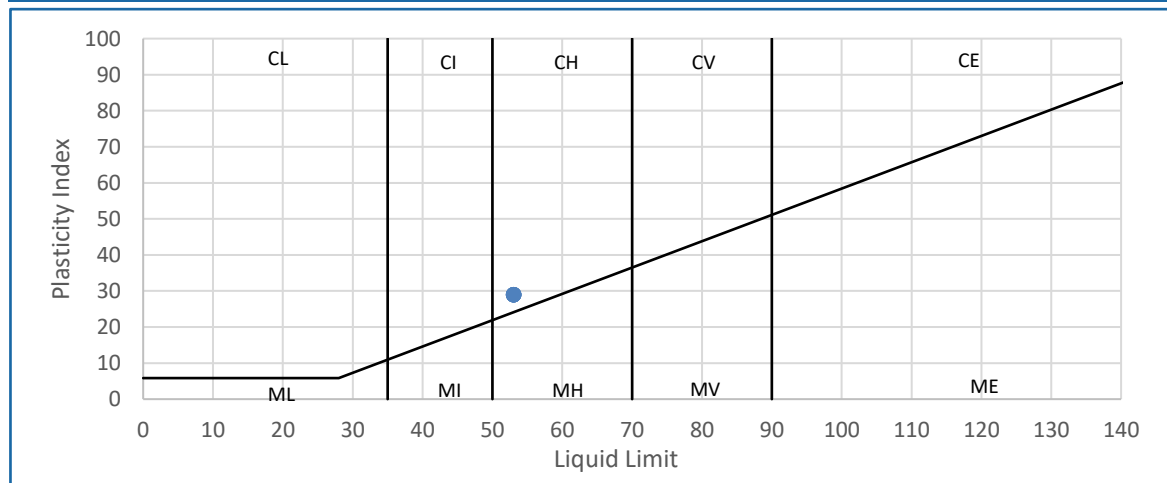
## Samples from BH2

| Lab Ref | Depth (m) | WC (%) | LL (%) | PL (%) | PI (%) | .425 mm(%) | mod. PI (%) | Av. Suc. (kPa) | Description |
|---|---|---|---|---|---|---|---|---|---|
| 7 | 3.06 | 30.2 | 53 | 24 | 29 | 82 | 24 | | Soft to firm brown silty CLAY with rare gravel. Gravel is fine and medium. |
| 8 | 3.56 | 29.2 | 53 | 24 | 29 | 82 | 24 | | Soft to firm brown silty CLAY with rare gravel. Gravel is fine and medium. |
