BS5837: 2012

Arboricultural Survey & Impact Assessment

Ocean House, site of the former Hilton House, Weston Parade, Southampton, SO31 5FB

**11/15/2025**

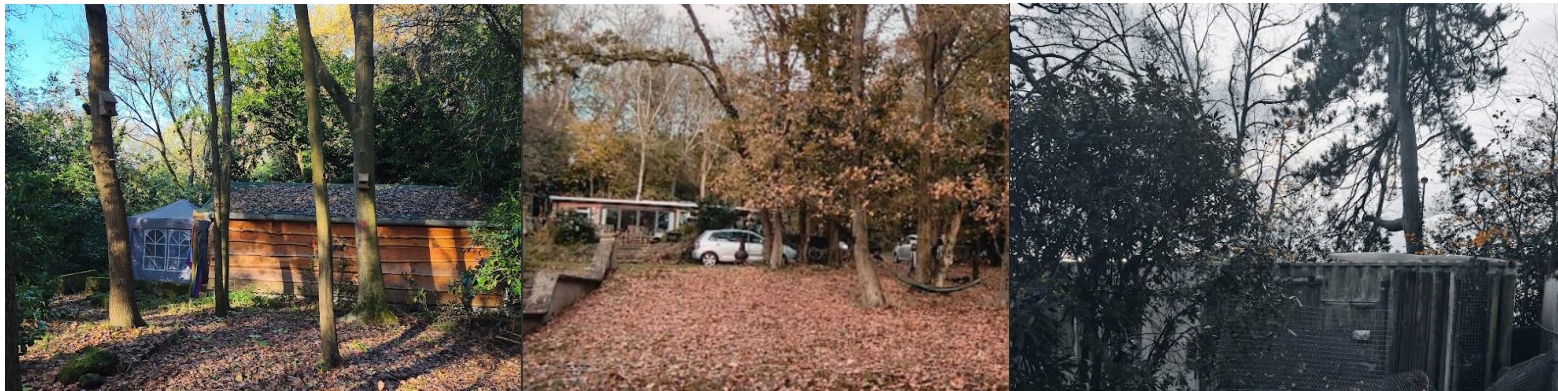
- I. a shed of timber construction (10) on a remnant foundational base (9) to the north of the site.
- II. a former shipping container (4) with a lean-to extension (5) on the existing remnant foundational base (3).
- III. The retention of a container at the site frontage (1).
- IV. It also details the 5 proposed caravan pitches (11).

*Figure 5: indicative photos of I. II. III.*

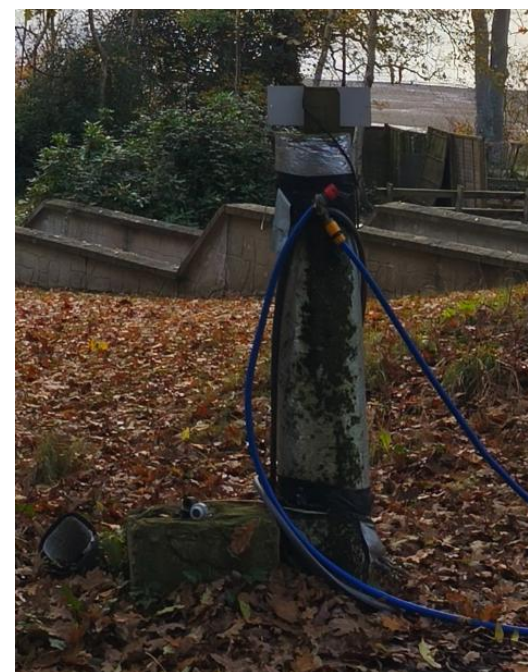
*Figure 8: Water access points are onsite at various locations.*
