# A0012 – 2026 – 28 Lakewood Road, Eastleigh

## Tree Survey Document

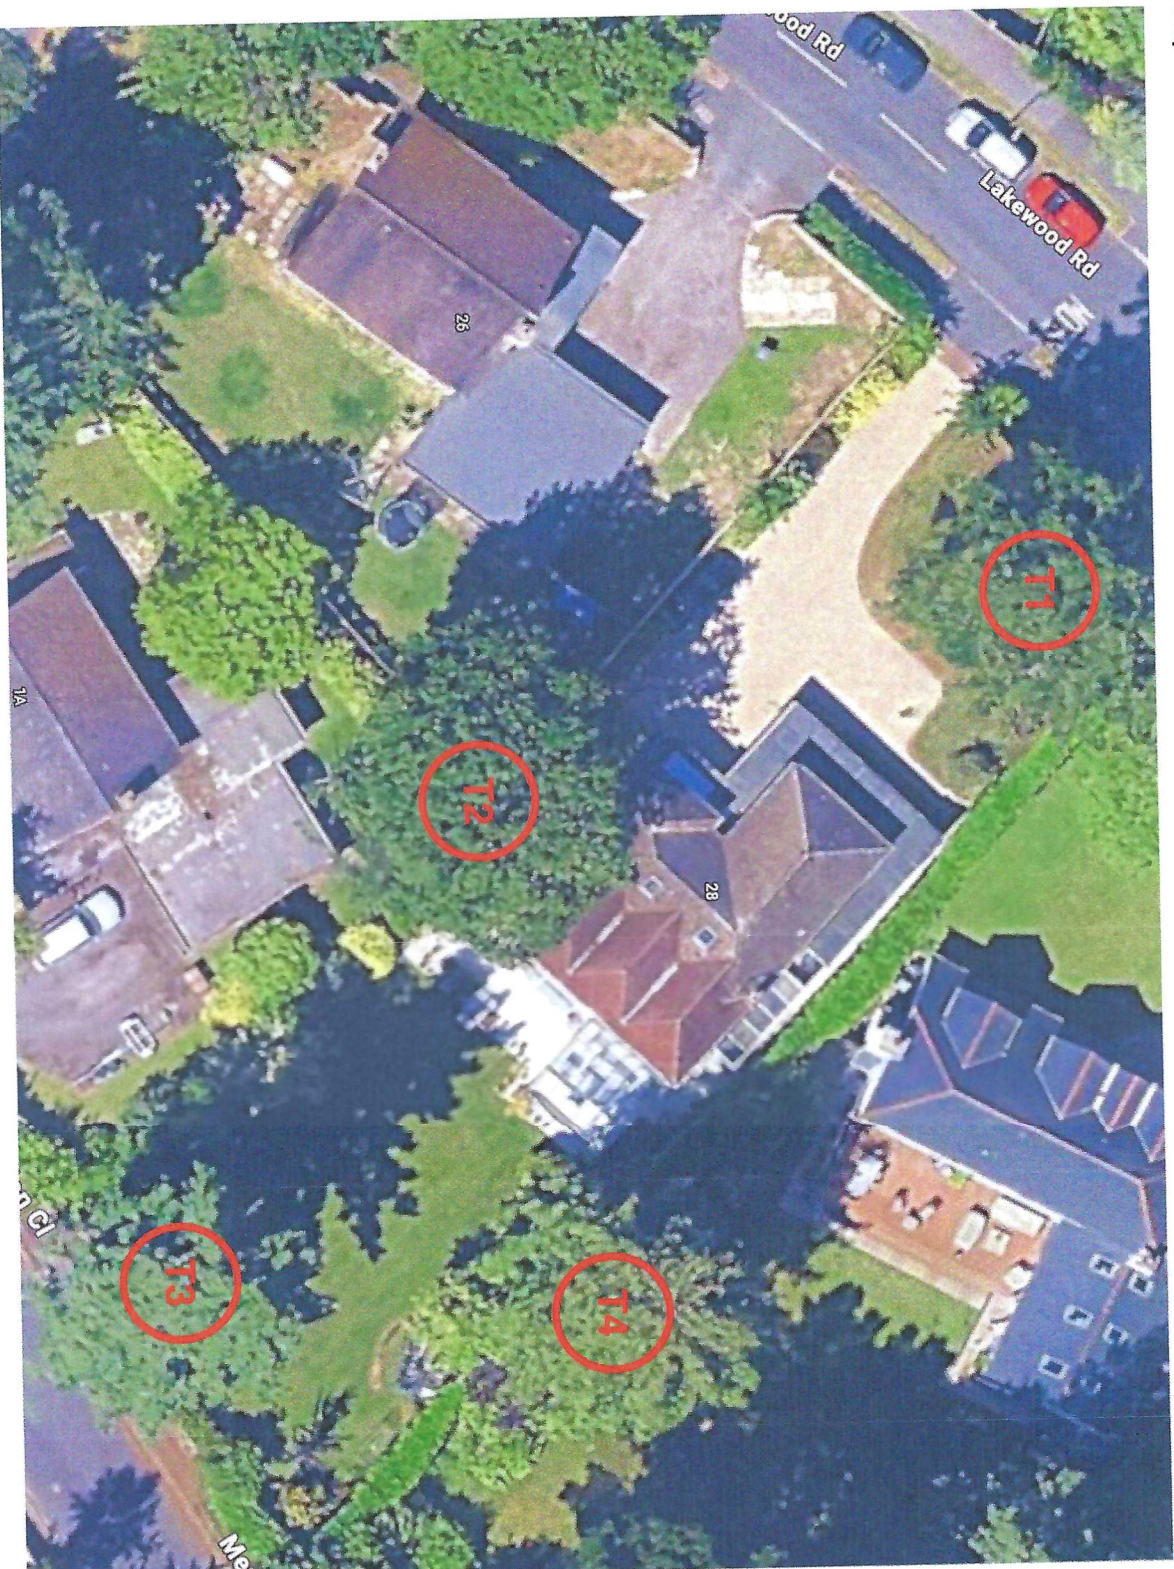
**TREE|ASSIST**  
TI - Photo

| Tree No. | Species | Height (M) | Crown Spread (M) | DBH Stem Diameter | Age Class | Condition | Observations | Recommended works | Priority |
|---|---|---|---|---|---|---|---|---|---|
| T1 | T1 - Douglas Fir - <i>Pseudotsuga Mezesii</i> | Height 36.8m | N - 8m<br>S - 8m<br>E - 8m<br>W - 10m | 1.1 Meters | Mature | Fair | <p>The Client has presented tomograph results from 2011 which at the time indicated an area of localised decay in the vicinity of the northern root buttress.</p> <p>Historical reports of <i>Phaeolus schweinitzii</i> forming on the northeast side of the stem seems to show increased symptoms since the last report.</p> <p>Bleeding on the northeast side of the stem to around 9 m from ground level and on the west side of the stem.</p> <p>Bore holes found within the areas where sap is excreting and remains of fungal brackets at the very base of the tree on the North side of the stem suggests recent fruiting growth.</p> <p>Slight delamination of bark from the cambium at the very base on the North side of the stem.</p> <p>When tapping around this area with the sounding hammer, it is very hollow in one condensed area at the base of the tree. It is very difficult to see the extent of the decay without further investigation.</p> <p>Crown looks healthy with good vitality, deadwood forming within the crown including a snapped-out limb at around 28 meters from ground level on East side. There are small amounts of foliage that is a lighter green but it's still dense forming cones throughout.</p> <p>Low hanging limbs are affecting utility cables within the first 5 m of the base of the tree.</p> | <p>Recommend tomograph for decay extent investigation</p> <p>Remove dead limb and all major deadwood from the crown.</p> | High<br>3 Months |
