**Project Name:** 1 - 3 Market Street\_ SO50 5RL  
**Project Description:** Building Works  
**Project Number:** JSD7105  
**Project Status:** Complete  
**Project Date:** 19/03/2024  
**Inspection Standard:** MSCC4 Sewers & Drainage GB (SRM4 Scoring)

1 - 3 Market Street, SO50 5RL

## Section Inspection - 13/03/2024 - Red.Gully1X

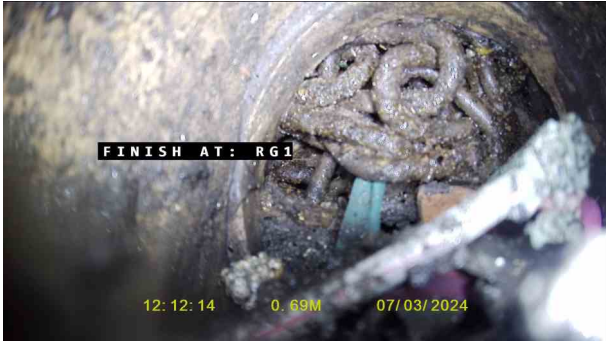
Red.Gully1X\_c482745b-f646-46d0-a1c4-44ab6fd14b00\_2024  
0319\_154101\_451.jpg, 00:00:37, 0.69 m  
Finish node, gully, reference: Red.Gully1, Gully is redundant

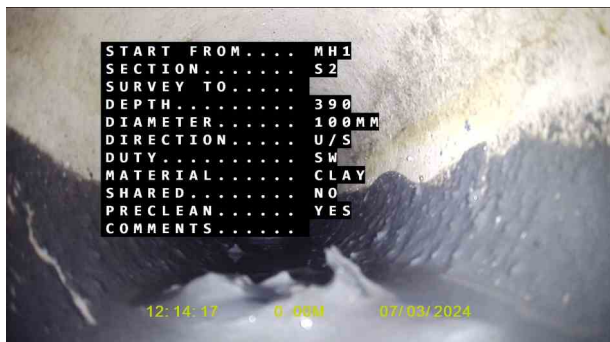
RWDP  
1X\_6deae217-9343-40da-a912-fdb09f344ae1\_20240319\_154  
318\_138.jpg, 00:00:00, 0.00 m  
Start node, manhole, reference: Manhole 1

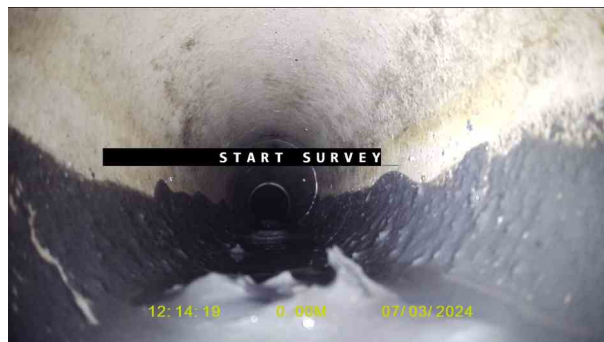
RWDP  
1X\_e5d2636f-a310-49d8-9c87-607ebf67bc42\_20240319\_154  
330\_287.jpg, 00:00:03, 0.00 m  
Water level, 0% of the vertical dimension

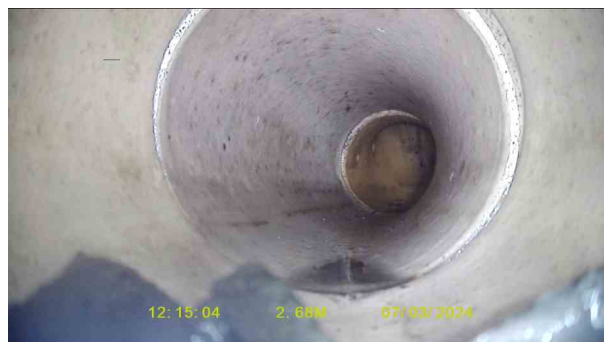
RWDP  
1X\_97b03119-96ed-4ddf-b5ce-a700e93d318b\_20240319\_154  
447\_033.jpg, 00:00:48, 2.68 m  
Line deviates right

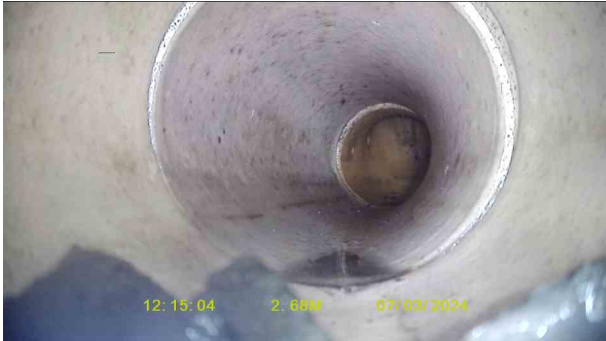
1X\_c88ebd88-327b-4f93-a59c-5d9d1b7d3717\_20240319\_154  
459\_289.jpg, 00:00:48, 2.68 m  
Joint displaced, medium

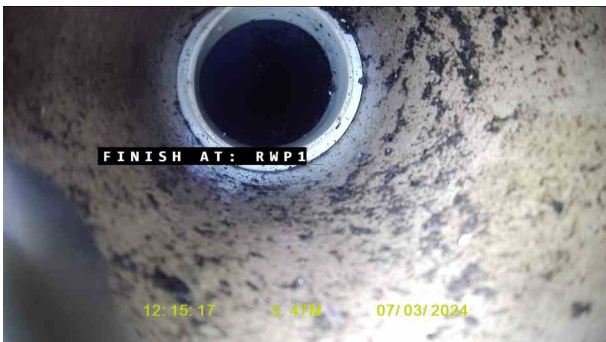
1X\_1a6a2252-5e23-438f-9184-62710305923a\_20240319\_15  
4543\_882.jpg, 00:01:01, 3.47 m  
Finish node, major connection without manhole, reference:  
RWDP 1

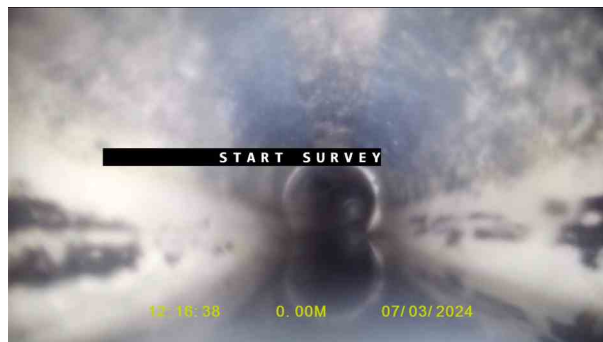
RWDP  
2X\_120f8a39-0d1d-448c-bfdc-e3a603941c36\_20240319\_154  
848\_226.jpg, 00:00:02, 0.00 m  
Water level, 5% of the vertical dimension

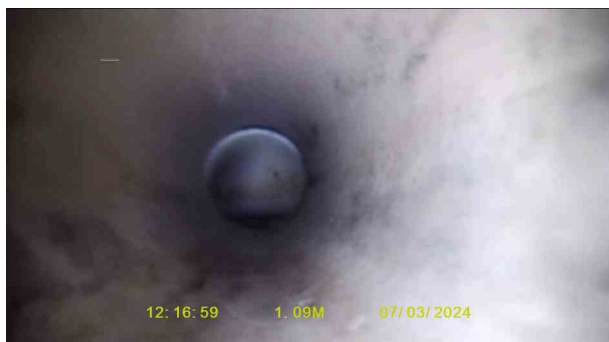
RWDP  
2X\_766ceac6-9b69-4eb0-b30d-f89f2424d652\_20240319\_154  
844\_696.jpg, 00:00:23, 1.09 m  
Water level, 0% of the vertical dimension

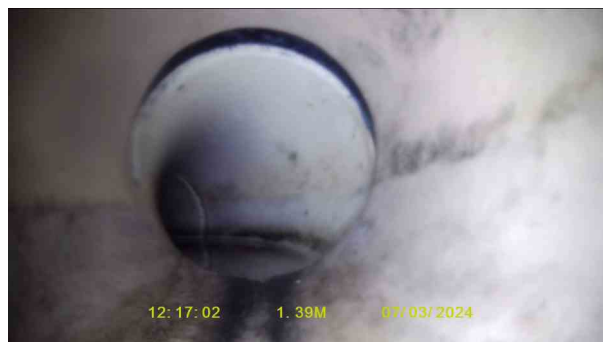
RWDP  
2X\_fa8ba669-2d8f-4e0b-81e0-f33b2e3c24cb\_20240319\_1549  
11\_092.jpg, 00:00:26, 1.38 m  
Open joint, medium

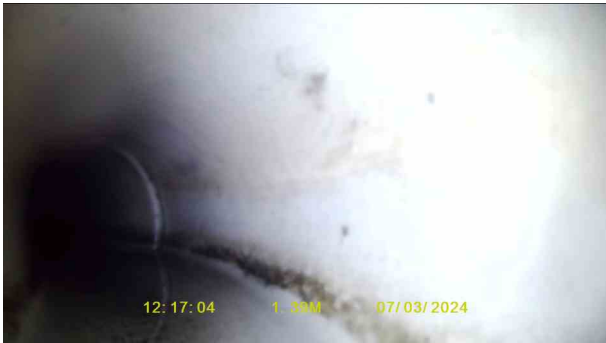
RWDP  
2X\_dc6a0483-51a9-48bb-8d05-fa5d8060842a\_20240319\_154  
926\_239.jpg, 00:00:29, 1.39 m  
Line deviates left

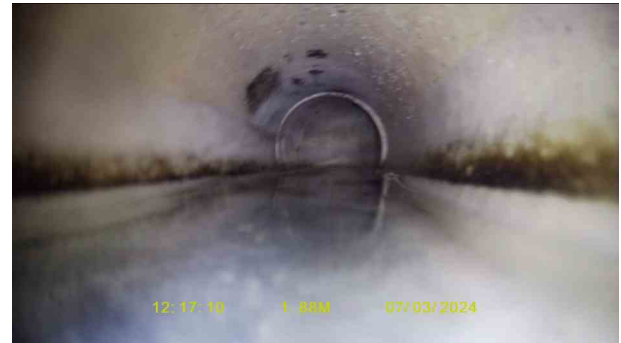
RWDP  
2X\_9fbec5db-38b8-4e31-b742-2a2926d9441f\_20240319\_154  
949\_655.jpg, 00:00:34, 1.88 m  
Water level, 20% of the vertical dimension

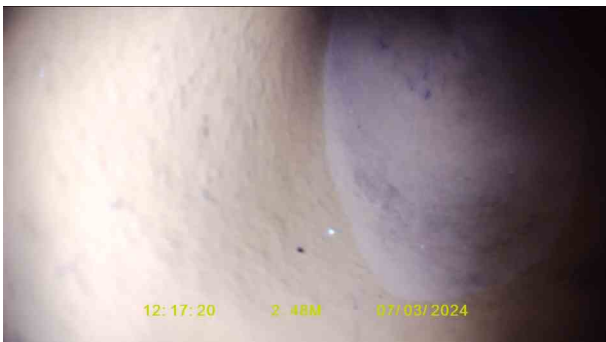
RWDP  
2X\_9c0cc65e-a9fc-46f7-ae64-2f922dedc7a6\_20240319\_1550  
30\_885.jpg, 00:00:45, 2.48 m  
Line deviates up, Rest Bend

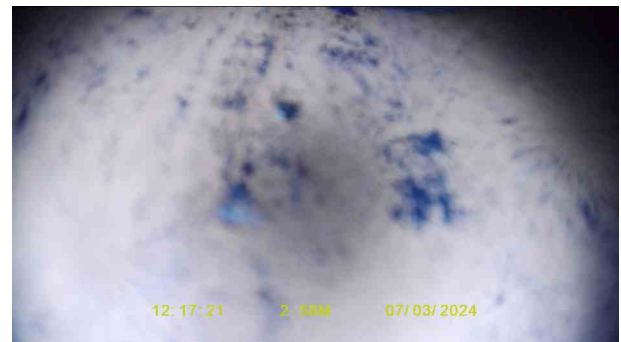
RWDP  
2X\_8bb81125-9563-48ef-a8ae-6fb3e7c92c27\_20240319\_155  
056\_094.jpg, 00:00:46, 2.58 m  
Line deviates up, Rest Bend

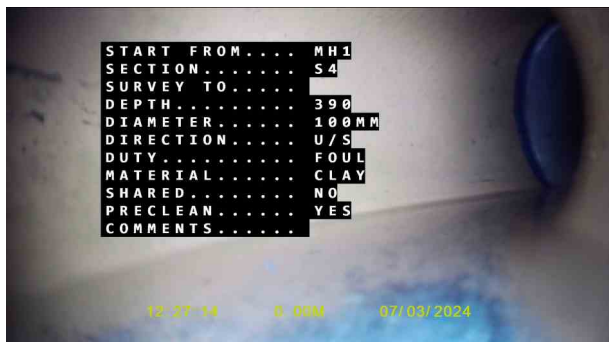
SVP  
1X\_7bd4c953-7834-4148-974c-1274ac895376\_20240319\_15  
5235\_345.jpg, 00:00:00, 0.00 m  
Start node, manhole, reference: Manhole 1

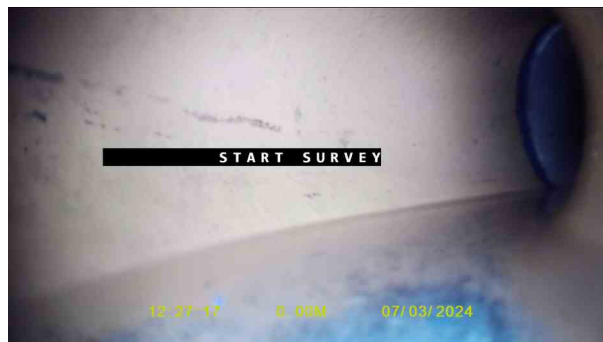
SVP  
1X\_5125d4a0-8112-4484-b823-44a4e98630e4\_20240319\_15  
5253\_070.jpg, 00:00:03, 0.00 m  
Water level, 5% of the vertical dimension

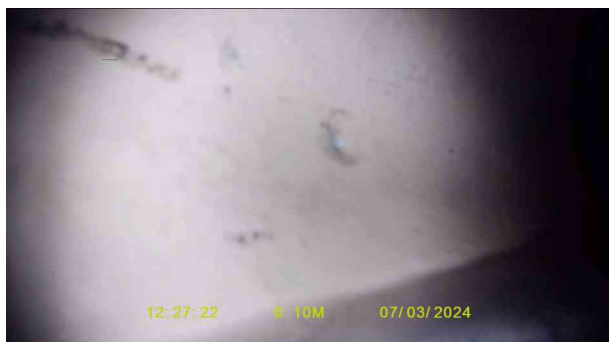
SVP  
1X\_0efc4dc4-3081-4c57-8146-677594ae97a4\_20240319\_155  
310\_676.jpg, 00:00:08, 0.10 m  
Line deviates right

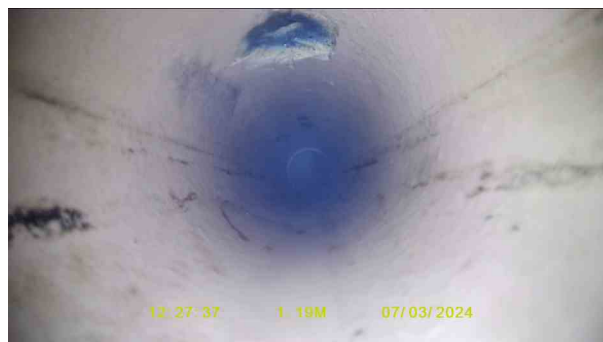
SVP  
1X\_6ab0d985-bda8-45b0-b6b3-ee43bb88a5e5\_20240319\_15  
5342\_769.jpg, 00:00:23, 1.19 m  
Hole in drain or sewer from 11 o'clock to 1 o'clock

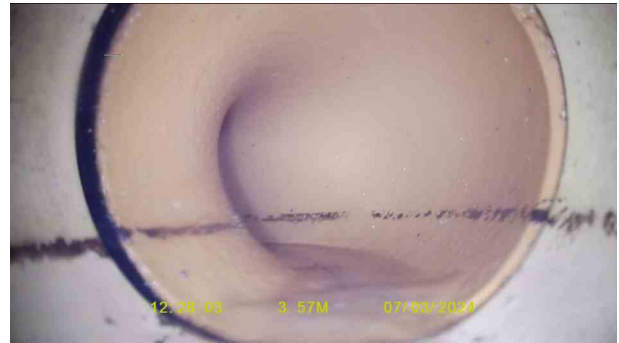
1X\_69c6ec58-d415-48b0-ac3c-edbab717ffaa\_20240319\_155  
448\_672.jpg, 00:00:48, 3.57 m  
Open joint, medium

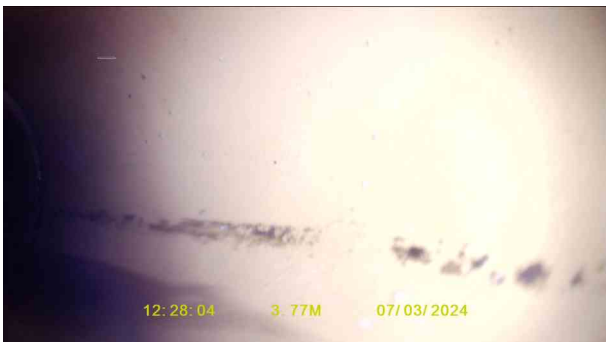
1X\_183e444f-2b2e-49f7-9e42-313583d1c459\_20240319\_155  
508\_827.jpg, 00:00:49, 3.77 m  
Line deviates left

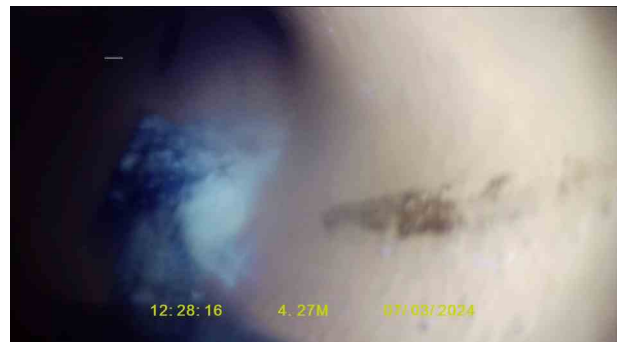
1X\_2b13a06d-4934-4526-8042-70e970110f29\_20240319\_15  
5546\_811.jpg, 00:01:02, 4.27 m  
Line deviates up, Rest Bend

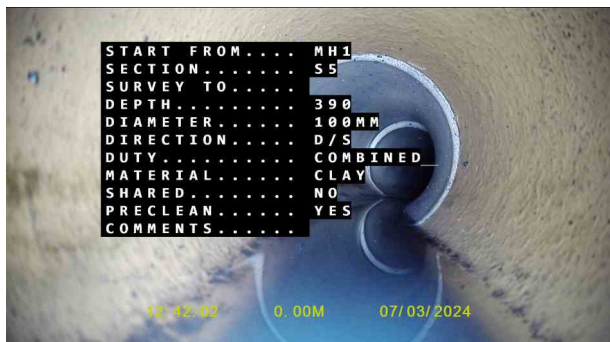
Manhole  
1X\_4d6101c3-7ba4-4013-adb3-41b2660797b2\_20240319\_16  
2405\_662.jpg, 00:00:00, 0.00 m  
Start node, manhole, reference: Manhole 1

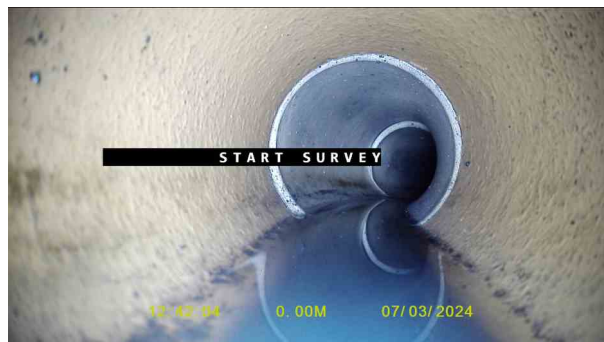
Manhole  
1X\_b684a182-9460-4678-a955-c75f56a6457b\_20240319\_162  
416\_487.jpg, 00:00:03, 0.00 m  
Water level, 5% of the vertical dimension

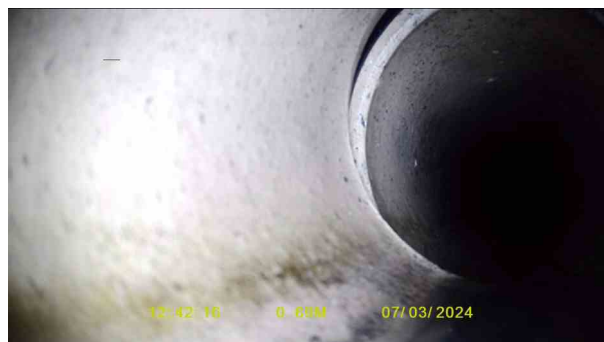
Manhole  
1X\_7bb2b75d-f8e4-46af-98ab-b3472451d36c\_20240319\_162  
457\_536.jpg, 00:00:16, 0.69 m  
Open joint, medium

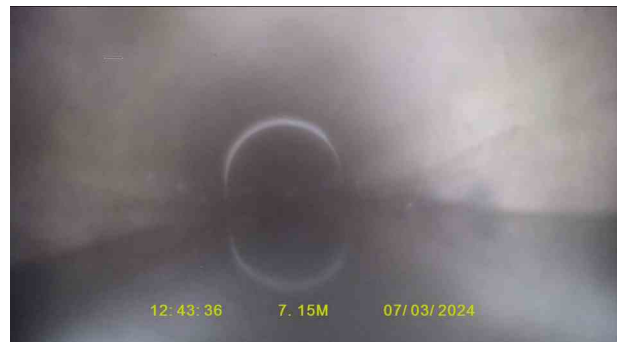
Manhole  
1X\_80a2f6b9-8e9f-4a09-93c1-8d9bbe17a727\_20240319\_162  
953\_043.jpg, 00:01:35, 7.15 m  
Water level, 20% of the vertical dimension

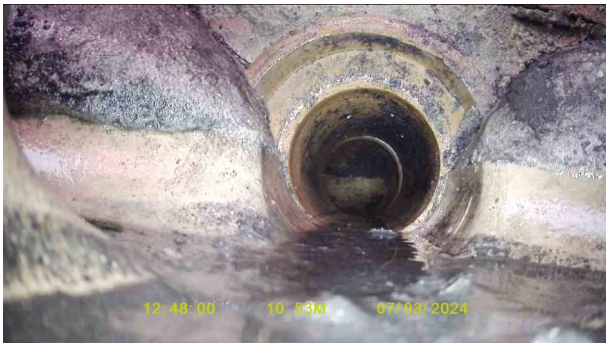
Manhole  
1X\_245adb34-42d7-4e86-a80d-f83f5ad719d1\_20240319\_163522\_052.jpg, 00:03:26, 10.53 m  
Finish node, manhole, reference: Manhole 2

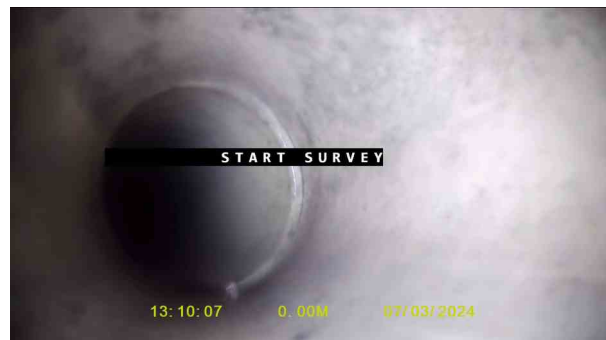
RWDP  
3X\_45ac6d64-5417-43ed-96d7-ce2675e34ed0\_20240319\_16  
3812\_035.jpg, 00:00:03, 0.00 m  
Water level, 0% of the vertical dimension

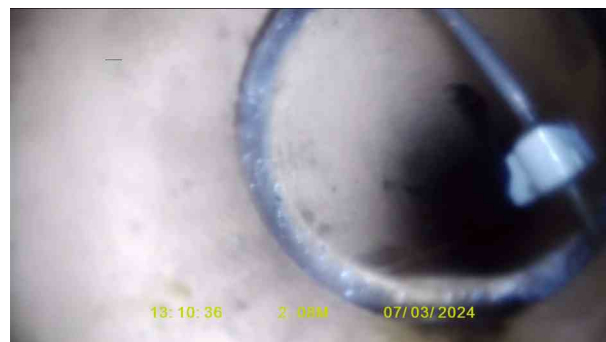
RWDP  
3X\_309eca70-1727-4a80-8d5f-45cb40712d1f\_20240319\_163  
925\_249.jpg, 00:00:26, 1.98 m  
Other obstacles at joint from 11 o'clock to 4 o'clock, 15% cross-sectional area loss, Piece of metal obstructing line

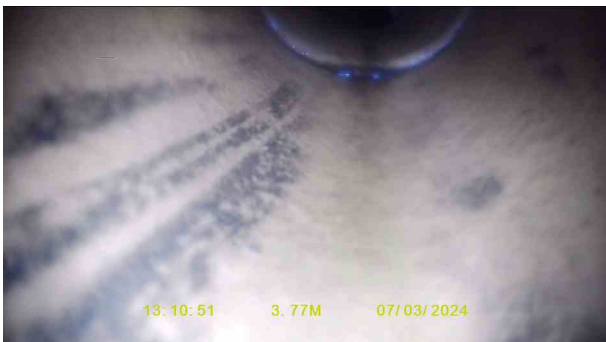
RWDP  
3X\_bd00792f-c217-433f-8a7e-ae7f67bbce1e\_20240319\_1641  
34\_207.jpg, 00:00:47, 3.77 m  
Line deviates up

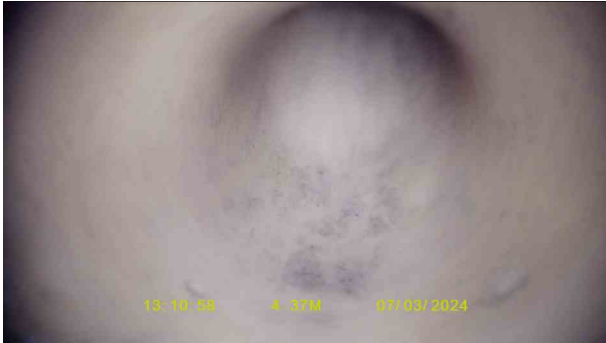
RWDP  
3X\_ccf954a8-0561-48b4-8ef0-9151b7da0c65\_20240319\_164  
223\_998.jpg, 00:00:54, 4.37 m  
Line deviates up, Rest Bend

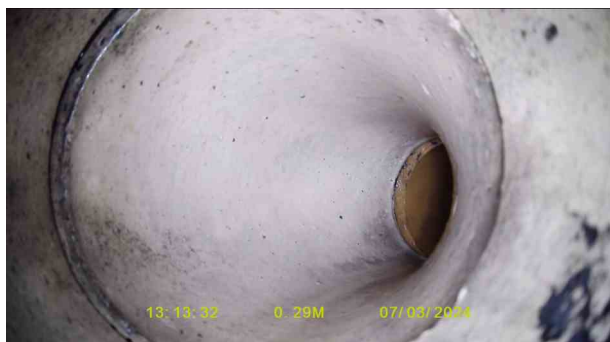
RWDP  
4X\_d06778ee-4b35-41b7-a975-a2ec3efeab10\_20240319\_170  
954\_011.jpg, 00:00:09, 0.29 m  
Line deviates right

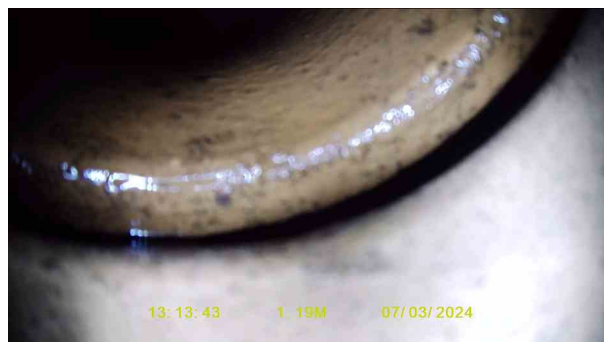
RWDP  
4X\_f5d31879-6314-4b1d-bd5e-a7c18aba2ff8\_20240319\_1710  
26\_337.jpg, 00:00:20, 1.19 m  
Open joint, medium

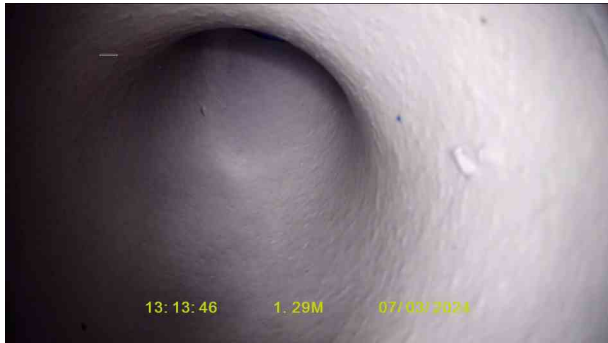
RWDP  
4X\_7f295baa-493c-471f-8fad-4155afe5b947\_20240319\_1710  
53\_652.jpg, 00:00:23, 1.29 m  
Line deviates up, Rest Bend

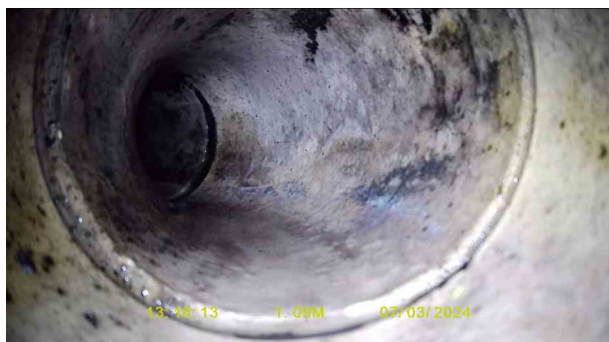
RWDP  
5X\_a73e251a-7853-489e-8a97-9fd8fc53a786\_20240320\_084  
421\_200.jpg, 00:00:18, 1.09 m  
Line deviates left

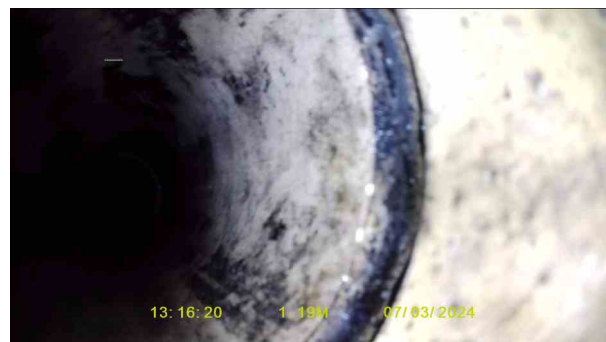
RWDP  
5X\_a0d25278-588e-4072-b231-051c097c0783\_20240320\_08  
442\_613.jpg, 00:00:24, 1.19 m  
Open joint, medium

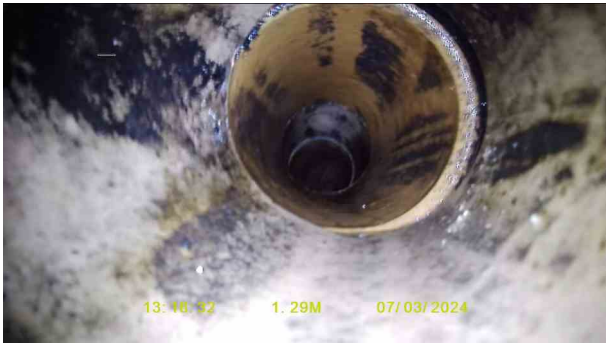
RWDP  
5X\_8e1fdab9-3f0d-4725-9729-8bc467dd17ad\_20240320\_084  
524\_241.jpg, 00:00:36, 1.29 m  
Open joint, medium

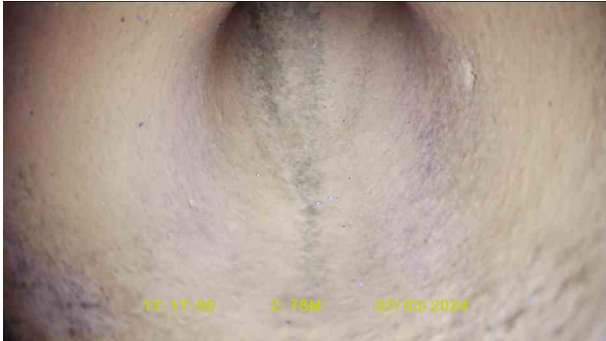
RWDP  
5X\_e9d00c25-dfd7-415e-8d43-ba3a9e961f53\_20240320\_085  
124\_508.jpg, 00:01:04, 2.78 m  
Line deviates up, Rest Bend

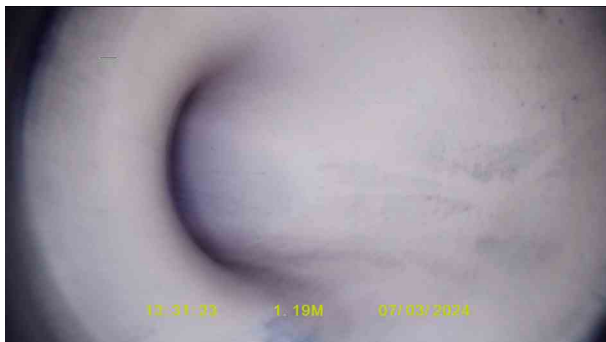
RWDP  
6X\_2365787b-1275-45ba-a88b-d780263c10a4\_20240320\_09  
4057\_890.jpg, 00:00:24, 1.19 m  
Line deviates left

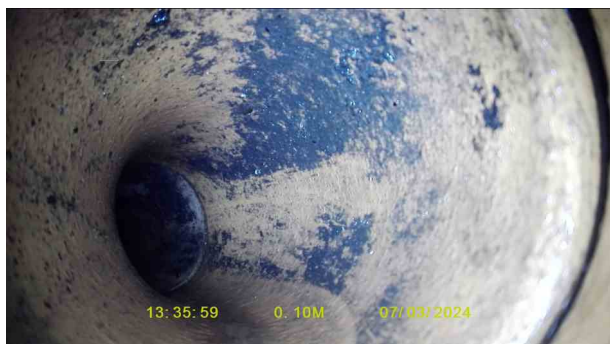
Open joint, medium

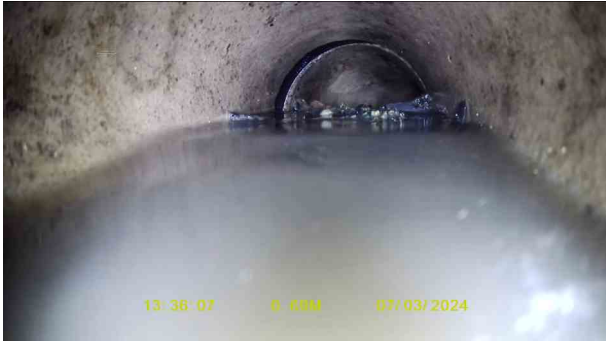
Manhole  
2X\_e180e7ba-86a9-4a04-bb00-ab7548002c6b\_20240320\_095628\_250.jpg, 00:00:16, 0.69 m  
Water level, 30% of the vertical dimension

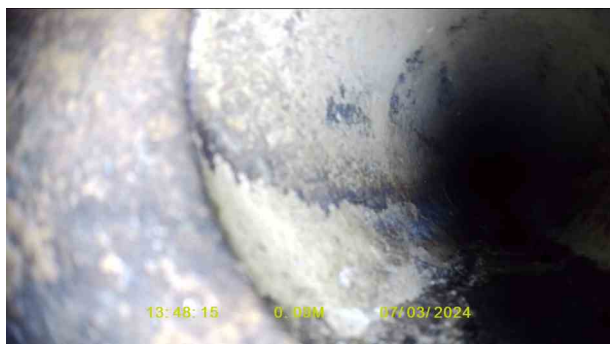
SVP  
2X\_e701ce62-48ed-4728-9bb5-4982212dbe85\_20240320\_10  
0724\_664.jpg, 00:00:09, 0.09 m  
Line deviates right

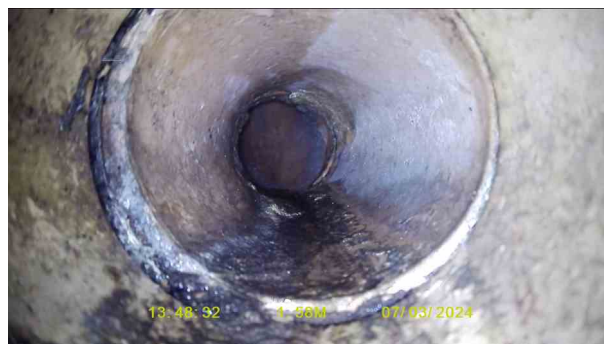
SVP  
2X\_a88911fc-7bdd-4968-9c5c-85725a0da2c7\_20240320\_100  
809\_241.jpg, 00:00:26, 1.49 m  
Open joint, medium

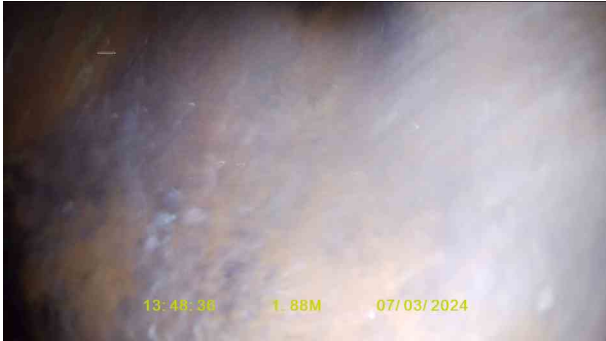
SVP  
2X\_1853355a-2981-4dec-9ee5-243edb5a1210\_20240320\_10  
0833\_328.jpg, 00:00:30, 1.88 m  
Line deviates up, Rest Bend

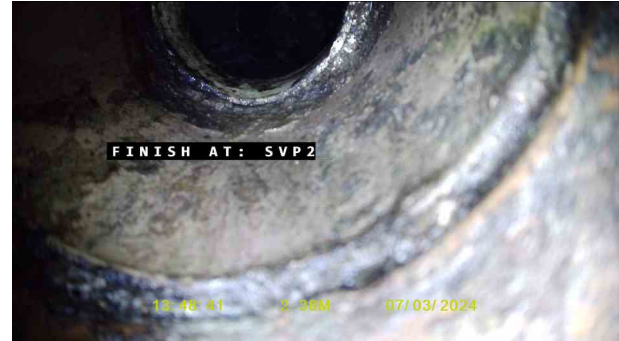
SVP  
2X\_ac865a6e-8d8f-4034-add3-ca4ed32e6d45\_20240320\_100  
851\_523.jpg, 00:00:34, 2.38 m  
Finish node, major connection without manhole, reference:  
SVP 2

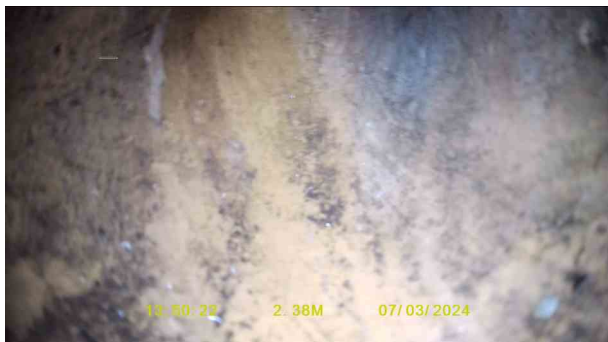
SVP  
3X\_8c09b435-3ca2-4c57-881b-727da00f3e23\_20240320\_102  
039\_070.jpg, 00:00:50, 2.38 m  
Line deviates up, Rest Bend

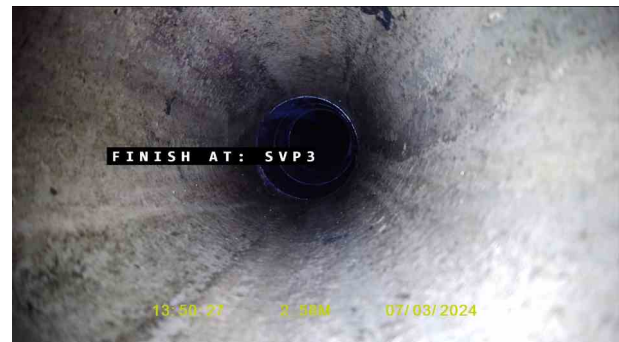
SVP  
3X\_764482d2-3d2c-42e2-a294-b01bbf186412\_20240320\_102  
102\_830.jpg, 00:00:54, 2.58 m  
Finish node, major connection without manhole, reference:  
SVP 3

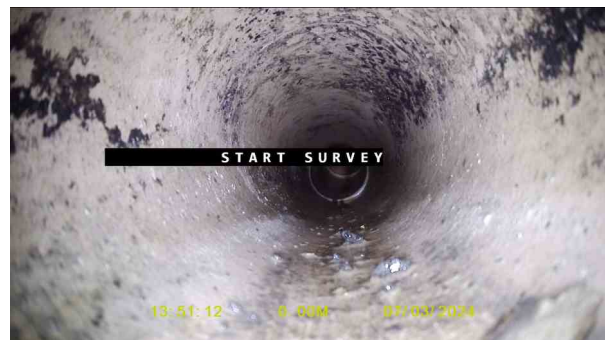
Gully  
1X\_41f2f058-b35d-4f7a-9dfd-b0af0b8541fe\_20240320\_10224  
4\_456.jpg, 00:00:05, 0.00 m  
Water level, 0% of the vertical dimension

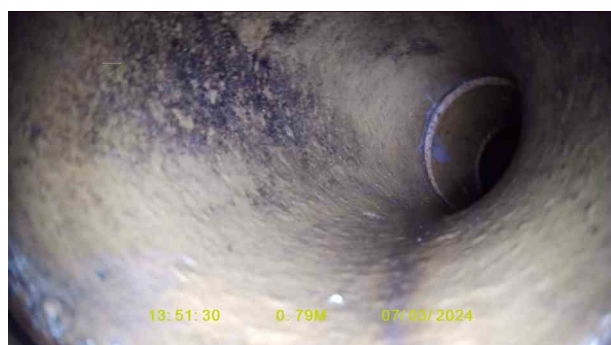
Gully  
1X\_913665fd-2640-4e67-b9ce-91c4f60e597c\_20240320\_102  
341\_246.jpg, 00:00:23, 0.79 m  
Line deviates right

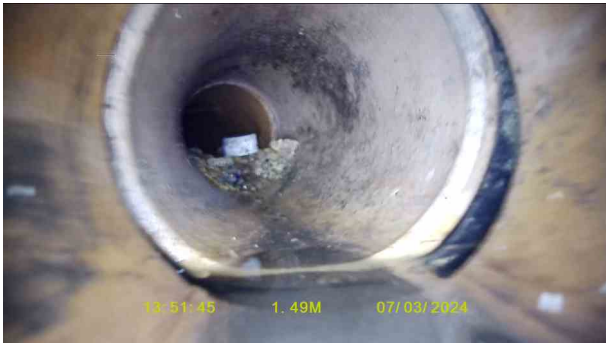
Gully  
1X\_ce571131-df52-4d57-822c-c7a8c5ad5515\_20240320\_102  
503\_528.jpg, 00:00:38, 1.49 m  
Open joint, large

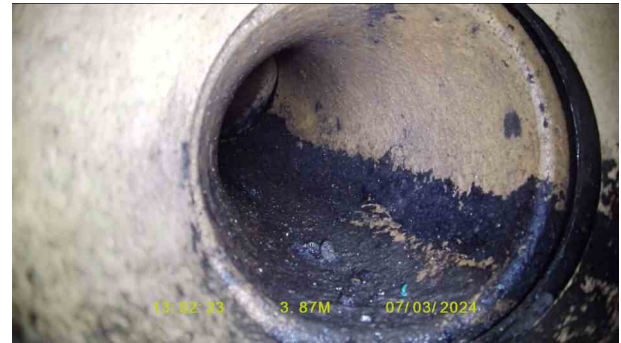
Gully  
1X\_b7f24a29-3480-45ed-9ae3-af38404f719a\_20240320\_102  
758\_513.jpg, 00:01:16, 3.87 m  
Open joint, large

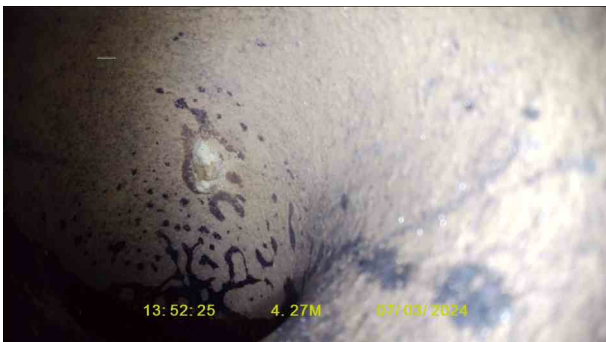
Gully  
1X\_fb08b2d2-a9f9-436d-bd3c-e0fa9a2c2510\_20240320\_1029  
22\_567.jpg, 00:01:18, 4.27 m  
Finish node, gully, reference: Gully 1

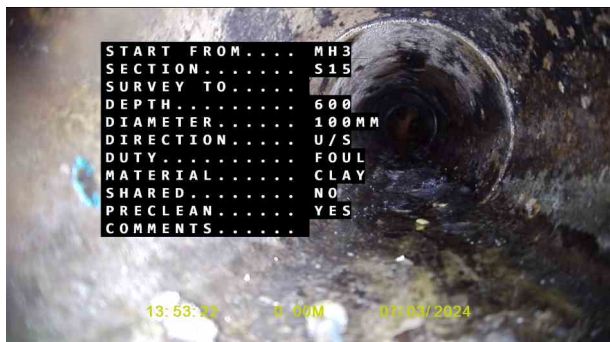
SVP

Start node, manhole, reference: Manhole 3

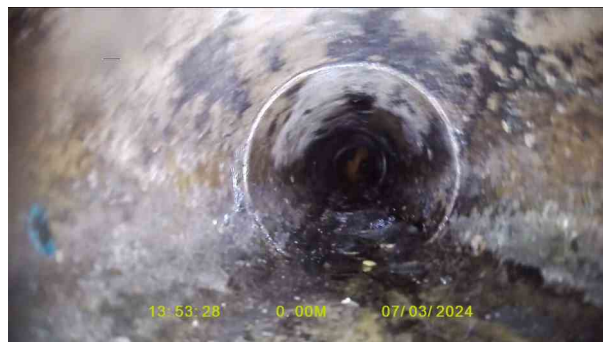
SVP

Water level, 0% of the vertical dimension

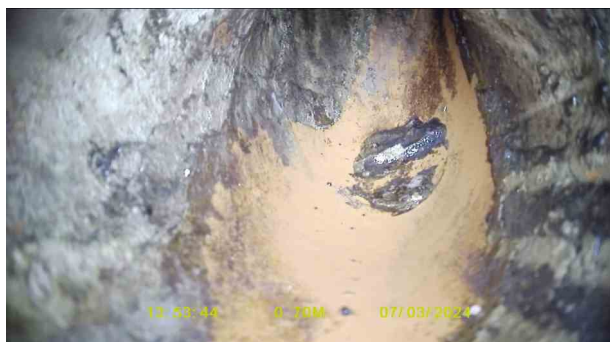
SVP

Line deviates up

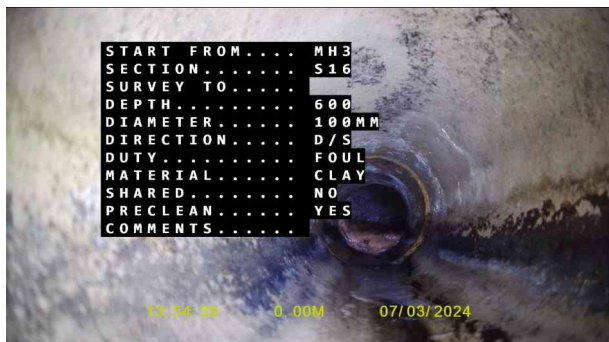
Manhole  
3X\_12842336-abf2-45fb-84b0-83f78cc49ba8\_20240320\_1036  
28\_451.jpg, 00:00:00, 0.00 m  
Start node, manhole, reference: Manhole 3

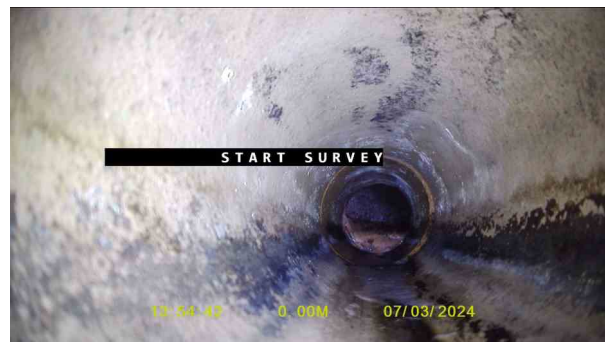
Manhole  
3X\_44409749-1ceb-407c-a097-f7767082c0fc\_20240320\_103  
639\_718.jpg, 00:00:03, 0.00 m  
Water level, 0% of the vertical dimension

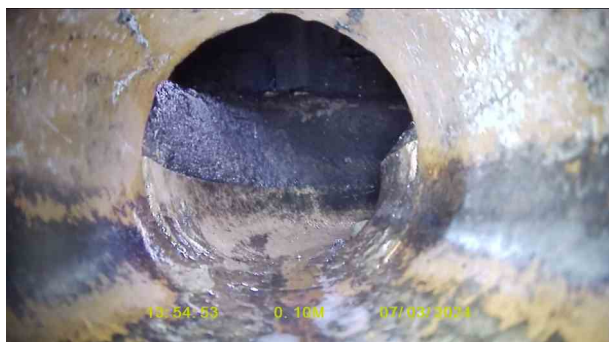
Manhole  
3X\_74ec6c76-09a0-4968-a7fd-79c163981c3e\_20240320\_103  
722\_672.jpg, 00:00:13, 0.10 m  
Line deviates right

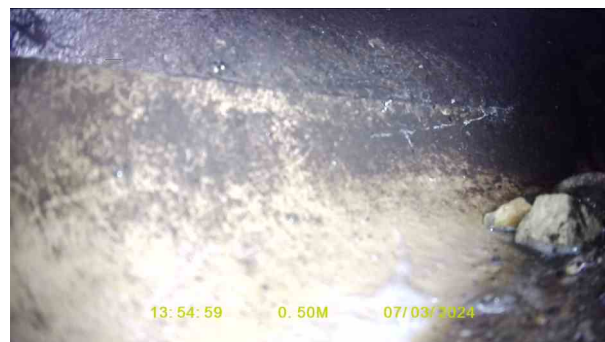
Manhole  
3X\_3570854f-b8d7-4fc6-a521-be4dba34f3e8\_20240320\_1037  
52\_149.jpg, 00:00:19, 0.50 m  
Finish node, manhole, reference: Manhole 4

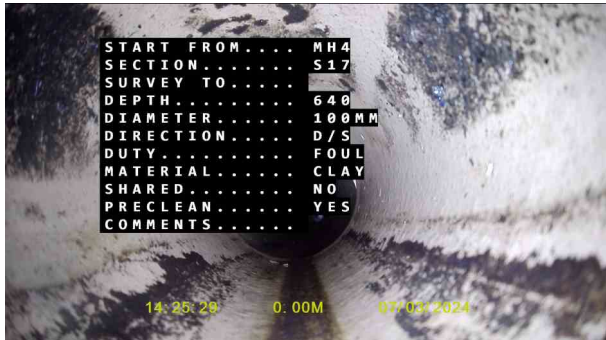
Manhole  
4X\_2e843ea6-c5e3-4873-839c-892c0a61098a\_20240320\_104306\_183.jpg, 00:00:00, 0.00 m  
Start node, manhole, reference: Manhole 4

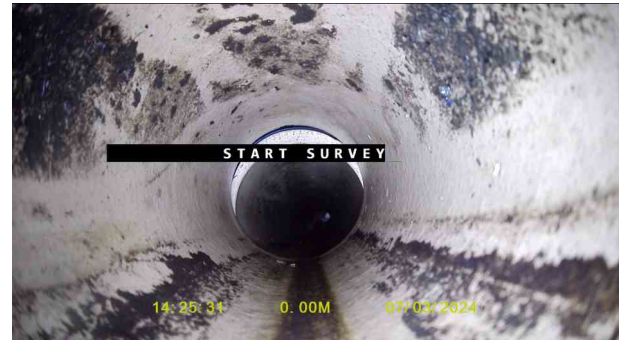
Manhole  
4X\_f07848c6-1dfe-4669-8032-c440a459f597\_20240320\_104317\_089.jpg, 00:00:03, 0.00 m  
Water level, 0% of the vertical dimension

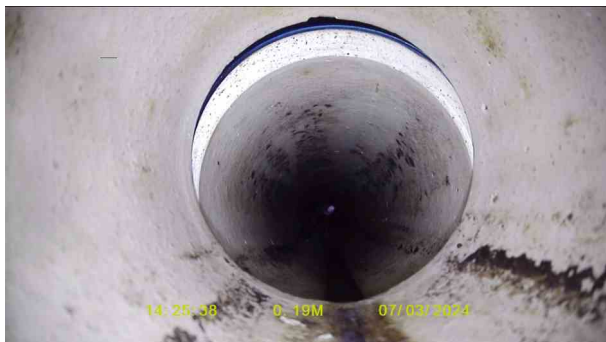
Manhole  
4X\_4bd82246-b6d0-42a2-a844-e36aa7aeacc7\_20240320\_104337\_194.jpg, 00:00:10, 0.19 m  
Joint displaced, large

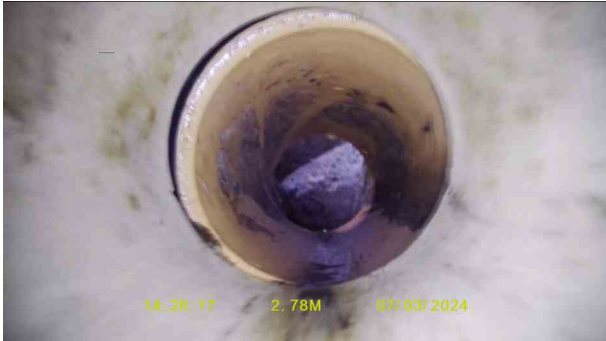
Manhole  
4X\_cf104af0-a512-4305-bd94-7e1f9818d2d6\_20240320\_1045  
47\_211.jpg, 00:00:49, 2.78 m  
Open joint, medium

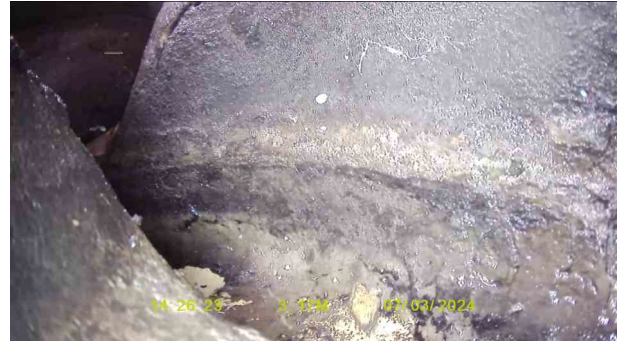
Manhole  
4X\_4b661bed-236d-4e69-a513-e573027e07ed\_20240320\_10  
4618\_877.jpg, 00:00:55, 3.27 m  
Finish node, manhole, reference: Manhole 5

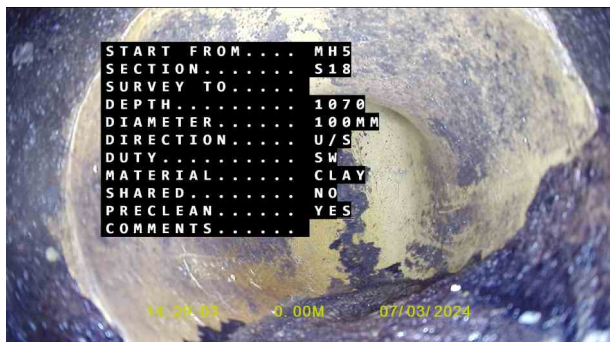
RW Gully

Start node, manhole, reference: Manhole 5

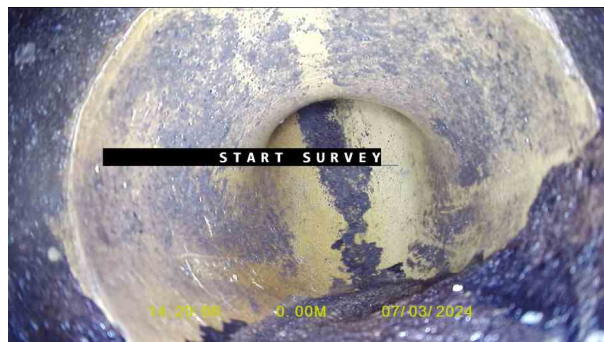
RW Gully

Water level, 0% of the vertical dimension

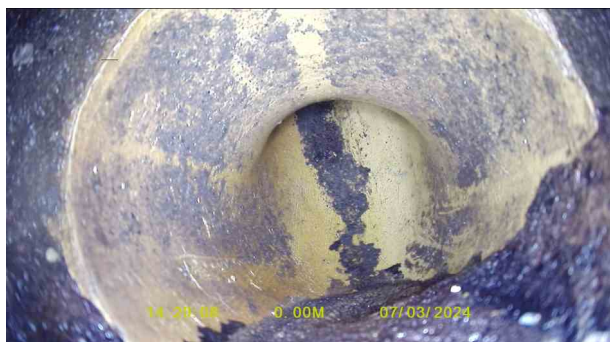
RW Gully

Attached deposits, encrustation from 4 o'clock to 8 o'clock,  
10% cross-sectional area loss

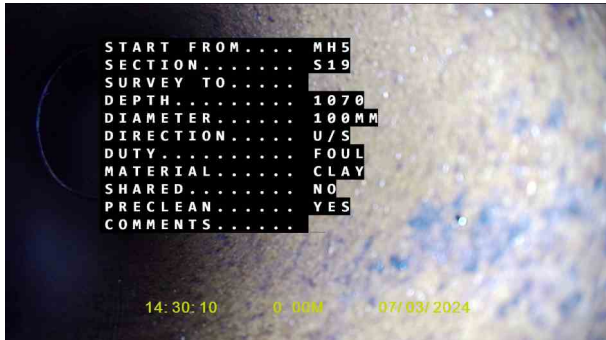
W\_C  
1X\_8b5ef4d2-718b-4aaf-a430-8733f2922820\_20240320\_105  
110\_650.jpg, 00:00:00, 0.00 m  
Start node, manhole, reference: Manhole 5

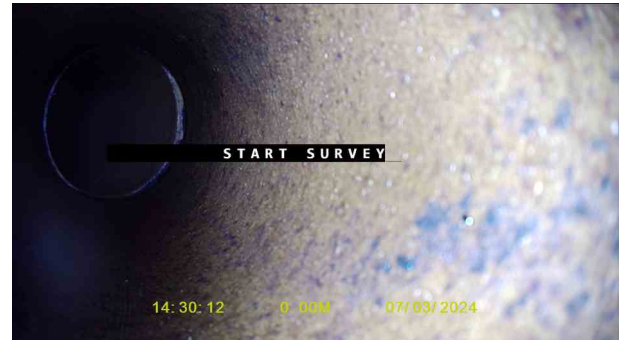
W\_C  
1X\_9e7b8f54-4172-4b66-ae6b-d668c4bcc8d2\_20240320\_105  
120\_114.jpg, 00:00:02, 0.00 m  
Water level, 0% of the vertical dimension

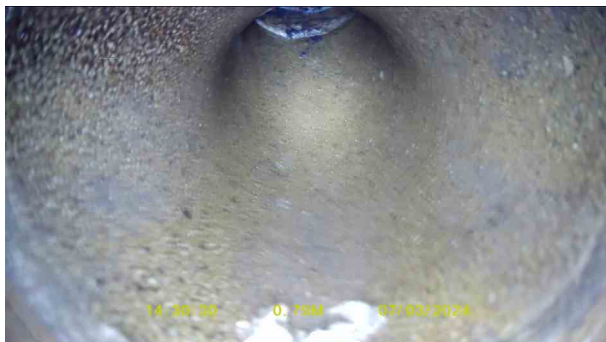
W\_C  
1X\_80d39d97-e96c-492b-abb8-5f675cabbb9c\_20240320\_105  
226\_973.jpg, 00:00:20, 0.79 m  
Line deviates up, Rest Bend

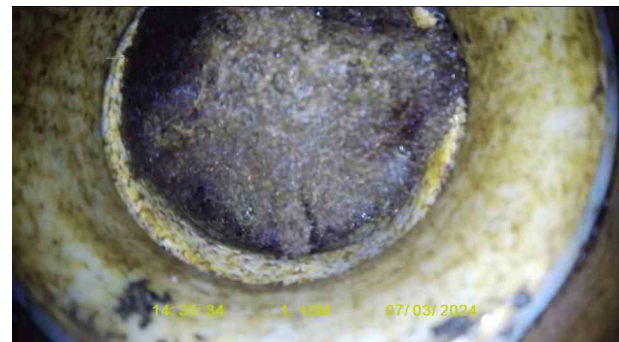
W\_C  
1X\_aaa76632-5ff0-491a-8aba-b264518172a9\_20240320\_105  
334\_858.jpg, 00:00:24, 1.19 m  
Settled deposits, coarse, 90% cross-sectional area loss

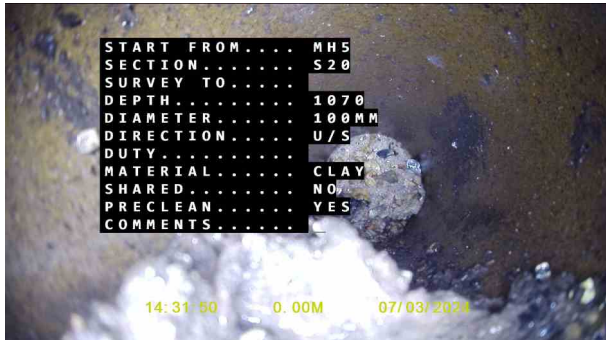
RedundantX\_ad55494e-de16-40e7-a006-b6f6dbd9338b\_2024  
0320\_105748\_471.jpg, 00:00:00, 0.00 m  
Start node, manhole, reference: Manhole 5

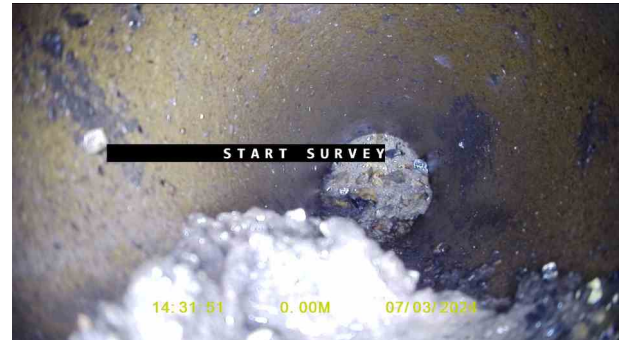
RedundantX\_170ee3f4-26ea-4fef-b0b1-4a7ae0961de6\_20240  
320\_110644\_202.jpg, 00:00:02, 0.00 m  
Water level, 0% of the vertical dimension

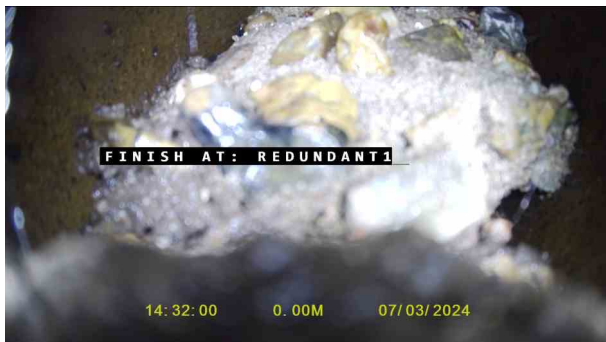
RedundantX\_3c3c4071-af70-486b-96fd-4a91d8ae9a41\_2024  
0320\_110639\_139.jpg, 00:00:12, 0.09 m  
Survey abandoned, Line is redundant#

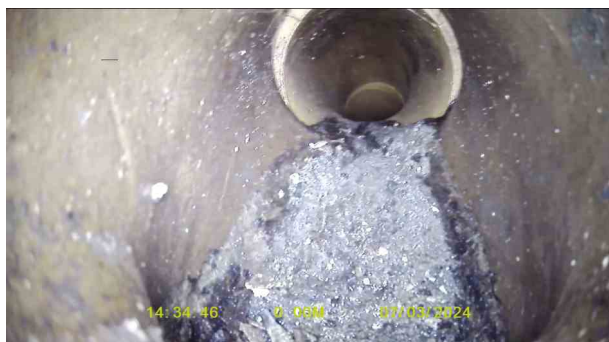
Manhole  
5X\_58e5fa59-be5e-434e-8fd9-ab32cc1e031b\_20240320\_111  
348\_530.jpg, 00:00:10, 0.10 m  
General remark, Drops into main channel

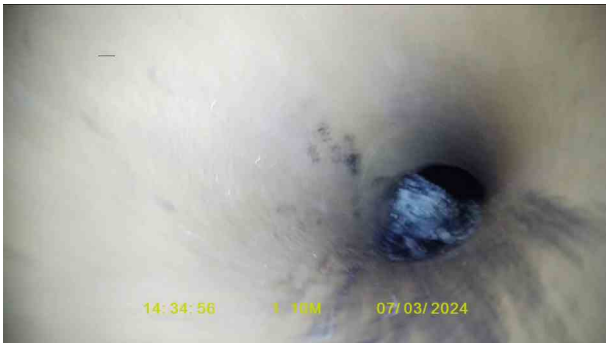
Manhole  
5X\_56eb968e-8c13-4651-a0f5-145292a4b94e\_20240320\_111  
540\_066.jpg, 00:00:20, 1.10 m  
Line deviates right

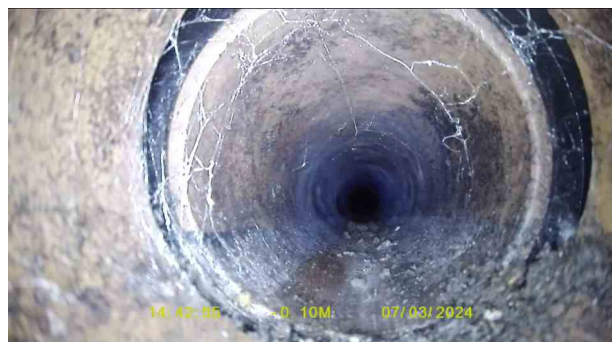
Open joint, large

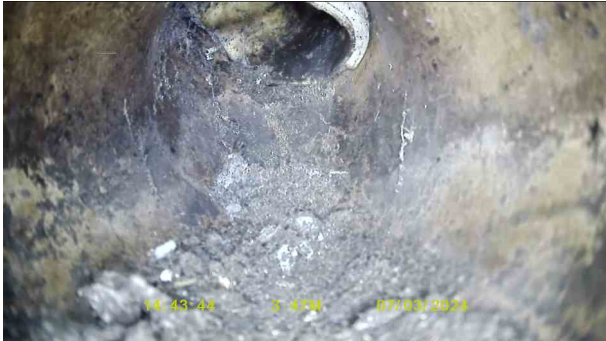
SVP  
5X\_79afa480-b583-46b9-a2de-ba887e197790\_20240320\_11  
2311\_885.jpg, 00:00:57, 3.47 m  
Line deviates up, Rest Bend

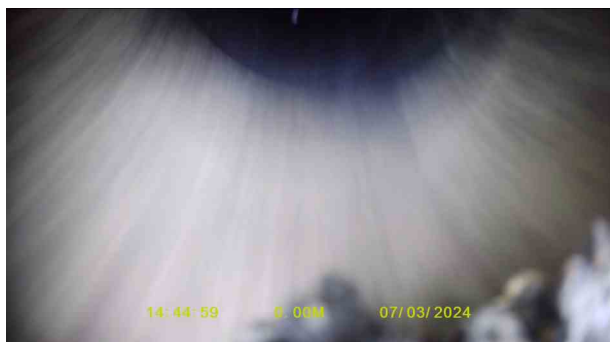
SVP  
6X\_94780432-1803-47ab-a24f-15b1bd62ac64\_20240320\_112  
713\_436.jpg, 00:00:07, 0.02 m  
Line deviates up, Rest Bend

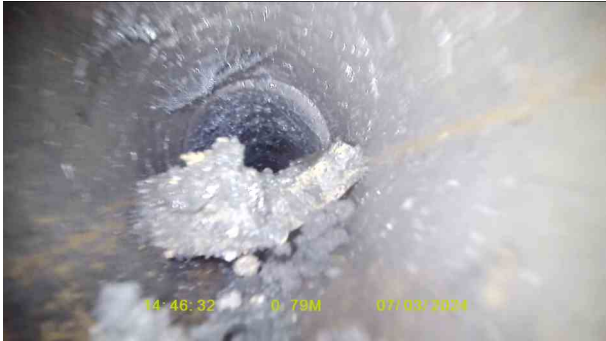
6X\_70dea177-2732-46dc-bce3-30cee12904c0\_20240320\_123809\_849.jpg, 00:00:42, 0.79 m  
Settled deposits, coarse, 15% cross-sectional area loss

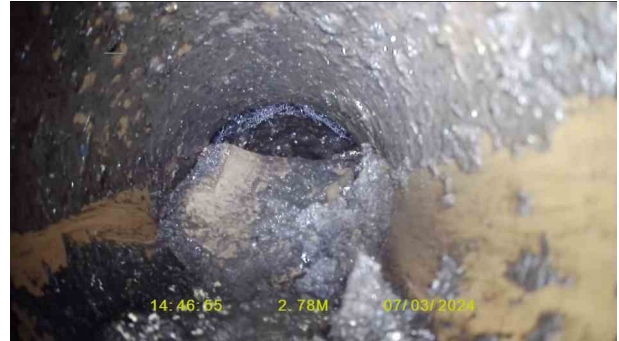
6X\_9bf221ea-a255-4de5-b90b-8ed6e0a9e4c2\_20240320\_123859\_690.jpg, 00:01:05, 2.78 m  
Survey abandoned, Camera unable to push further

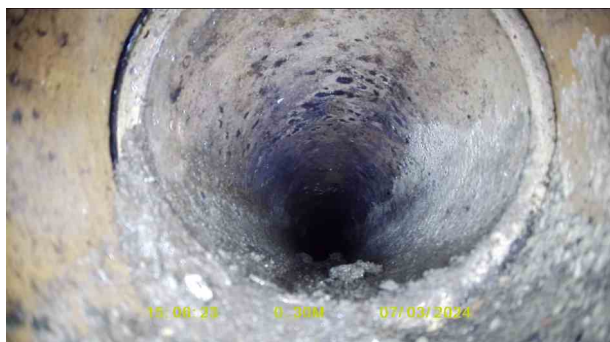
SVP  
7X\_efdaccdd-08b8-4519-a31f-c7a016f1bbbc9\_20240320\_1241  
50\_253.jpg, 00:00:13, 0.30 m  
Open joint, medium

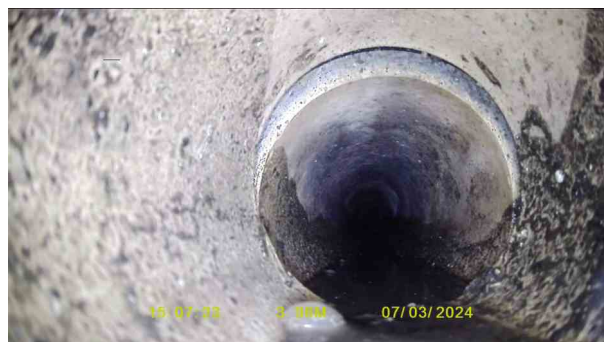
SVP  
7X\_0f50c5e0-7b5b-47e4-bf2e-5a8a5dffc9bf\_20240320\_12430  
3\_784.jpg, 00:01:12, 3.98 m  
Open joint, medium

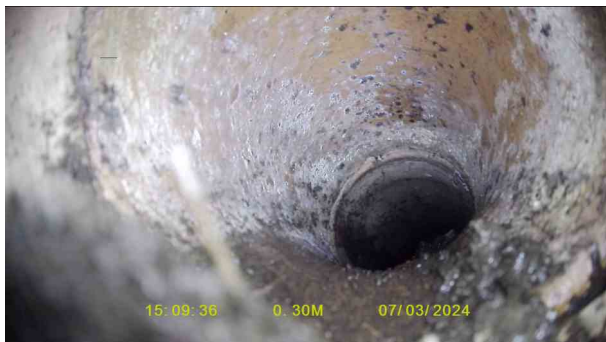
RedundantX\_bfcb4812-3e59-4124-8a38-283a3c0081ef\_2024  
0320\_124609\_171.jpg, 00:00:11, 0.30 m  
Line deviates right

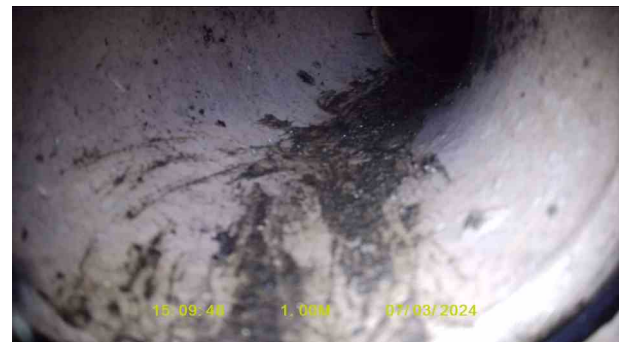
RedundantX\_c8767487-f8e0-44a2-9499-a46fabd9522c\_2024  
0320\_124639\_995.jpg, 00:00:22, 1.00 m  
Line deviates right

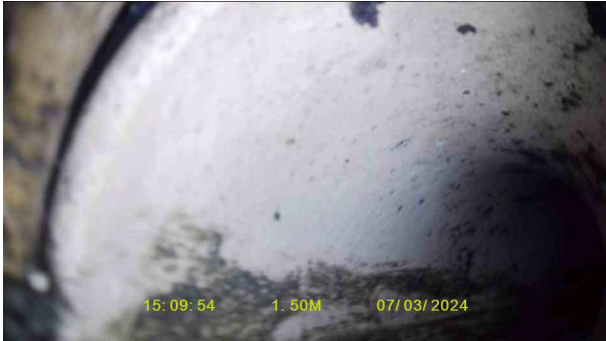
RedundantX\_45daddc0-a30b-440e-9c03-29c6df6e0539\_2024  
0320\_124658\_187.jpg, 00:00:28, 1.50 m  
Line deviates right

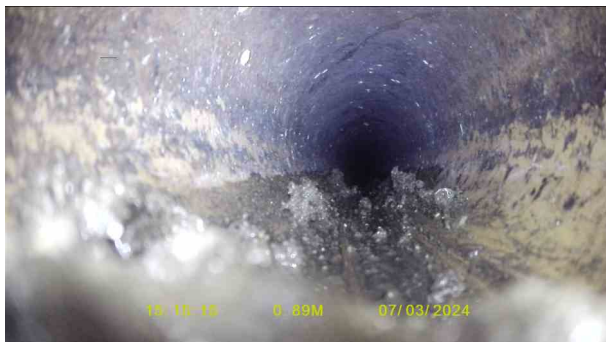
Manhole  
7X\_4cc60a64-7052-48d9-8096-f8aa2f18c6fa\_20240320\_1251  
09\_892.jpg, 00:00:22, 0.89 m  
Settled deposits, coarse, 10% cross-sectional area loss

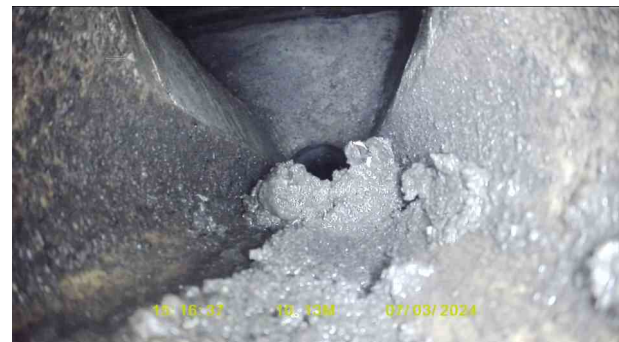
Manhole  
7X\_4631b8ee-d8a7-41d9-aef7-febc9e868cdd\_20240320\_125  
256\_481.jpg, 00:01:43, 10.10 m  
Settled deposits, fine, 15% cross-sectional area loss

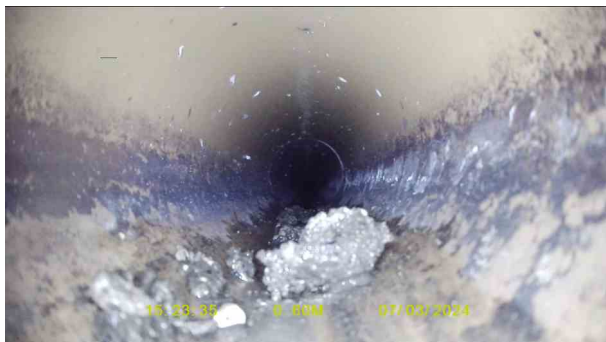
Manhole  
8X\_de174dfa-a69e-437a-aa01-28f535455762\_20240320\_125  
546\_643.jpg, 00:00:12, 0.47 m  
Settled deposits, coarse, 10% cross-sectional area loss

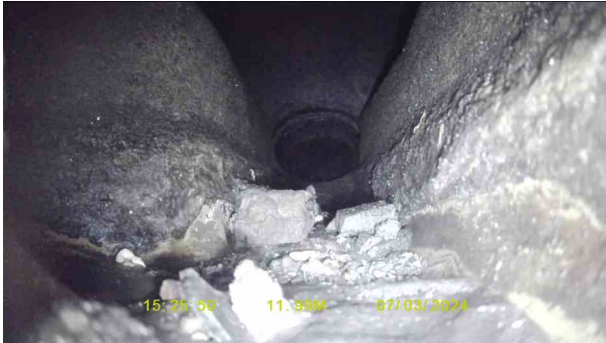
Manhole

8X\_2ed27f3a-dc91-4f5d-a83d-80b7d6eafe42\_20240320\_1309  
39\_849.jpg, 00:02:27, 12.05 m  
Settled deposits, coarse, 15% cross-sectional area loss

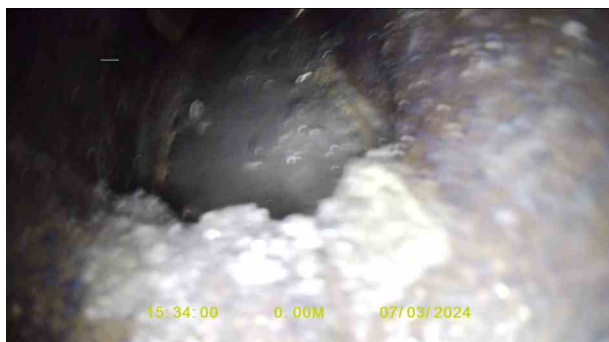
Manhole  
9X\_9d39f0eb-aa45-4037-846e-71f5da7da15f\_20240320\_131357\_401.jpg, 00:00:13, 0.06 m  
General remark, Drops into main channel

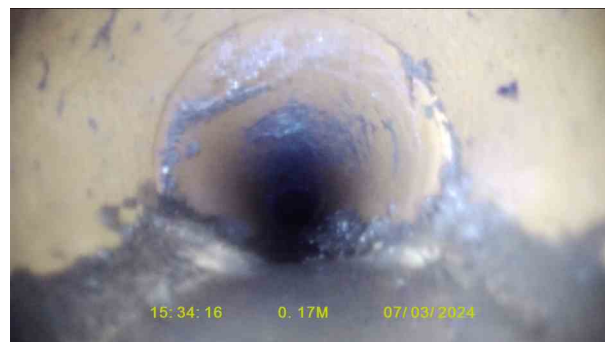
Manhole  
9X\_db496bb9-53d4-446d-9bc7-6258fdb40230\_20240320\_131438\_318.jpg, 00:00:29, 0.17 m  
Attached deposits, encrustation from 5 o'clock to 9 o'clock, 15% cross-sectional area loss

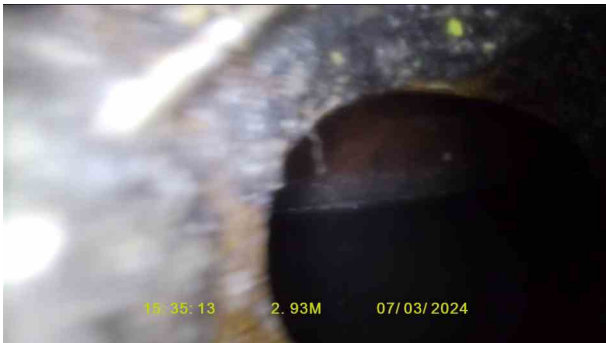
Manhole  
 9X\_24c0d3f5-80ff-4a2a-b965-53c5cd5ef516\_20240320\_1319  
 13\_907.jpg, 00:01:26, 2.93 m  
 General remark, Drops into main line via junction

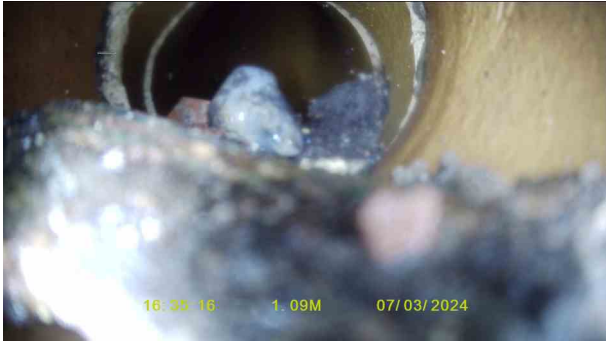
RWDP

7X\_cfc69e7d-1590-4ed5-9c1d-cdacc4fb7508\_20240320\_1327  
25\_410.jpg, 00:00:18, 1.09 m

Settled deposits, coarse, 10% cross-sectional area loss

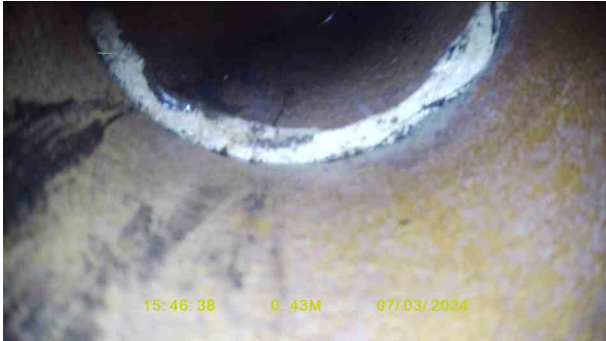
RedundantX\_82090881-853e-4d21-ba09-6dc7d0556101\_202  
40320\_134427\_893.jpg, 00:00:22, 0.43 m  
Survey abandoned, Line is redundant

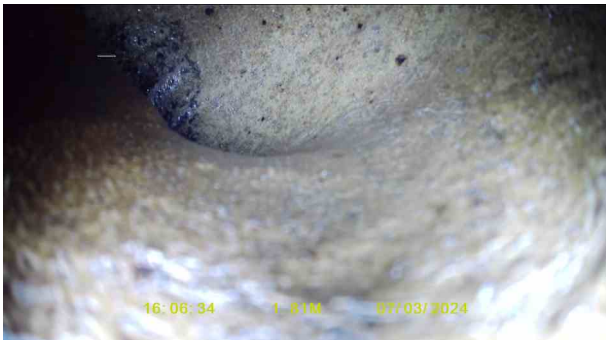
RedundantX\_a7706047-31ab-4719-a32b-0bd0bdfd8916\_2024  
0320\_135054\_566.jpg, 00:00:35, 1.81 m  
Survey abandoned, Line is redundant
